Bembridge Section 19 Flood Investigation

Final Report

May 2022

Isle of Wight Council

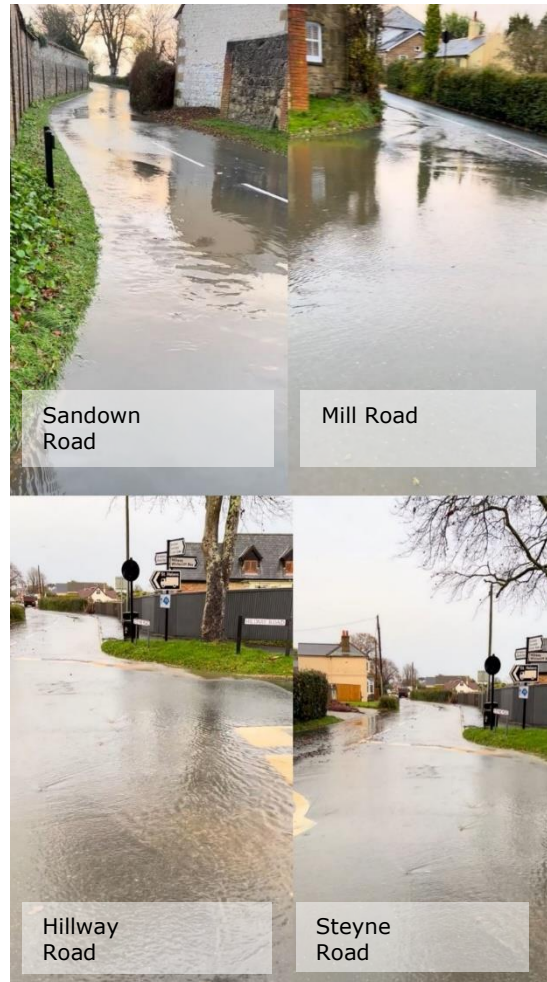
The flow path at Steyne Road is shown in Figure 4-2 above as a largely constrained flow path following the route of Steyne Road to Lane End before flowing out to sea. The upstream convergence of flows from the roundabout at Steyne Road is shown clearly in the photographs in Figure 4-3.

Figure 4-3: Converging flows at Steyne Road (undated)

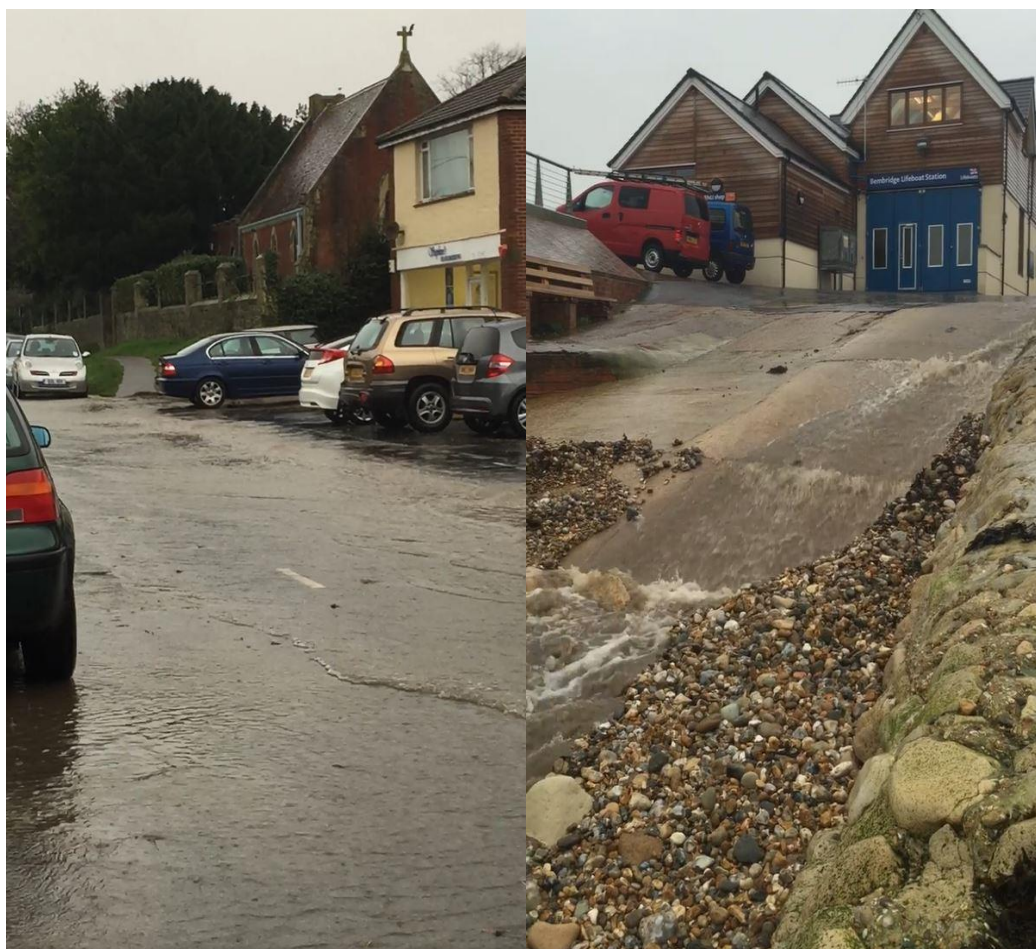
The surface water continues to flow northeast from Steyne Road to Lane End Road and then to Bembridge Lifeboat Station (Figure 4-4). The locations of these photographs can be seen on Figure 8-2.

Figure 4-4: Lane End Road and Bembridge Lifeboat Station (undated)

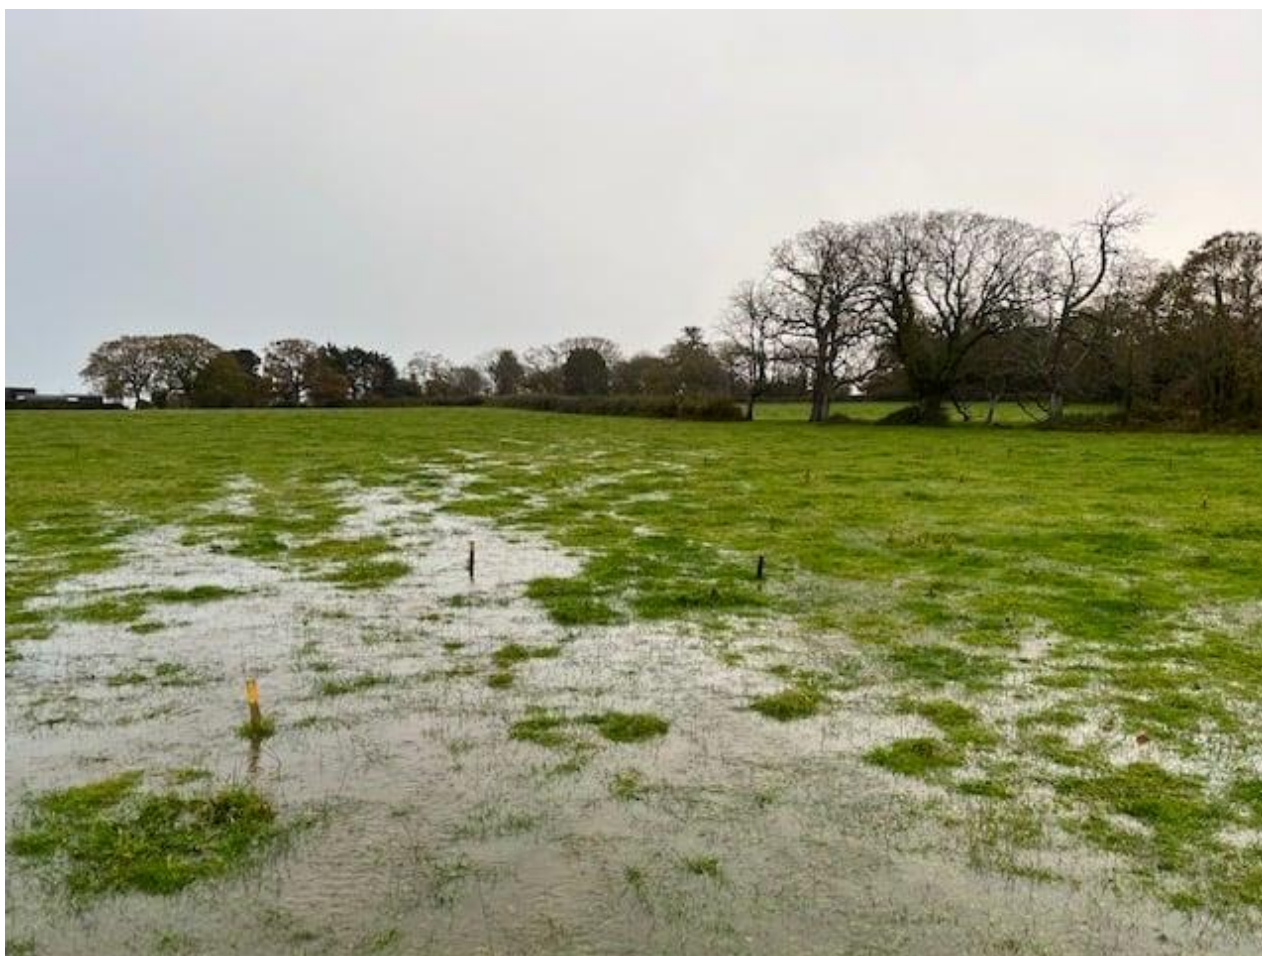
The respondents to the survey have identified surface water runoff from surrounding fields as a source of flooding. This includes the field to the south of Steyne Road (Figure 8-3).

Figure 8-3: Field to the south of Steyne Road

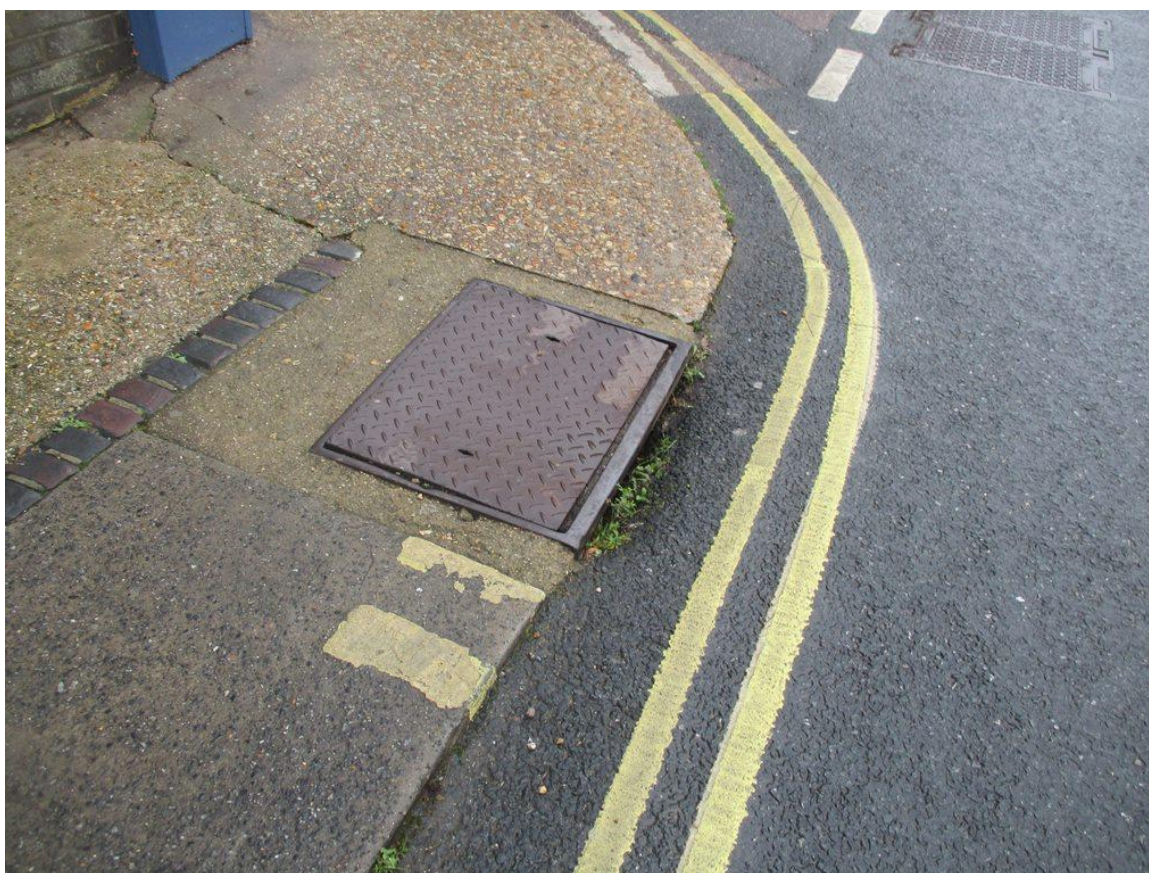
Gravel washed into the highway drainage system was raised as a concern by local residents. Reports also mentioned that the openings to in-kerb slot drains (locally referred to as letterboxes) were too narrow for the volume of surface water to enter the highway drainage system, with inefficient openings around High Street down to Solent Landing (Figure 8-4) and separately at Hillway. As a result, rather than surface water entering the highway drainage system, it followed the flow paths identified in the RoFSW mapping along the surface of the highway. It is noted, however, that highway drainage systems are normally designed for the 1 in 10 year rainfall event and therefore, if the entry points to the subsurface system had been more efficient, flooding could have occurred due to surcharging of the piped network.

Figure 8-4: Slot drain on High Street

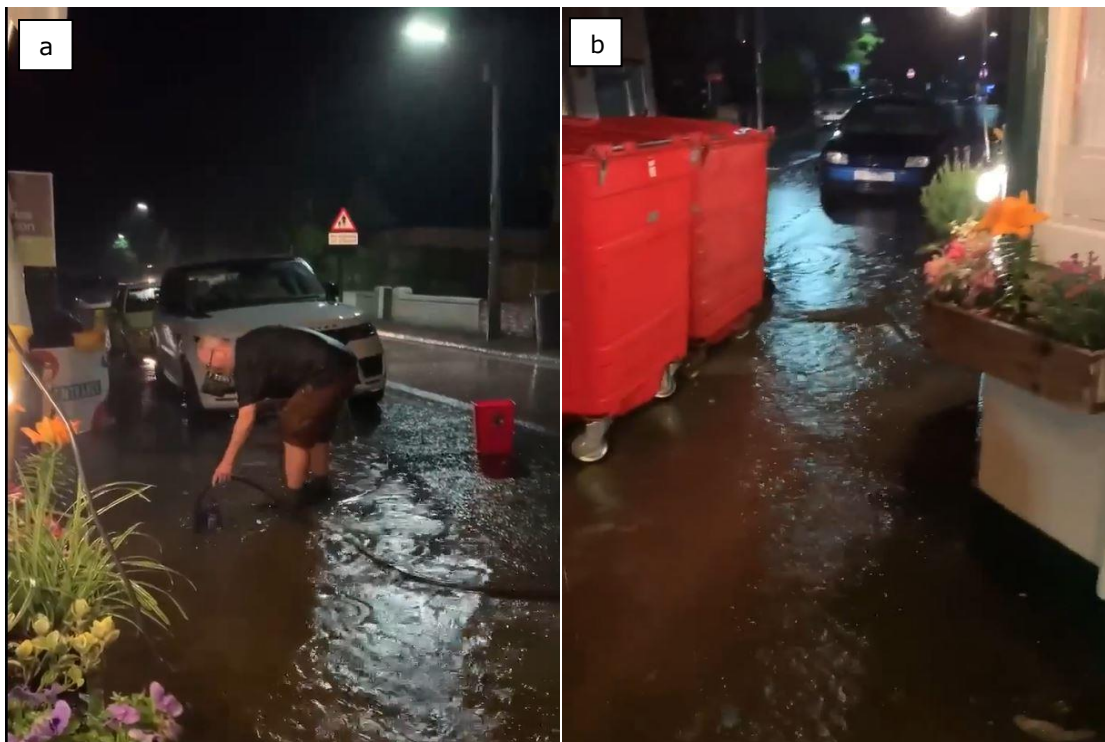
Figure 8-5 depicts the primary flow path down High Street which flowed past and flooded The Old Village Inn pub (location 1). Picture A shows the upstream view of flow path and picture B shows the downstream view of flow path.

Figure 8-5: Location 1, The Old Village Inn, High Street

The Old Village Inn pub had been refurbished just before the June 2021 flood event, and was forced to close and be refurbished again due to the damage caused by flood water.

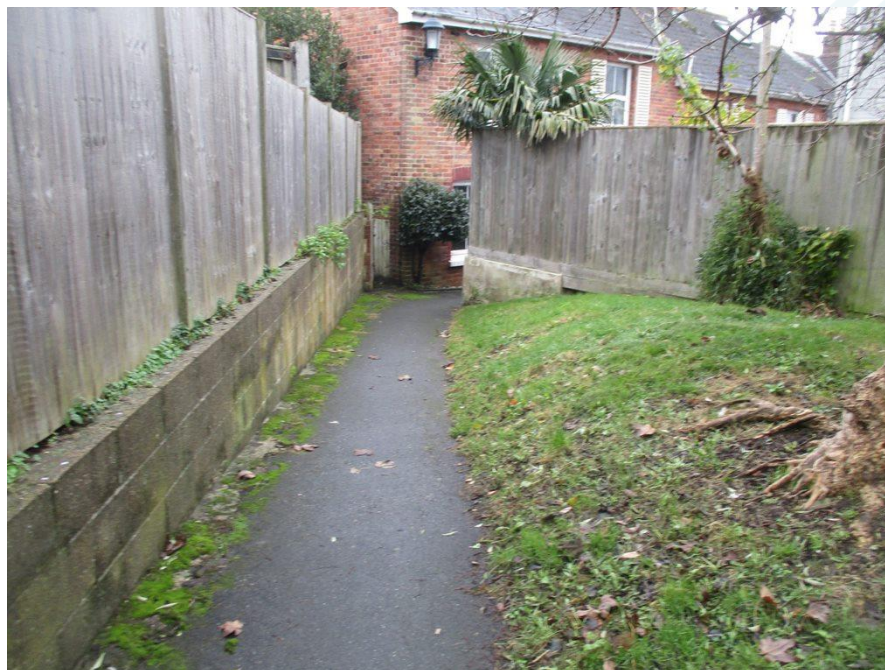
During the 28 – 29 June 2021 event, the surface water flow pathways followed the topography of the land from the top of High Street to Solent Landing. There were also secondary flow paths contributing to the flooding from High Street to Solent landing. These included Dennet Road, Pump Lane and Station Road as well as footpaths between King’s Road and Station Road as shown in Figure 8-6 (location 2), following the steep topography which slopes to the north at this location.

Figure 8-6: Location 2, footpath between Kings Road and Station Road.

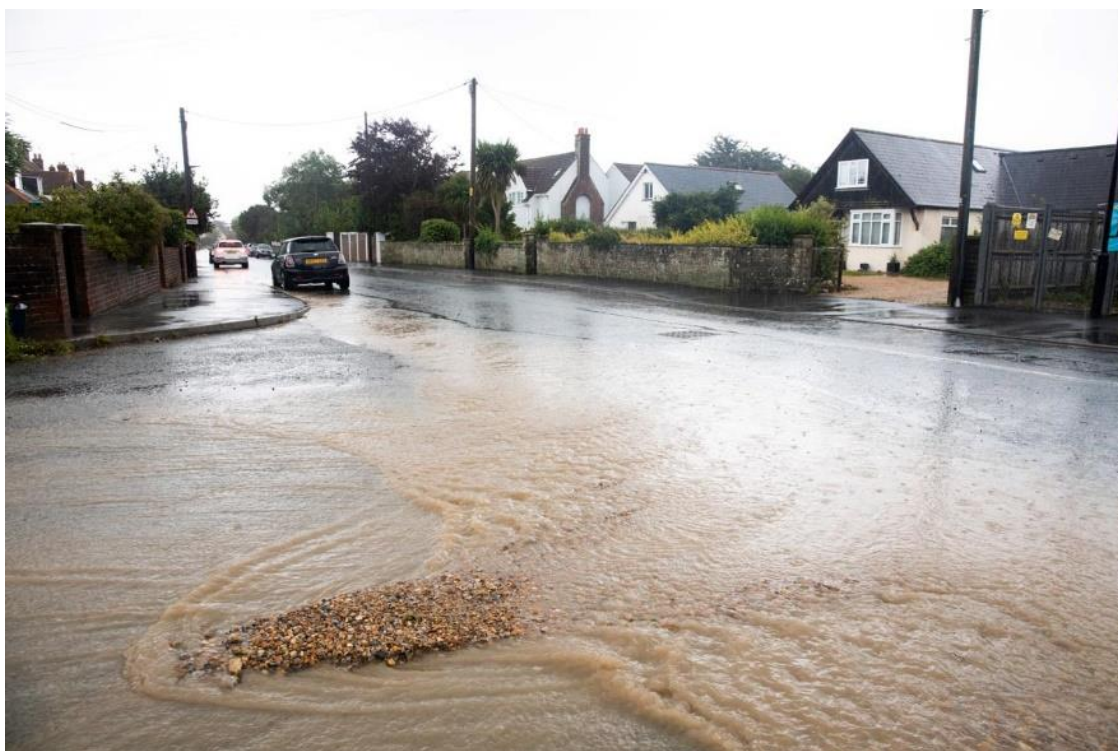
Figure 8-7: Location 3, Preston Road

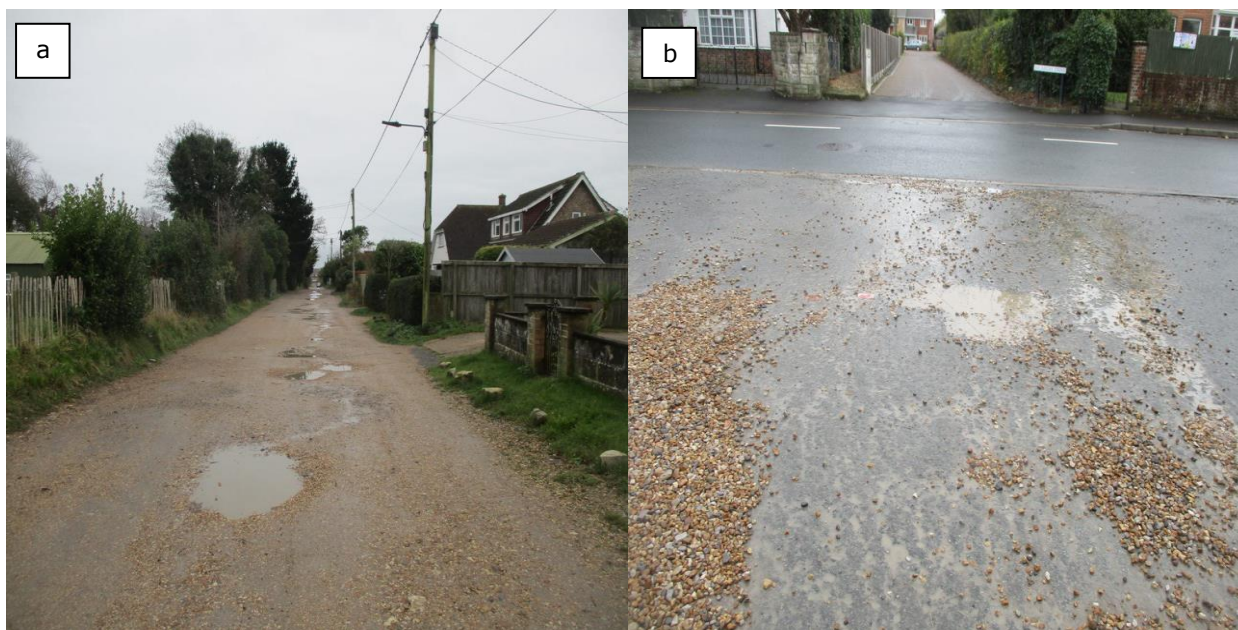
Figure 8-8: Location 4, Mitten Road
