Isle of Wight Council

**Cowes to Gurnard Coastal Slope Stability Study
Ground Behaviour Assessment
August 2000**

Halcrow Group Limited

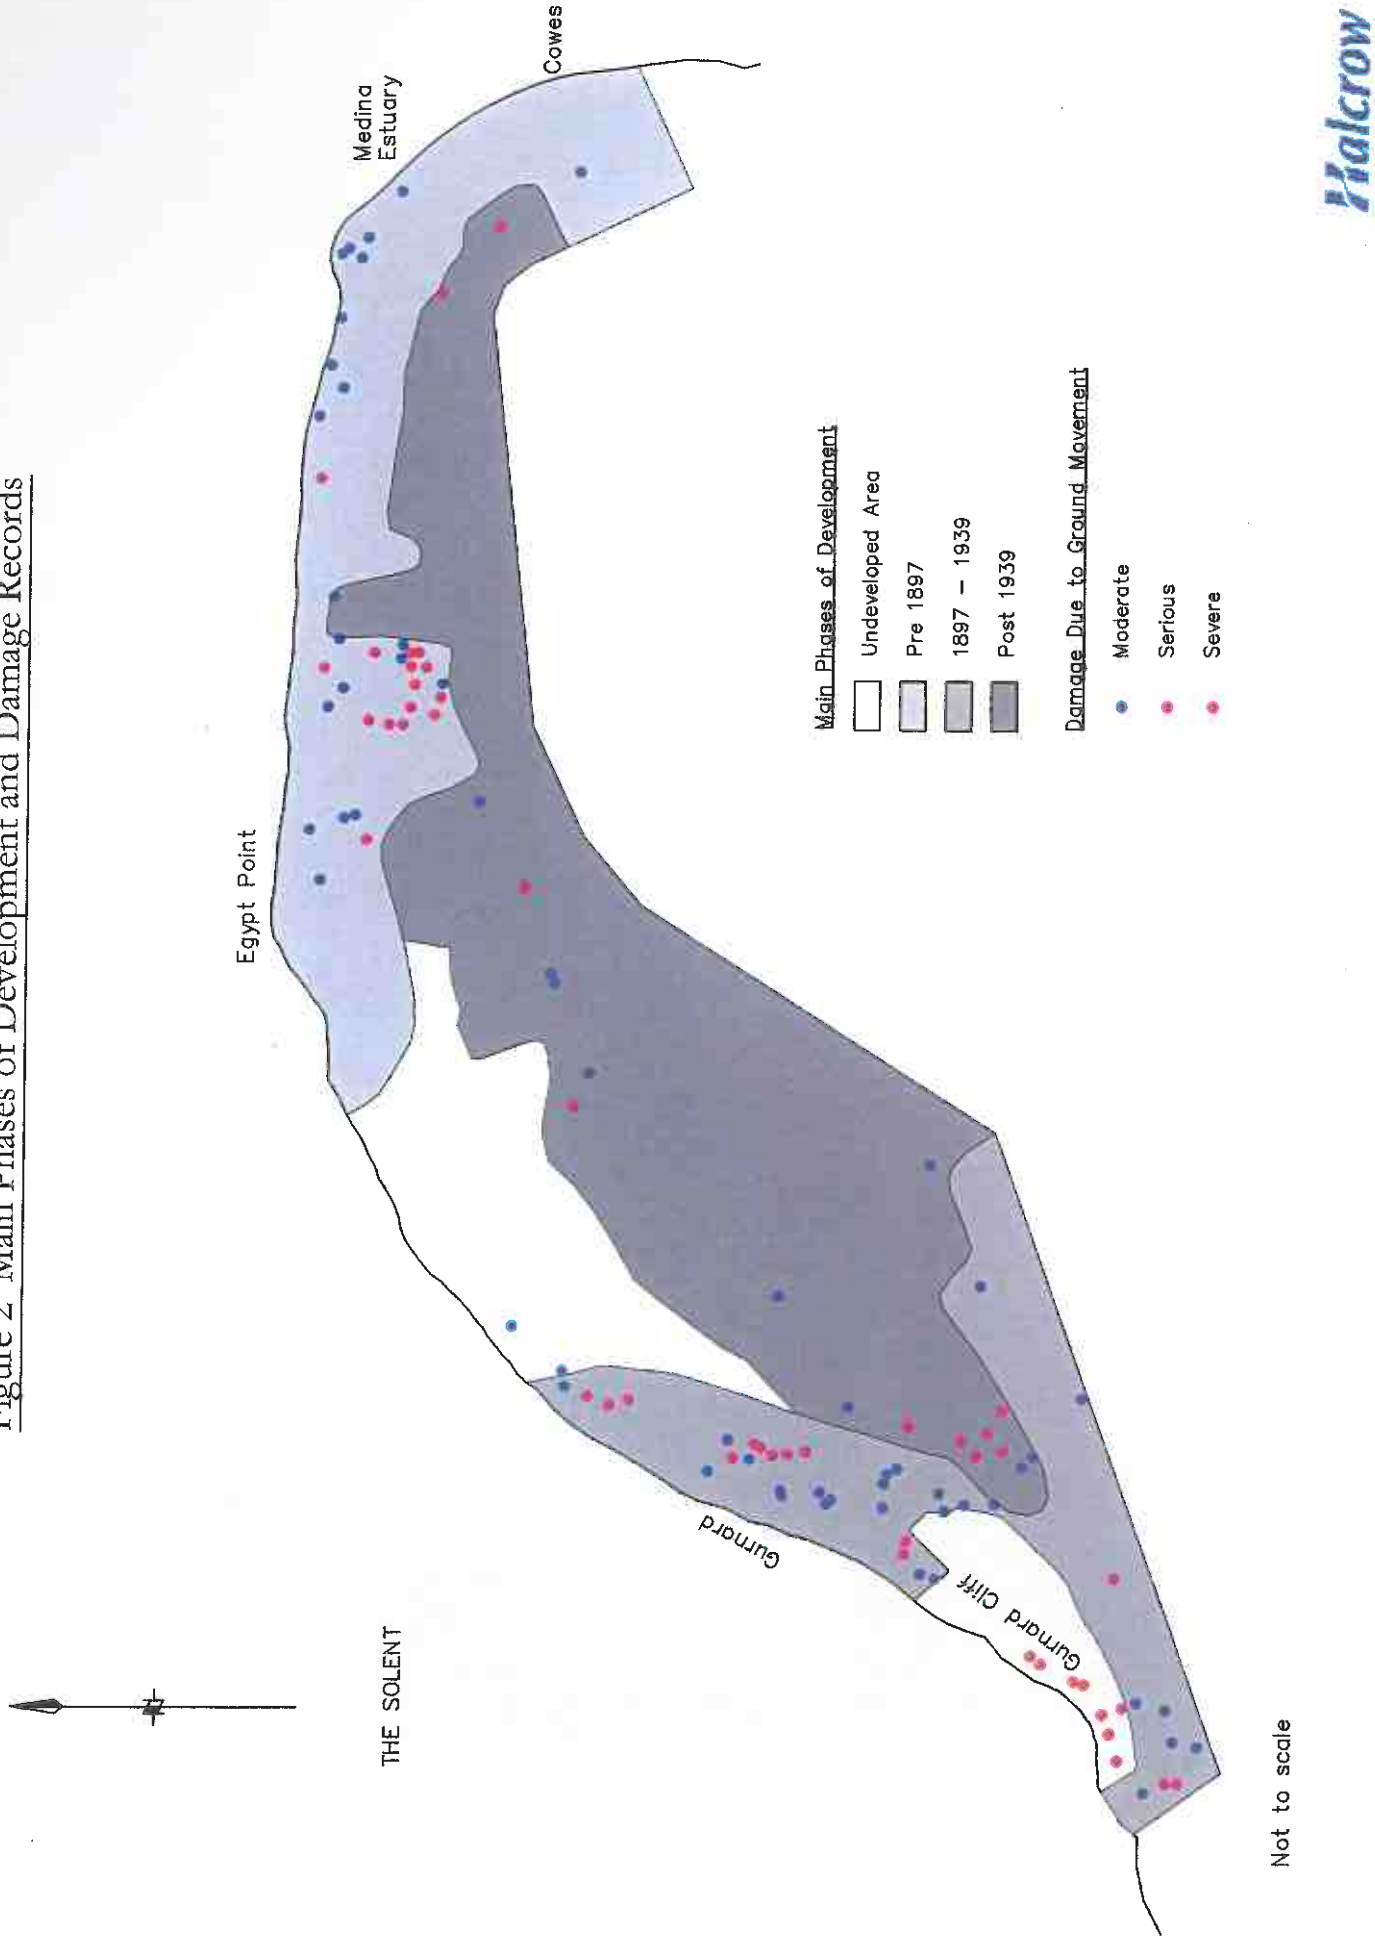
Figure 2 Main Phases of Development and Damage Records

Figure 2 presents the distribution of damage throughout the study area, which shows marked concentrations of moderate to severe damage. These concentrations appear linked to landslide areas at Gurnard Cliff, the area above Prince's Esplanade and the Cliff Road area (see Section 5.2.2). Other damage appears more widespread although there are notable linear distributions of damage above and at the base of the coastal slopes.

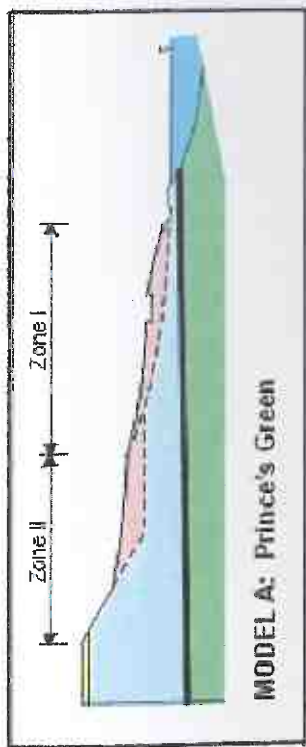
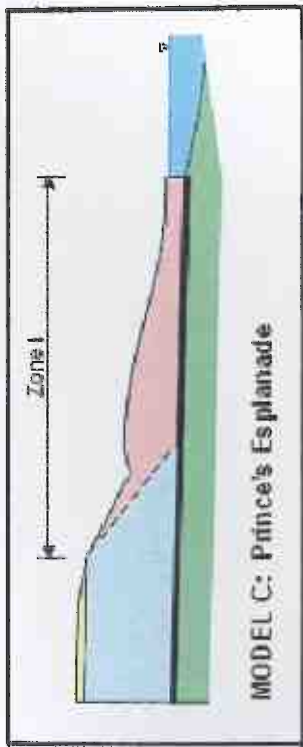
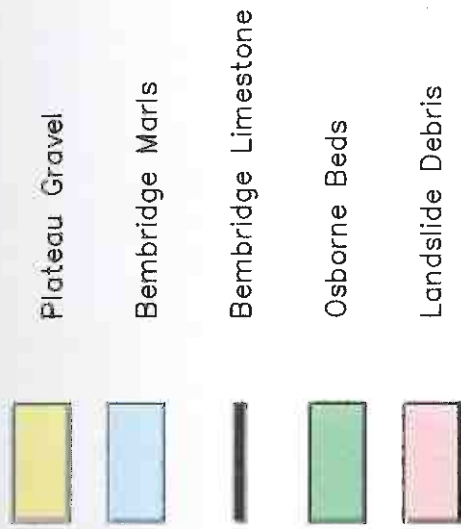
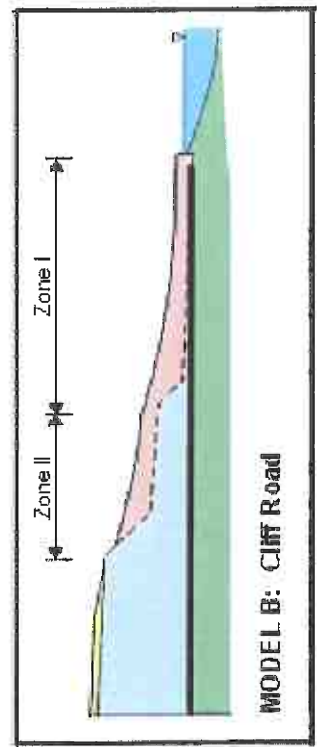
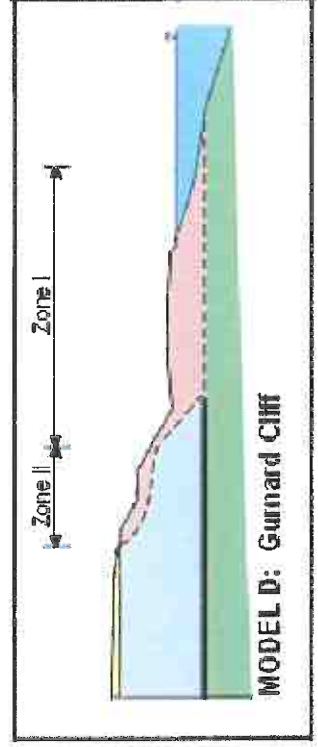
Figure 5 Cliff Behaviour Models

- **Model A: Prince's Green**, characterised by relict degraded shallow landslides (mudslides) within the Bembridge Marls. The slopes are highly degraded with gently sloping benches less than 12° and scarp slopes less than 25°. The scarp and bench morphology indicates strong lithological control on the mechanism of landsliding. The slopes appear reasonably well drained except in localised areas. Borehole evidence indicates that the Bembridge Limestone is at or slightly lower than sea level. The *in situ* dip of strata is to the south, which is not favourable for deep-seated bedding failures. Therefore, the mechanism of failure is most likely translational comprising mudsliding. Several zones of failure may be identified. The depth of landslide deposits in Zone I can be expected to be about 5m, given that there is evidence of buried organic material and peat deposits revealed by several boreholes. The depth of landslide deposits in Zone II can be expected to be slightly deeper with a basal shear surface within the Bembridge Marls.

- **Model C: Prince's Esplanade**, characterised by active deep-seated landsliding developed within Bembridge Marls. The markedly linear landslide benches have consistent gradients of about 5° seaward, with the rear scarp up to 23°. Drainage is generally poor with large areas of ponding and soft ground to the rear of the landslide benches. The *in situ* dip of strata is to the south with the Bembridge Limestone outcropping at or slightly below sea level. The geomorphology and available borehole data indicates failure at a consistent depth, coincident with the Bembridge Limestone. The depth of failure can be expected to be up to 15m in places. Given the apparent southerly dip of *in situ* strata, the bedding probably does not facilitate the occurrence of deep-seated failure, although cambering or down warping of strata to the north (as a result of valley-bulging or unloading of coastal slopes) may have contributed to instability along this coastal section.

- **Model D: Gurnard Cliff**, characterised by active deep-seated landslide developed within Bembridge and Osborne Marls. The landslide bench has a gradient of about 4° seaward and a rear scarp up to 27°. Drainage is poor with a large area of ponding, soft ground and stream flow to the rear of the landslide bench. The *in situ* dip of strata is to the south with the Bembridge Limestone outcropping at or slightly below sea level. In comparison with Model C, there is a narrow upper tier (Zone II) of predominantly shallow rotational slides with a lower degraded translation landslide (Zone I) up to 15-20m deep, with a basal shear surface probably within the Osborne Marls. Given the apparent southerly dip of *in situ* strata, the bedding probably does not facilitate the occurrence of deep-seated failure, although cambering or down warping of strata to the north (as a result of valley-bulging or unloading of coastal slopes) may have contributed to instability along this coastal section.

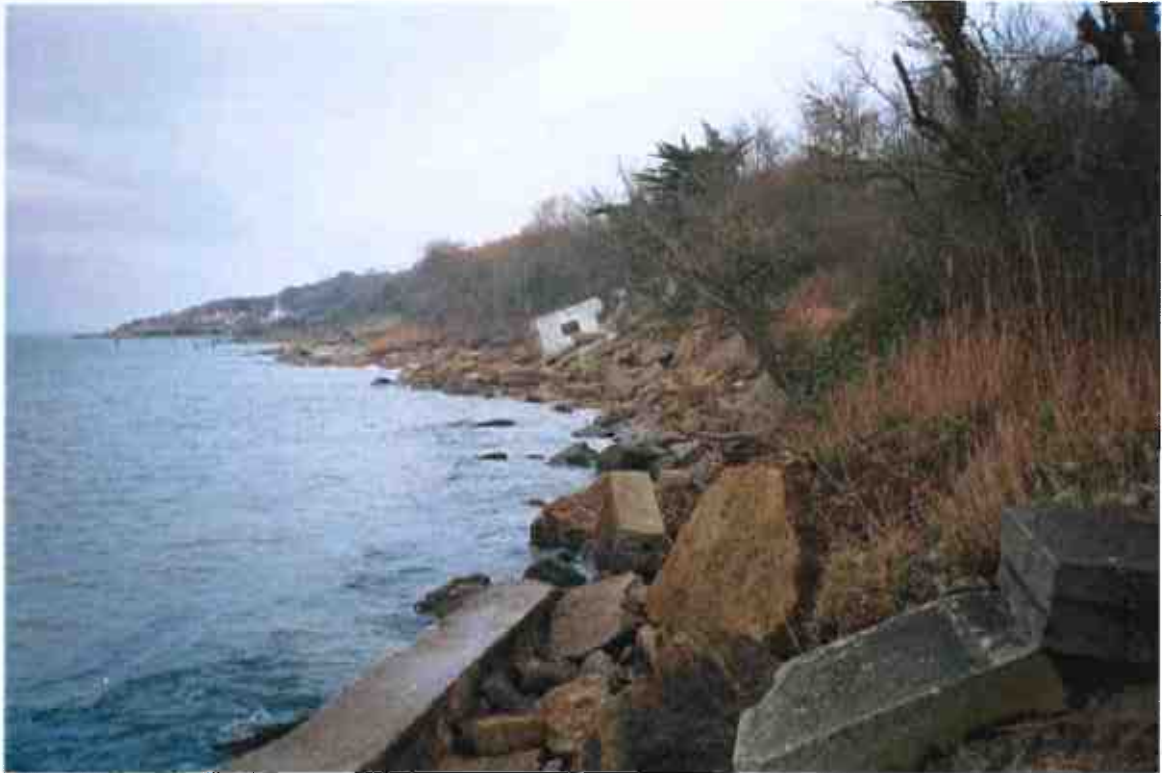
For example, the concentration of severe damage at Gurnard Cliff has resulted from coastal mudslides, comprising undermining and recession of the cliff top, active settlement of the cliffs and translational movement of debris to the foreshore. Outward displacement and heave of mudslide lobes at the base of the coastal cliffs has promoted the destruction of coastal defences along this section.

Plate 5 Collapsed Private Coastal Defences at Gurnard Cliff

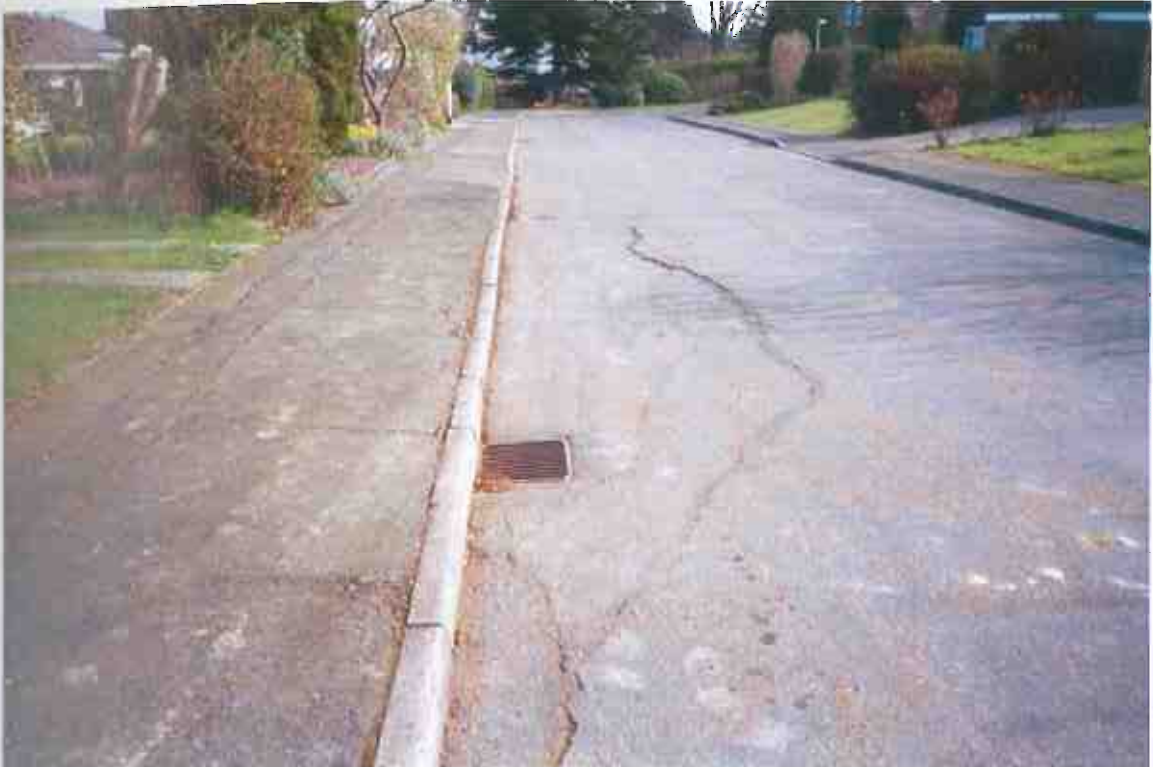
Subsidence and crack damage of road pavement (moderate damage)

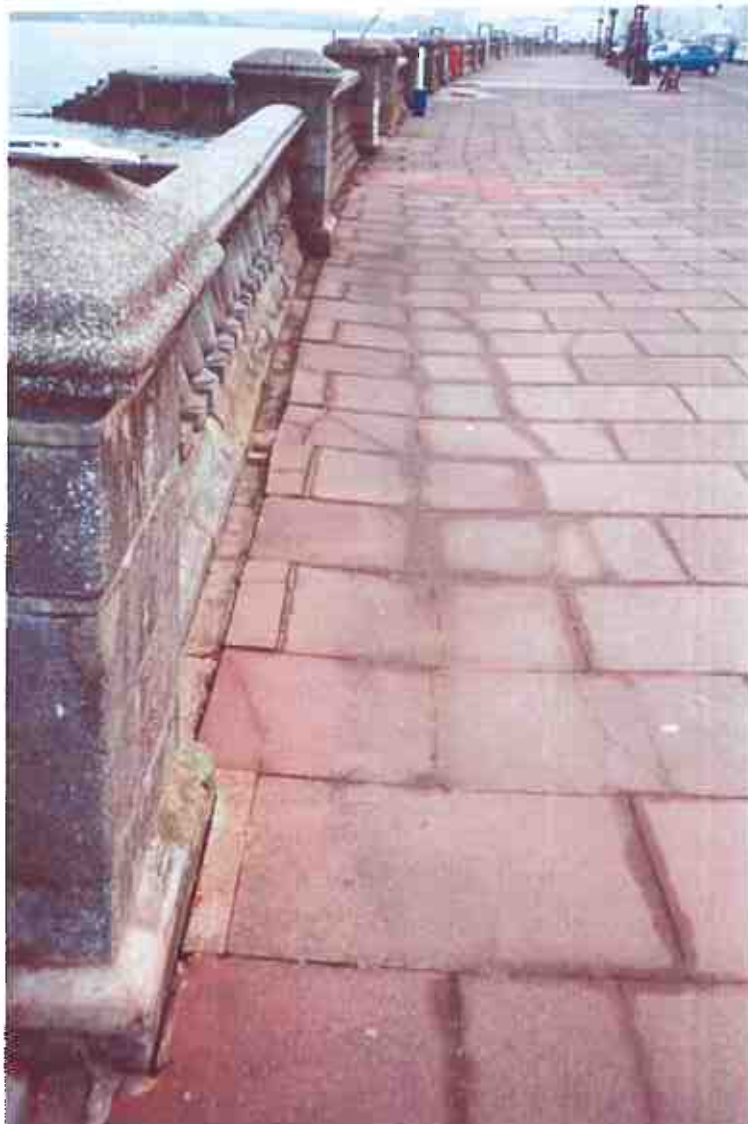
Subsidence and crack damage to the Parade, Cowes (moderate damage)

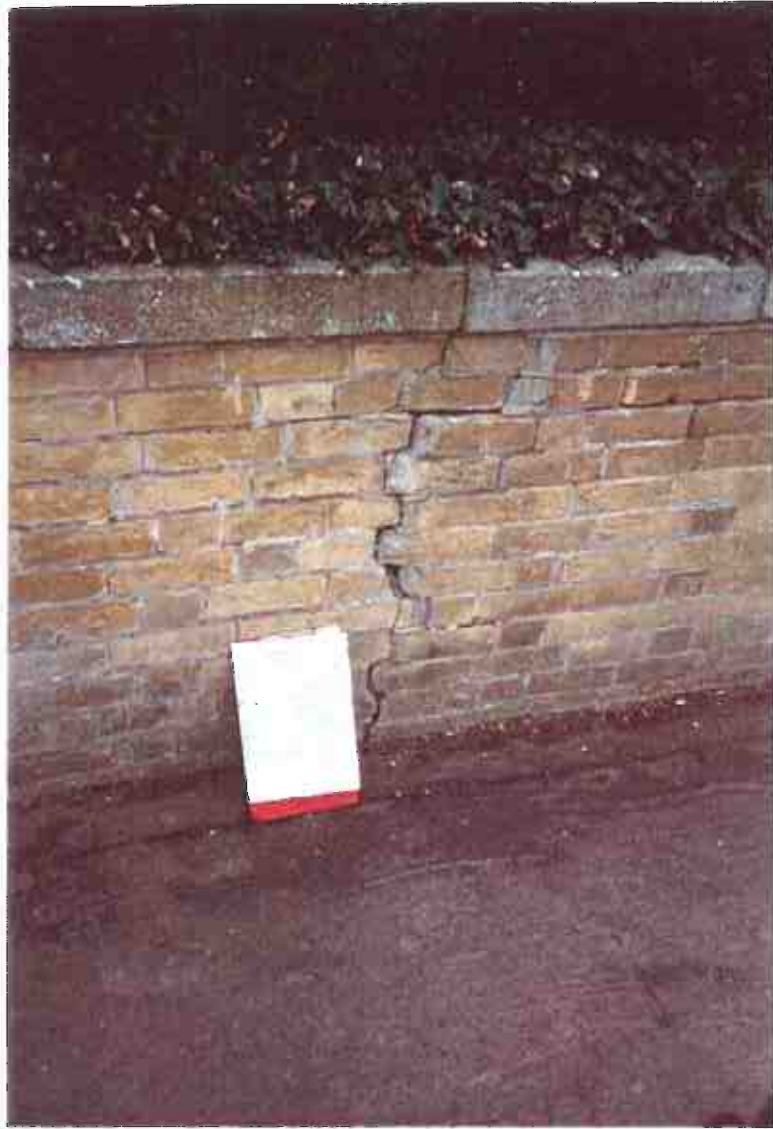
Crack damage to low boundary wall (moderate damage)

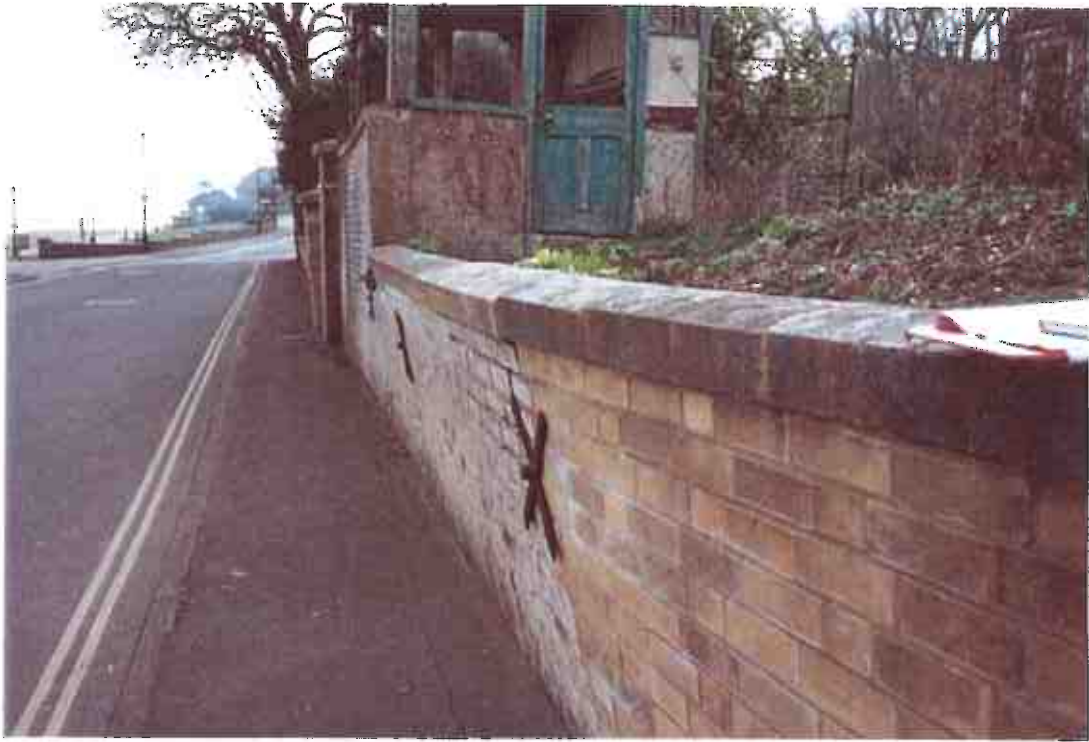
Forward tilt and heave of walls and outbuilding (serious damage)

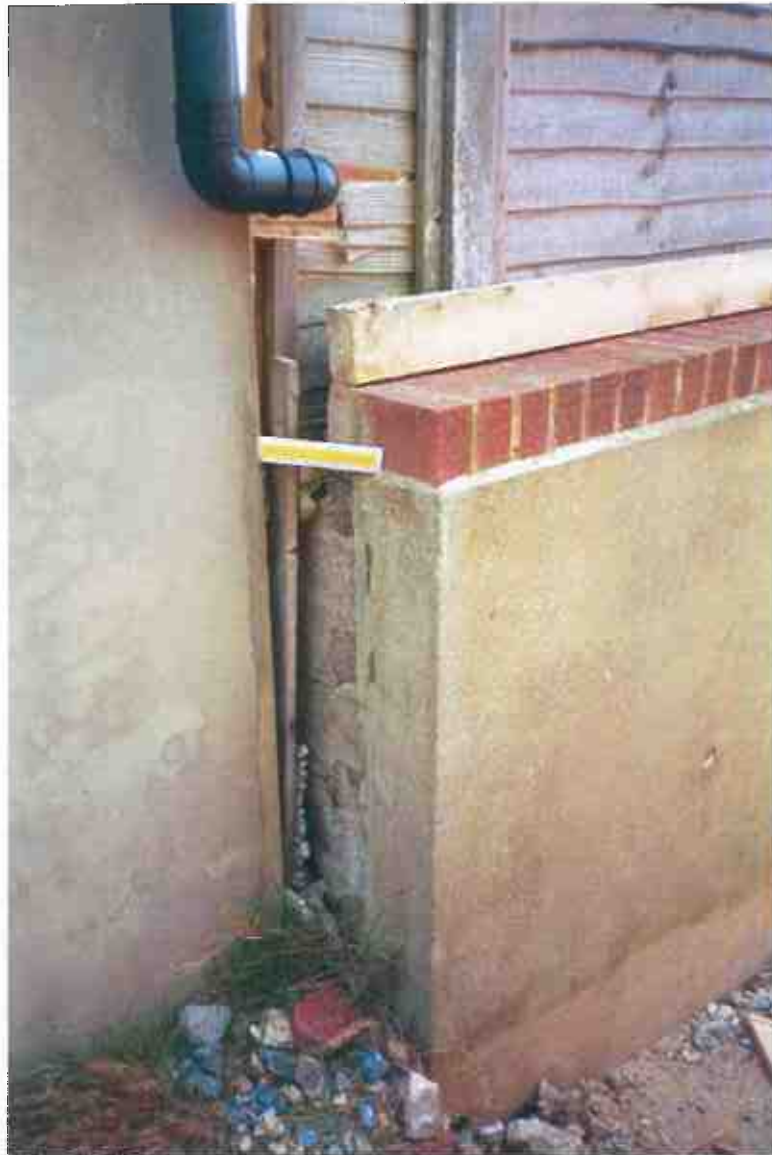
Separation and outward displacement of podium (serious damage)

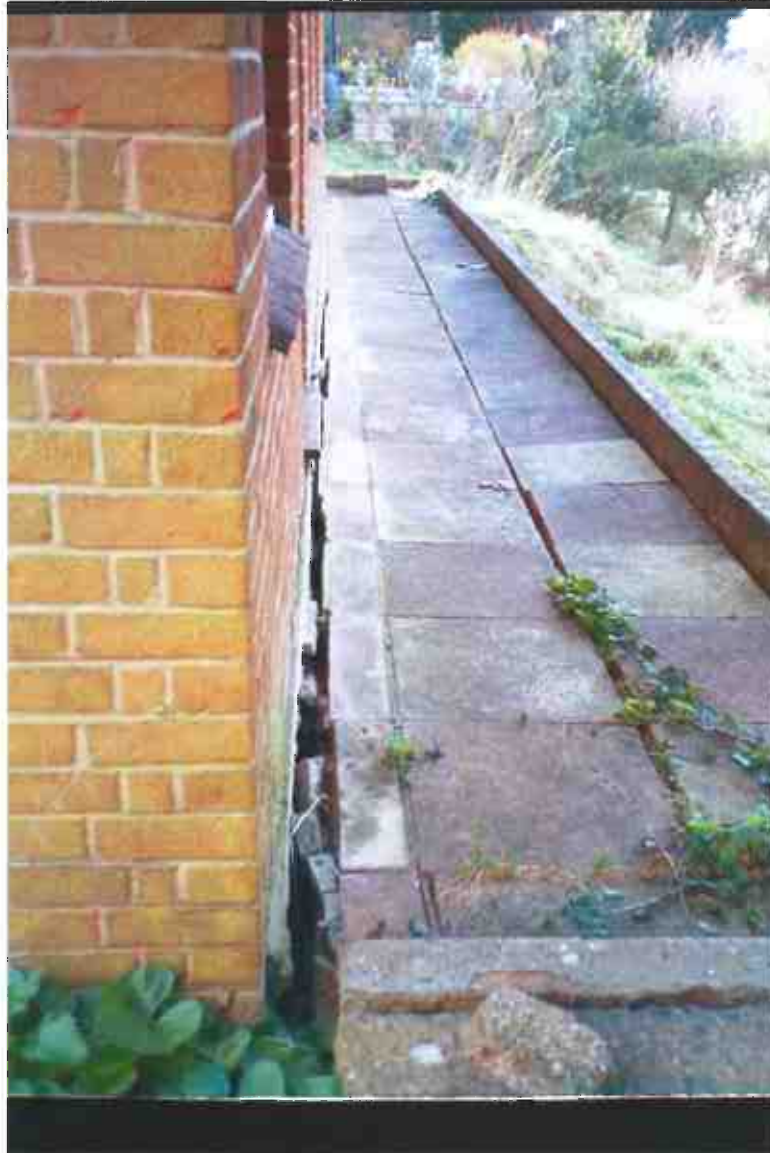
Separation of podium from main structure (serious damage)

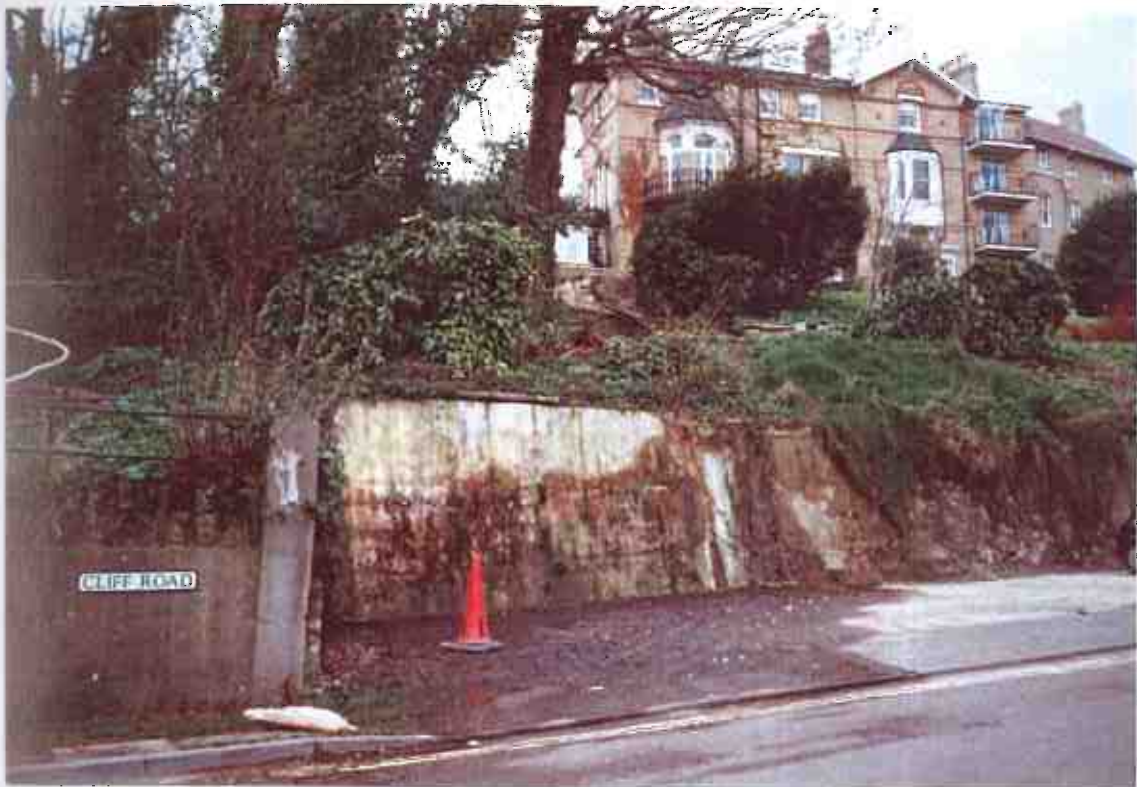
Groundwater seepage and general decay of retaining wall (serious damage)

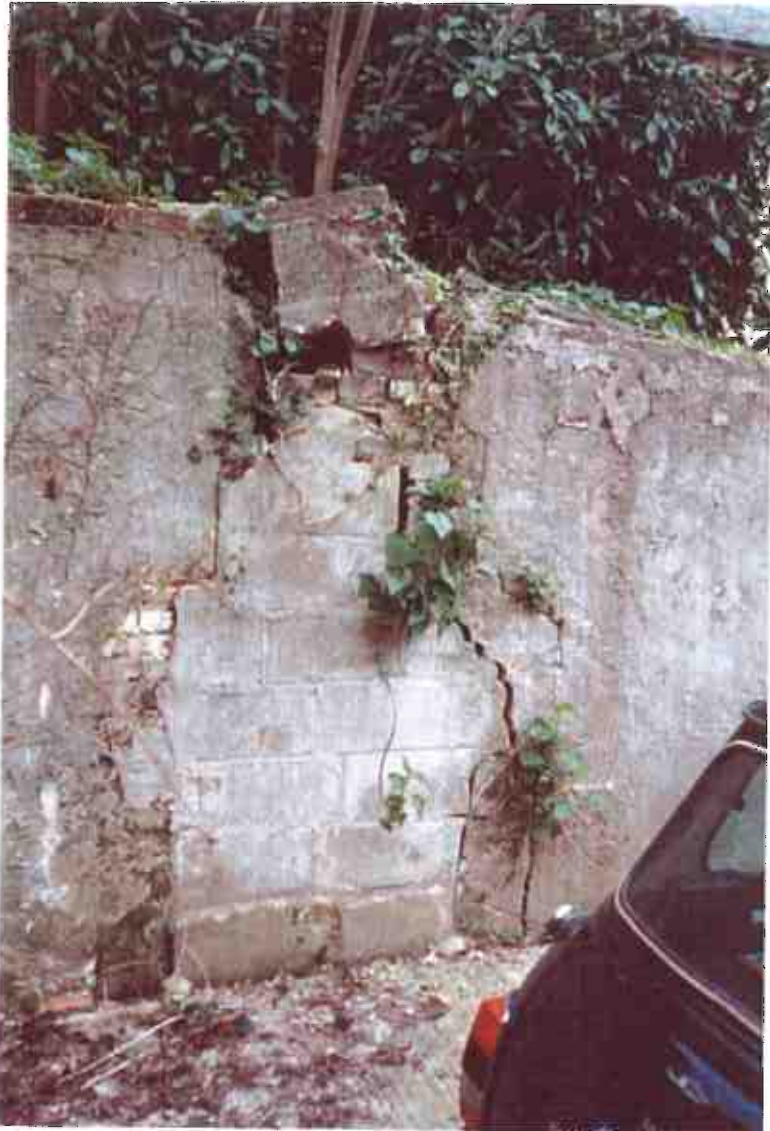
Crack damage and dislodgement of masonry blocks (serious damage)

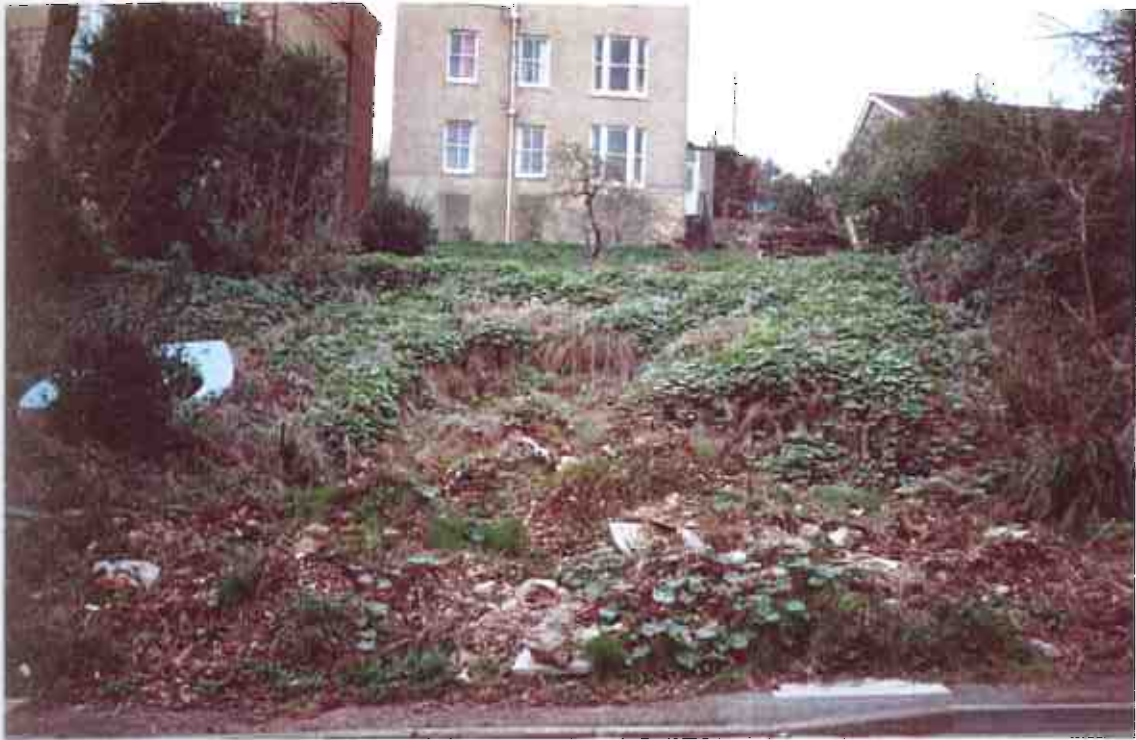
Small failure of garden slope (severe damage)

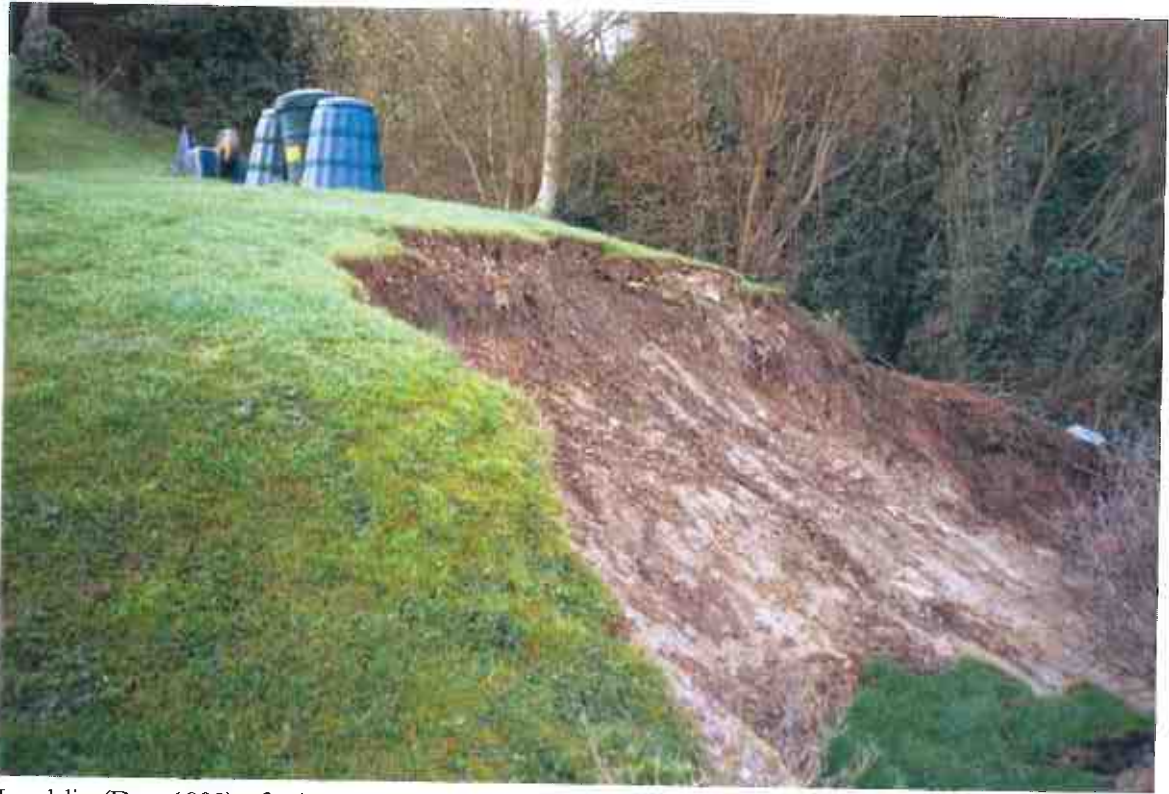
Landslip (Dec. 1999) of private garden at crest of coastal slope (severe damage)

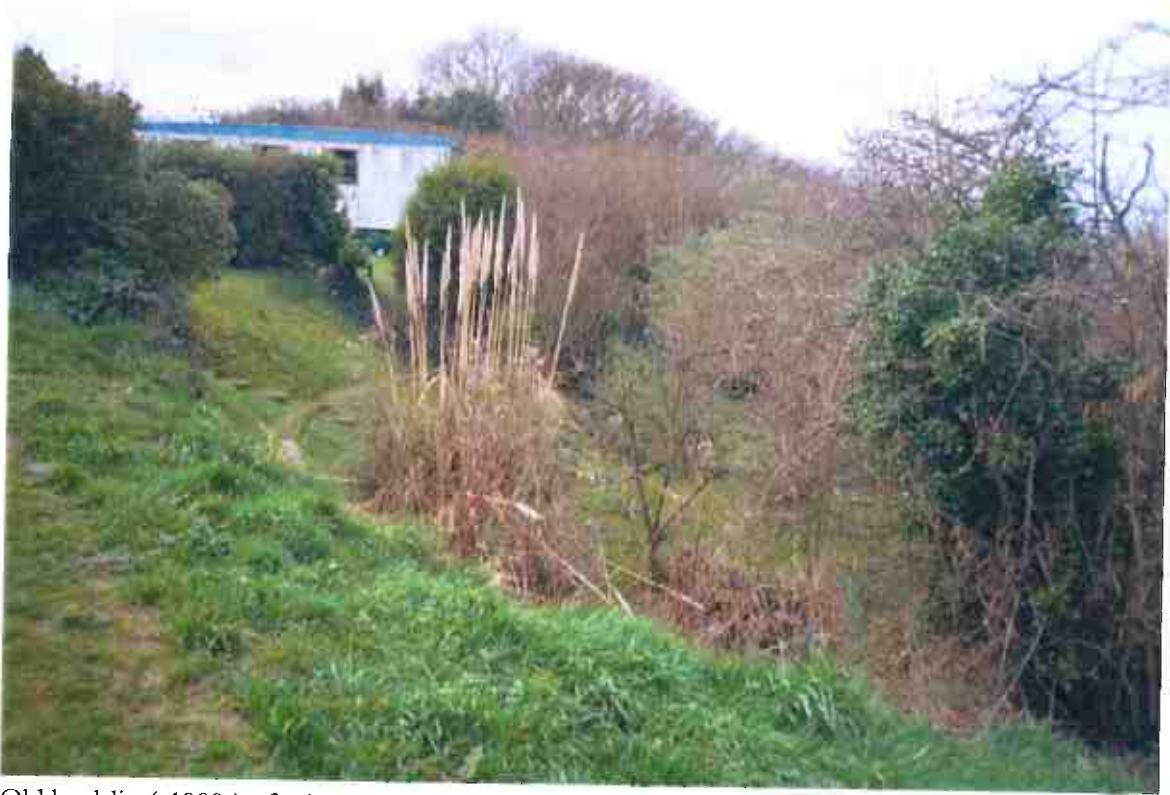
Old landslip (c1980s) of private garden at crest of coastal slope (severe damage)
