GEOTECHNICAL STUDY AREA G7

CASTLEHAVEN LANDSLIDE, NITON, VENTNOR UNDERCLIFF, ISLE OF WIGHT, UK

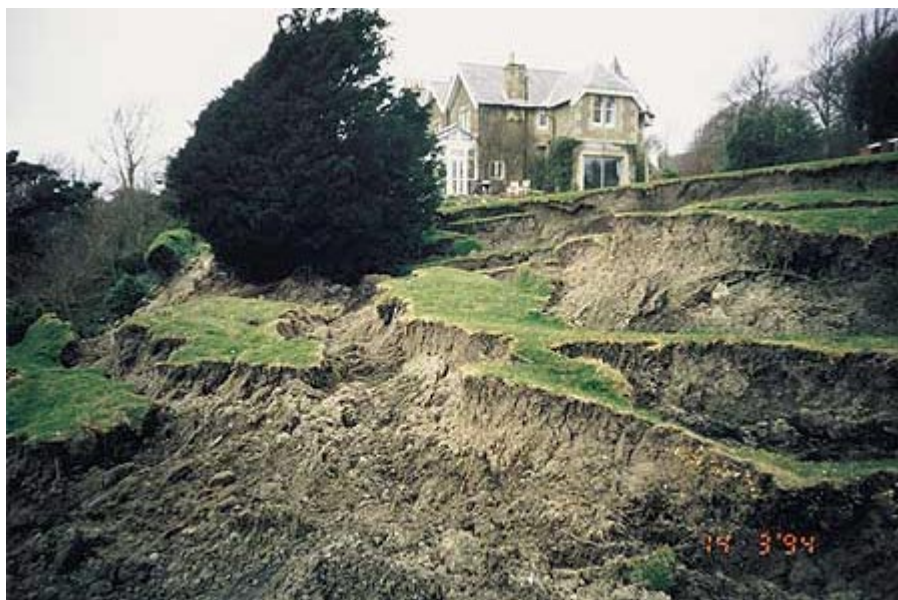
Plate G5 Reeth Lodge, Castlehaven, Isle of Wight, UK

In early January 1994, contemporary landslide activity extended into the developed area of Castlehaven for the first time, when the gardens of Reeth Lodge (Plate G7) and Victoria Lodge collapsed down a steep scarp slope. Ground movements have continued until the present time leading to the further extension of activity upslope into the developed area and further destruction of property in February 1995. A total of 95m recession of the coastal slope has occurred since January 1994. The principal cause of the problem has been clearly linked to the erosion of the sea cliffs since 1908 with specific landslide events being triggered during extreme rainfall periods which generate high groundwater levels (Plate G7a). The uncontrolled discharge of surface water from roads and domestic sources may have inadvertently contributed to the problem by raising groundwater levels.

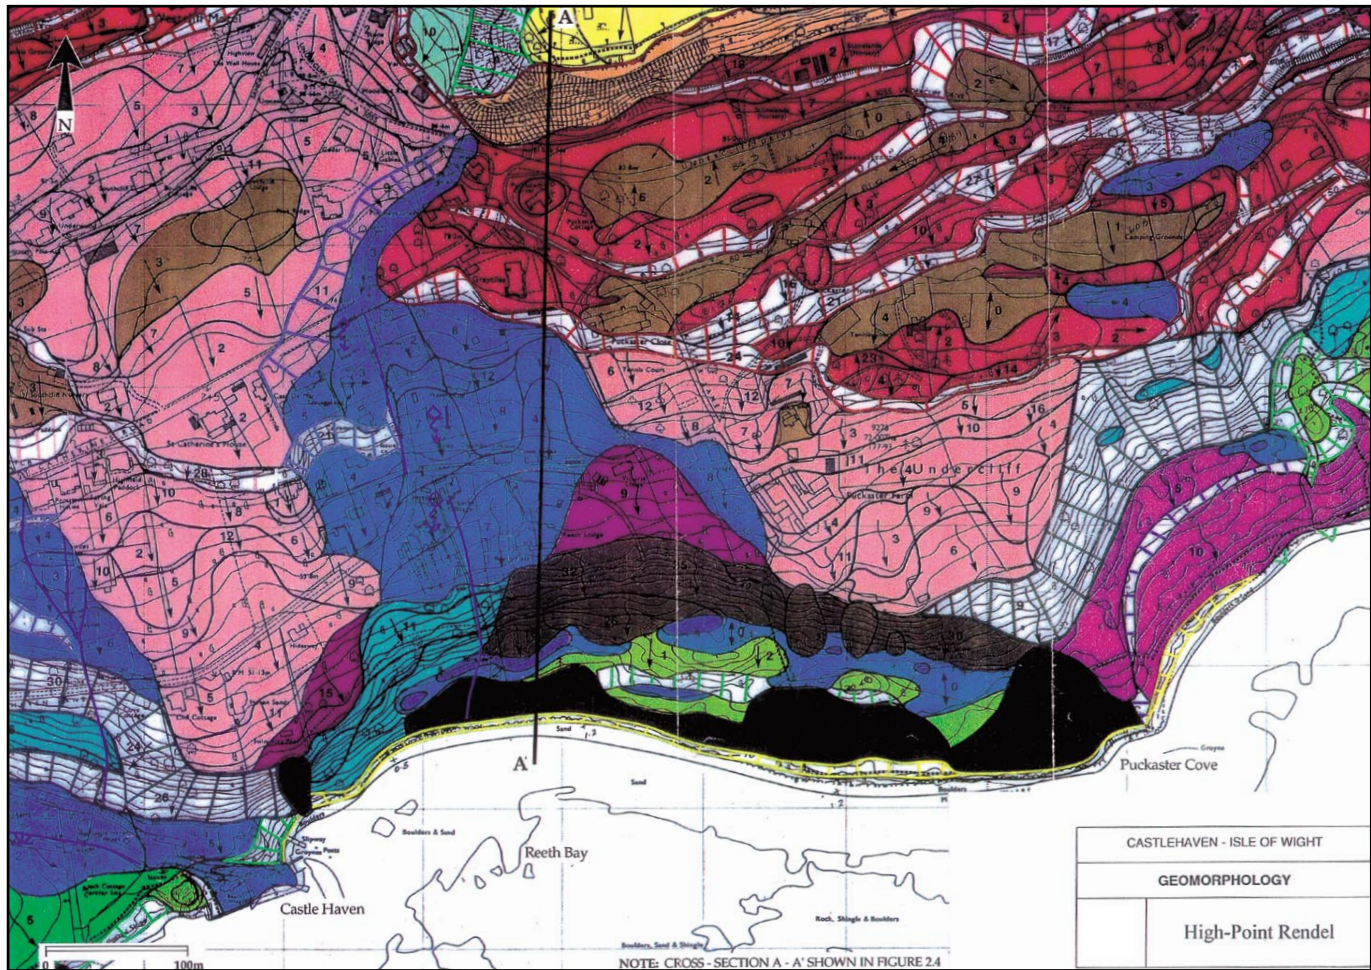
Figure G7.2 Geomorphological map of the Castlehaven area (see Figure G7.3 for the Key).

A complex pattern of landslide features has been identified in the area arranged within a number of distinct landslide systems (Figures G7.2 and G7.3). These systems are long established and probably developed in excess of several thousand years ago. Since that time they have remained largely inactive, although periodic slow ground movement will have occurred, particularly during extreme wet periods. The Castlehaven landslide system coincides with the presence of a palaeo-drainage valley within this part of the Undercliff which probably postdates the formation of the ancient landslide complex.

At Reeth Lodge, located directly above the coastal slopes, past landslide activity has generally been confined to the lower tier compound failure zone. However, in January 1994 and February 1995 ground movements extended into the upper tier multiple rotational zone causing damage to structures and loss of land and put at risk other homes and properties in the area. The geomorphology of the Castlehaven area was mapped in detail in January 1994 following significant landslide activity near Reeth Lodge (Rendel Geotechnics 1994). The field survey utilised colour vertical aerial photographs at 1 : 4,000 scale taken in January 1994, to obtain details on the more active and inaccessible areas and to identify landslide system boundaries. The photographs were also compared with earlier photographs taken in 1985 to identify any notable changes over the period.

Further cliff recession and landslide activity occurred in February 1995 which caused additional damage in the area around Reeth Lodge and Victoria Lodge. Consequently the geomorphological map was updated in March 1995 to show the extent of the latest movement. Movement has continued since March 1995 and is evidenced by the continued development and widening of cracks, steps and benches and movement of material downslope, particularly in the area around Reeth Lodge, Victoria Lodge and Puckaster Farm. These observations are borne out by automatic tiltmeter records monitored in the area by the Isle of Wight Council.

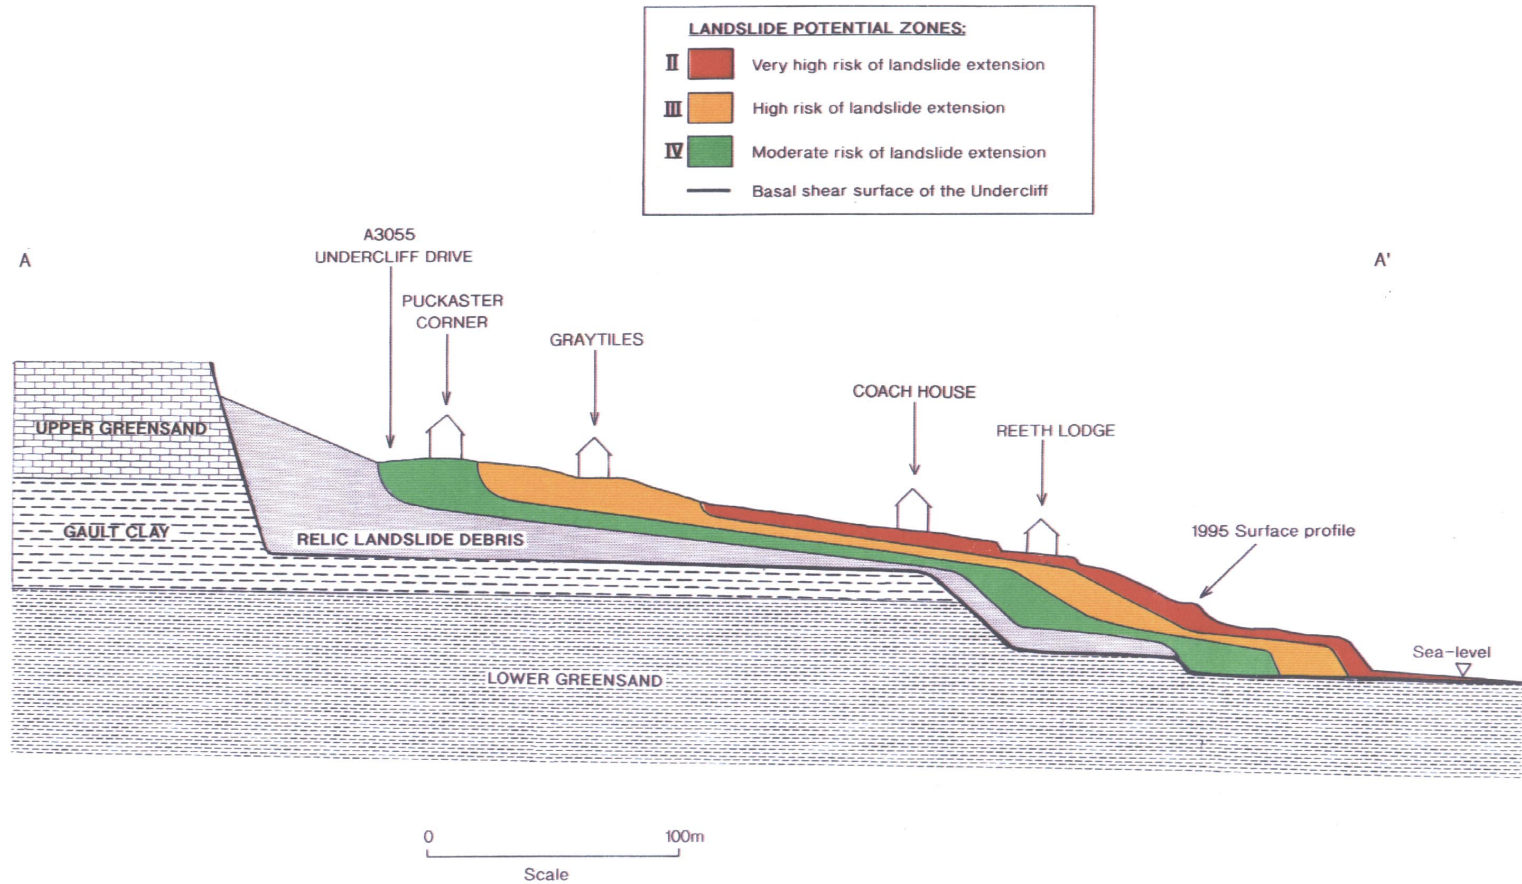
Figure G7.4 Diagram showing landslide potential at Castlehaven.

Future rates of cliff retreat and landslide activity are inherently difficult to predict but may be based on a projection of past erosion and landslide extension. On this basis Figures G7.4 and G7.5 have been compiled from the geomorphological map of this part of the Undercliff (Figures G7.2 and G7.3) and show future landslip potential in terms of a series of zones, which will become increasingly at risk of failure if retreat of the sea cliff and Gault Clay scarp continues. The landslide potential can also be substantiated by historical evidence from elsewhere within the Undercliff.

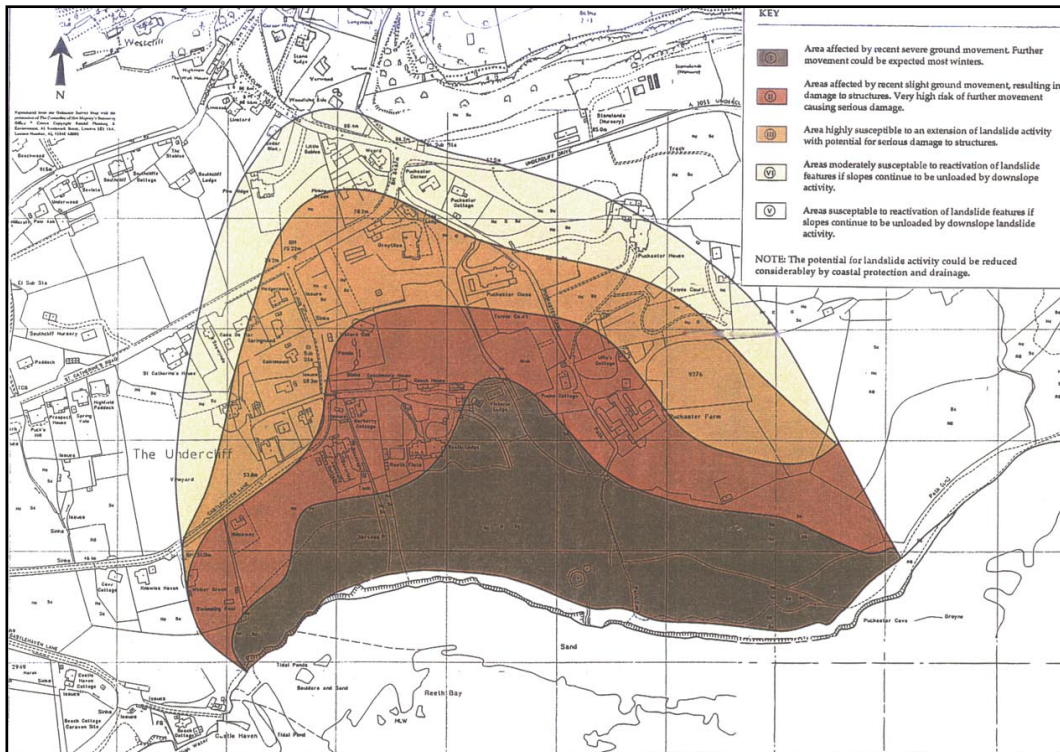
Figure G7.5 Potential land loss map around Reef Bay, Castlehaven.

1. Physical loss of areas of land, estimated to be approximately 210,000m². This estimate may be on the low side bearing in mind projected sea-level rise and increased climate storminess.
2. Considerable direct and indirect loss of property, in the order of 40 properties with risk-free values totalling approximately £5.8m.
3. Loss of infrastructure, such as statutory services and roads, including the main coast road A3055 running round the Isle of Wight, totalling approximately £1.4m.
4. Loss of amenity and considerable environmental interest.

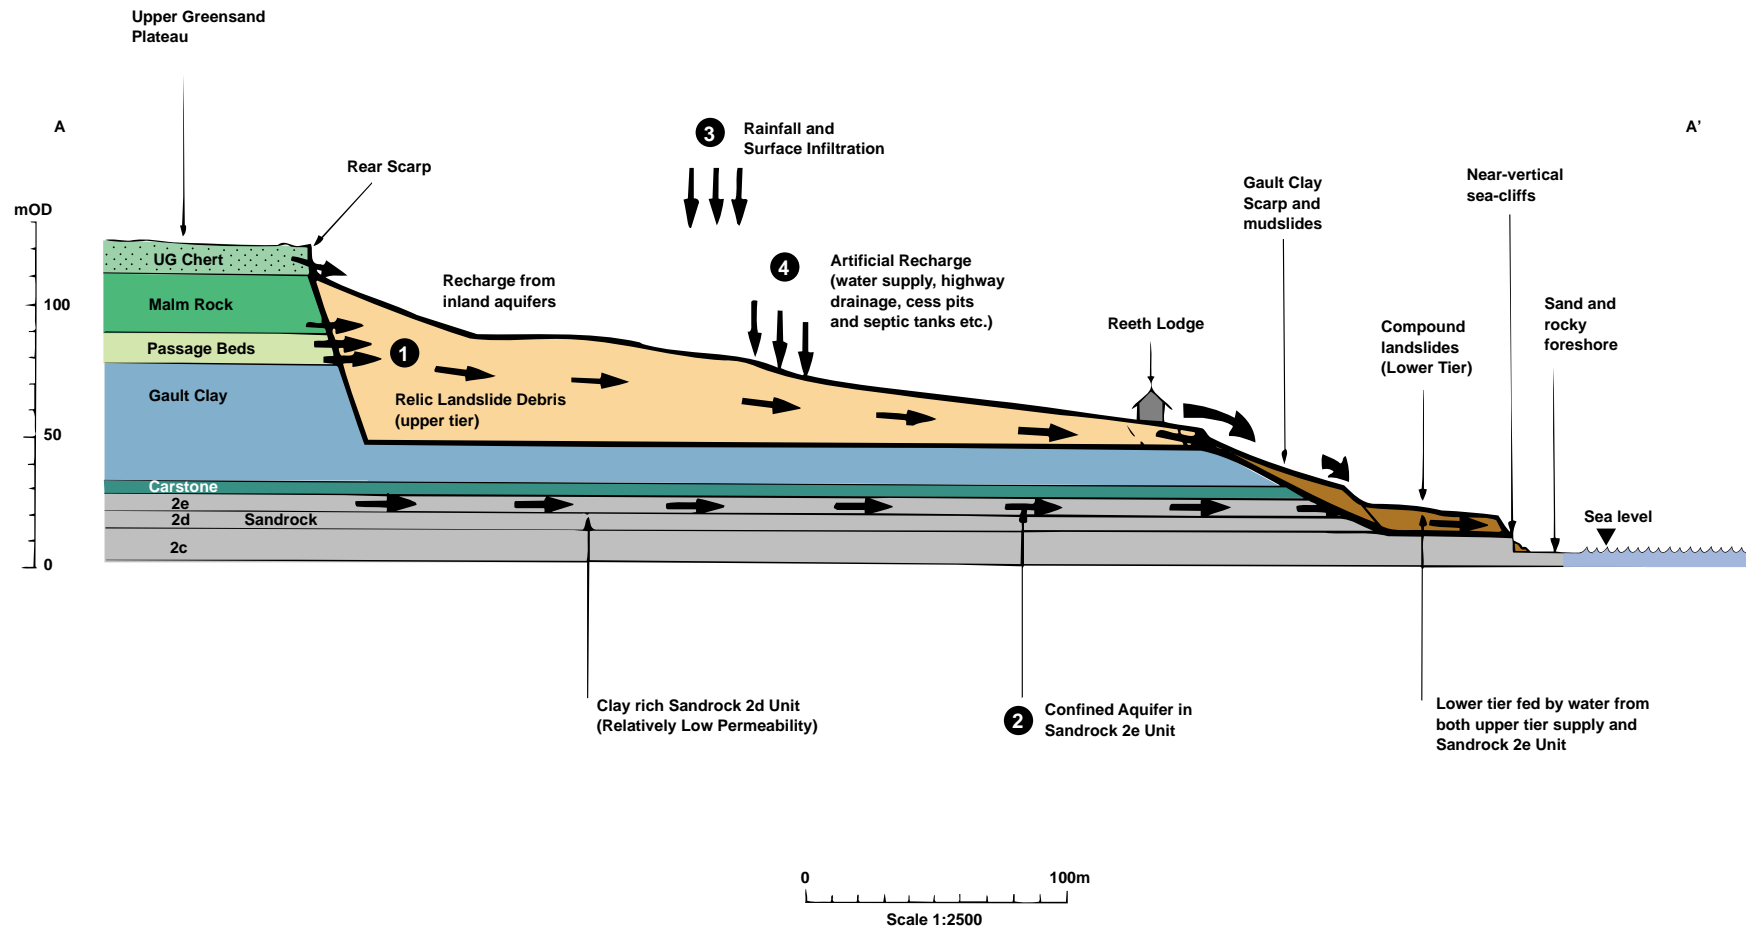
Figure G7.6 Principal sources of groundwater to the Castlehaven landslide.

The Malm Rock and Chert beds of the Upper Greensand are exposed in a near vertical rear scarp, on the eastern side of Niton marking the landward limit of the Undercliff. The Lower Chalk is mostly absent above the rear scarp resulting in a level Upper Greensand plateau. The Passage Beds and underlying Gault Clay are obscured by relic landslide debris at the foot of the inland scarp. However, the Gault Clay (known locally as 'Blue Slipper') is exposed in the prominent scarp on the coastal slopes near Reeth Lodge, which arcs towards the coast between Puckaster and Castlehaven. See Figure G7.6.

The relatively impermeable, often over-consolidated Gault Clay restricts the vertical drainage of groundwater to lower levels, so that large quantities of water are stored above in the Upper Greensand. This forces the groundwater to plane horizontally along the dip of the strata into the Undercliff landslide debris which also rests on the Gault Clay. Similarly, at depth the clay rich 2d unit of the Sandrock is an aquiclude, which inhibits downward drainage. Thus water may be confined between the 2d unit of the Sandrock and the base of the Gault Clay above, which may provide a source of groundwater and high pore water pressures on the lower levels of the landslide.

In addition to the natural sources of water within the Undercliff, artificial surface drainage makes a significant contribution to the groundwater regime. Uncontrolled discharge of surface water through soakaways and highway drains and the discharge of foul sewage from septic tanks and cesspools occurs from all of the properties in the lower Niton area. The progressive deterioration and leakage of services such as water mains and service pipes caused by ground movement has added to this problem by artificially recharging the water table. This prevents the ground from "drying out" during the summer months which undoubtedly contributes to the destabilisation of the coastal slopes.
