GEOTECHNICAL STUDY AREA G9

SANDOWN BAY CLIFFS, ISLE OF WIGHT, UK

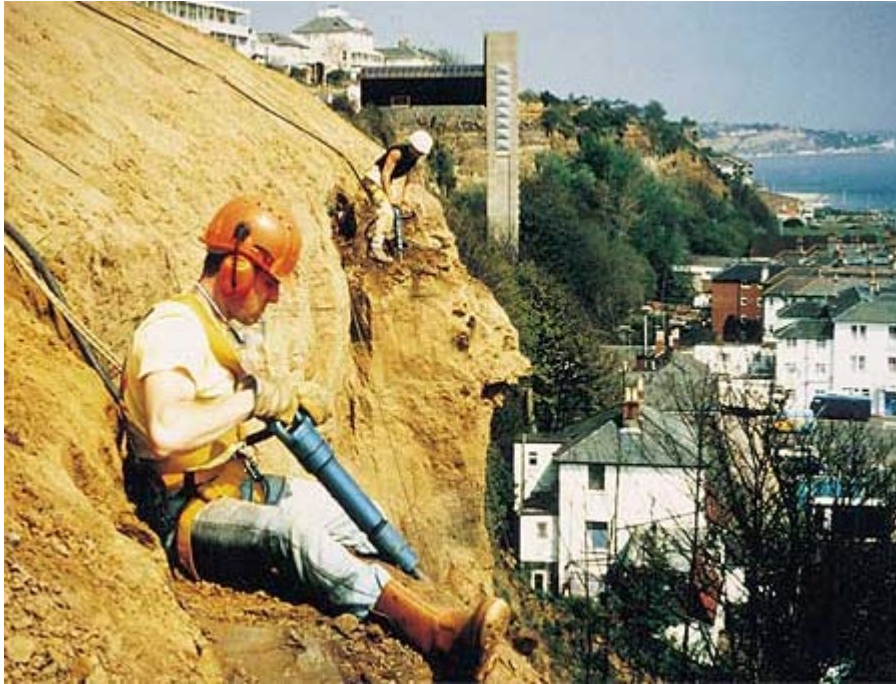
Plate P9 *Cliff stabilisation works, Sandown Bay, Isle of Wight*

The areas of cliff identified for priority stabilization have been treated (Plate G9). The methods adopted are described and illustrated below and have been undertaken following various investigations, in situ tests and research being carried out, as well as reviews of the details of the design and implementation of the stability measures. Essentially these have consisted of realignment of the cliff top, scaling, rock anchoring and rock bolting, buttressing, drainage and structural support to existing overhanging engineering structures. In addition, experimental application of an impregnating epoxy material to create a weather resistant crust over the cliff face was also commissioned. This element of the geotechnical study of Isle of Wight sites provides an example of a systematic approach to the management of a weak cliff line in an

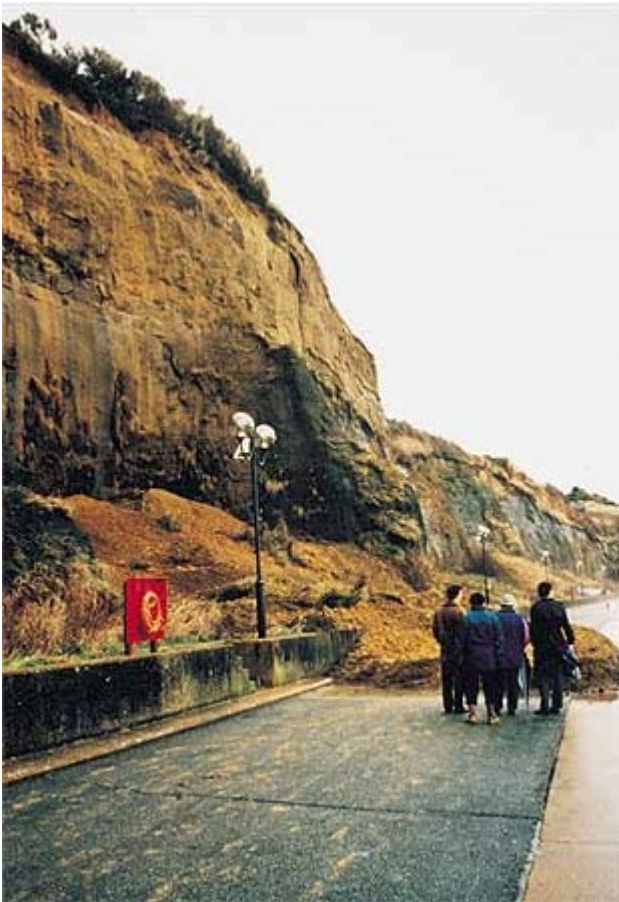
The 3.5km length of weak sandstone cliffs between Shanklin and Sandown on the south-east coast of the Isle of Wight lies within a major tourism area that has a history of cliff failure and progressive cliff recession. The rate of recession, although relatively slow, has placed at risk some of the cliff top paths and structures in areas of public access and amenity. Furthermore the debris from rockfalls and cliff face erosion presents a significant risk to the safety and development of seafront hotels, businesses and leisure facilities adjacent to the base of the cliff (Plates G9a, G9b, G9c).

Plate G8a *Cliff fall at Littlestairs, Shanklin*

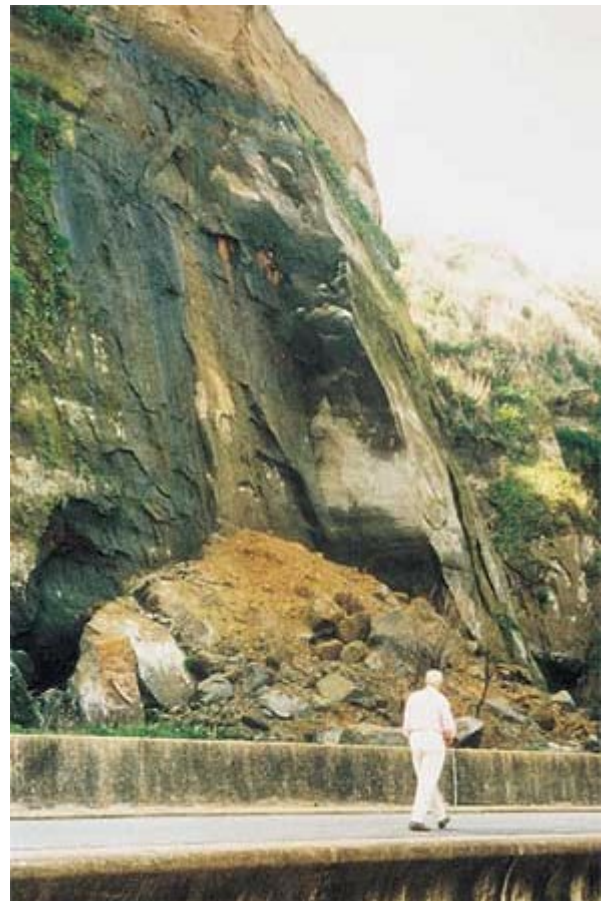
Plate G9b *Cliff fall at Littlestairs, Shanklin*

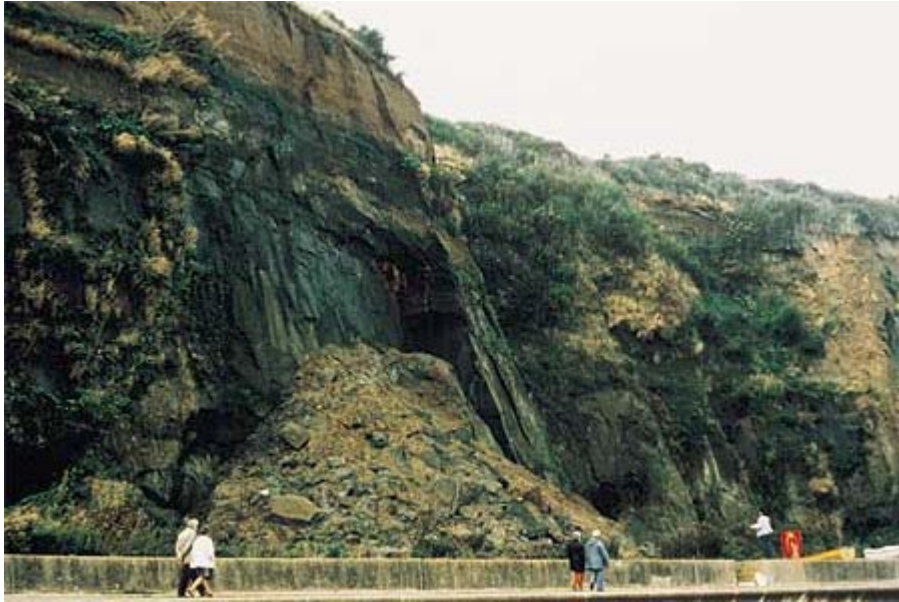
Plate G9c Cliff fall at Littlestairs, Shanklin

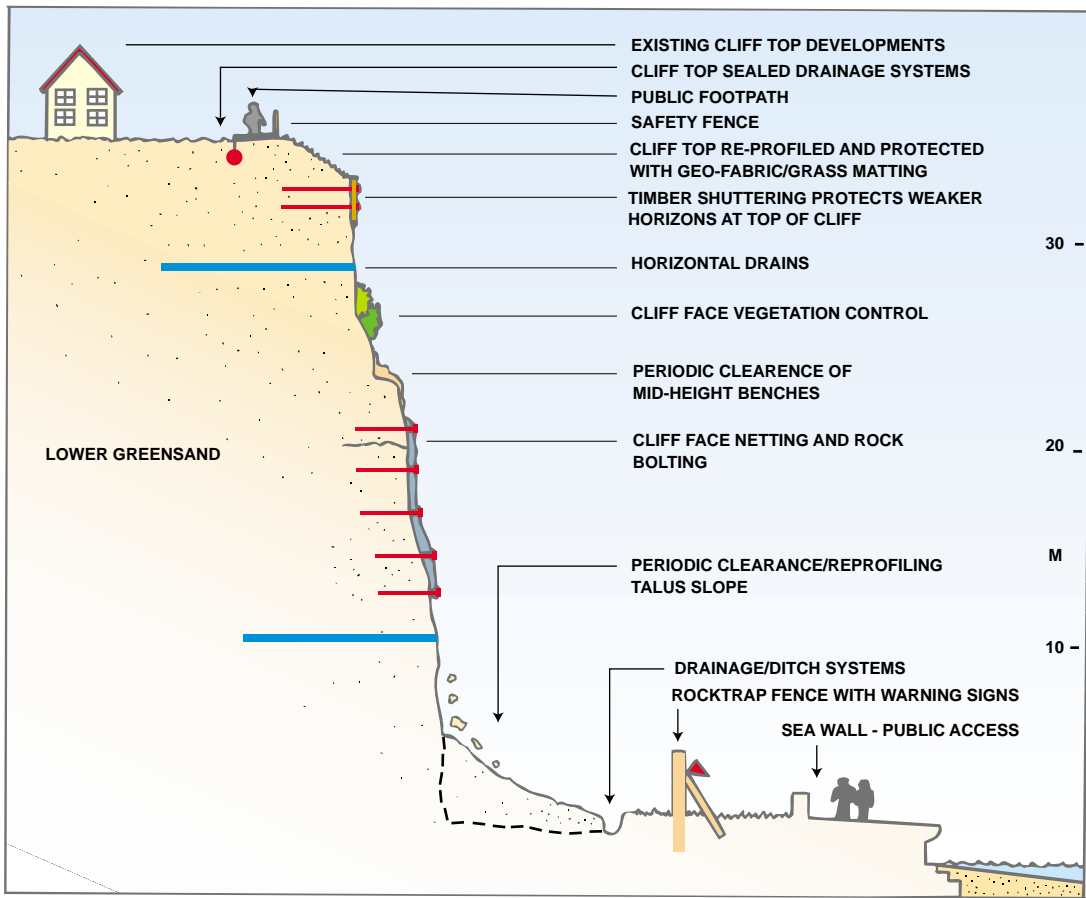
The Sandown Bay cliffs range in height from approximately 10 to 35-40m and are inclined at between 60° and vertical to overhanging, although their common inclination is 70-80°. It is the combination of this steep cliff morphology, the largely weak and incompetent nature of the rock mass and the presence of discontinuities which lead to the problems of instability. See Figure G9.2.

Figure G9.2 Cross section illustrating stabilization measures, Sandown Bay.

In recent years a total of approximately £1,500,000 has been spent on cliff stabilization works; this has followed a prioritised works programme as described above (see Figure G9.2). The main elements of the current approach have involved re-profiling of the cliff top where sufficient space is available for the cliff top to be de-vegetated and battered back. Re-profiling was concentrated at the southern end of the Bay and allowed the removal of superficial deposits, which as a result of cliff recession were overhanging, plus some of the overhanging sandstone. More importantly, however, re-profiling removed a number of large buttresses left by the failure of adjacent material along joints perpendicular to the face and tension fractures on the upper cliff face.

The angle of the battered slope was determined by a number of factors. It was necessary to remove as much of the existing unstable upper face as possible if more expensive stabilization measures were not to be employed; land take, however, had to be minimal. Observation of existing slopes showed that an angle of 60° should be stable and consultation indicated that this would be the maximum able to support the controlled growth of vegetation. The ability to grow and maintain vegetation on the slope was important as this would prevent excessive infiltration into the cliff top close to the face. The second technique used was face scaling. This work involved the removal of loose materials using hand held pneumatic drills with operatives working using abseiling techniques.

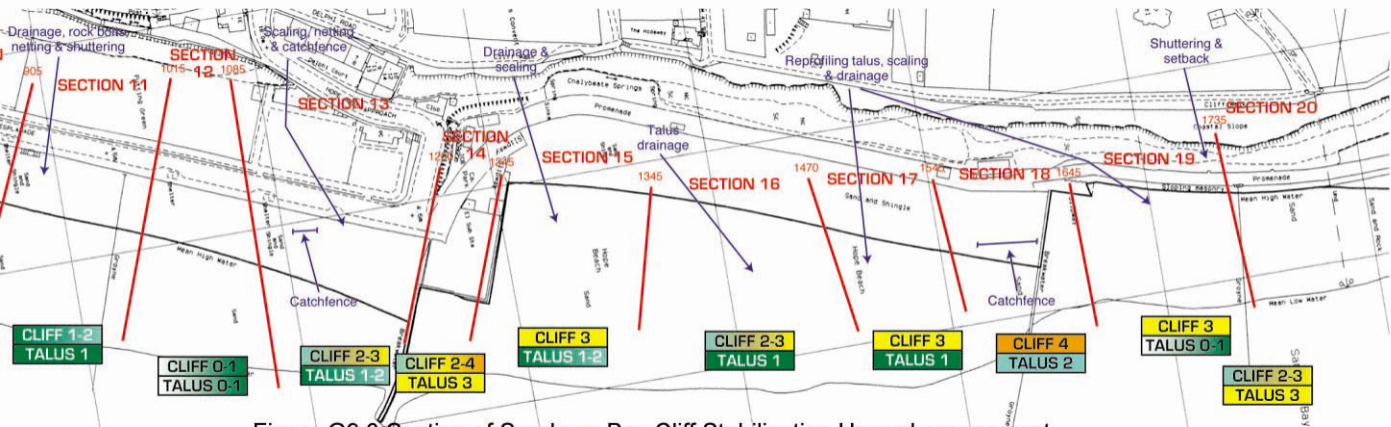
The cliff proformas contain a sketch of the cliff face and cliff profile and a description of cliff geology. The latter included material composition, stratigraphy, geological structure data, locations, mechanisms and size of cliff failures, the potential for further instability, location of seepage lines, cliff vegetation and any structures such as paths and buildings in the vicinity of the cliff. Some of this information was collected by cliff abseiling techniques. The talus slope, if present, was described in terms of its drainage, stability, vegetation, slope and general dimensions. These data enabled the relative hazard of cliff falls and talus failure to be assessed for each section. Cliff and talus hazard ratings of between 1 and 4 (4 = highest hazard) were assigned to each section of the cliffline on the basis of a qualitative assessment of the potential for failure. See Figure G9.3.

Figure G9.3 Section of Sandown Bay Cliff Stabilisation Hazard assessment (please contact the project partners (see 'Home' page) for details of the complete plan.)
