GEOTECHNICAL STUDY AREA G6

WOODLANDS, ST LAWRENCE, VENTNOR UNDERCLIFF, ISLE OF WIGHT, UK

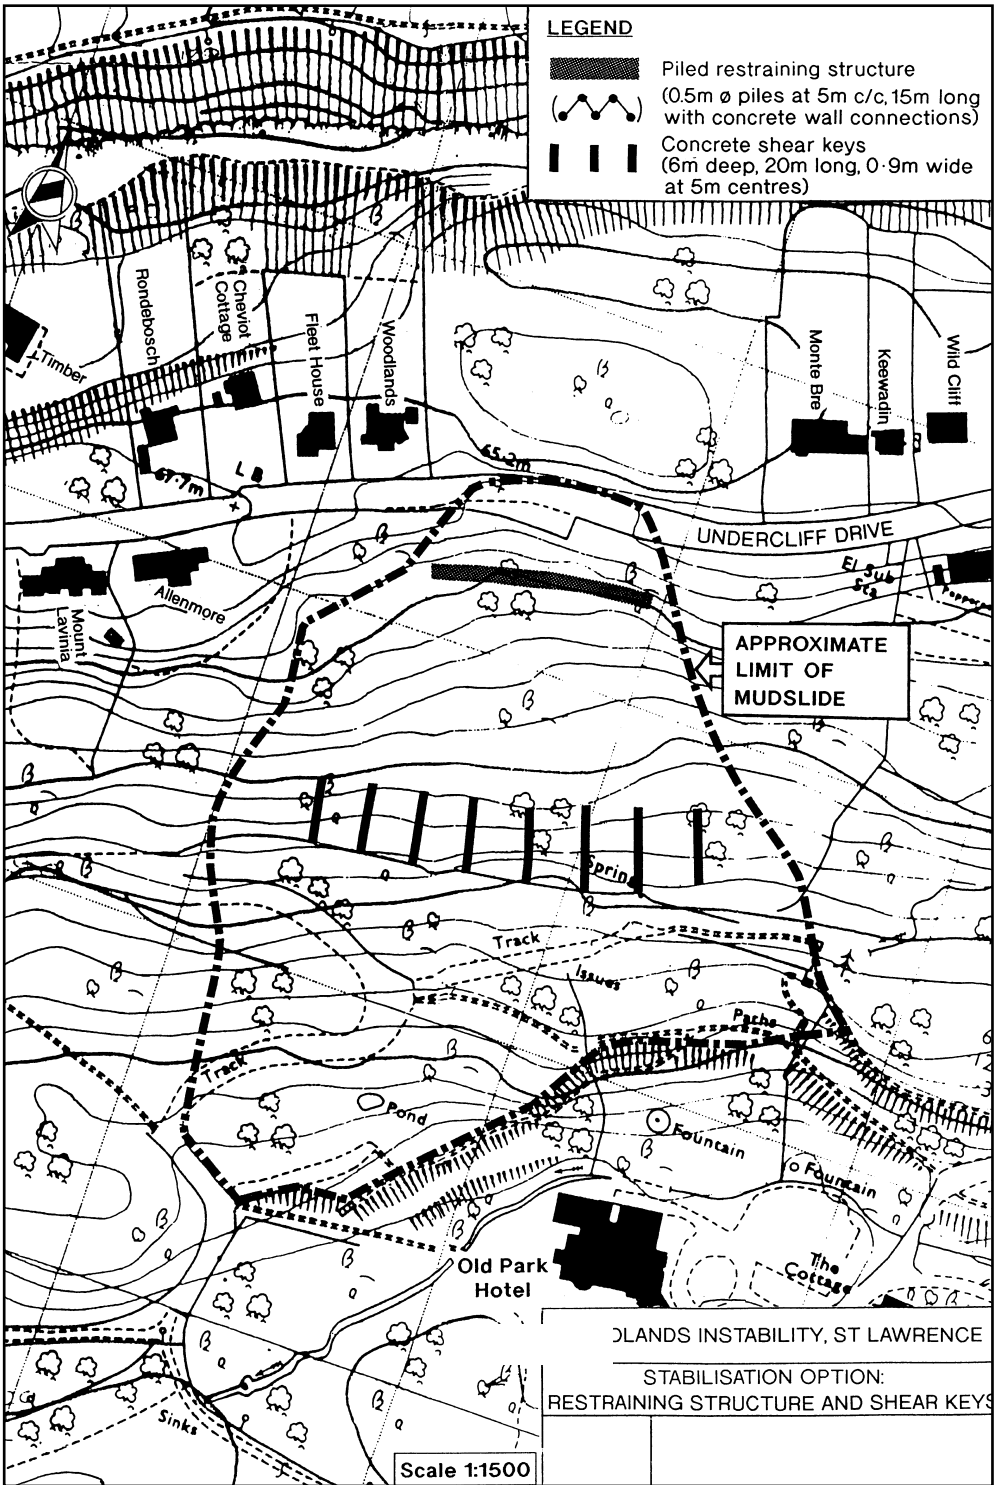
Figure G6.2 Proposed stabilisation measures.

The stability analysis demonstrated that under contemporary conditions the shallow slide was actively unstable (Factor of Safety is 0.87). It is clear that landslide activity was being caused by the particularly high groundwater levels and poor drainage at the site. Drainage measures aimed at reducing groundwater levels would bring about an improvement in slope stability; the sensitivity analysis indicated that an effective reduction of groundwater levels by 2 metres would

bring about a 14% improvement in the Factor of Safety. Proposed stabilization measures are also shown in Figure G6.2.

Slope instability has also been promoted by artificial loading (i.e. placement of fill during construction and maintenance of the road) at the head of the shallow slide. The sensitivity analysis demonstrated that the shallow slide was particularly sensitive to the addition of load at the head scarp and that the Factor of Safety may have been reduced by as much as 76% through the construction of the road in its present location. Removal of some of this load would significantly improve the stability of the site with little disbenefit to the stability of the deep-seated multi-rotational landslide zone.

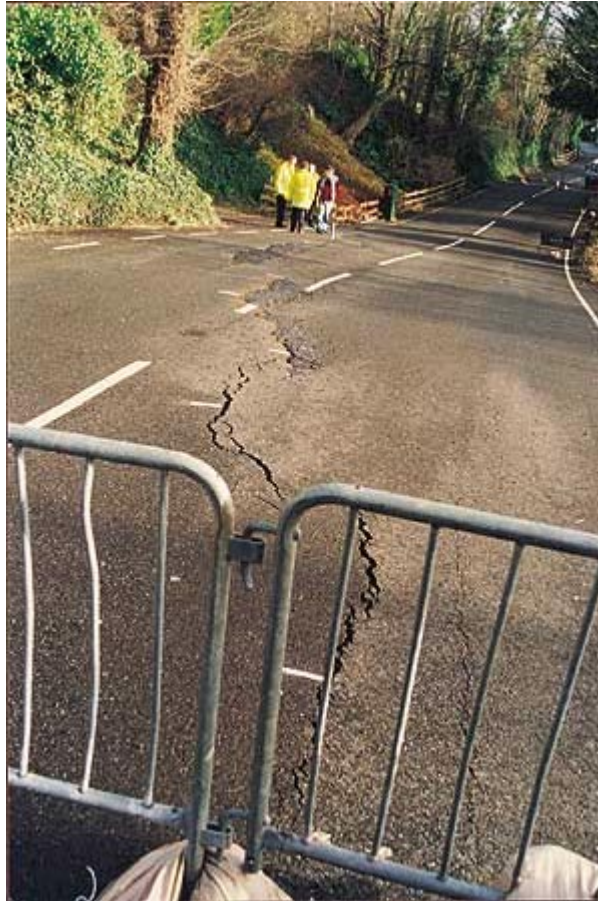
Of particular significance at this site is the presence of a multi-rotational degradation zone which is characterised by relatively active shallow rotational slips and landslides. The continued movement and degradation of the shallow mudslides in recent times has undoubtedly caused the repeated settlement of the road carriageway in recent years. The settlement of the road

has involved slight rotation and backtilt of the road pavement, consistent with the mechanism of failure at the head scarp of a shallow slide.

This study indicates that the repeated settlement of the Undercliff Drive at this location has been caused by the ongoing movement of an active shallow slide developed upon the deep-seated multi-rotational failure zone forming the upper slopes of the Undercliff (Plate G6a). It is apparent that various attempts have been made in the past to drain the slopes, all of which have either failed or have fallen into disrepair. It was clear that if a "do nothing" option was adopted, the stability of the shallow slide would deteriorate further leading to more frequent and extensive damage to the road. Seasonal slope movements would increase and there would be an increased likelihood of major events such as occurred a short distance to the west in 1926. Furthermore, if slope instability was allowed to deteriorate, the shallow slide would become more extensive. There was also a risk that landslide activity will spread upslope, potentially destabilising the deep-seated slide and associated development together with an increased likelihood of debris runout at the foot of the slope in the vicinity of a major hotel.

Plate G6a *Damage to the main road A3055 at Woodlands*
