GROUND MOVEMENT IN VENTNOR, ISLE OF WIGHT

A SUMMARY OF THE STUDY OF LANDSLIDE PROBLEMS IN VENTNOR, CARRIED OUT FOR THE DEPARTMENT OF THE ENVIRONMENT (Research Contract No. PECD 7/1/272)

Geomorphological Services Limited

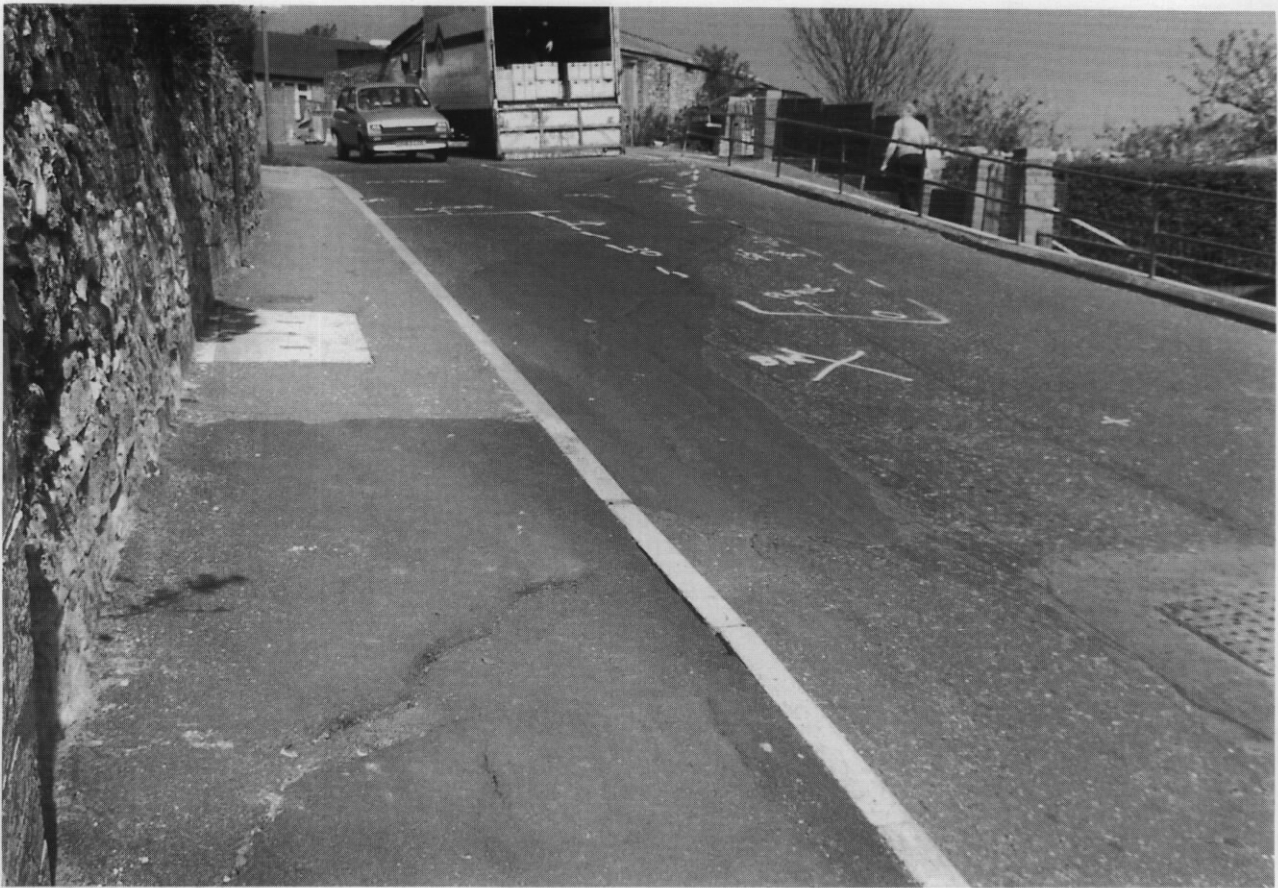
Plate 2: Within the "graben", roads and hardstandings require regular repair

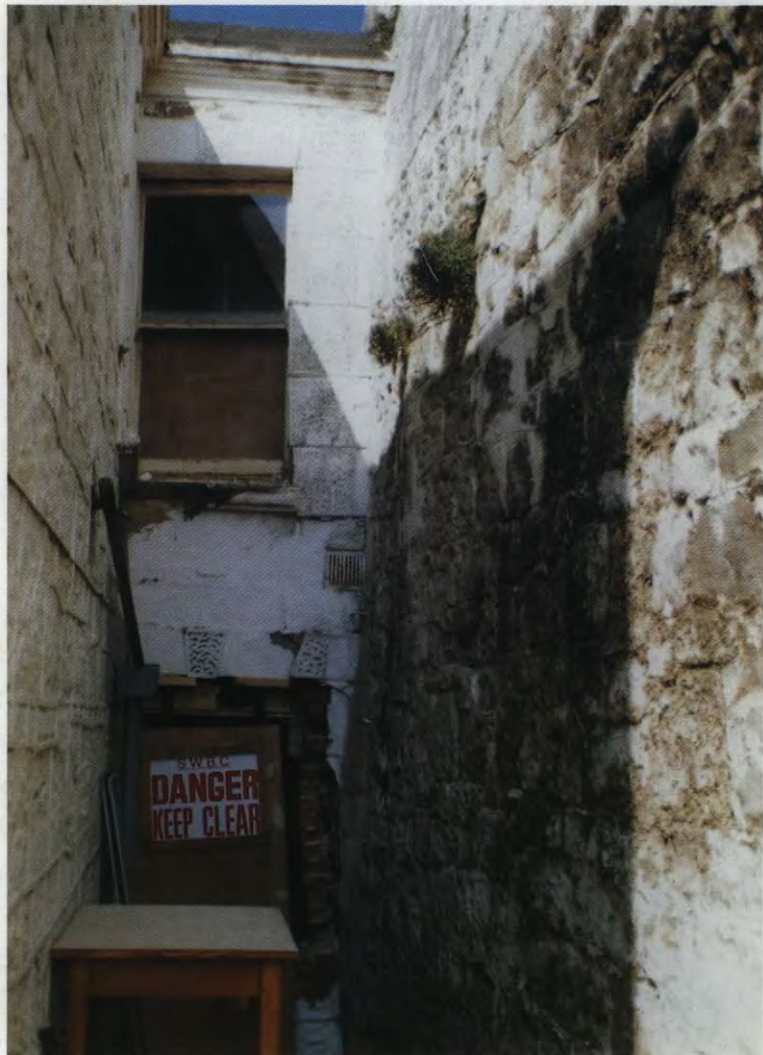
Plate 3: Damage caused by compression of two adjacent properties

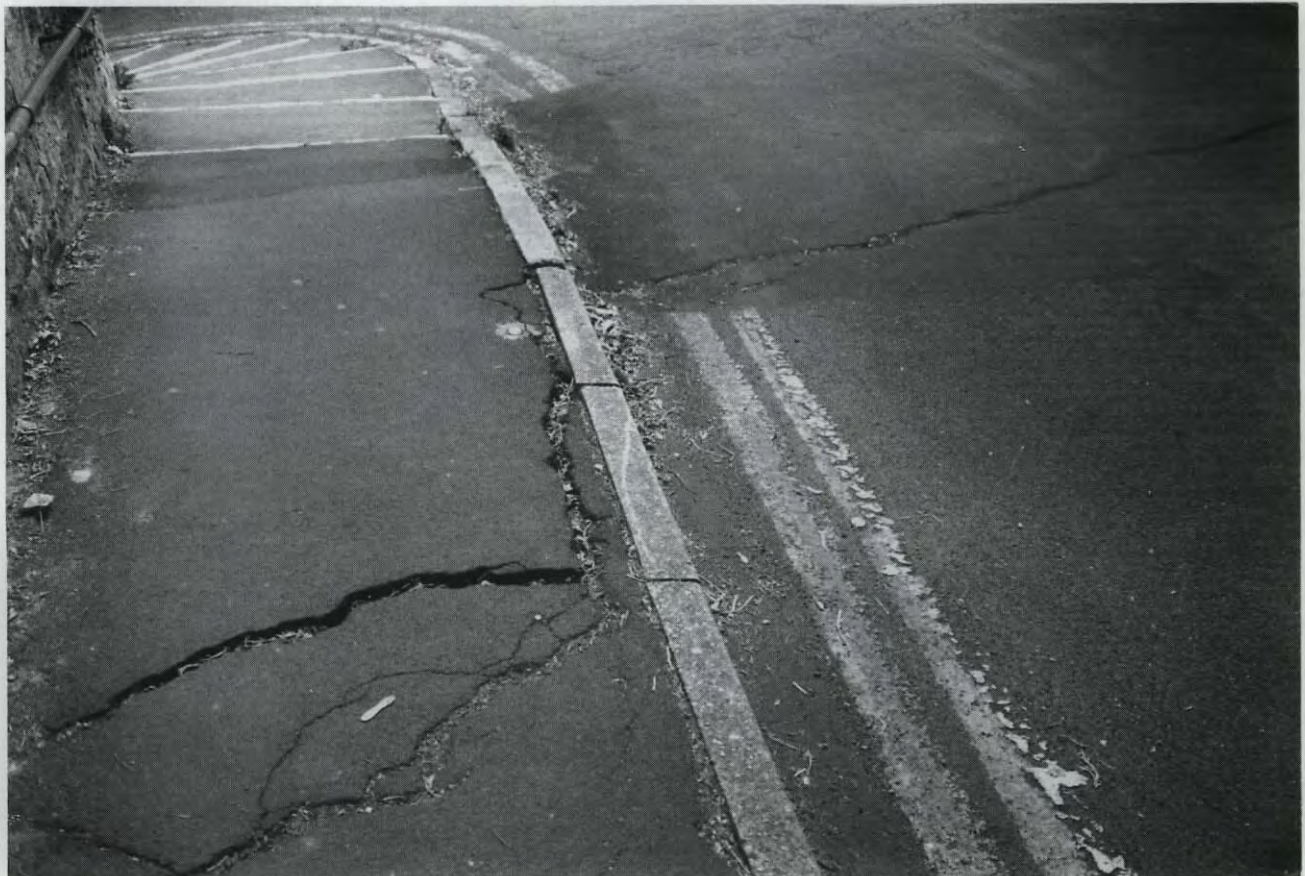
Plate 4: Severe cracking, extension and settlement to the road and footpath

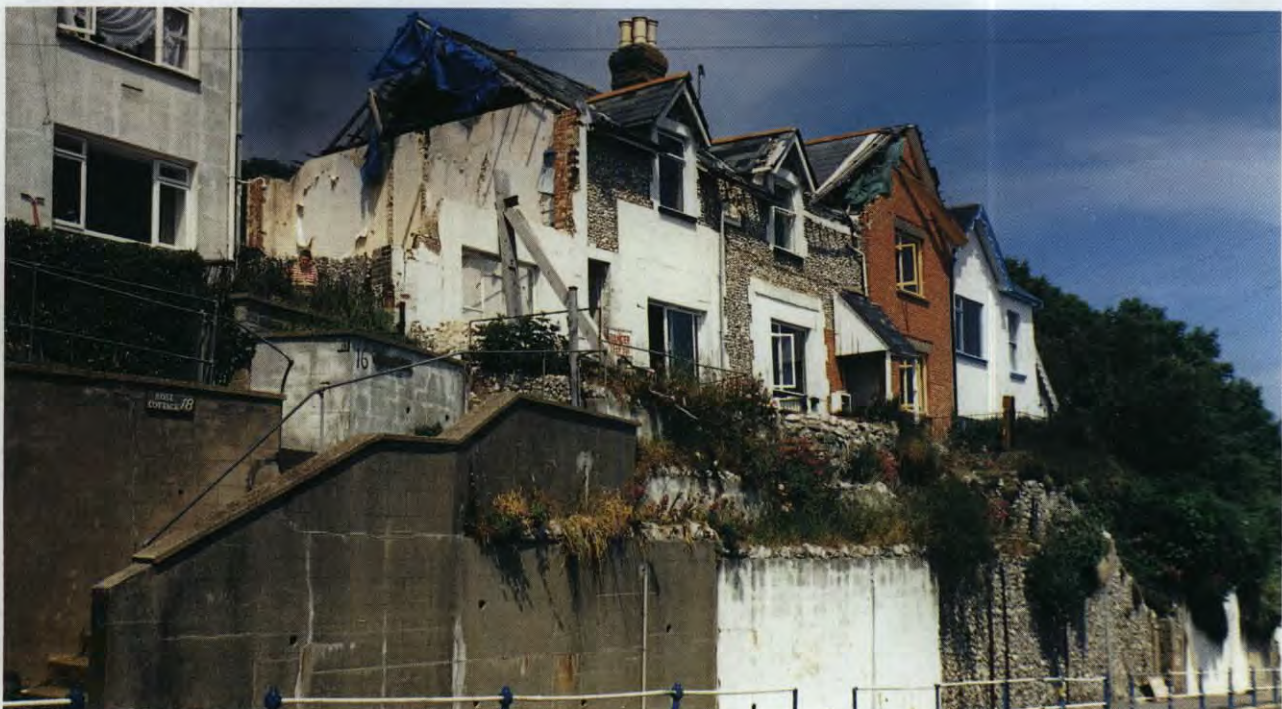
Plate 5: Severely fractured and tilted structure in course of demolition (1988)

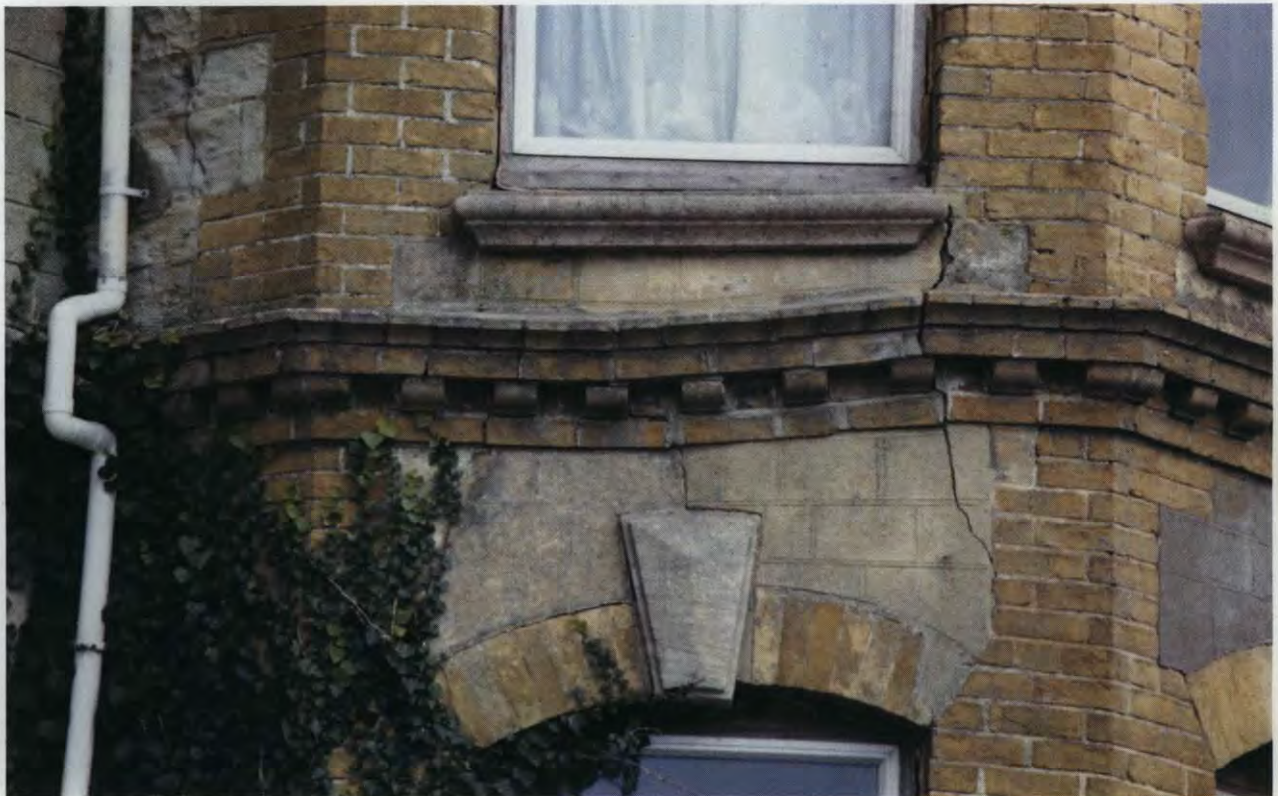
Plate 6: Structural damage has caused misalignment of the string course and also displacement of the arch and keystone

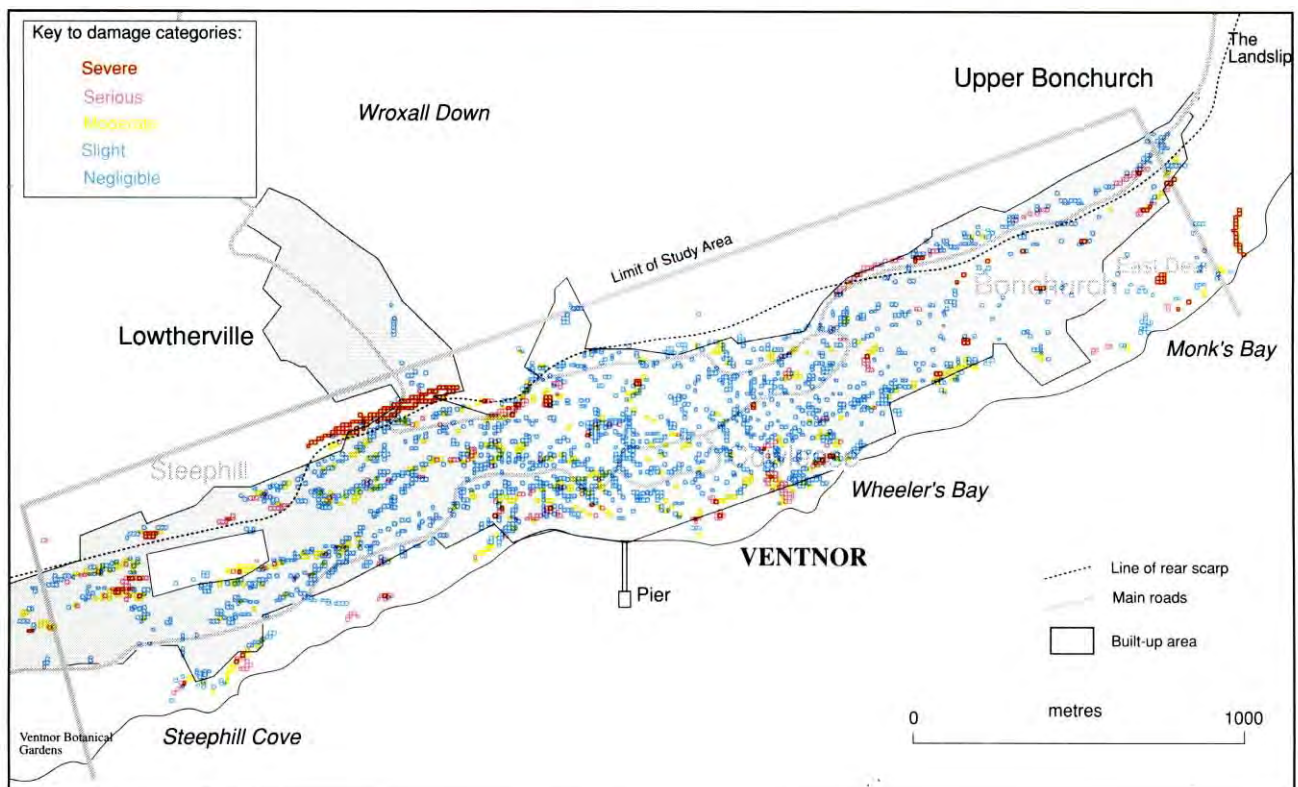
Figure 3: Distribution of damage caused by ground movement

The results of the damage survey are presented in Figure 3 and Table 2, which reveal that only 18% of damage is of a **serious** or **severe** intensity. Much of the damage (32%) is only **slight** or **negligible**, not requiring urgent repair. However, the most significant class of damage (with over 1200 examples) seems to be **moderate** (i.e. widespread cracking, slightly tilted walls or fractured structural members and service pipes).

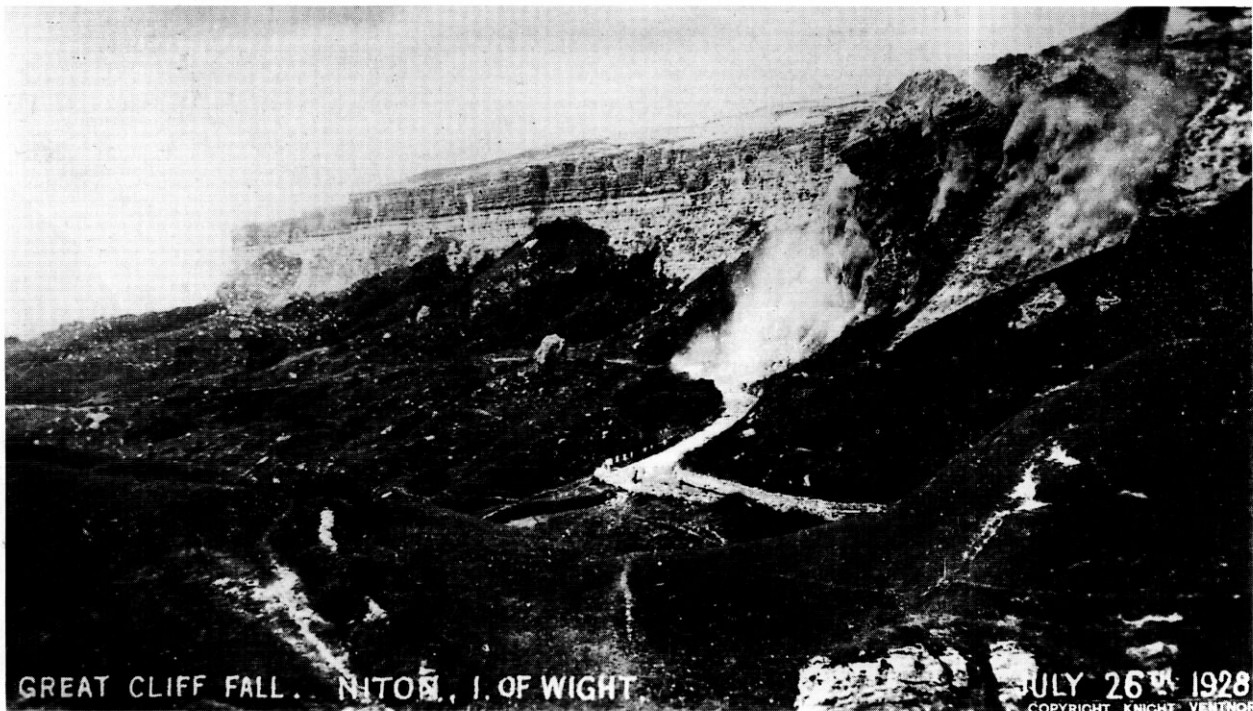
Plate 7: Rockfall at Gore Cliff, 1928

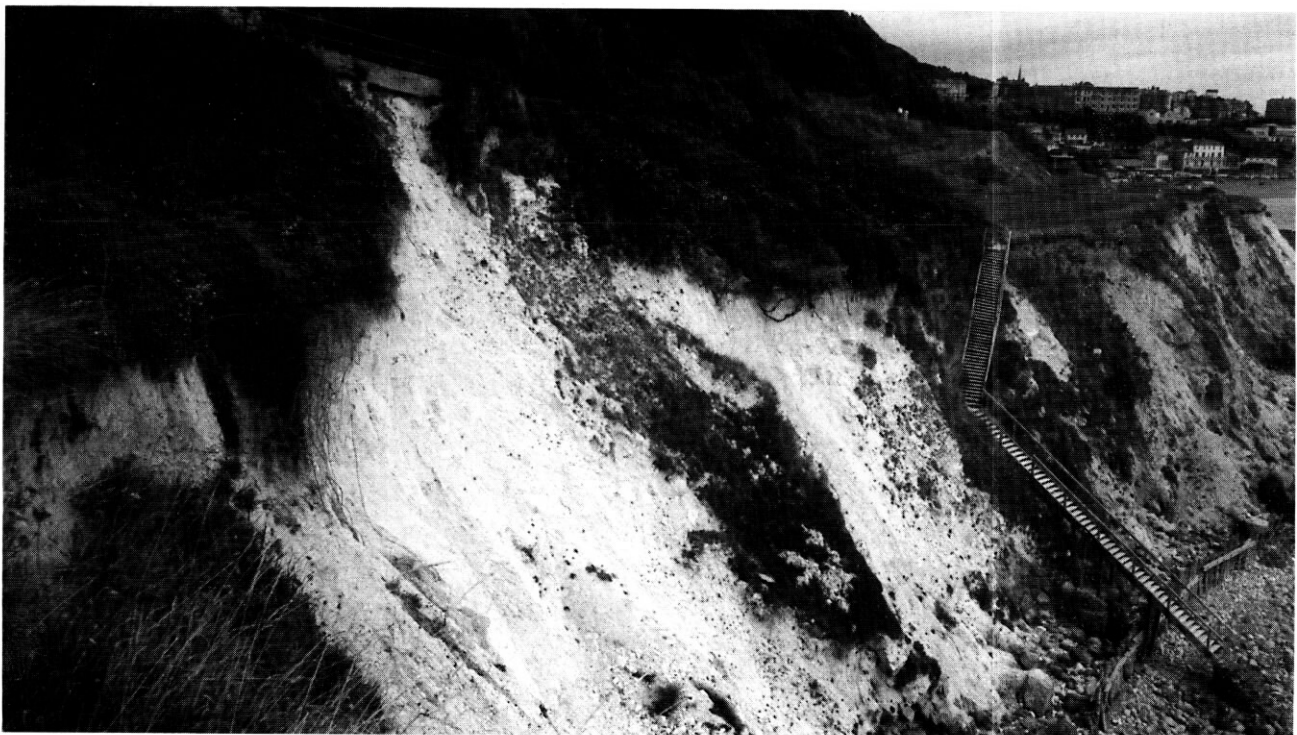
Plate:8 Coastal erosion at the Western Cliffs

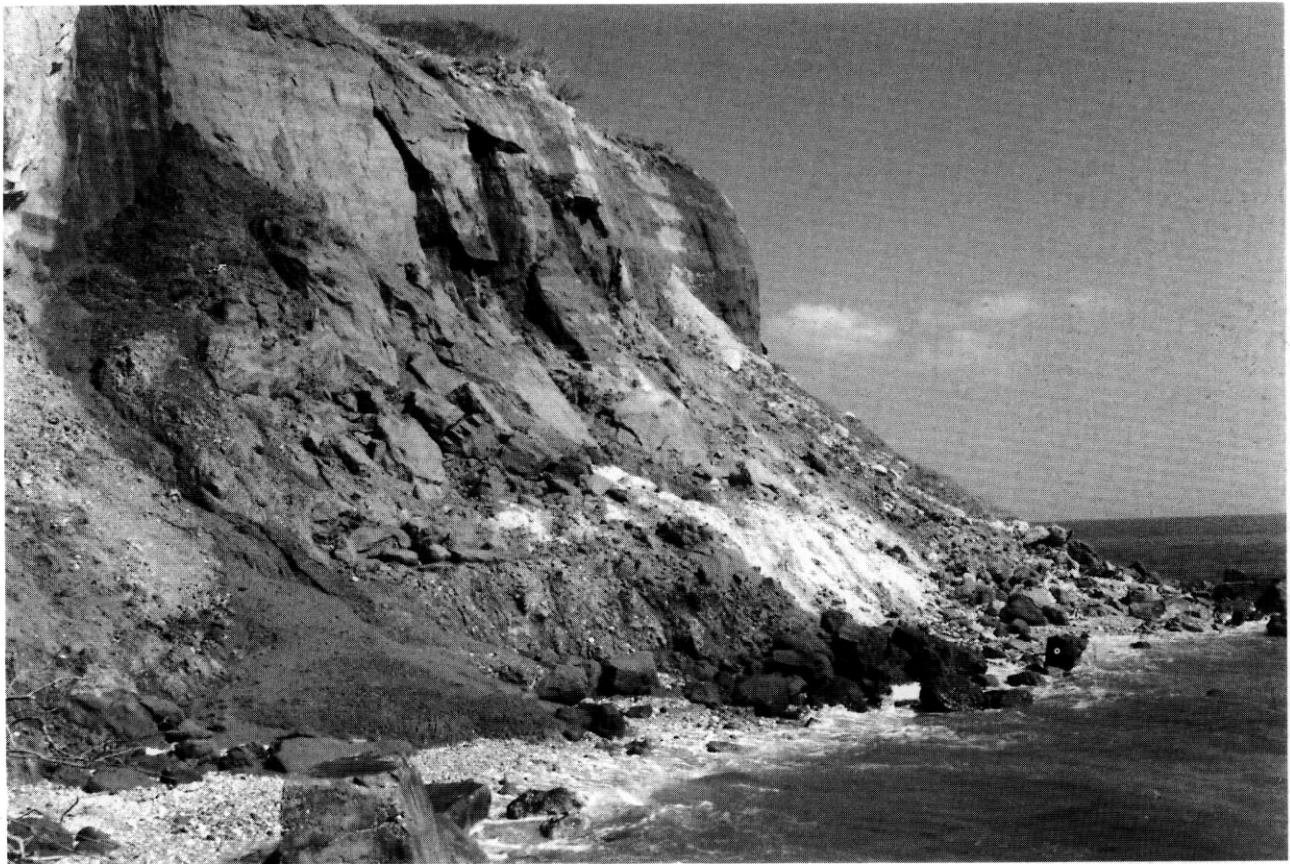
Plate 9: Erosion of the Lower Greensand cliffs, Monk's Bay

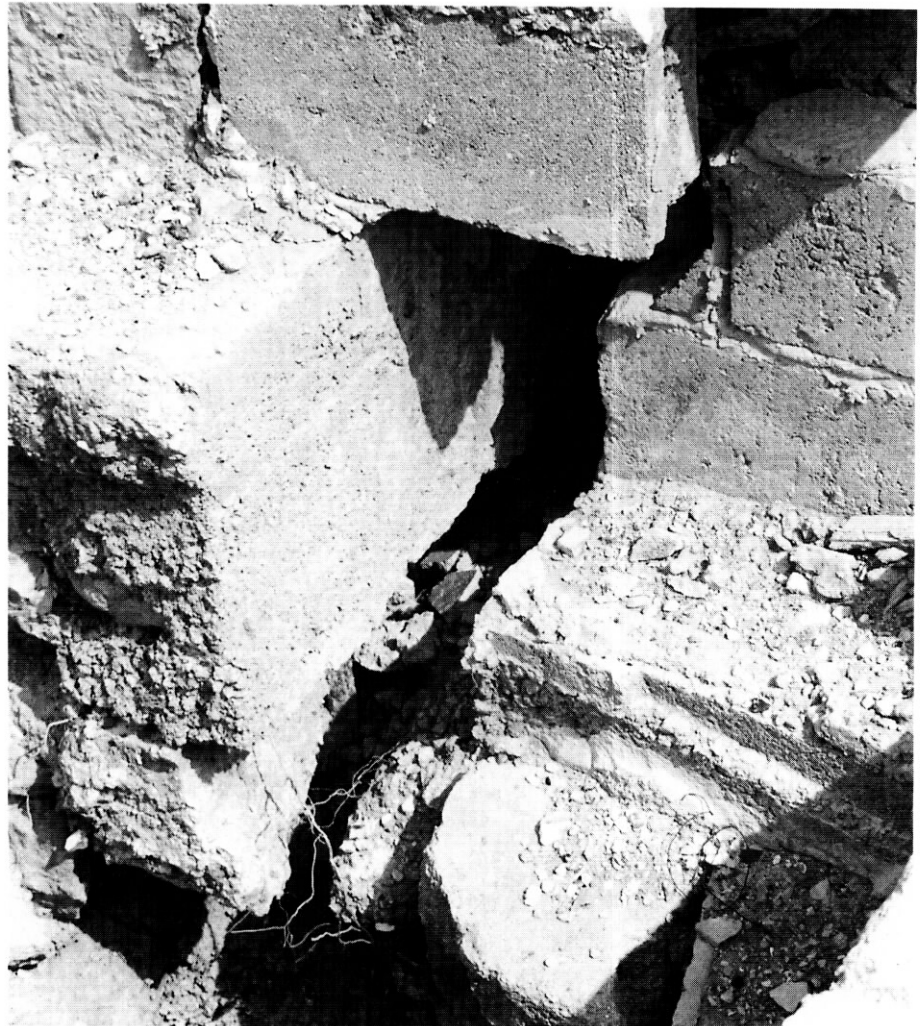
Plate 10: Differential movement and extension resulting in severe fracturing to foundations

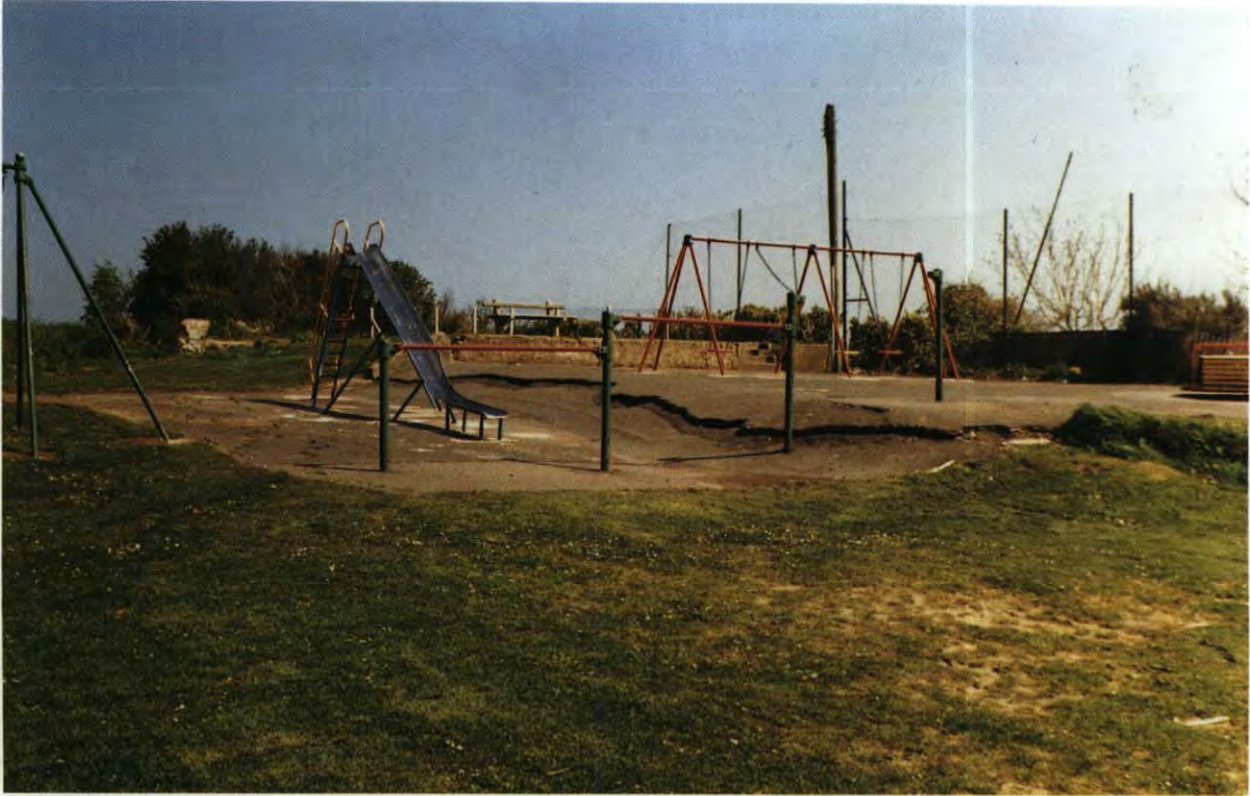
Plate 12: Development of a major fissure marking the side of "the graben"

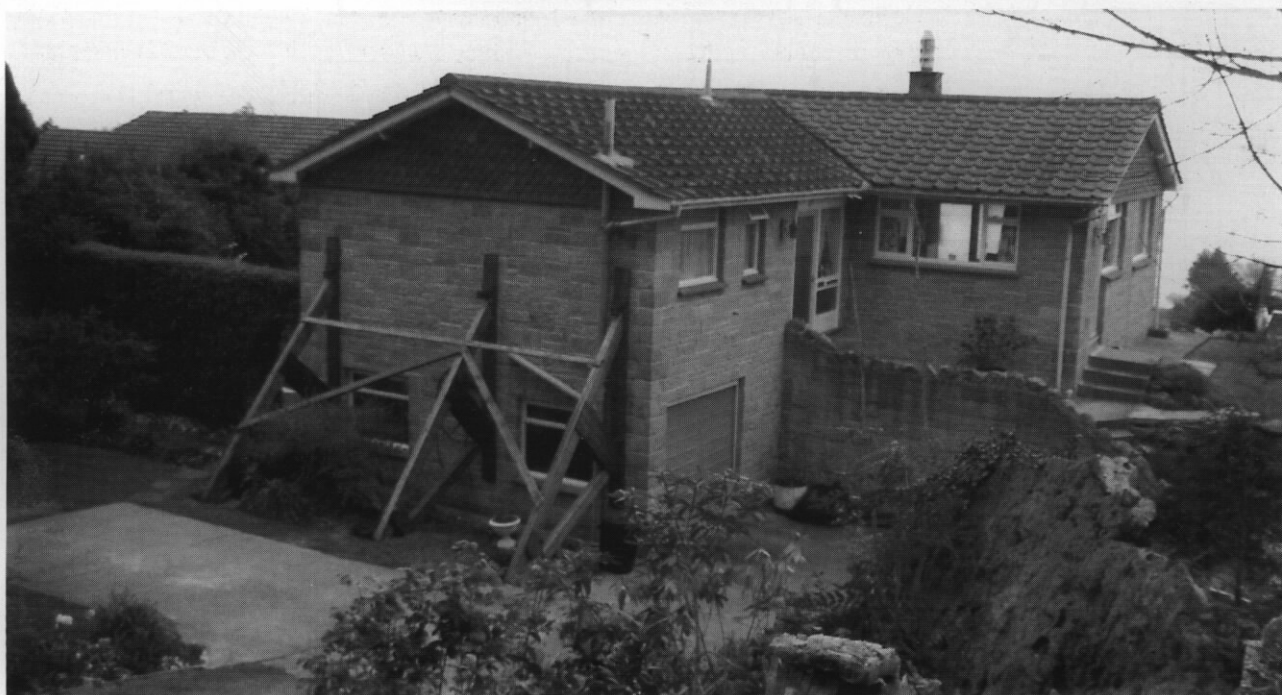
Plate 14: Raking shores used to counter localised rotational tilt

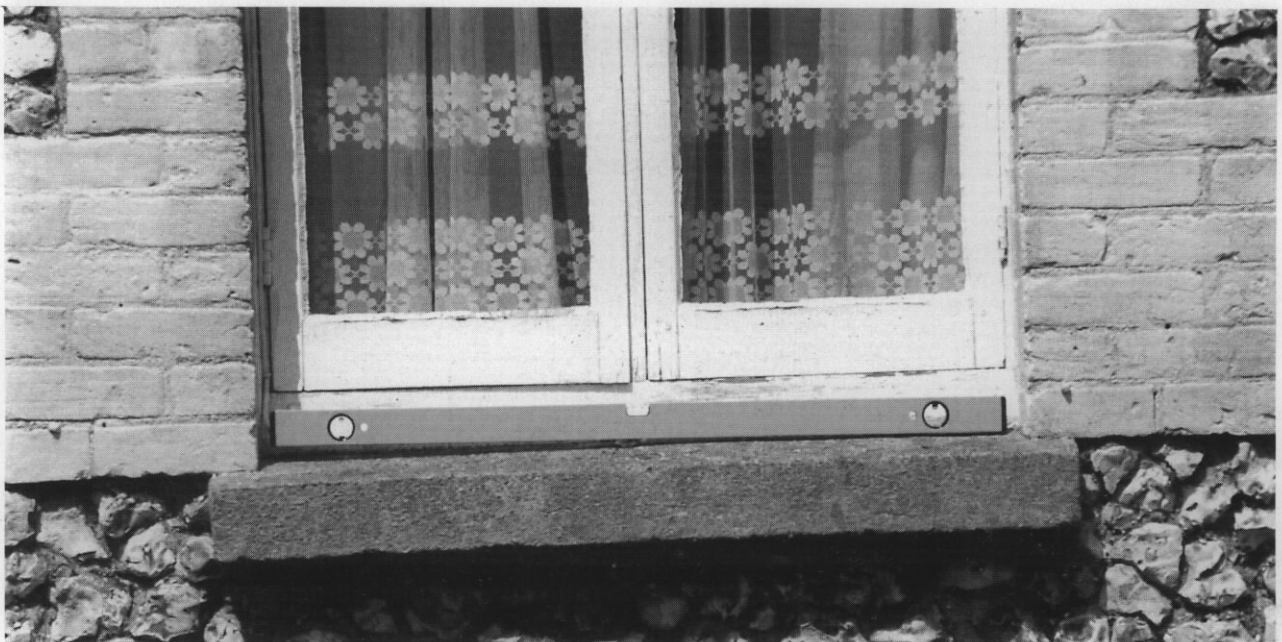
Plate 15: Differential ground movement has distorted the frame and tilted the sill

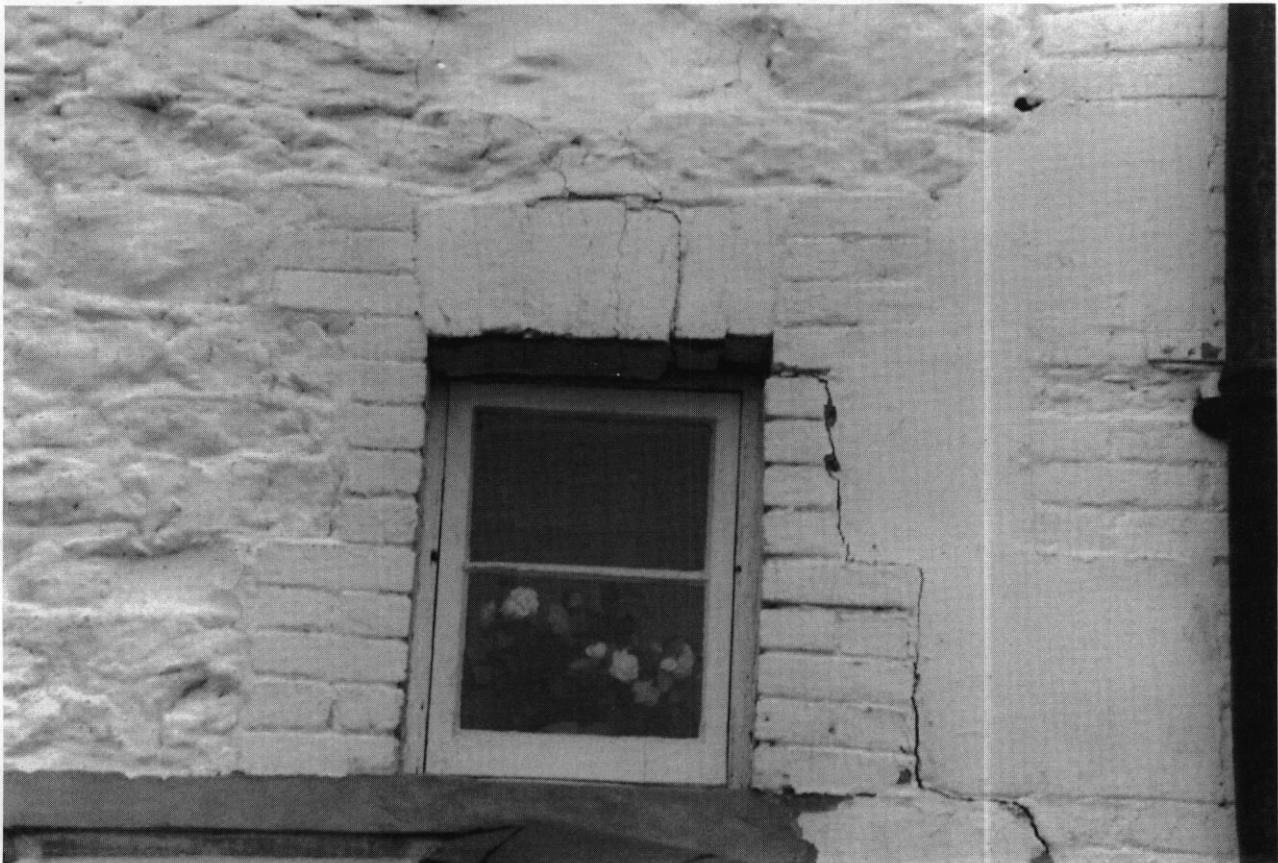
Plate 16: Both long-standing movement and recent fracturing are evident in this photograph

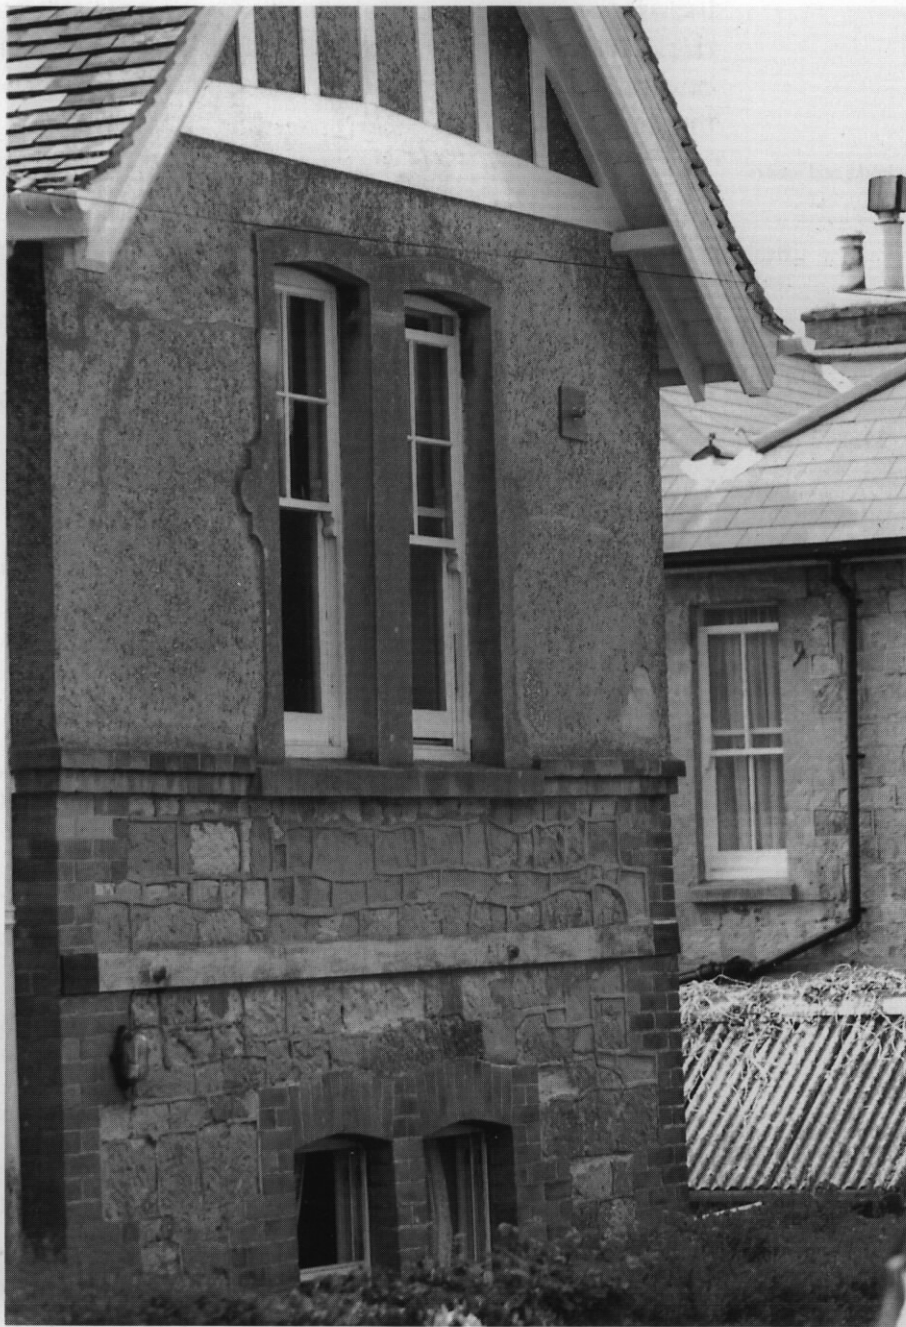
Plate 17: Steel tie rods and beam used to hold building together
