## **Isle of Wight Shoreline Management Plan 2**

### **Appendix C: Baseline Process Understanding** **C2: Defence Appraisal**

December 2010

**Coastal Management;**  
**Directorate of Economy & Environment, Isle of Wight Council**

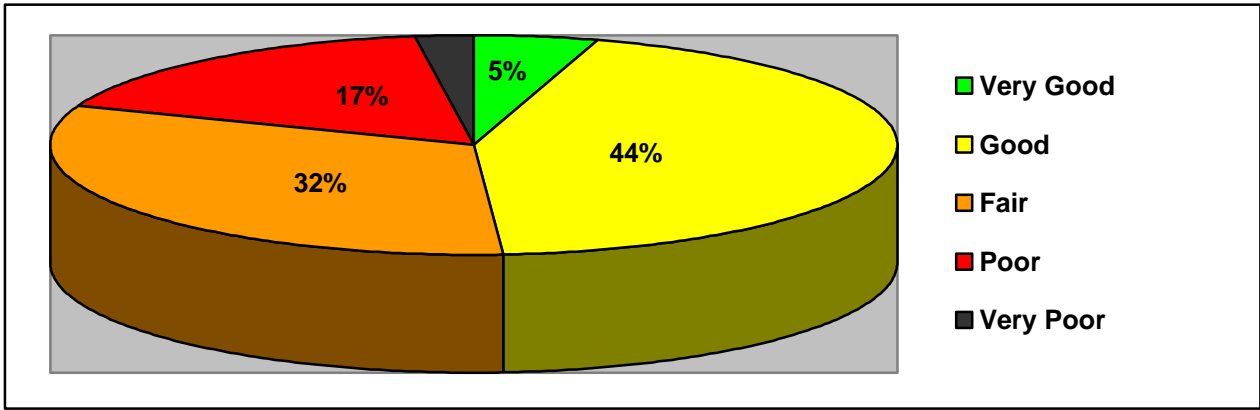
**Chart 6 - SMP2 Coastal Frontage Summary – Condition of Defence Elements**

The Isle of Wight SMP2 defended frontage provides a varied selection of condition grades for the study area. Condition grades range from 1 (Very Good) to 5 (Very Poor). The majority of the defences have a

condition grade 2 (Good) or 3 (Fair) (44% and 32% respectively). Of the remaining defences, 17% have a condition grade of 4 (Poor) and only 5% have a condition of 1 (Very Good).

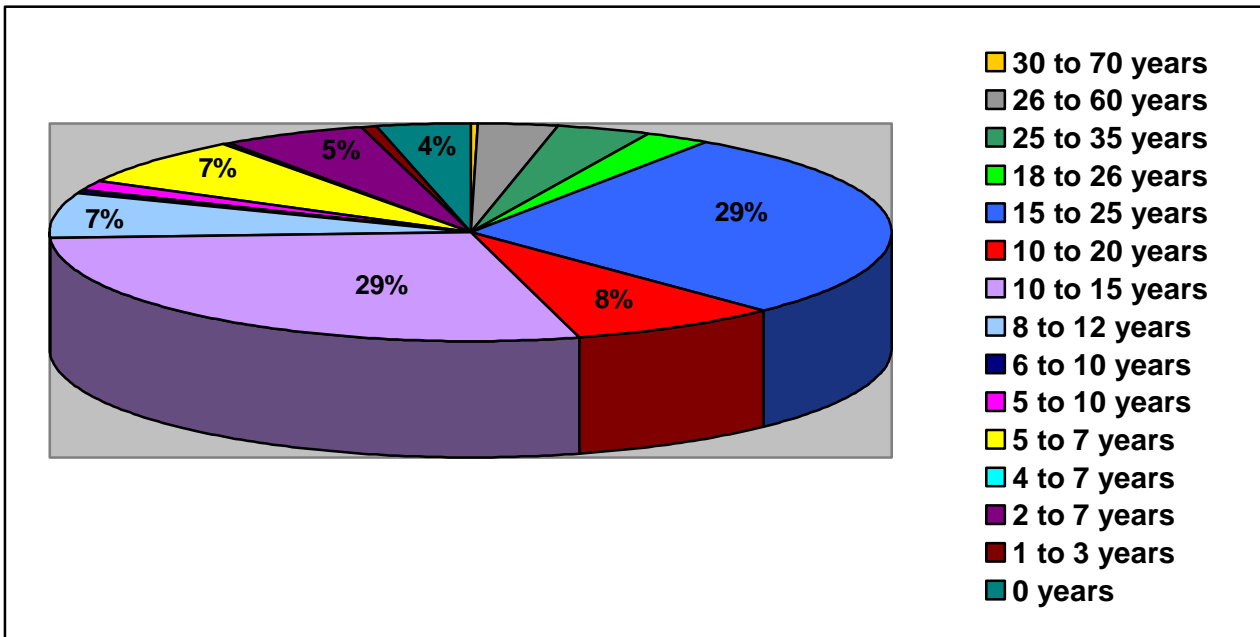
**Chart 7 - SMP2 Coastal Frontage Summary – Residual Life of Defence Elements**

It is important to note that there are a large number of defences that have the potential to fail within Epoch 1, but may not fail until Epoch 2. This provides uncertainty to the consequences of defence failure which is taken into account in subsequent tasks.

92% of the defences along the Isle of Wight frontage are expected to fail within Epoch 1 (0 – 20 years), based on worst-case scenario of the first date of possible defence failure. Alternatively 58% are likely to fail in Epoch 1, with the remainder in Epoch 2 (20 – 50 years), based on the mean date of possible defence failure within each category.
