**COASTAL LANDSLIP POTENTIAL ASSESSMENT:**

**Isle of Wight Undercliff, Ventnor.**

**REPORT ON THE STUDY OF LANDSLIDING  
IN AND AROUND LUCCOMBE VILLAGE**

GEOMORPHOLOGICAL SERVICES Ltd,

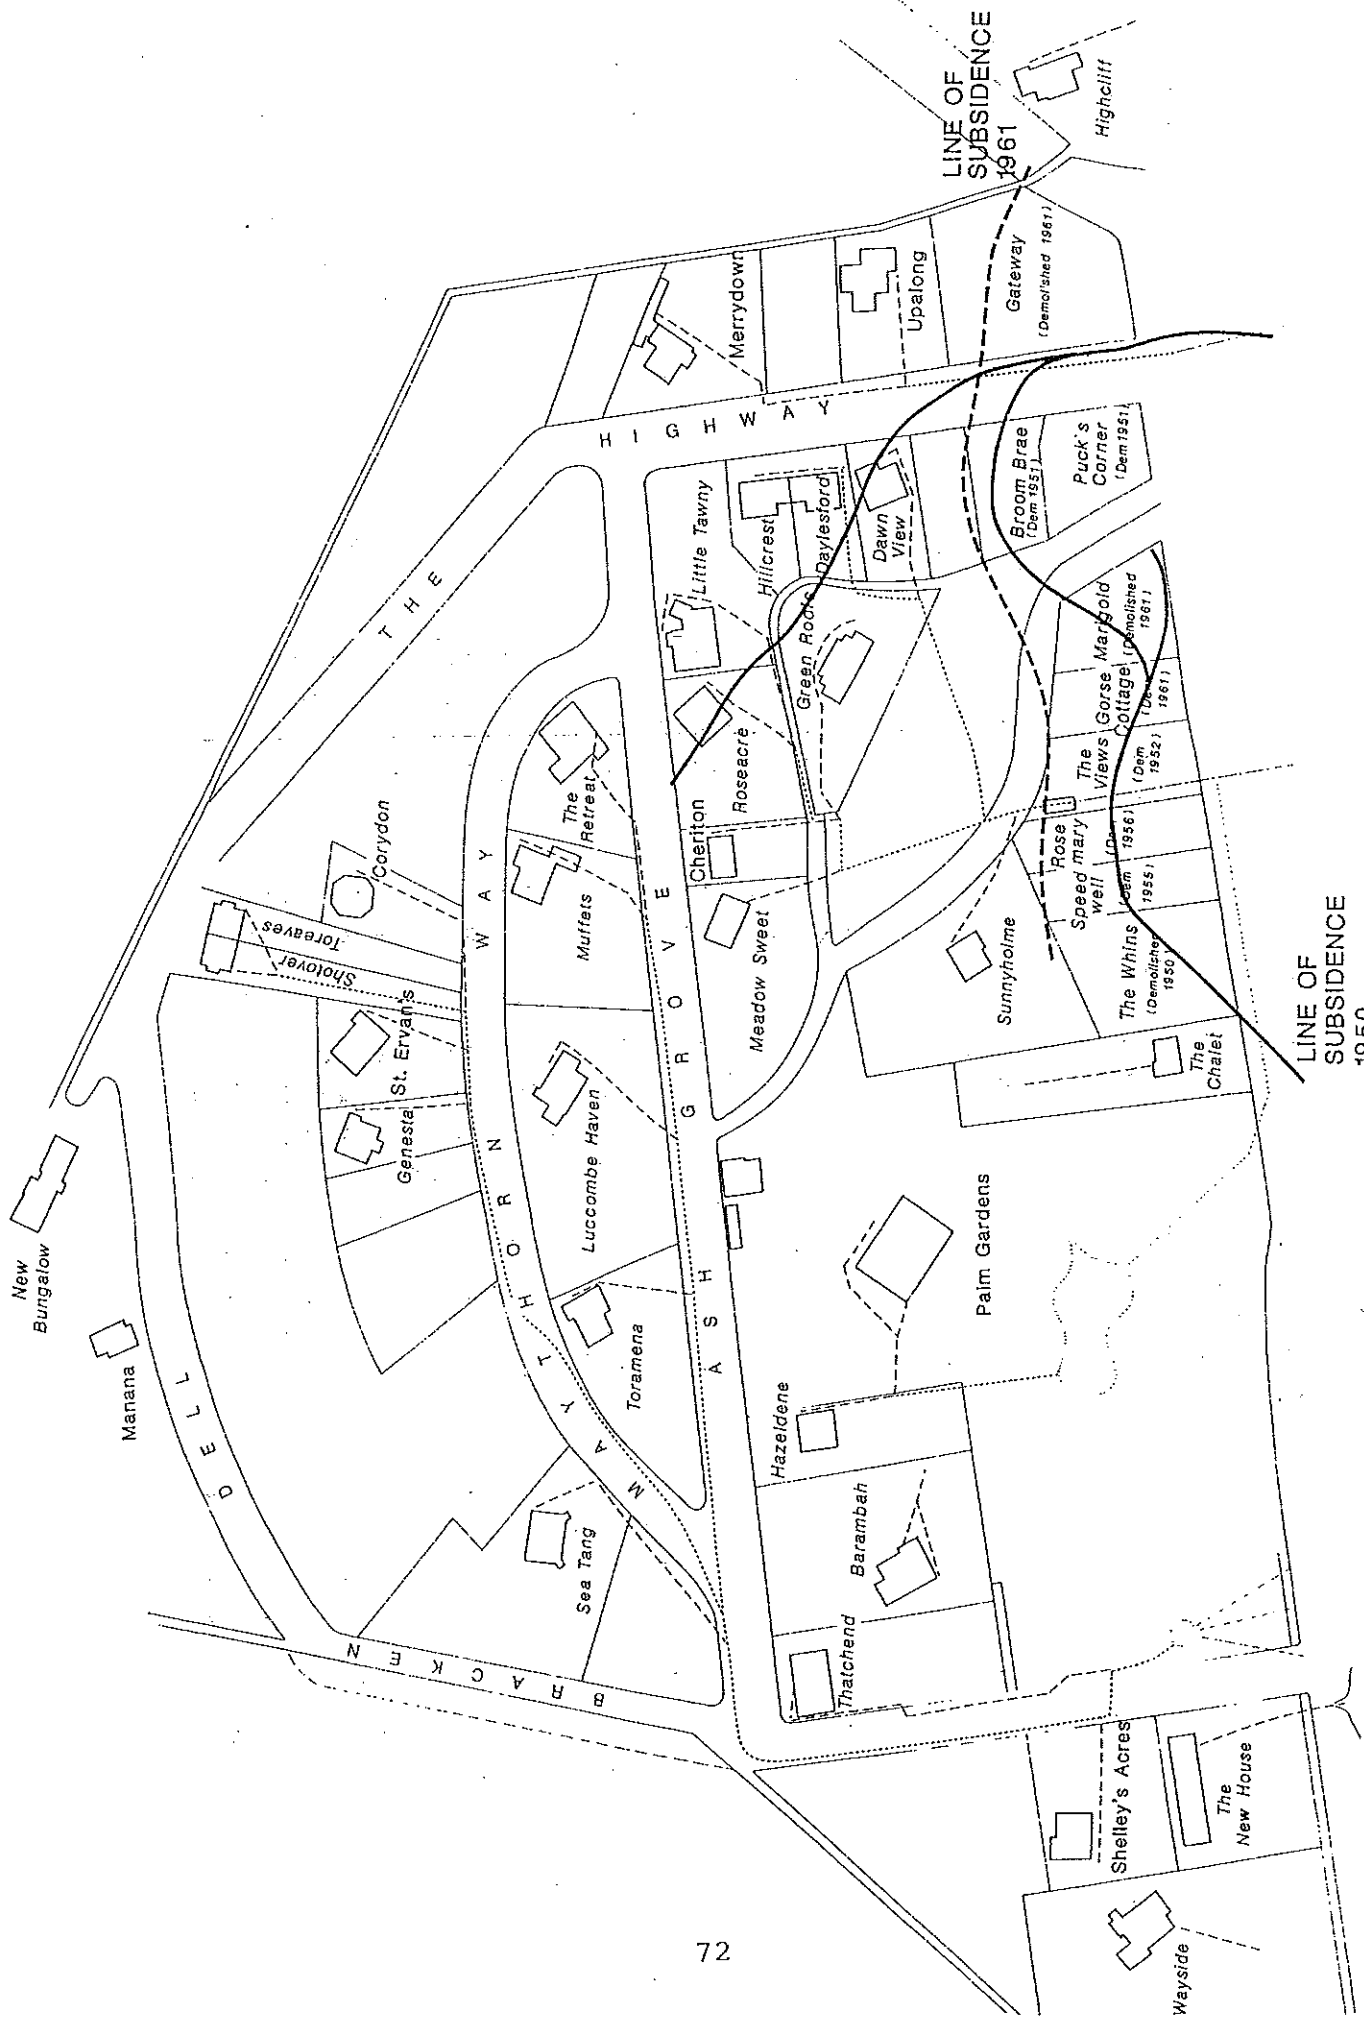
Figure 5.1 Surveyor's plan of landslide extent in 1950 and 1961.

- (i) 1950/1951 slippage; the local surveyor's plan (Figure 5.1) indicates that the major movements and subsidence occurred along the coastal access road to the village. The main tension scar extended from the 'Whine' to 'Broom Brae', delimiting the area of most active landsliding. In addition, a secondary tension scar opened further inland extending from Luccombe road to 'Dawn View' and 'Roseacre'. This scarp is possibly an extension of

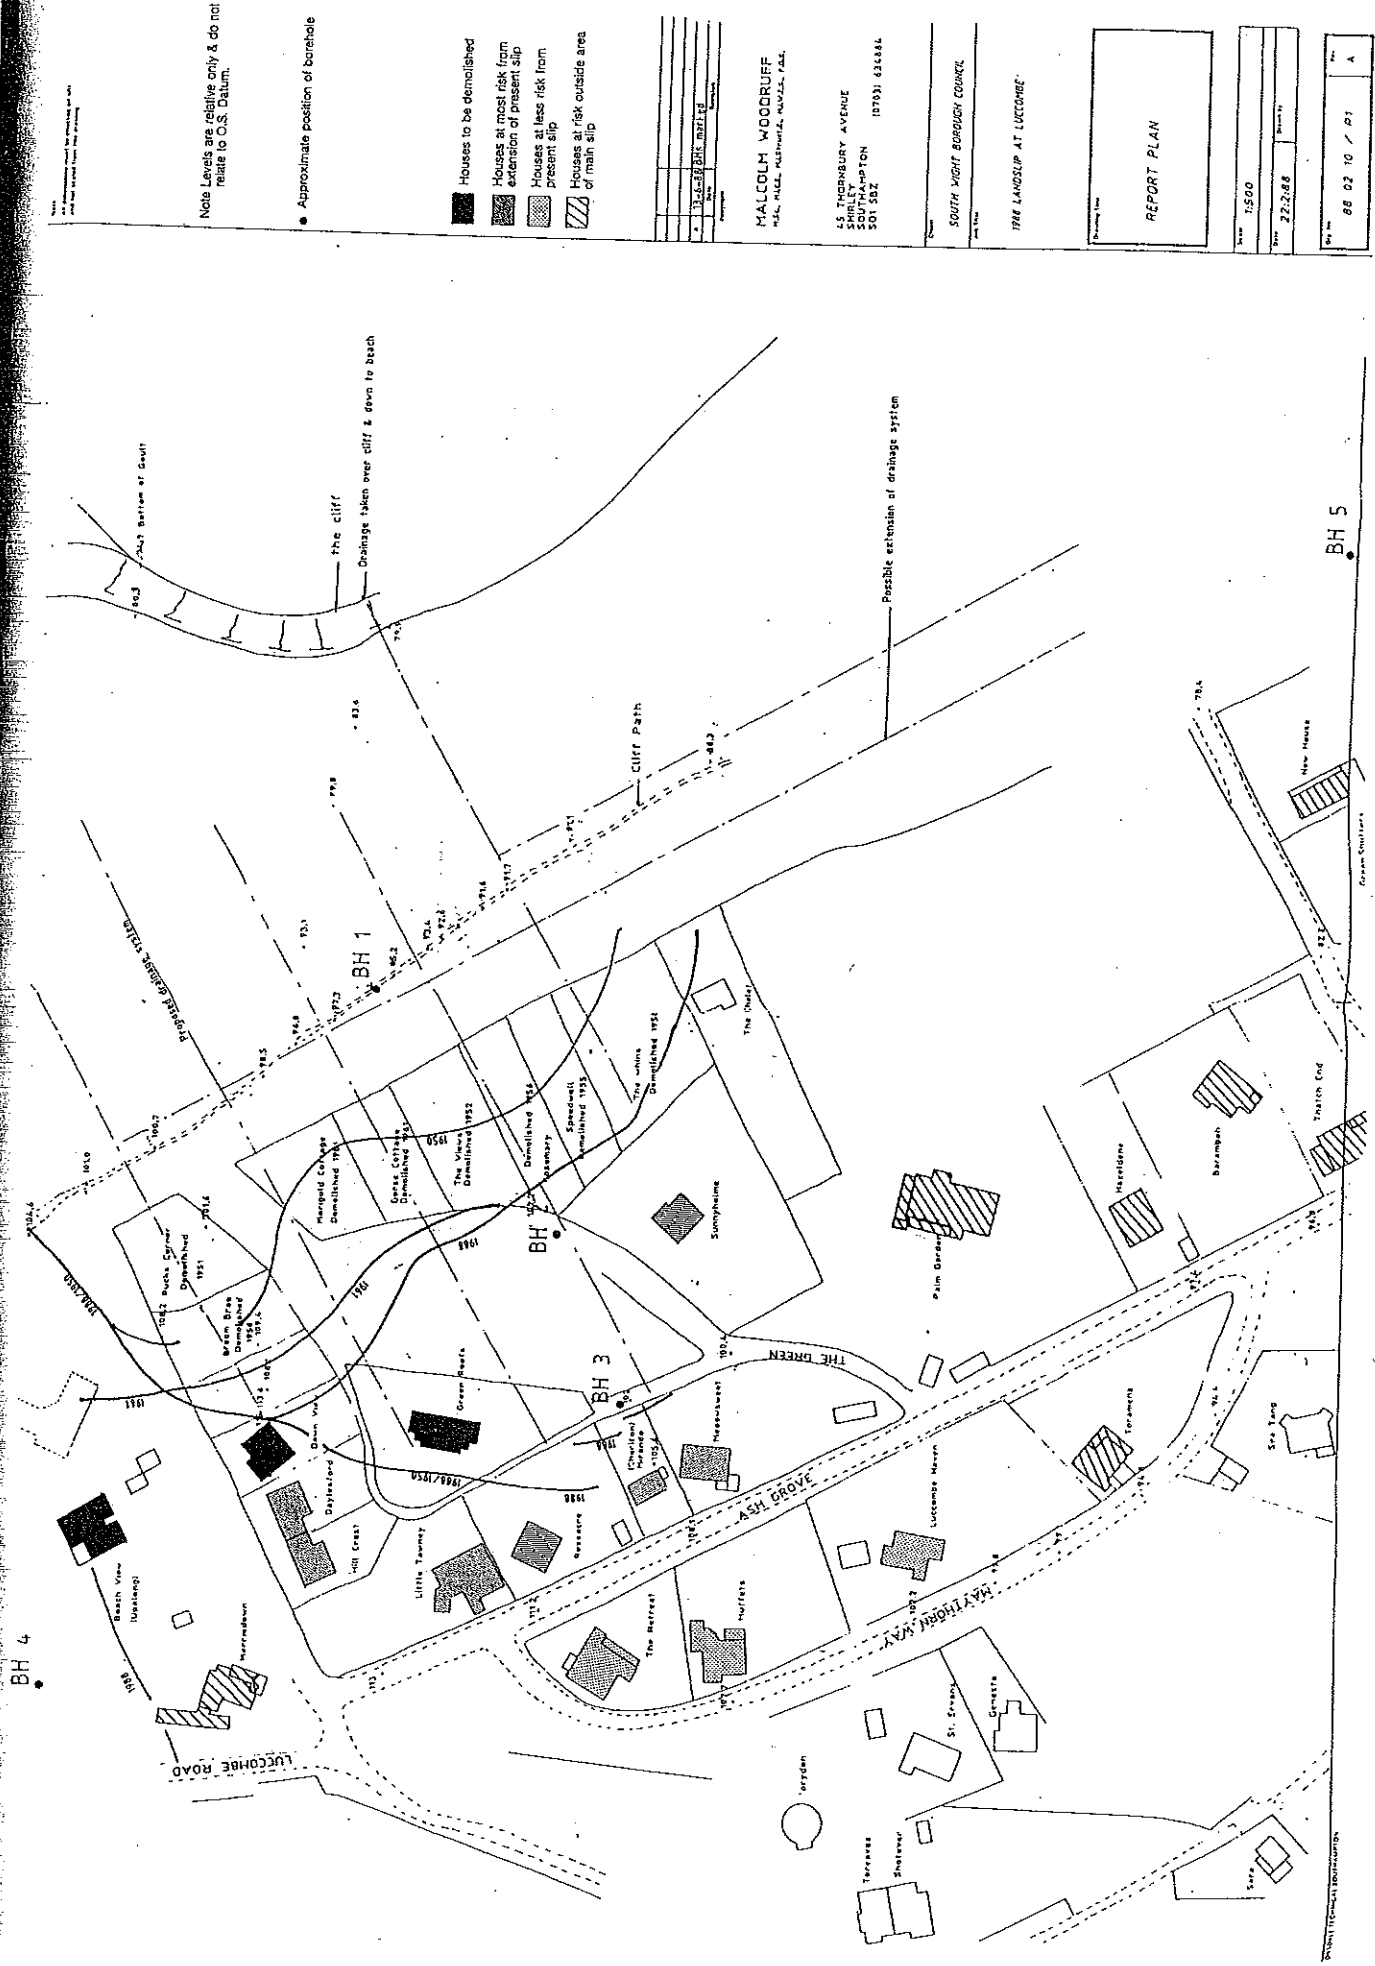
Figure 6.1 Map showing houses at risk from landsliding, location of boreholes and proposed drainage scheme (after Woodruff, 1988c).

- (ii) two piezometers were installed in each borehole; one at the base of the hole and one at the junction of the Gault Clay with the overlying Greensand debris. The results of the monitoring of these piezometers are presented in Table 6.1;
- (iii) slip indicators were placed in the deepest piezometer tubes to determine the depths of movement;

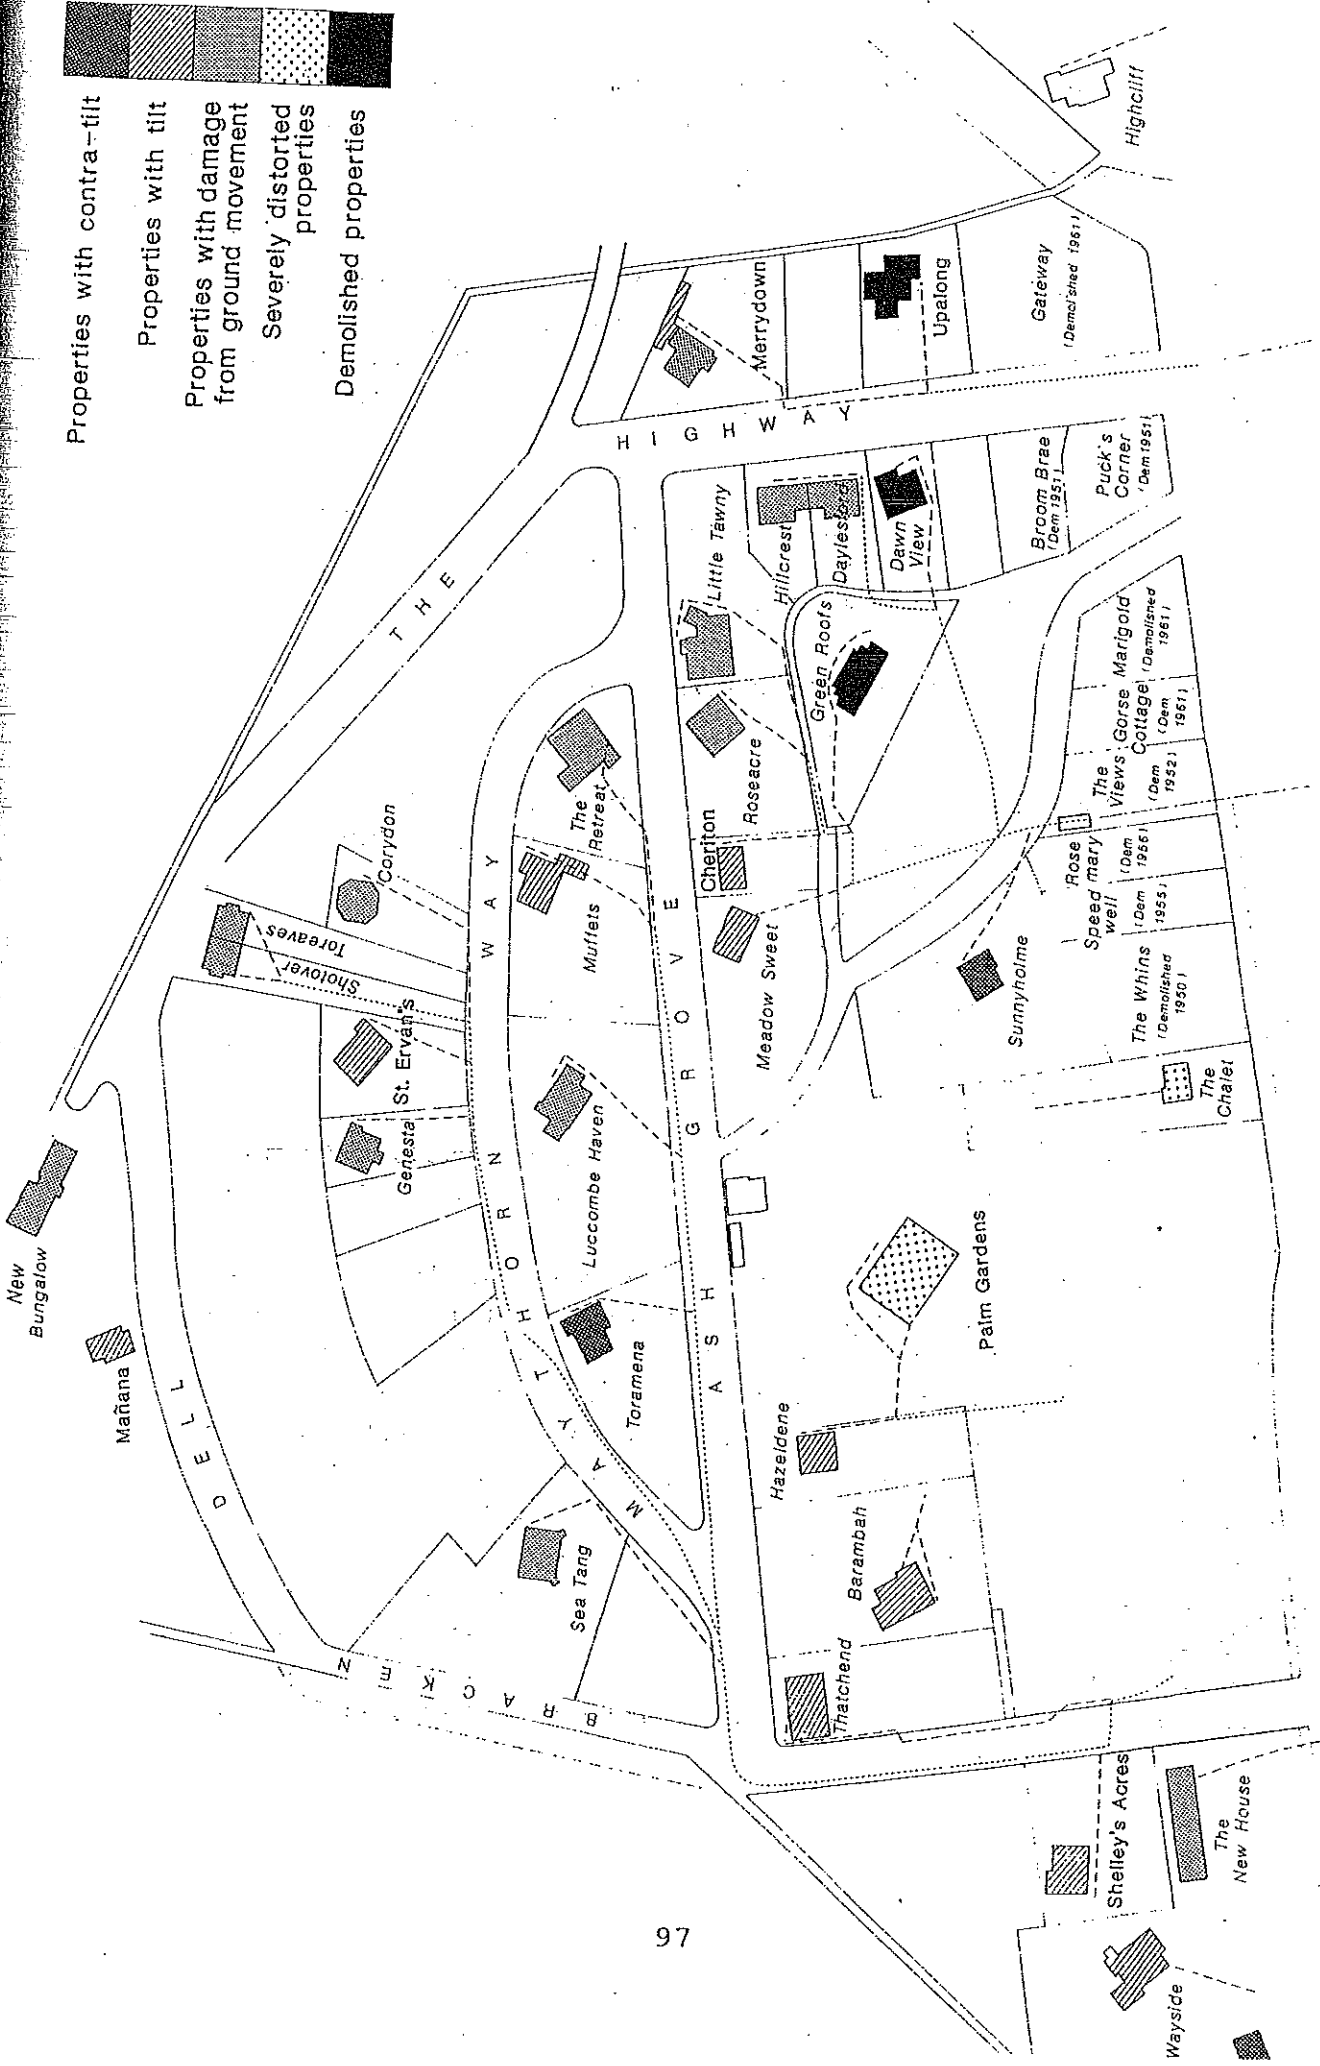
Figure 6.3 Building damage within Luccombe Village.

Properties with contra-tilt  
 Properties with tilt  
 Properties with damage from ground movement  
 Severely distorted properties  
 Demolished properties

Shotover, Toreaves, Corydon, Luccombe Haven, The Retreat, Roseacre, Little Tawny, Hillcrest, Daylesford and Merrydown;

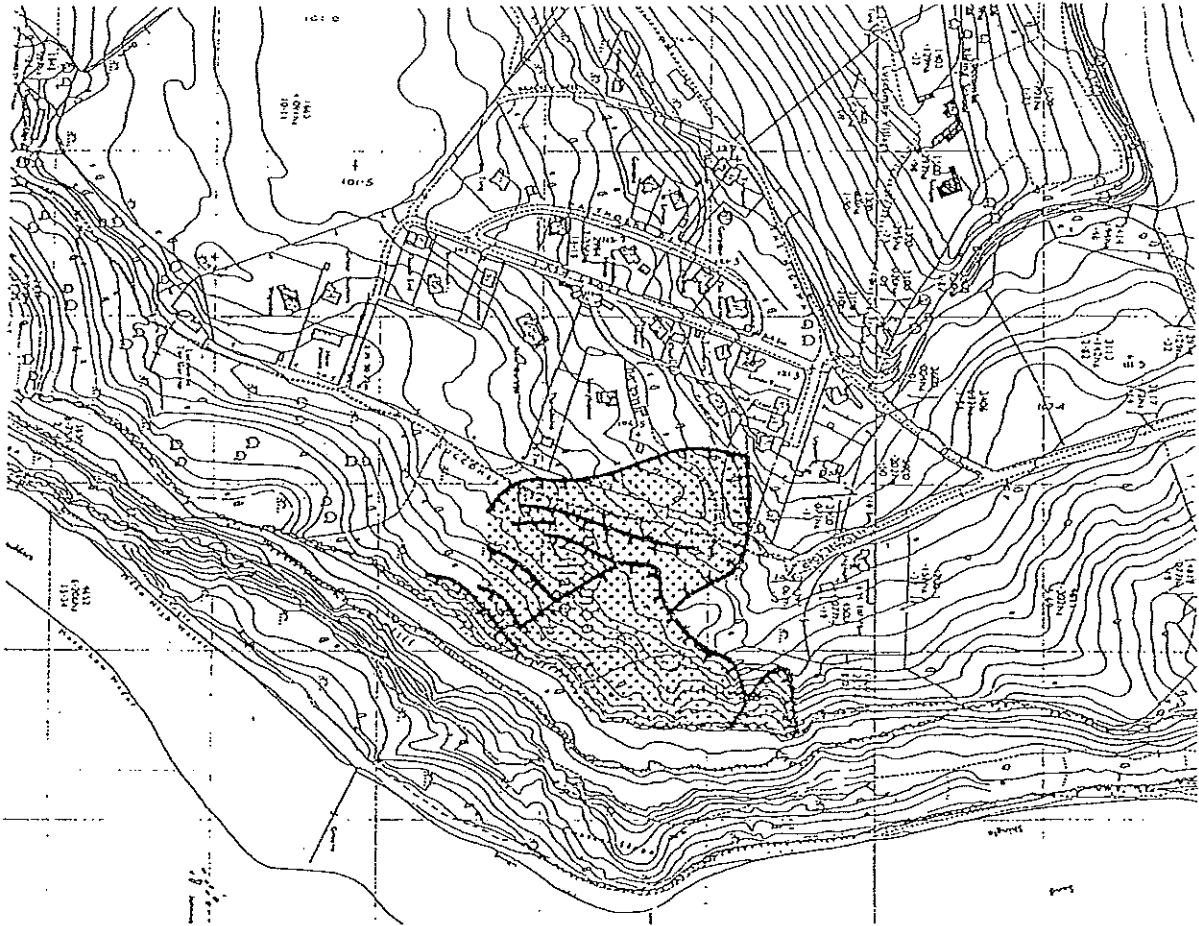
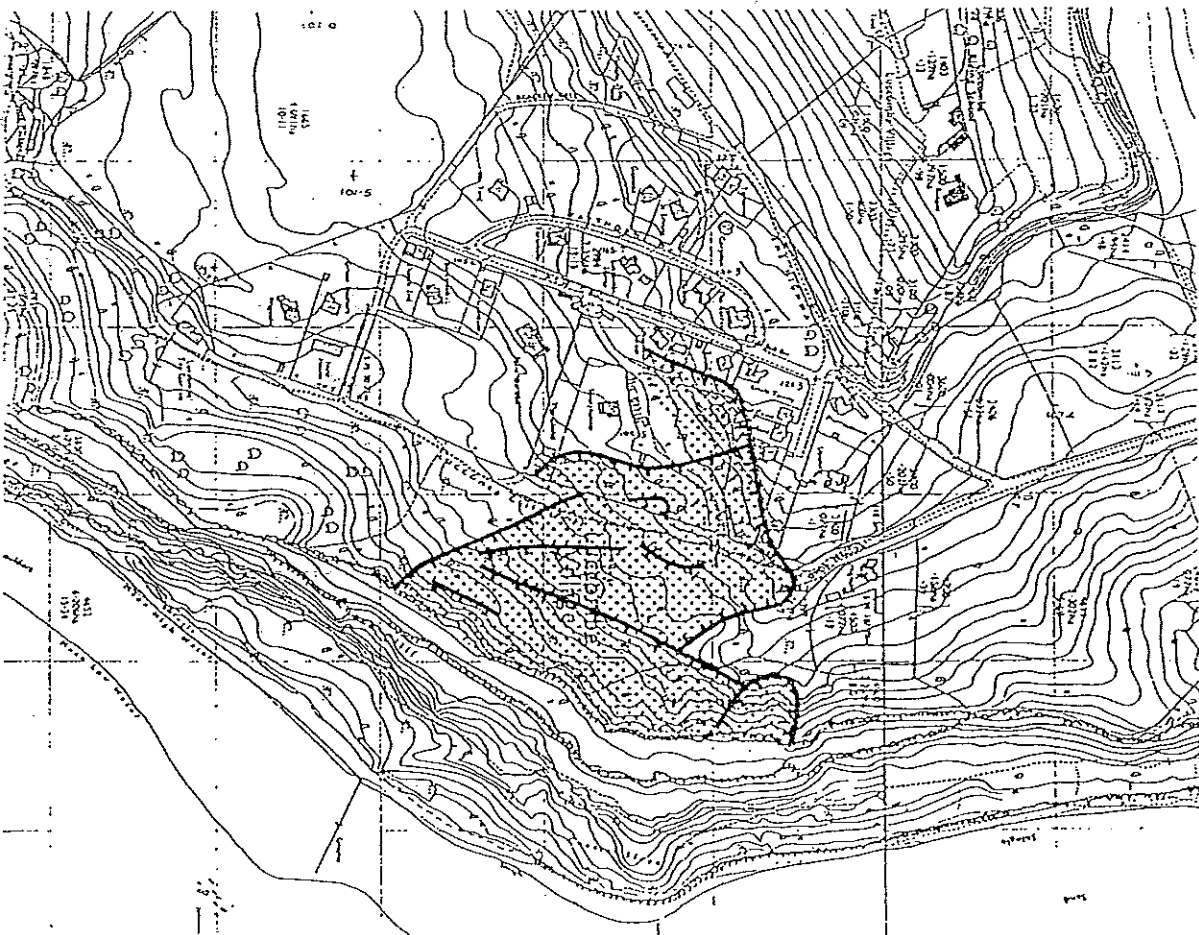
Figure 6.4 Comparison of the extent of landsliding in (a) June 1987 and (b) November 1988.

The overall pattern of movement appears to suggest periodic upslope retrogression of the head of the landslide area, and possibly seasonal movements within the centre portions (Wellam, pers. comm.). This is clearly demonstrated in Figure 6.4 which compares the main elements of the 1987-1988 slippage with the pre-existing features as determined from

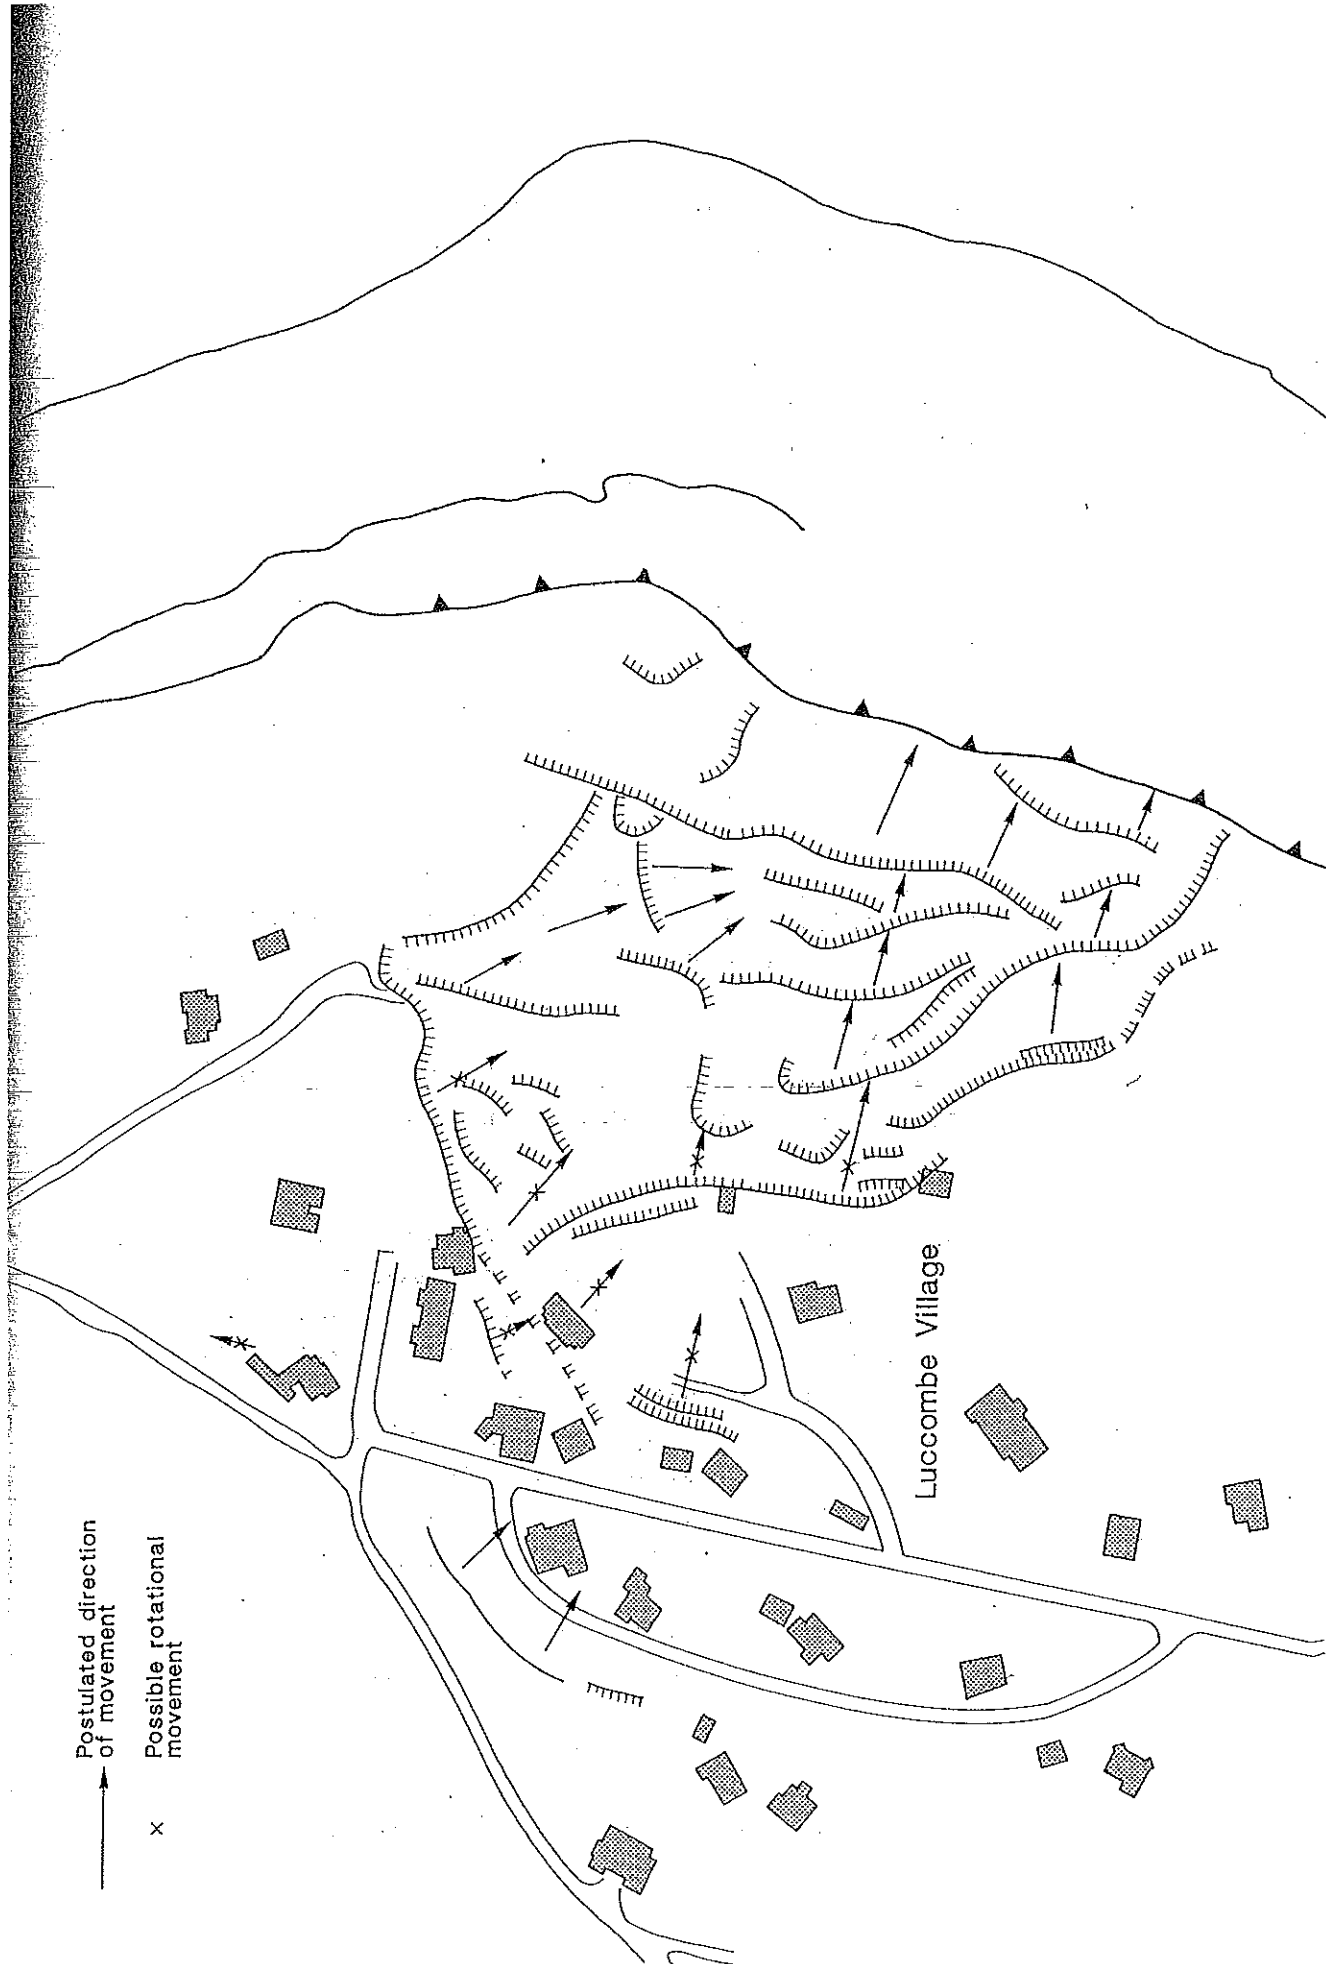
Figure 6.5 Direction of movements, 1988.

(d) immediately downslope of the area of uplift, the translational/spreading movements appear to have been toward the SSE, away from the turning

point. In places, movement appears to have been sub-parallel with the 2-3m high scarp downslope (Plate 30, Annex A);

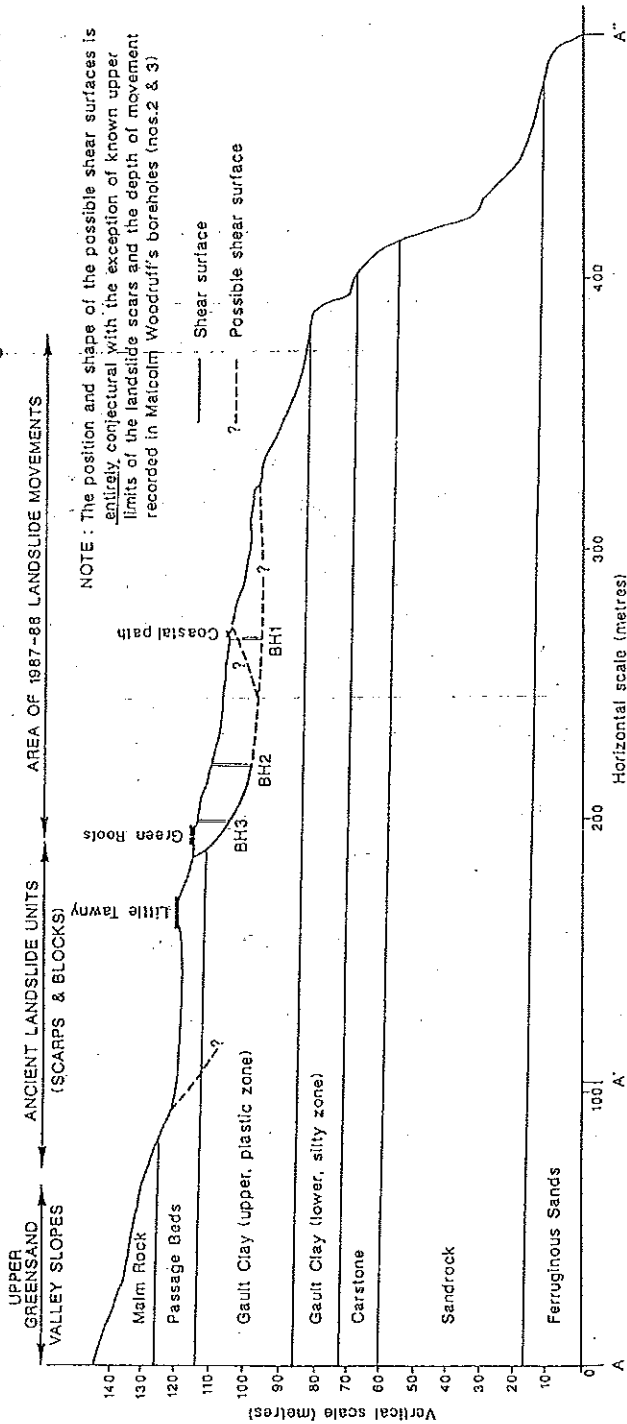
Figure 6.6 Schematic cross-section through the area of recent landsliding.

potential for the unloading is exacerbated by the estimated annual cliff retreat of 0.3m per year, which effectively perpetuates the activity below the coastal path. However, its significance in terms of reactivation of the rotational element of the slide is less clear, especially in the light of the apparently limited lateral movement experienced in this zone since 1961.

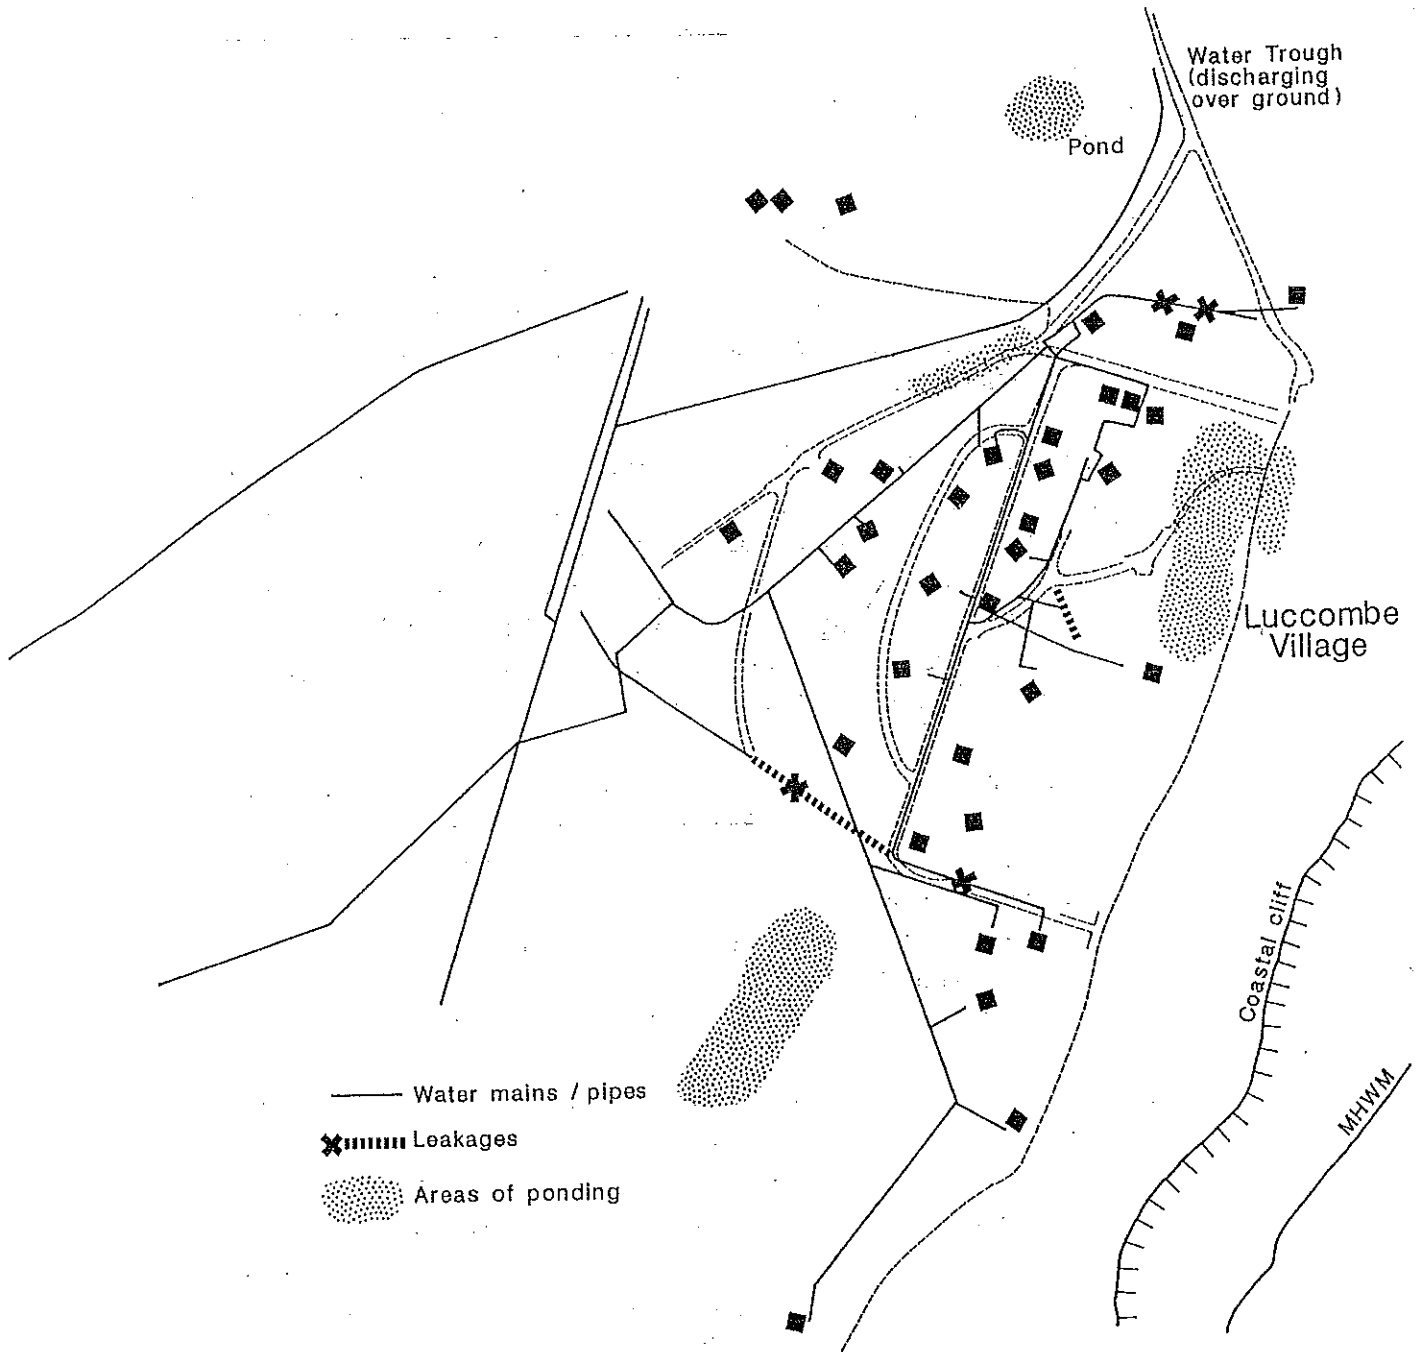
Figure 6.8 Recorded water mains leakages and areas of ponding.

- (d) as the village has no sewage system, the majority of the water supplied each day (c.15,000 litres) ultimately enters the landslide system, via leakage or septic tank discharge. The domestic wastes are variously discharged into septic tanks and directly into the ground. Irrespective of the efficiency of the methods (in terms of pollution control), all water discharged will find its way into the ground.

It is clear, therefore, that there has been considerable human interference with the natural drainage of the site, both through the concentration of runoff into a few locations and the artificial groundwater recharge of around 15,000 litres a day, through leakage and septic tanks. As a result, it is likely that since the development of the village the artificially raised groundwater levels will have resulted in a gradual reduction in slope stability. In combination with more long-term geomorphological factors (see (i) above), human activity has clearly produced a situation whereby the ancient landslide system within Luccombe Village has become increasingly susceptible to reactivation.
