# East Cowes - Section 19 Flood Investigation

## Final Report

August 2024

Isle of Wight  
Council

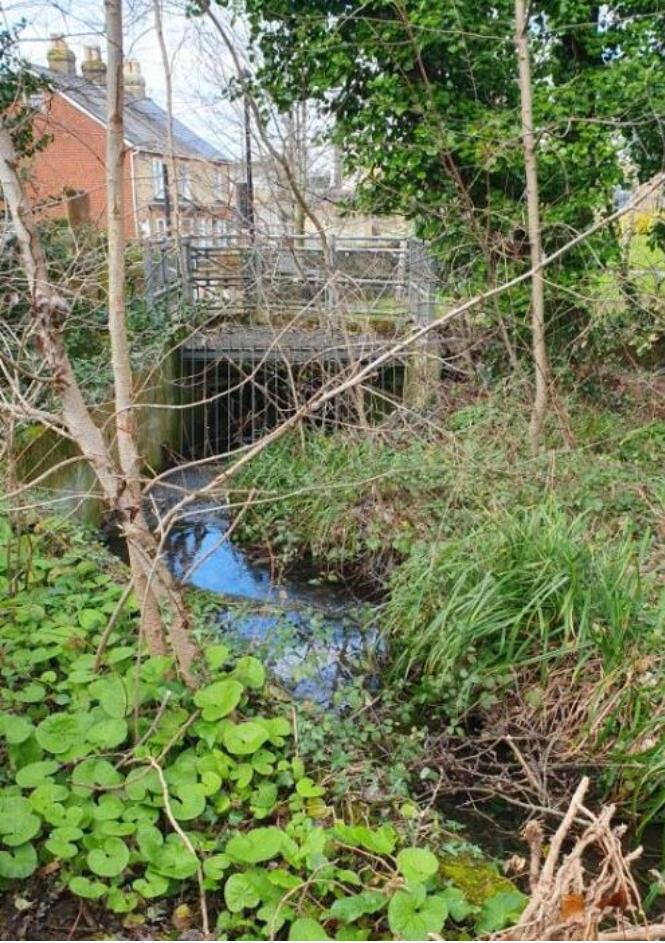
Figure 2-2 Simple culvert with debris screen along main river at Church Path (looking west) during normal conditions.

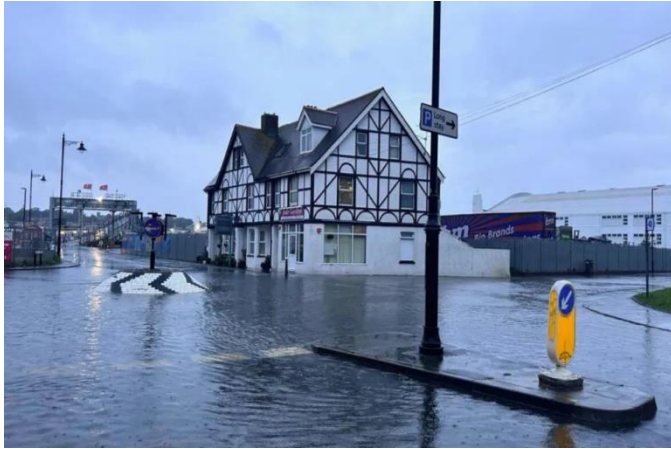
1. Dover Road and Well Road roundabout, looking north-westward from Well Road towards the Red Funnel Ferry Terminal

Figure 7- 3: Photographs of flooding in East Cowes on 25 October

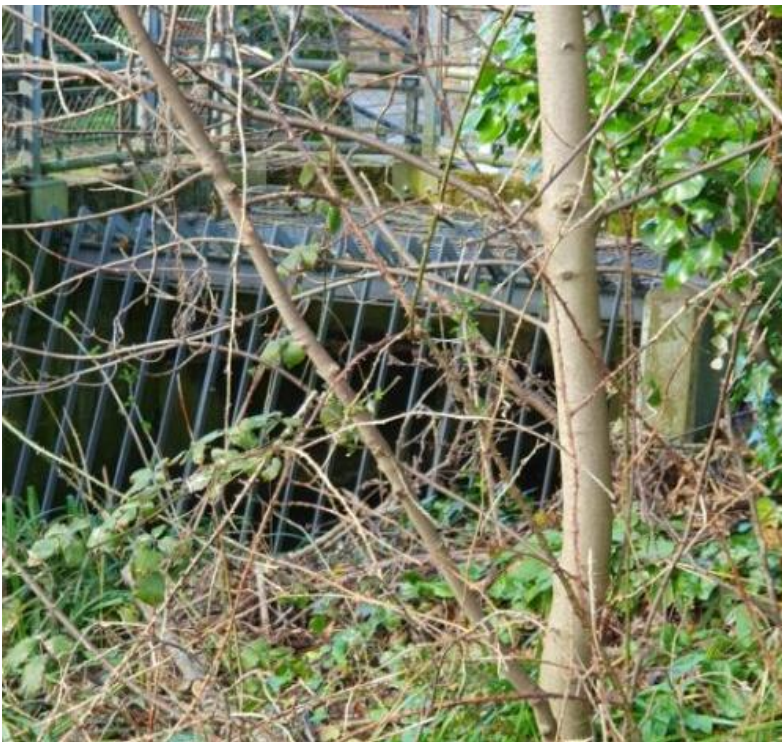
Figure 9-1 Simple culvert, looking northwest from further down on the right bank

Asset type	Elements	Material	Condition	Comments
Culvert	Upstream headwall	Concrete	Fair (3)	Some wear to concrete and spalling but no major damages observed.
	Downstream Headwall	N/A	ENI	Was unable to locate exact location of element.
	Culvert barrel	Concrete	ENI	Unable to see element.
	Channel bed	Earth	Fair (3)	Some soil accumulation at the channel bed.
	Apron	Earth	Fair (3)	Soil accumulation and overhanging vegetation.

Further comments: The simple culvert overall seems to be in Fair (3) condition. The concrete material has some wear to it, but no major damages were seen from point of view during the assessment. To note that the culvert upstream headwall was assessed only, and a full visual (CCTV) inspection would need to be carried out by a drone or other available equipment to see for any damages inside the culvert barrel.

The culvert headwall seems stable with some wear to the concrete. It is not known whether there is a damage within the culvert barrel therefore further inspection via a drone or other equipment for CCTV inspection would be required.

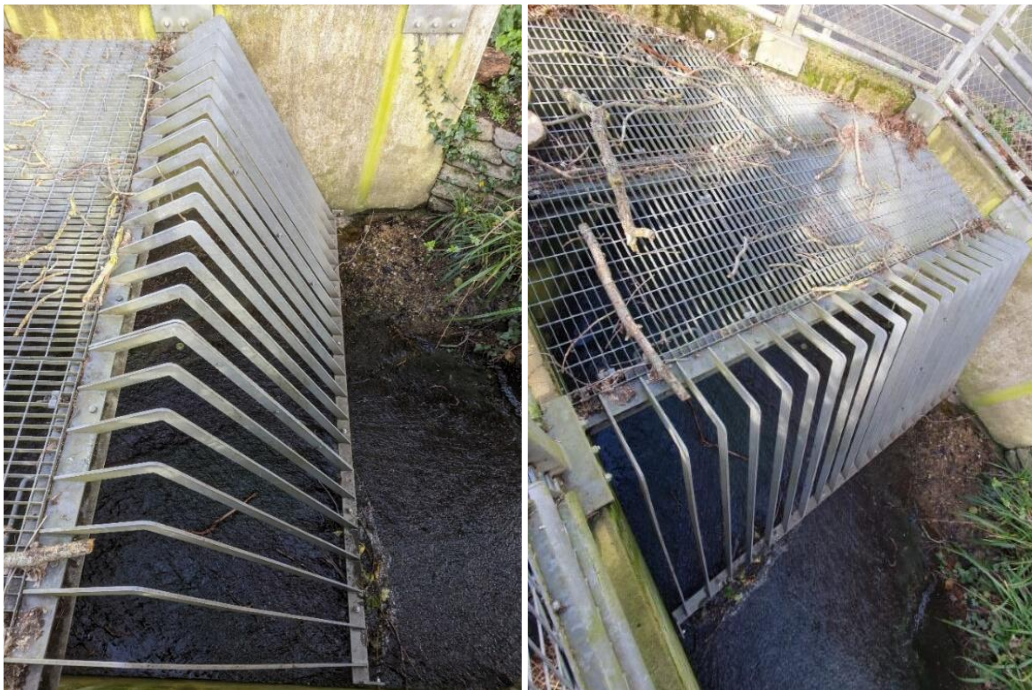
Figure 9-2 Debris screen, looking at asset from the left bank

Asset type	Elements	Material	Condition	Comments
Debris Screen	Screen	Metal	Good (2)	Minor cosmetic defect such as corrosion. No distortion or damage to bars.
	Frame	Metal	Good (2)	Minor cosmetic defect such as corrosion. Screws are in place.
	Upstream Headwall	Concrete	Fair (3)	Some wear to concrete and spalling but no major damages observed.
	Left bank wall	Concrete	Fair (3)	Some wear to concrete, moss cover.
	Right bank wall	Concrete	Fair (3)	Some wear to concrete, moss cover.

Further comments: The debris screen on the culvert seems to be in Good (2) condition. There was minor corrosion to the screen and frame but no distortion to the bars, or no missing screws. The concrete walls of the debris screen are in fair condition, only some spalling to the concrete was observed. The upstream headwall of the debris screen has some wear to it otherwise it is in fair condition. There was some debris (tree branches and leaves) at the screen and on the gantry.

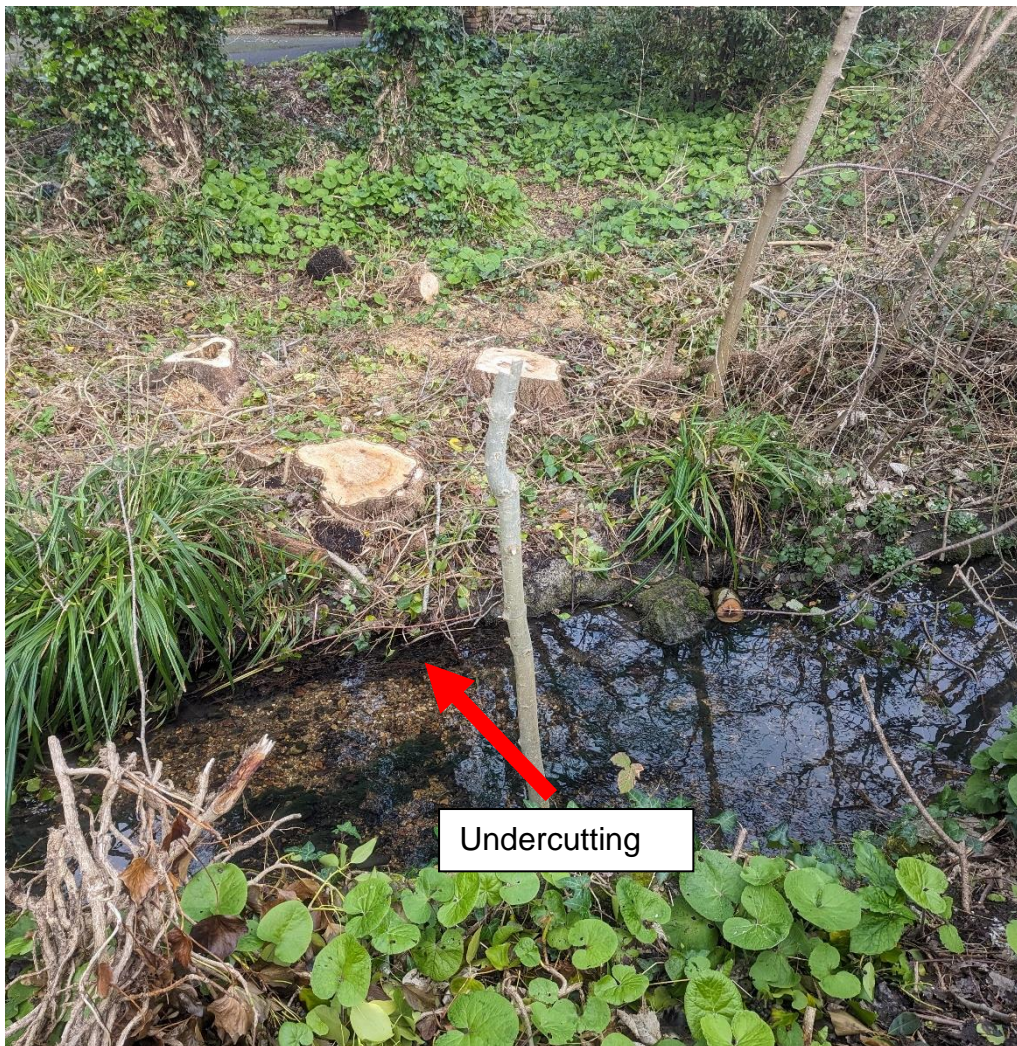
Figure 9-3 Natural high ground, looking north from the left bank

Asset type	Elements	Material	Condition	Comments
Natural High ground	Channel side	Earth	Fair (3)	Undercutting and erosion to channel side.
	High ground	Earth	Fair (3)	Vegetation growth and uneven high ground.

Further comments: The water flows through channel clearly. Where the screen wall ties into the high ground there are concrete sandbags are present for unknown length of the asset. The channel seems to be narrow and overgrown. Water level during the inspection was low.

The channel seems to be narrow and if a large amount of water is released into the channel it might not have the capacity to store water, which could back up from the culvert. Therefore, it is recommended that the channel is cleared and widened to be able to accommodate a larger capacity of water in there.

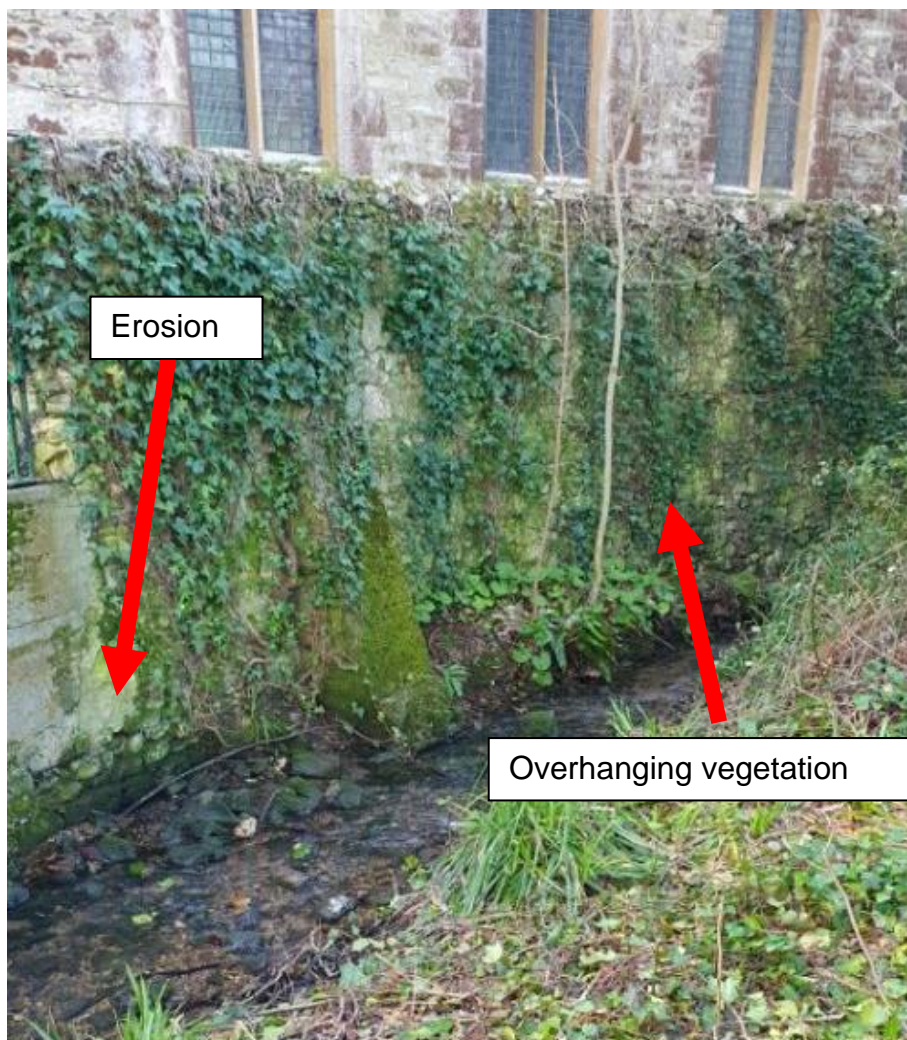
Figure 9-5 Wall, looking southwest from the right bank

Asset type	Elements	Material	Condition	Comments
Wall	Exposed face	Concrete	Fair (3)	Erosion and undermining at the toe of the wall. Cracks visible on exposed face.
	Crest	Concrete	Fair (3)	Overhanging vegetation on crest.
	Landward face	Concrete	Fair (3)	Spalling to concrete.
	Berm	Earth	Good (2)	Well vegetated.

Further comments: The condition of the wall overall is Fair (3). There are cracks and erosion to the exposed face with overhanging vegetation on the crest.
