# Totland to Colwell Bay Landslide Assessment

December 2013

Isle of Wight Council

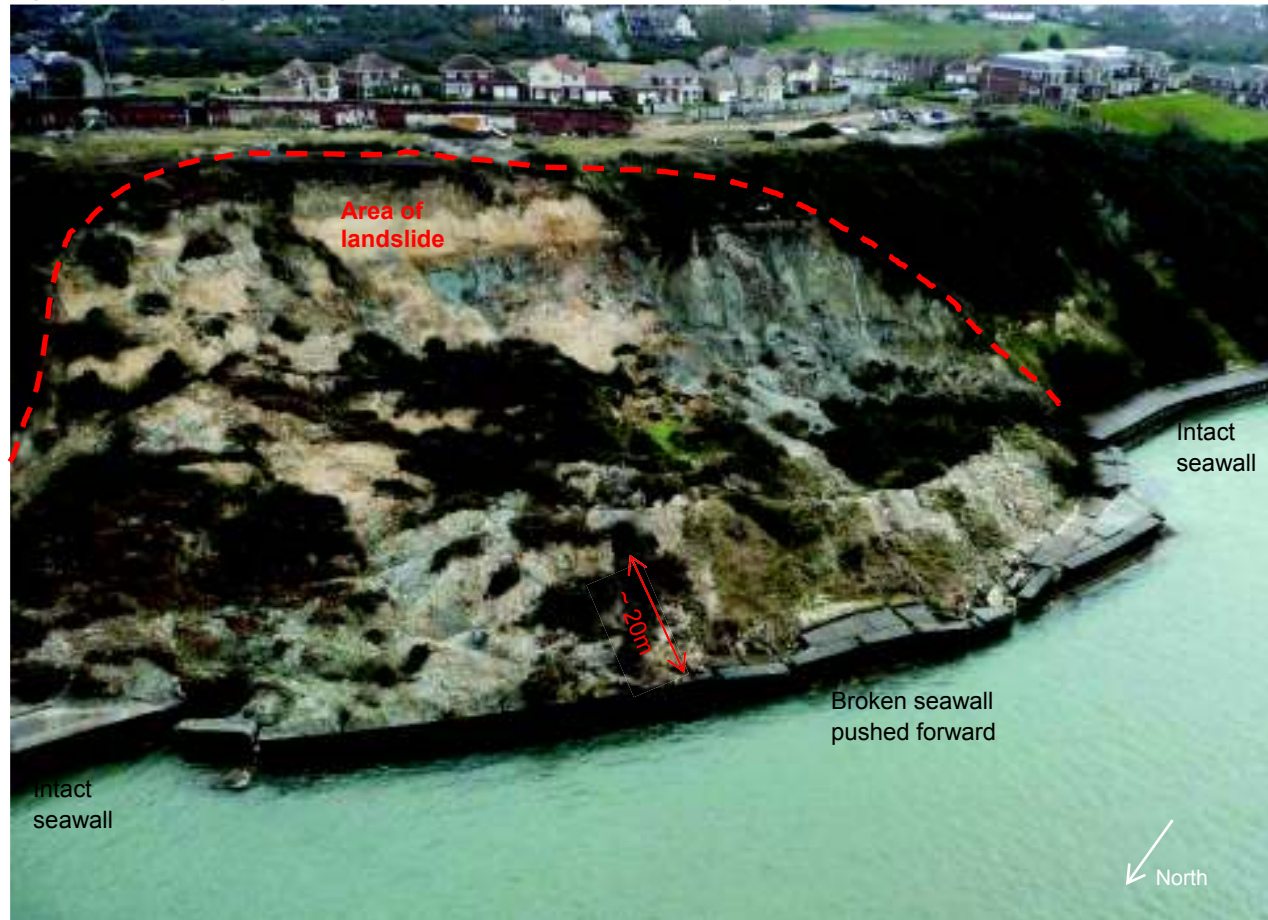
The seawall between Totland and Colwell was pushed up to 20m seaward due to a landslide that occurred on the cliffs behind the wall on the 26<sup>th</sup> December 2012. The movement caused numerous gaps in the seawall (Figure 2.3), allowing material to be subsequently eroded behind and beneath the wall, leading to further collapse and exacerbating the problem. The Public Right of Way footpath T34 between Totland and Colwell has been closed, which is an inconvenience to the local community and businesses that rely on the footpath for customers and tourists who use it regularly, especially in the summer months.

Figure 2.3: Photograph of the landslide and the distance moved by the seawall.

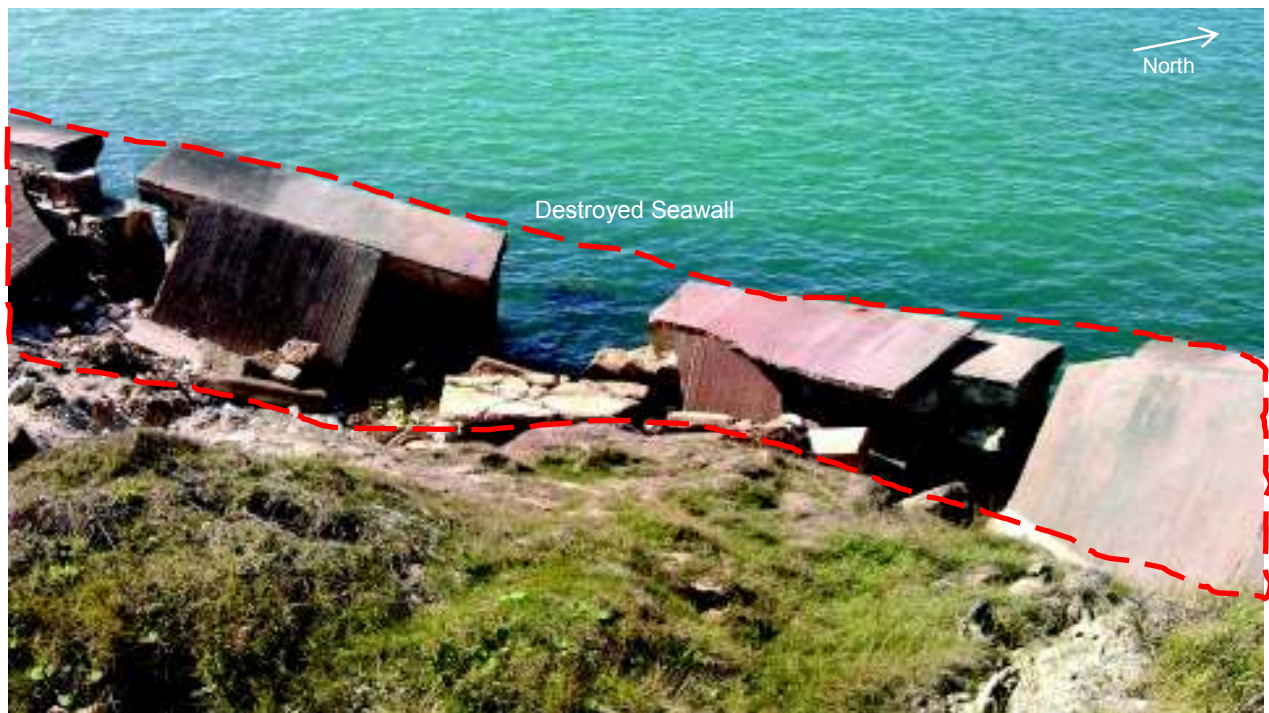
From the condition assessment work, it is assumed that the general condition of the seawall that failed was also in a good condition prior to the landslide event, and it would have been unlikely to demonstrate any visual signs of failure until movement started to occur. The wall in the failed section now offers limited protection to the cliff toe and significant gaps between the seawall units are present (Figure 3.3). In these gaps erosion of the material behind the seawall will occur, particularly during storms. However, the seawall encasement (in 5m sections) did not fail or crack during the movement, but it is unsure if the upper encasement was fixed to the toe as some units show signs of separation (at the wall and stepped apron interface).

Figure 3.3: A section of the seawall fronting the landslide in September 2013 when the defence condition survey was carried out.

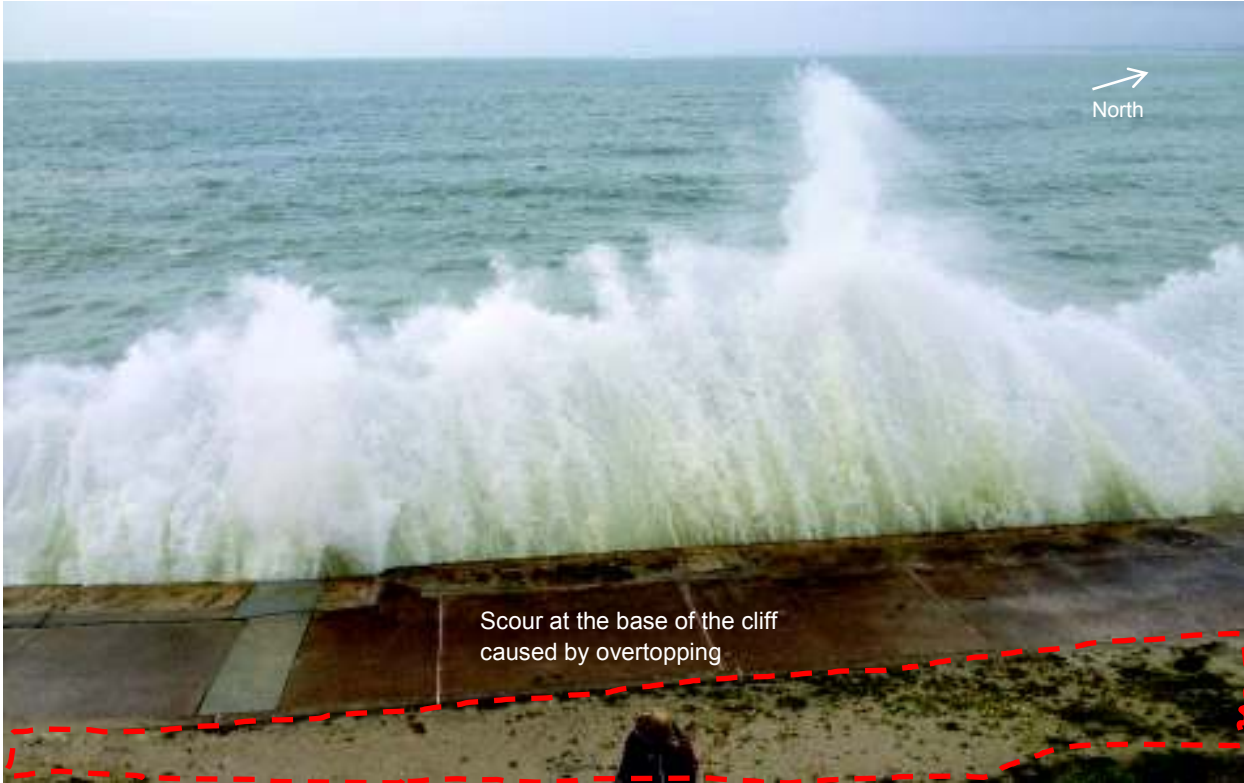
Along the rest of the frontage, although the wall is intact, overtopping of the seawall is common. This has led to the scour of the slope behind the wall (Figure 3.4). This could lead to instabilities because material is removed from the toe, which alters the equilibrium of the slope, and leads to the steepening of the cliff. Therefore, the slopes are at a greater risk of failure.

Figure 3.4: Overtopping of the seawall and scour caused at the base of the cliff.

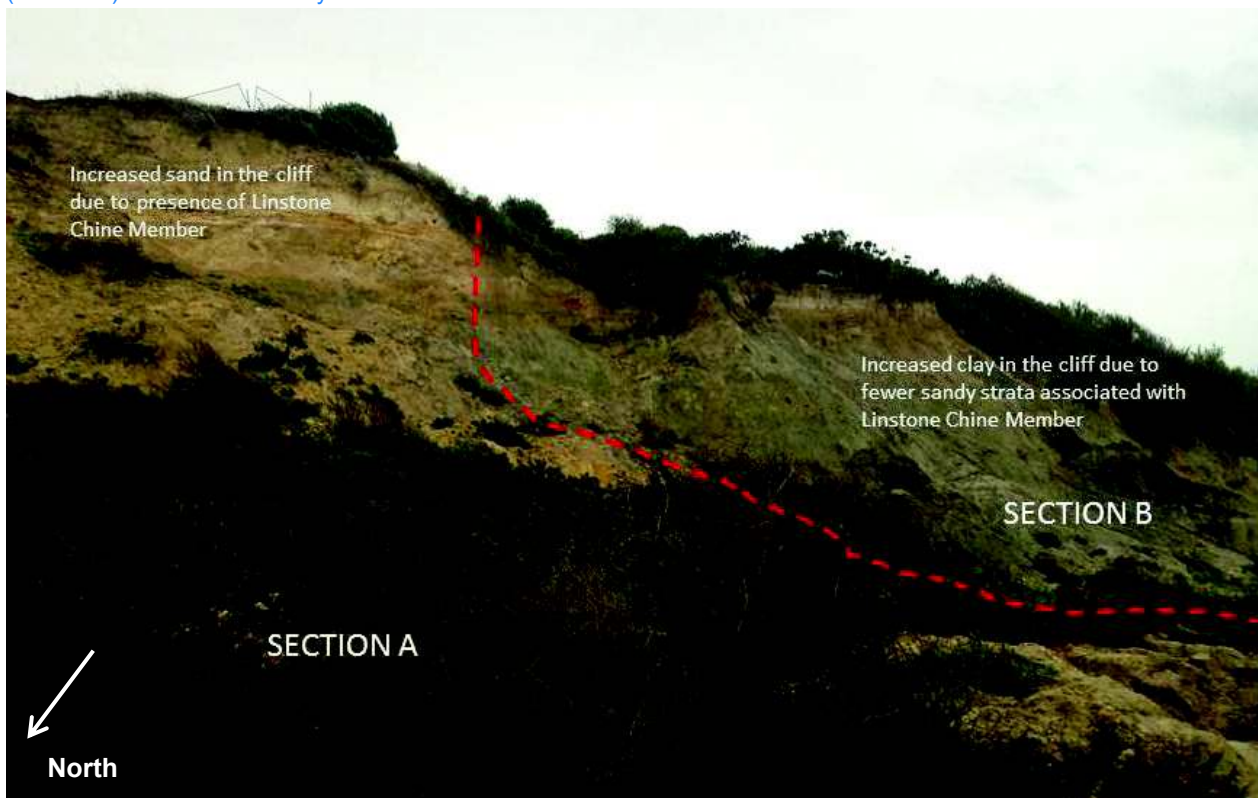
Figure 4.2: The distinction between Section A, containing greater amounts of sand within the strata and section B (red circle) with increased clay.

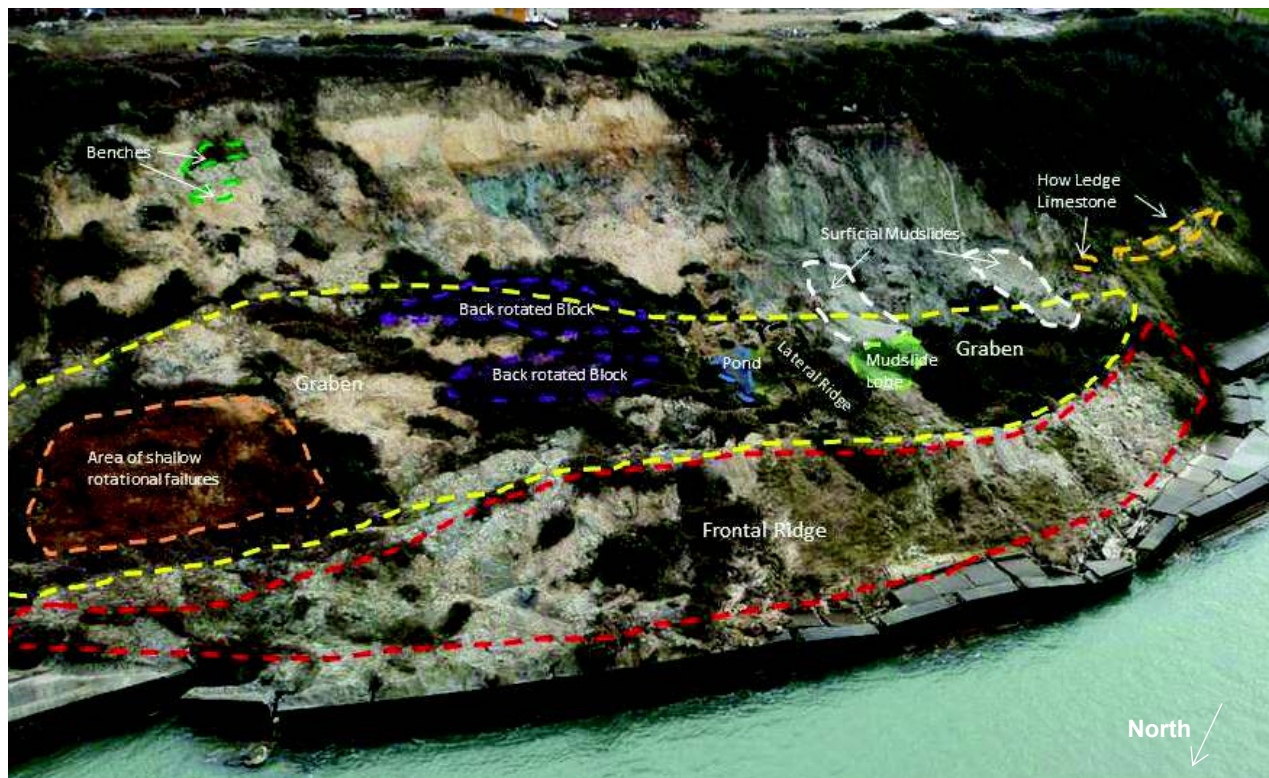
Figure 4.3: Some of the main features observed on the landslide. Image from the cliff top looking down over the landslide

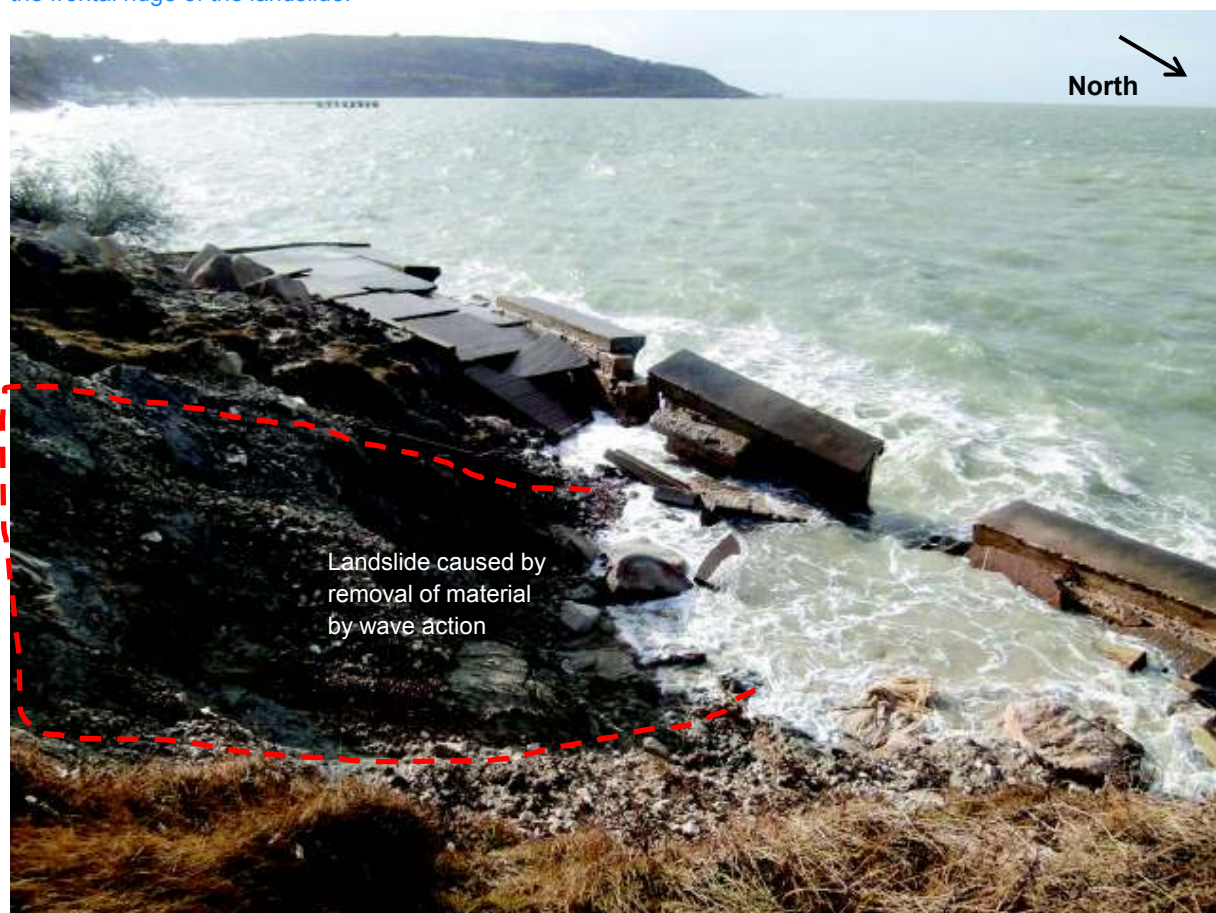
Figure 4.4: Landslides of the frontal ridge due to removal of toe support by the waves. Photo taken looking SW from the frontal ridge of the landslide.

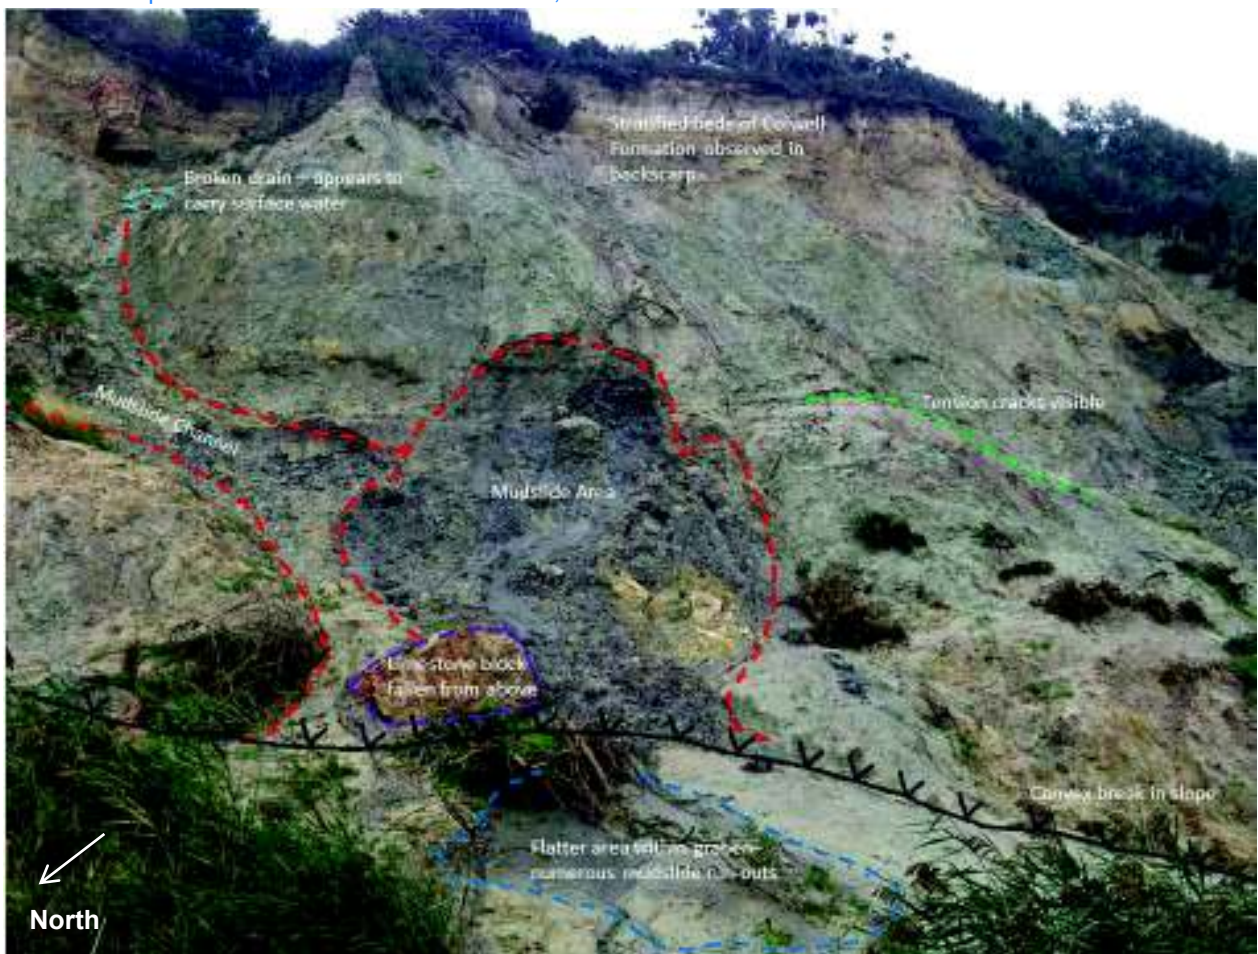
Figure 4.5: Recent Mudslides observed on the 22nd of October following a period of heavy rain. Image looking up at the Back scarp on the southern side of the landslide, within Section B.

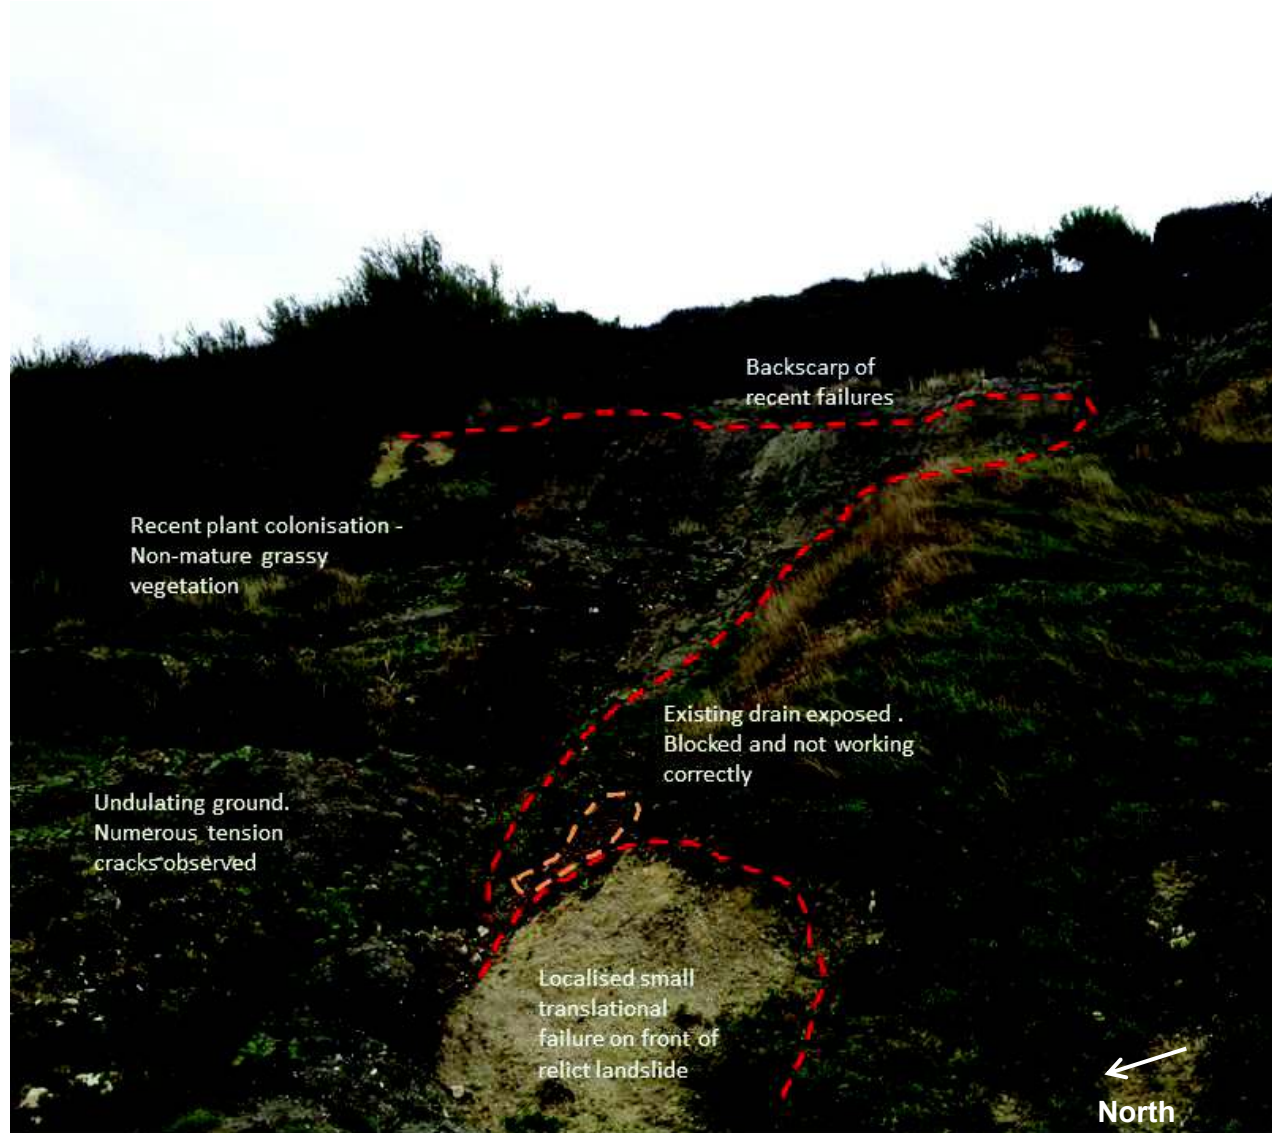
Figure 4.6: The recent surficial instabilities within the section of frontage to the south of the landslide.

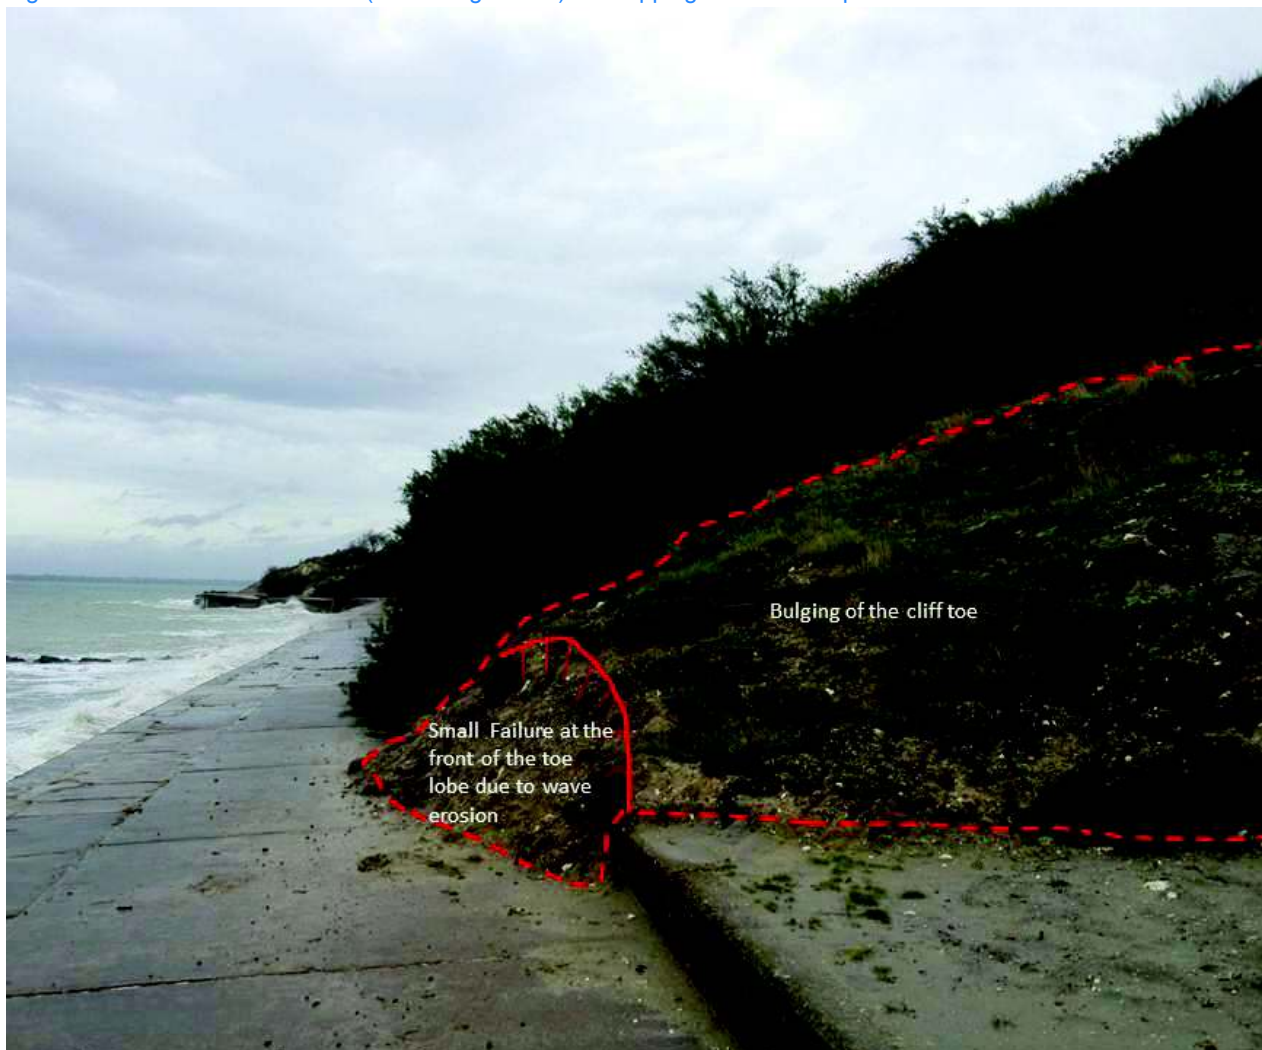
Figure 4.7: Toe of the landslide (seen in figure 4.6) overtopping the concrete promenade

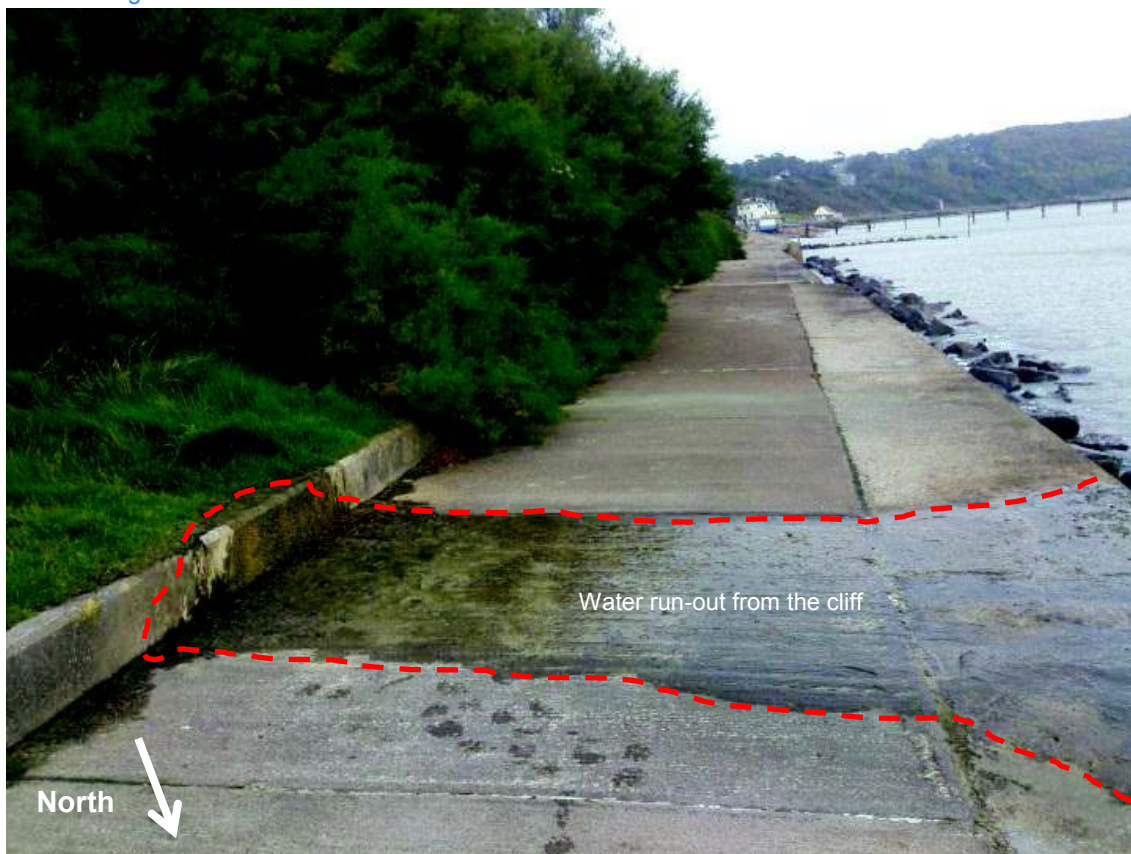
Figure 5.2: The run out of water in the section south of the landslide observed on 22<sup>nd</sup> October 2013. This photo is taken looking south towards Totland Pier.

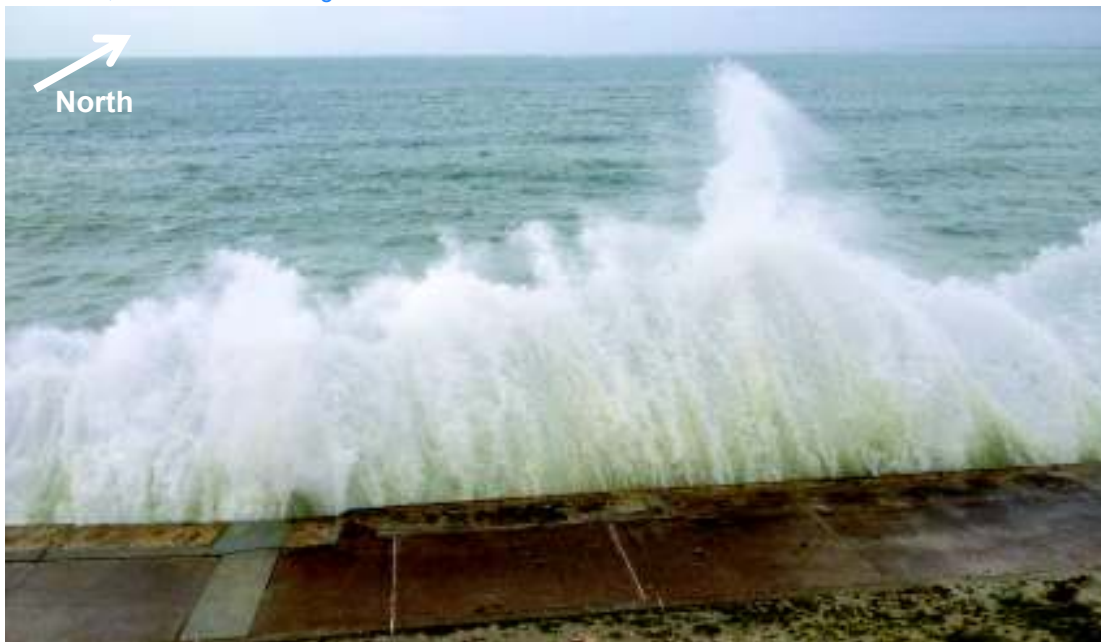
Figure 5.3: Waves overtopping the seawall on 22<sup>nd</sup> October 2013. Photo taken along the frontage south of the Landslide, from the cliff looking NW.

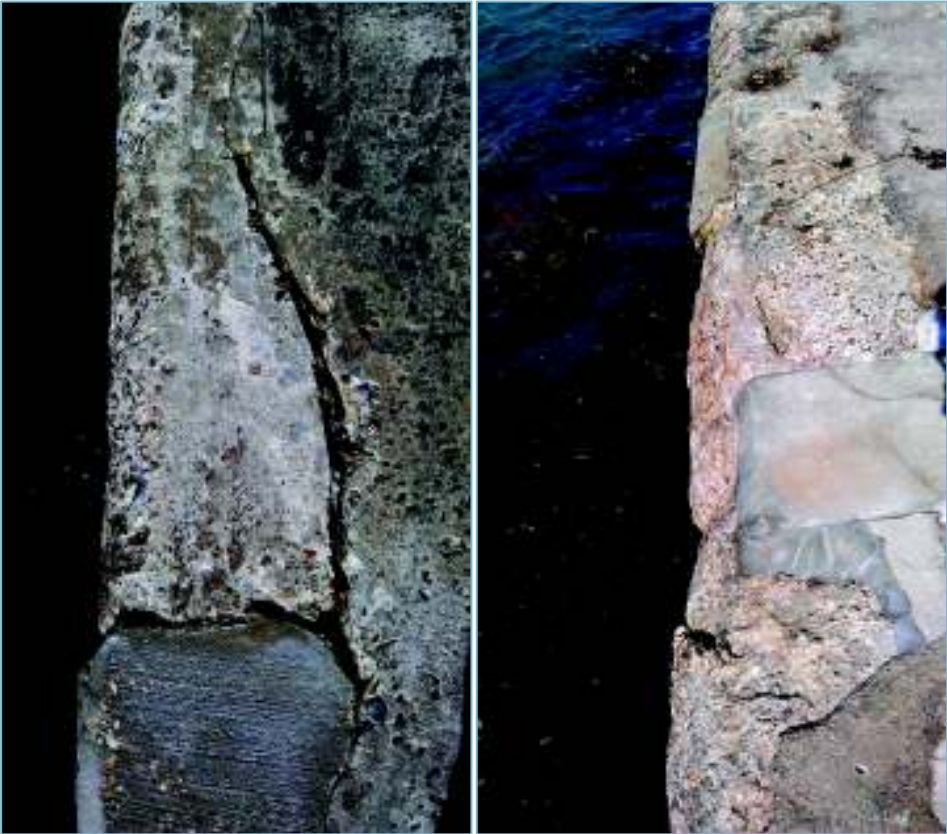
Figure 8.1: Defence Section 1 - Cracks along seawall crest.

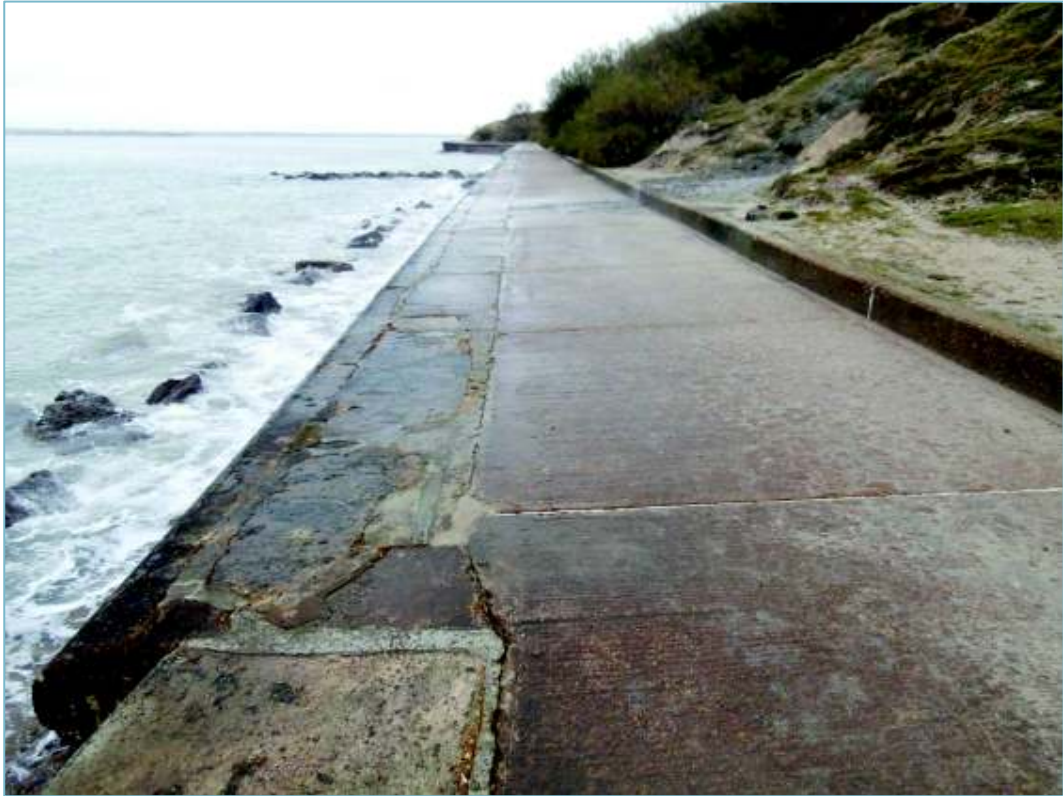
Figure 8.2: Defence Section 1 South – No current signs of seawall movement

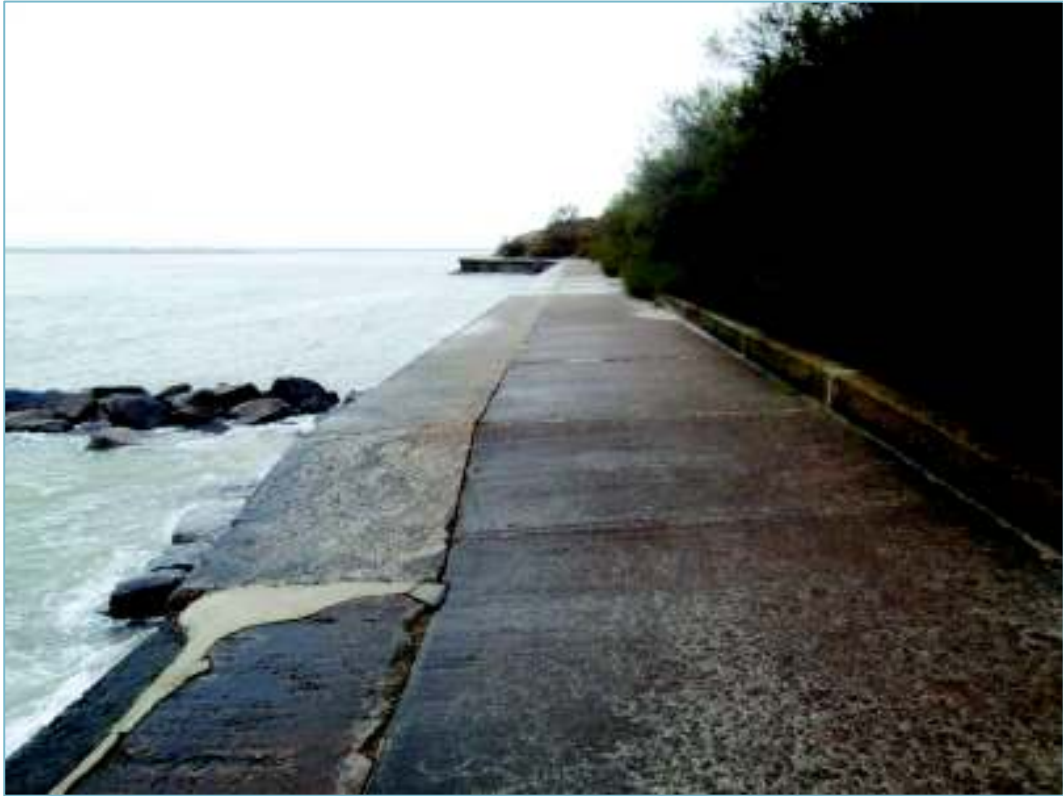
Figure 8.3: Defence Section 1 North – No current signs of seawall movement

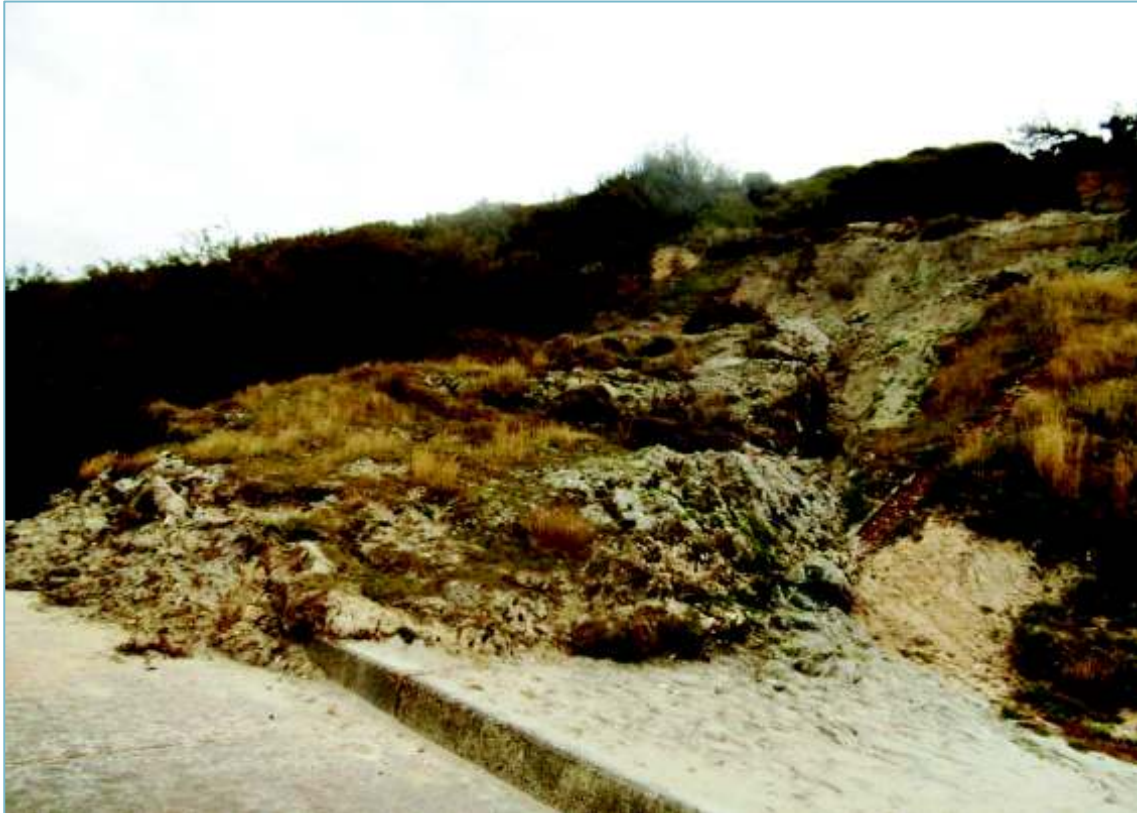
Figure 8.4: Defence Section 1 - Minor landslips at Totland Bay, spilling on to Promenade.

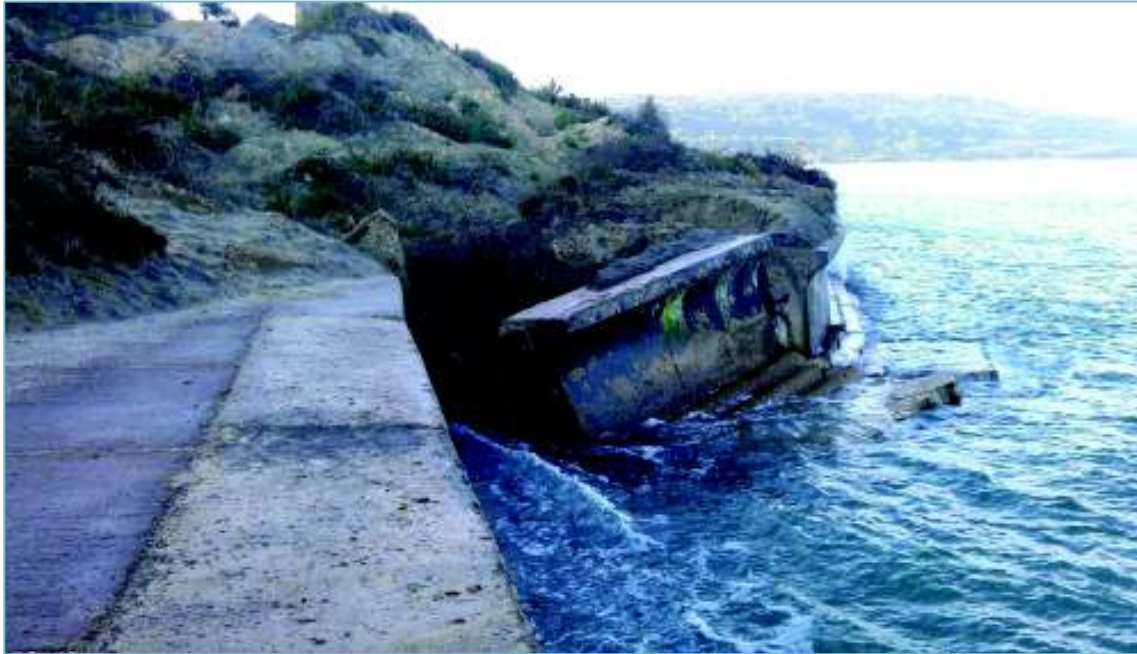
Figure 8.5: Defence Section 3 – Seawall adjacent landslide

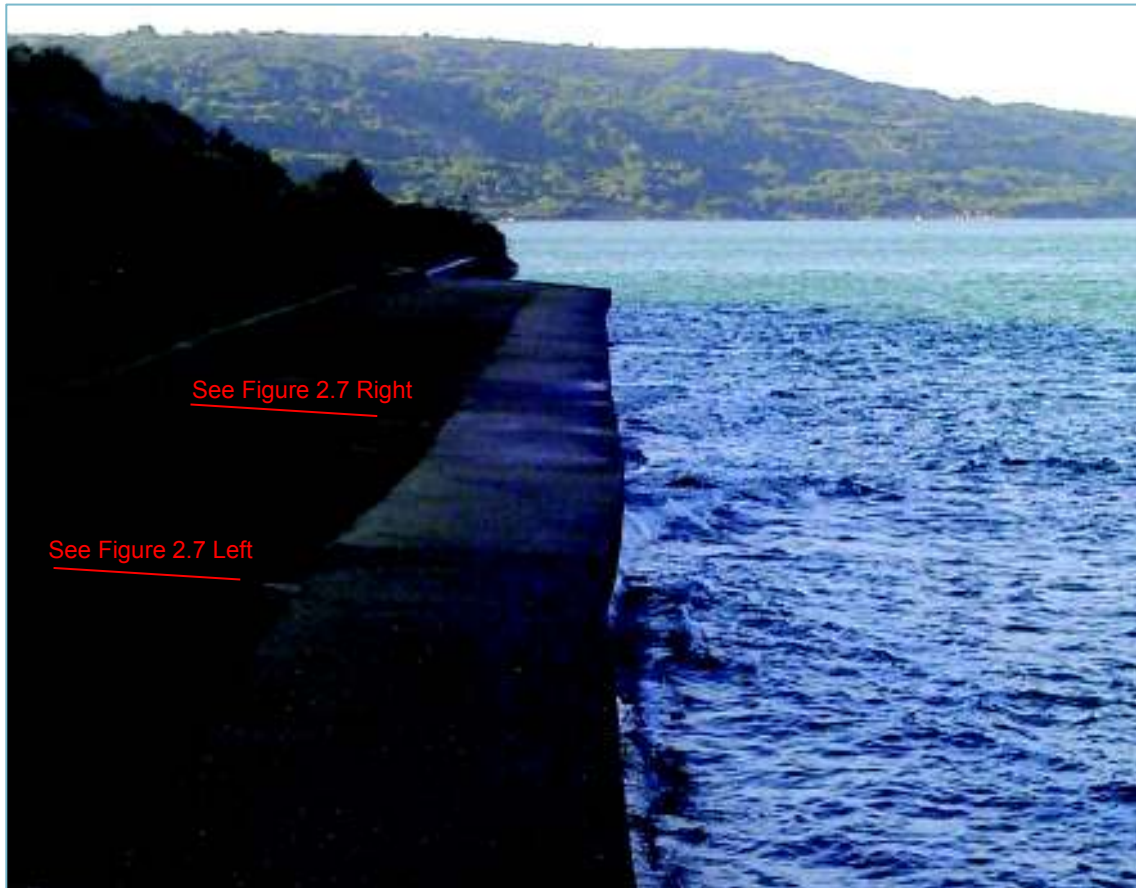
Figure 8.6: Defence Section 3 – Potential seawall movement

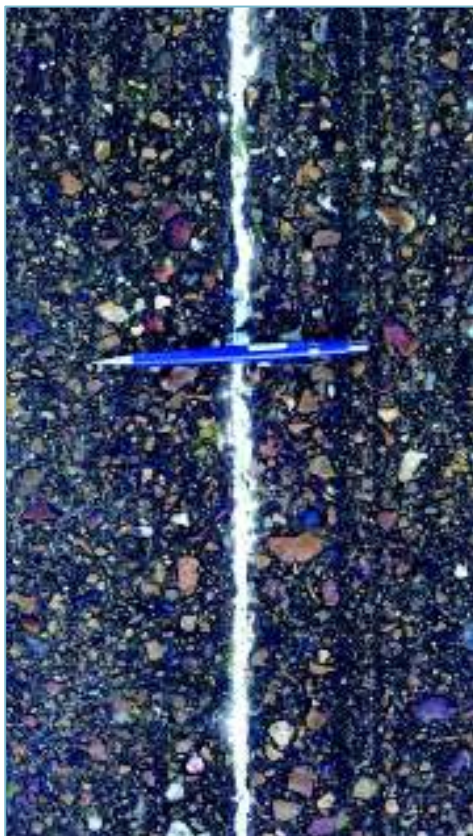
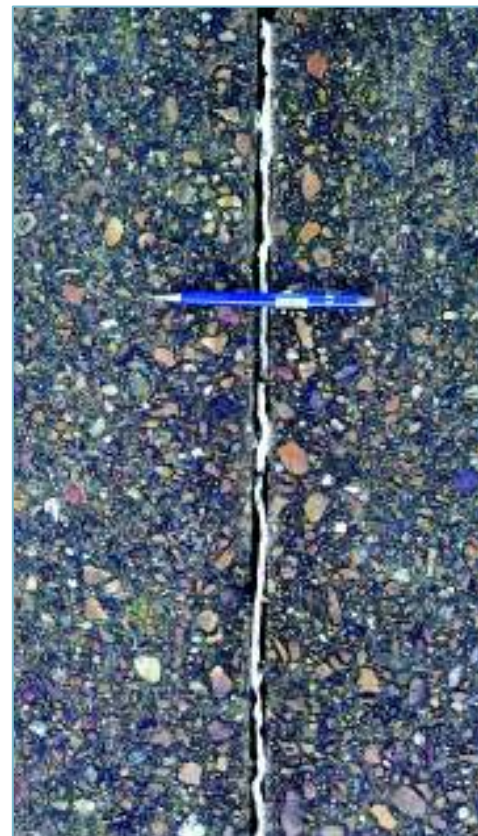
Figure 8.7: Defence Section 3 – Potential joint movement.

Left: Joint along section without movement,

Right: First joint in area of potential movement

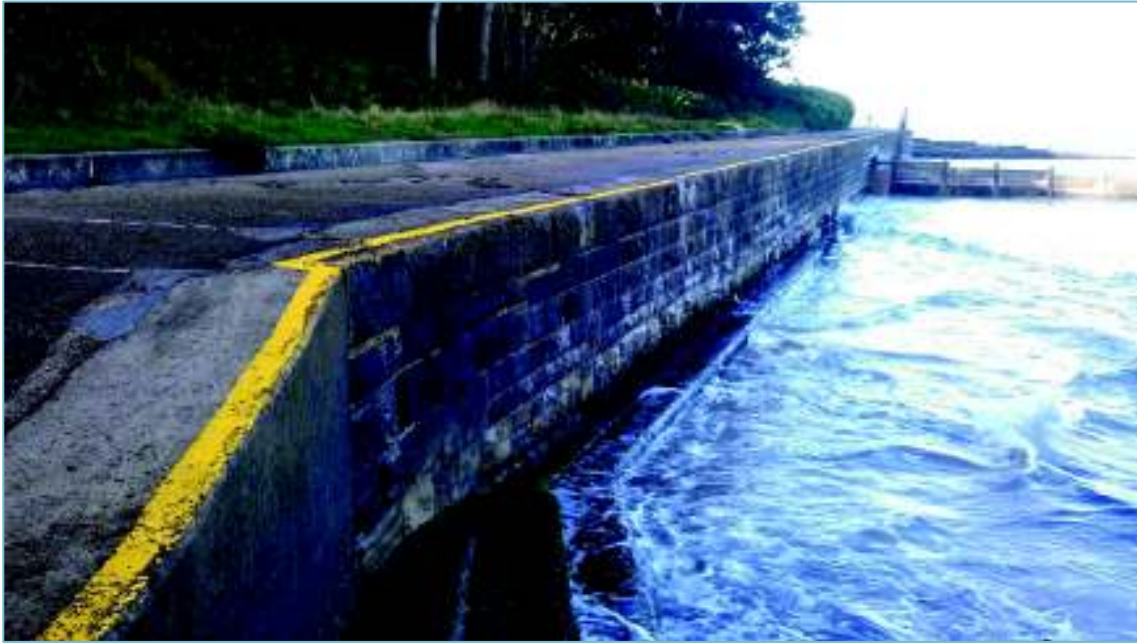
Figure 8.8: Defence Section 4 – Masonry Seawall north of Warden Point

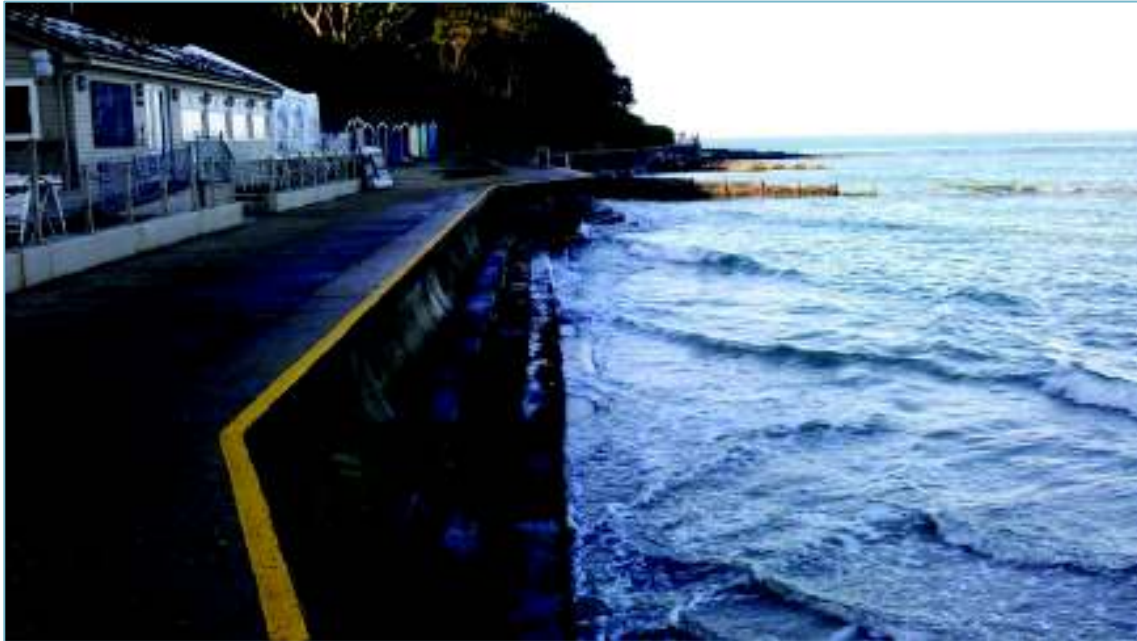
Figure 8.9: Defence Section 4 – Colwell Bay Seawall

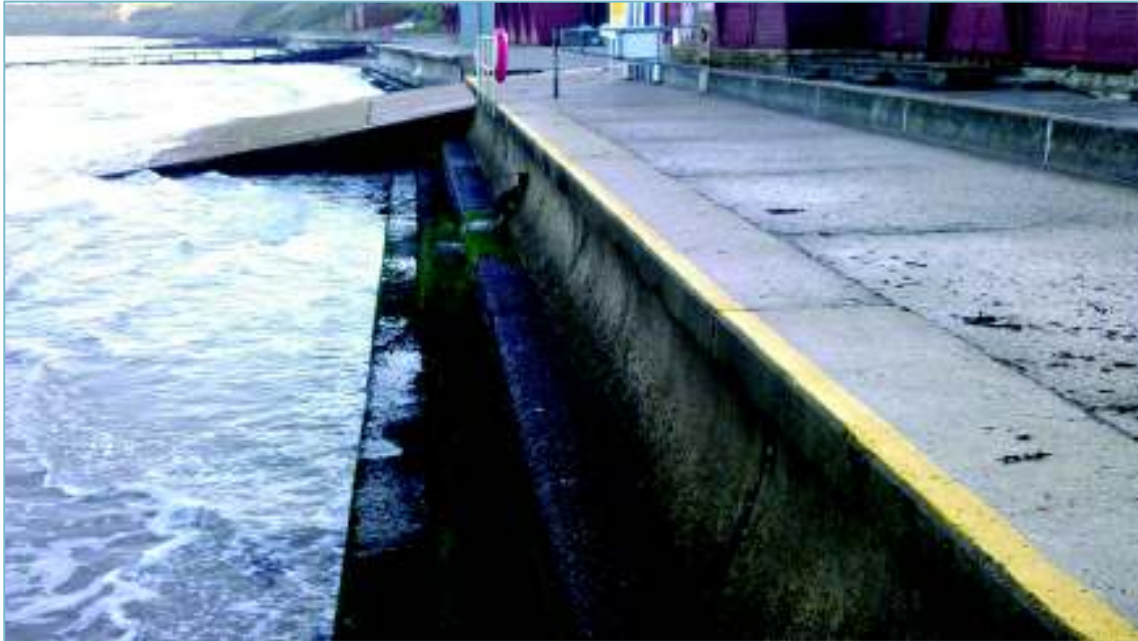
Figure 8.10: Defence Section 4 – Colwell Bay Seawall to Slipway

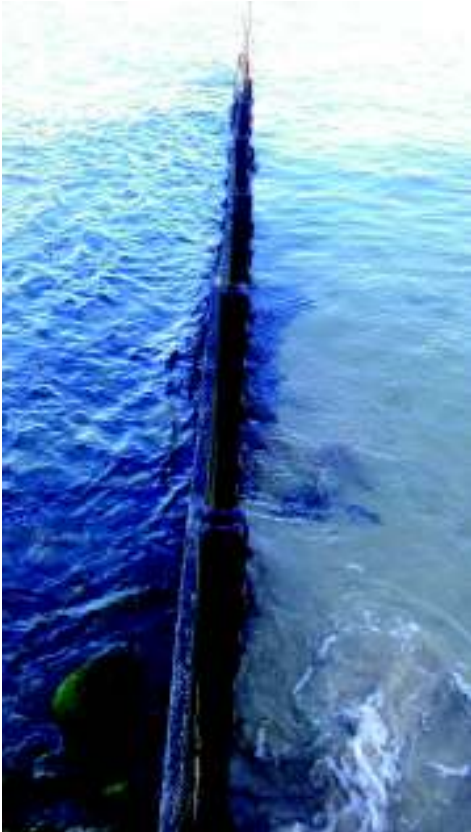
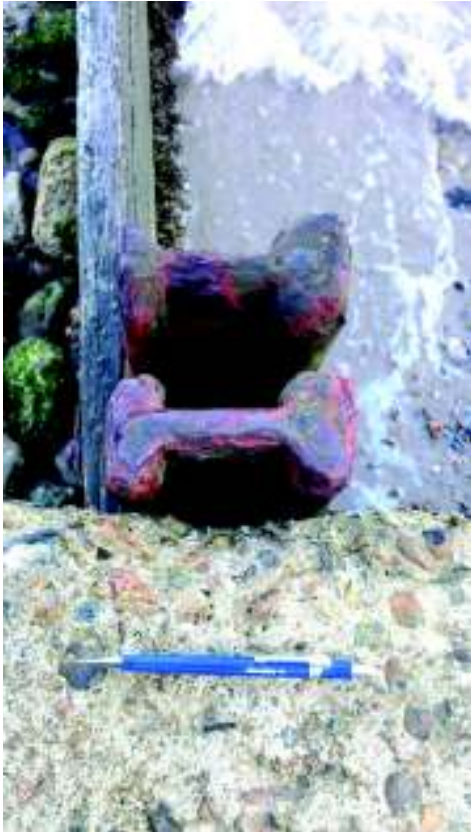
Figure 8.11: Defence Section 4 – Timber groynes straight and example “I” piles

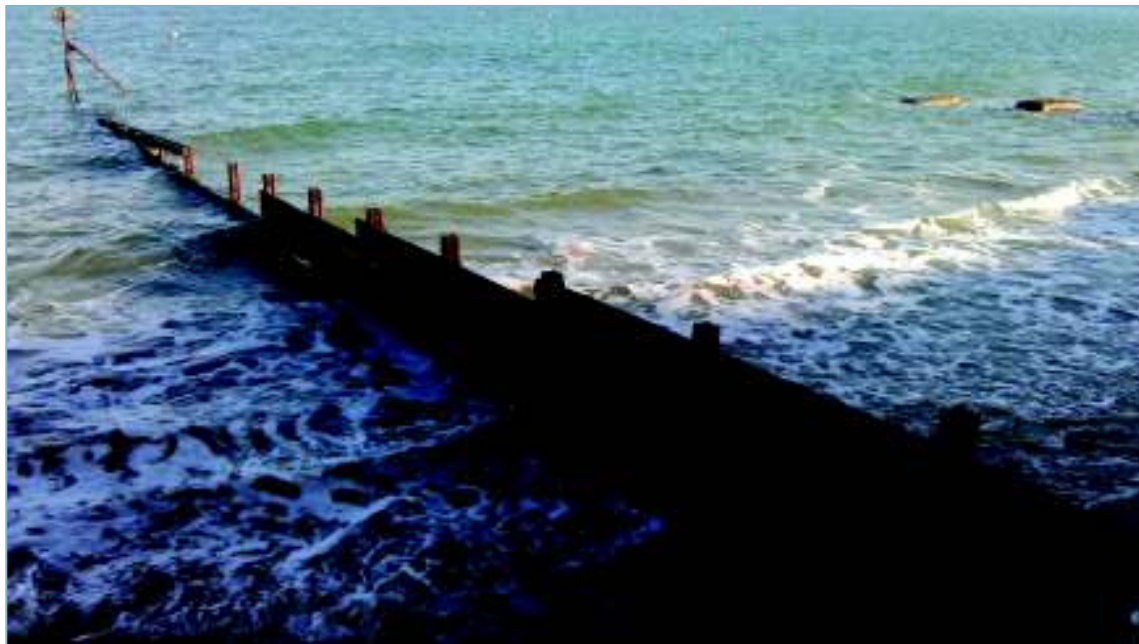
Figure 8.12: Defence Section 4 - Timber groyne with missing planks towards offshore end.
