# Totland to Colwell Bay Landslide Assessment

December 2013

Isle of Wight Council

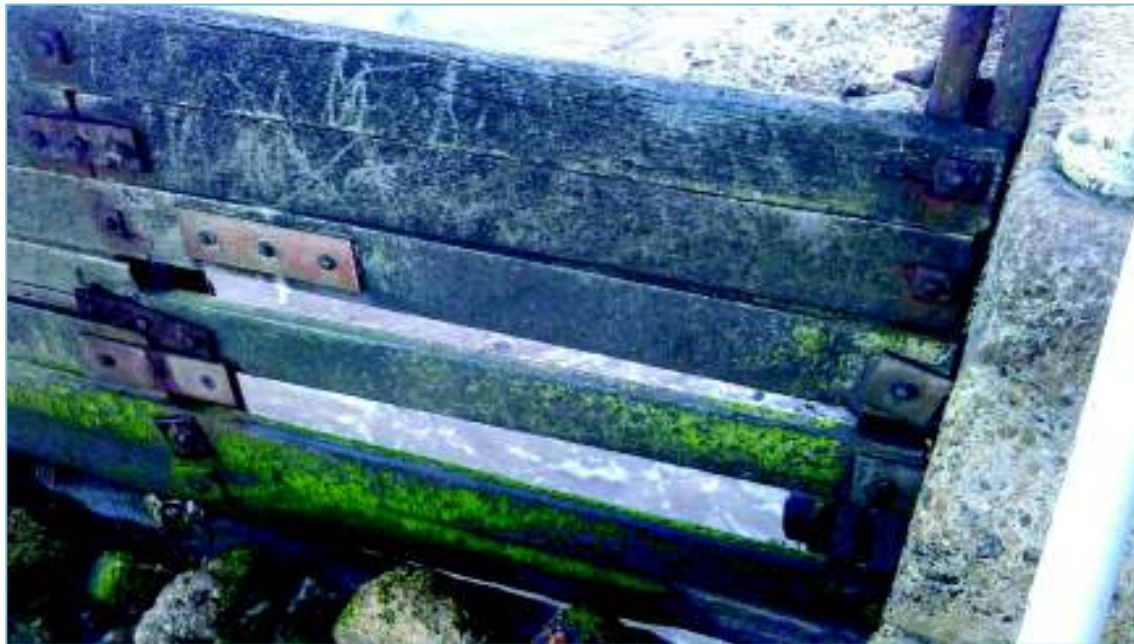
Figure 8.13: Defence Section 4 – Missing planks at inshore end of 2<sup>nd</sup> groyne.

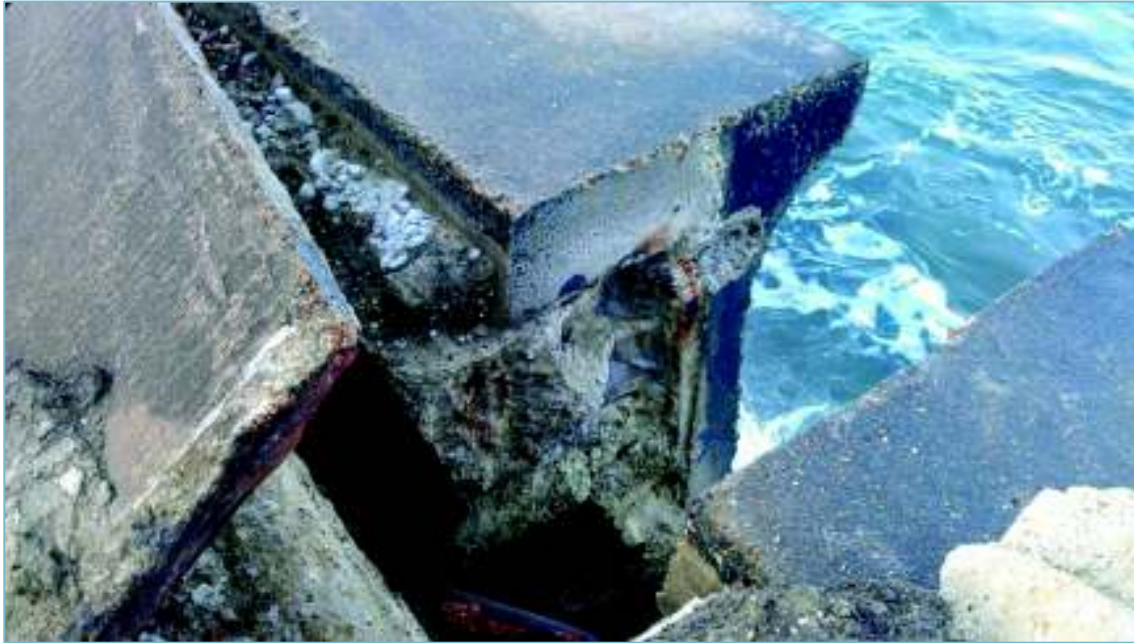
Figure 8.15: Cross section of failed seawall (20<sup>th</sup> September 2013)

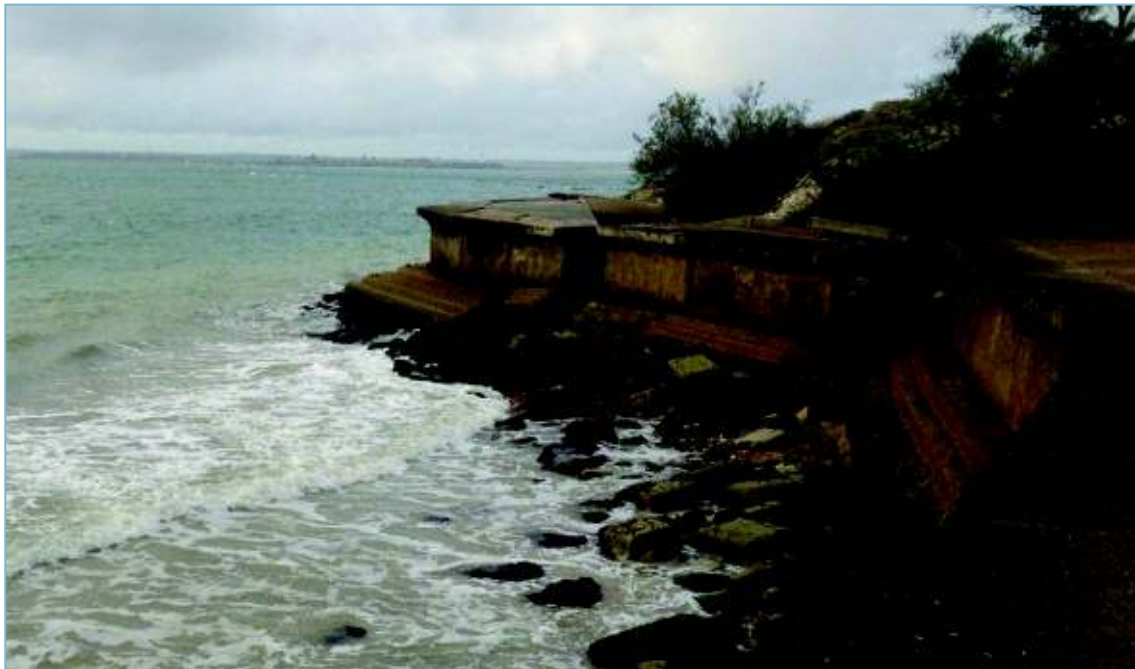
Figure 8.16: Failed seawall – viewed from Totland Bay looking north (19<sup>th</sup> September 2013).

Figure 8.16 shows the southern extent of the landslide viewed from Totland Bay looking north. The image shows the seawall has been pushed horizontally seaward. The seawall does not show significant signs of forward rotation indicating that the toe of the concrete structure has moved relatively freely without restraint by the steel sheet pile. In this location the seawall has been displaced seawards by approximately 10m. Given the extent of displacement there is no significant build-up of material in front of the structure toe, this indicates the seawall has predominantly moved across the surface, pushing only a shallow layer of material.

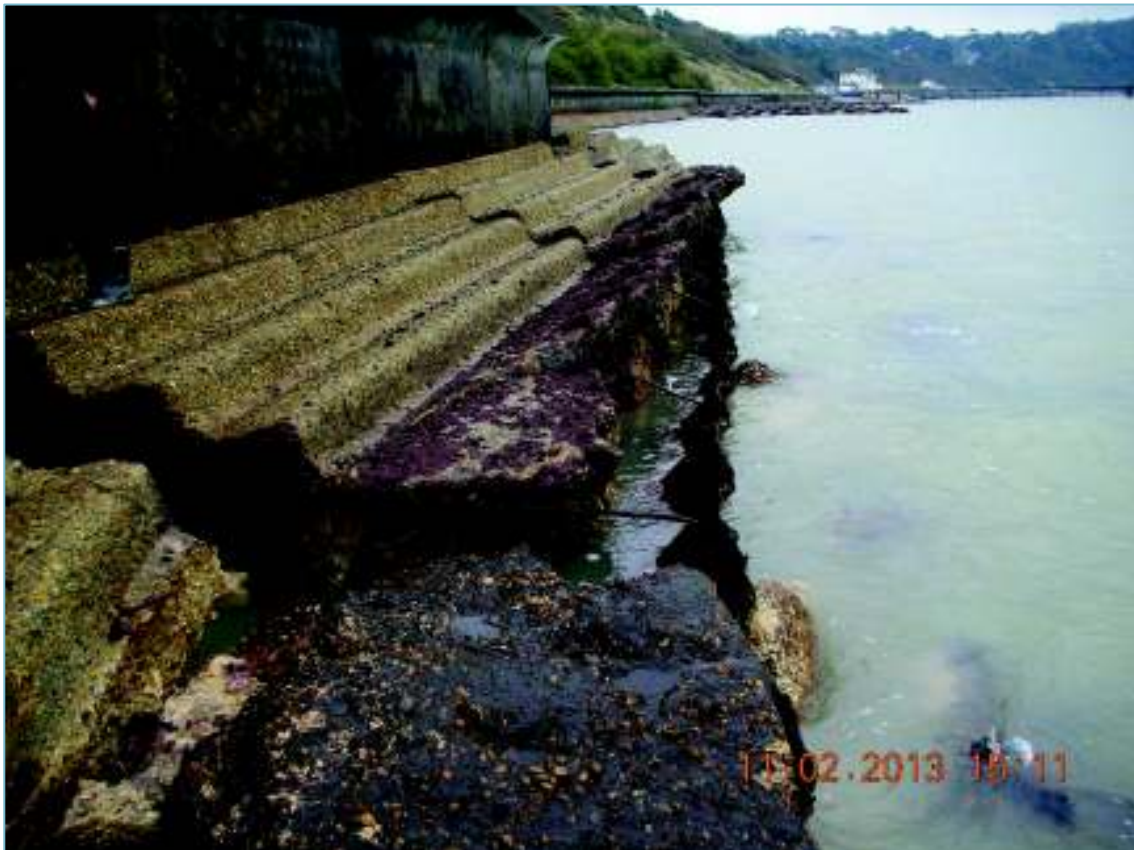
Figure 8.17: Failed seawall central section at low water – view looking towards Totland Bay (11<sup>th</sup> February 2013)

Figure 8.17 was taken by the Isle of Wight Council during low water in February. At this section the CCO analysis (Refer to Appendix A) shows the wall has displaced seawards by 17m. The image shows that the central sections of seawall have remained intact, but failure of the piles and apron connection has occurred. Along the section it can be seen that as the piles have rotated they have caused the stepped apron concrete to be cracked horizontally allowing the tie bars to pull free from the concrete. It is not clear if the walings were fitted, as proposed within the original design (shown in Figure 8.14), or if only the hooked tie bars were installed.

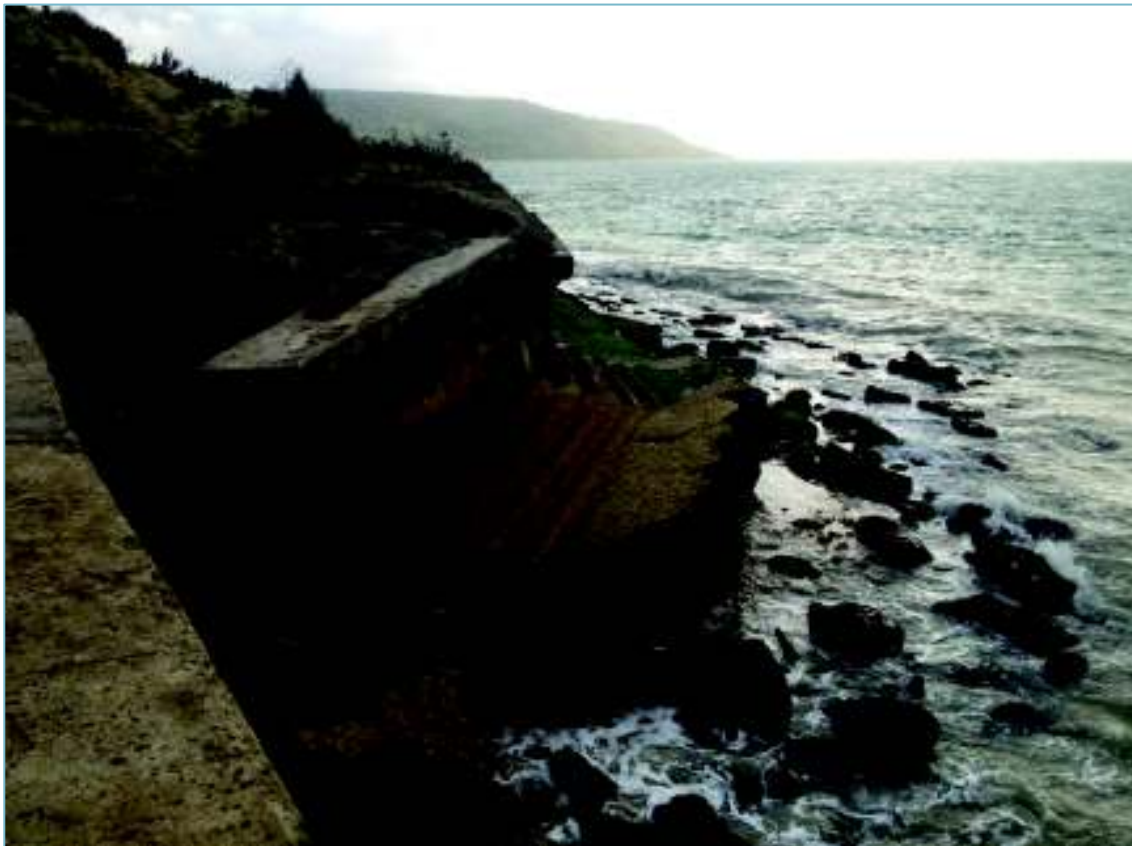
Figure 8.18: Failed seawall – viewed from Colwell Bay extent of landslide looking south (19<sup>th</sup> September 2013)

Figure 8.18 shows the failed seawall viewed from the Colwell Bay extent of the landslide, looking south towards Totland. The analysis by CCO (Refer to Appendix A) illustrates that this section has been displaced seawards by approximately 7m. The sheet piles are visible in front of the concrete apron, though connecting bolts have sheared and the sheet piles have become detached from the concrete apron and are bent forwards. Foreshore material has been displaced forwards ahead of the piles (indicated by the upwelling of sand through the rock material), this indicates that pile failure occurred at a lower level than the southern section shown in Figure 8.16. The back rotation of the end section of displaced wall is also an indicator that as piles were pushed forwards a void was formed beneath the seawall. Other sections may have failed under the same mechanism however the void behind could have been filled with landslide material as it moved seawards preventing back rotation.
