**GEOLOGICAL  
FAILURE REPORT**  
RED ZONE 10: CARAVAN  
PARK,  
UNDERCLIFF DRIVE  
May 2014

GEOLOGICAL FAILURE REPORT: RED ZONE 10 CARAVAN PARK

# ISLE OF WIGHT HIGHWAYS PFI UNDERCLIFF SITE 10, CARAVAN PARK GEOLOGICAL FAILURE REPORT

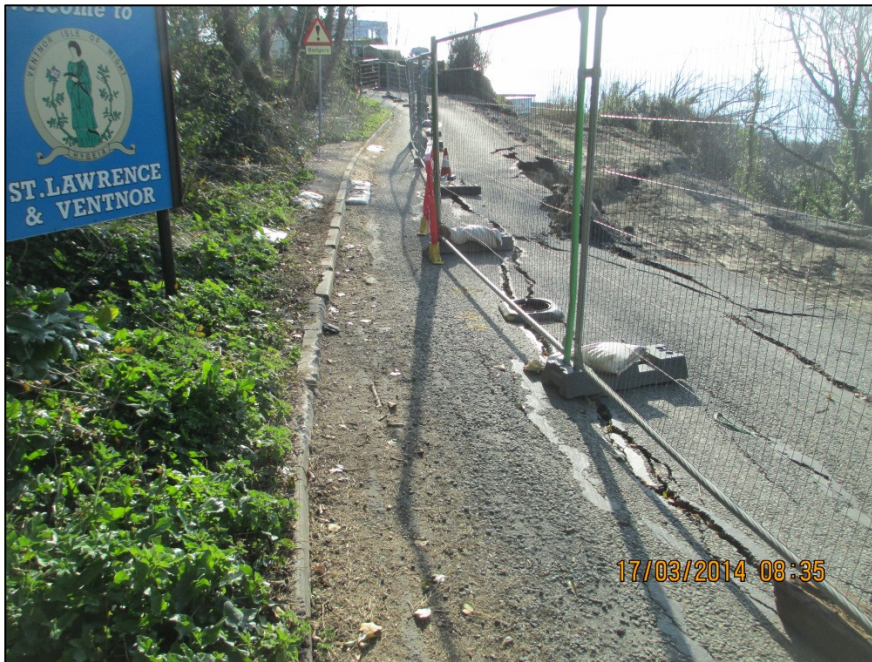
In addition to the information given in Appendix 1, a plan showing the extent of the ground movement caused by reactivation of the landslide along Undercliff Drive over January/February 2014 is shown in Appendix 3. The main line of the failure at Site 10 Caravan Park has cut through the footprint of the west bound carriageway and onto the east bound side along pre-existing cracks (see Fig 1a). The failure has also retrogressed towards

**Figure 1a.** Site 10 Caravan Park Geological Failure: Failure of the carriageway on the eastbound side and retrogression inland.

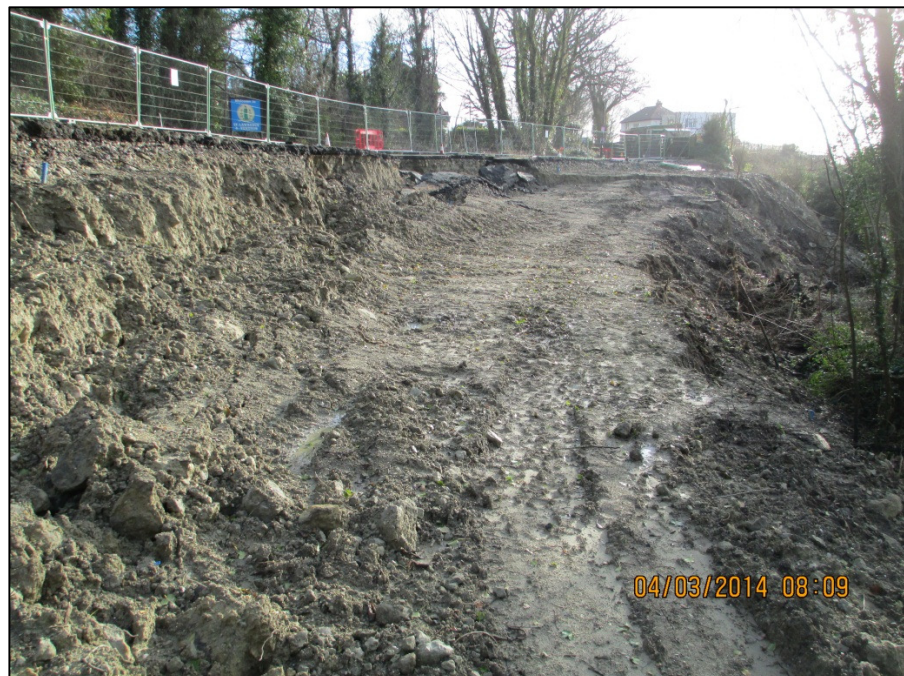
the eastbound carriageway and extends downslope for a distance of approximately 300m to the sea. The failure in this part of the landslide is characterised by large scale tension cracks (see Fig 1b and 1c) and fallen trees.

**Figure 1b.** Site 10 Caravan Park Geological Failure: Failure cutting across the footprint of the westbound carriageway and along existing cracks.

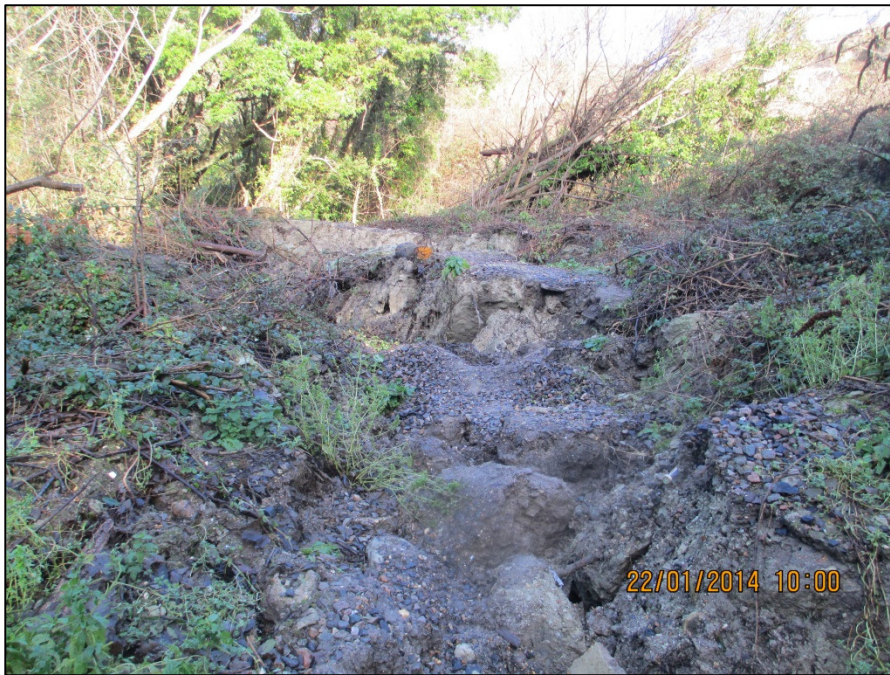
**Figure 1c.** Site 10 Caravan Park Geological Failure: Large tension cracks approximately 100m downslope of the site.

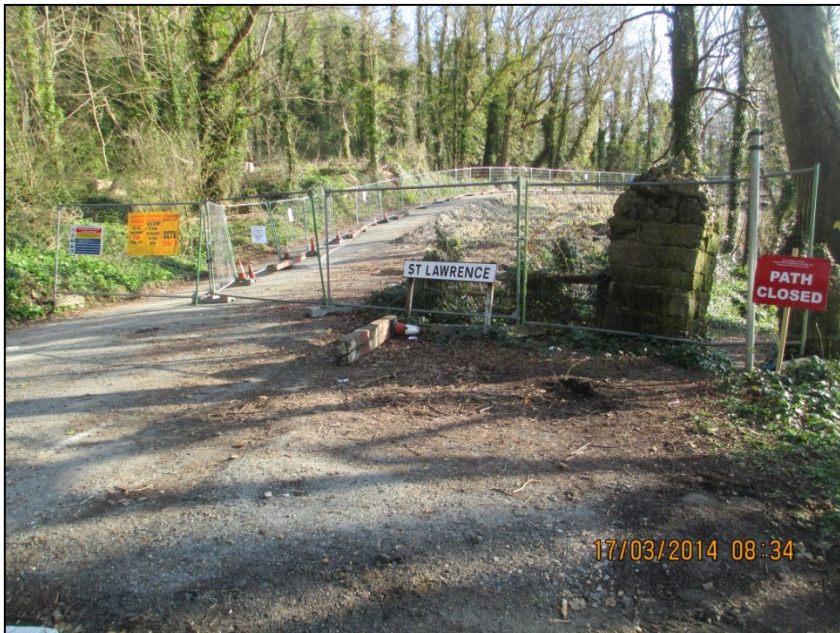
Inside the site the area has been completely cleared of all construction equipment, vehicles and barriers. Photos of the current condition of the site are provided in Fig. 2a, 2b and 2c.

**Figure 2a.** Site 10 Caravan Park Geological Failure: Barriers at the western extent of the site.

In order to make the site safe it has been contained using lengths of Heras fencing running the length of the failure between the western extent of the site and the boundary of Site 10 Caravan Park.

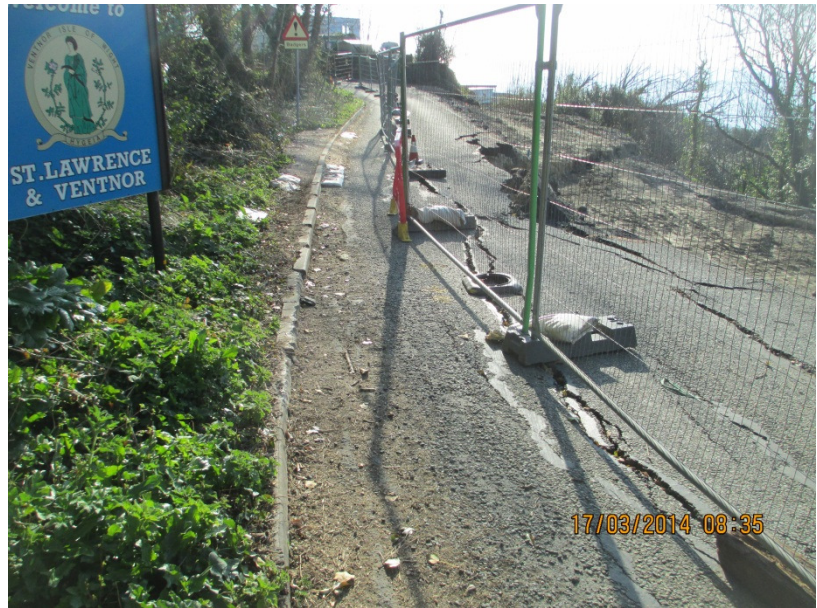
**Figure 2b.** Site 10  
Caravan Park  
Geological Failure:  
Barriers through the  
centre of the site.

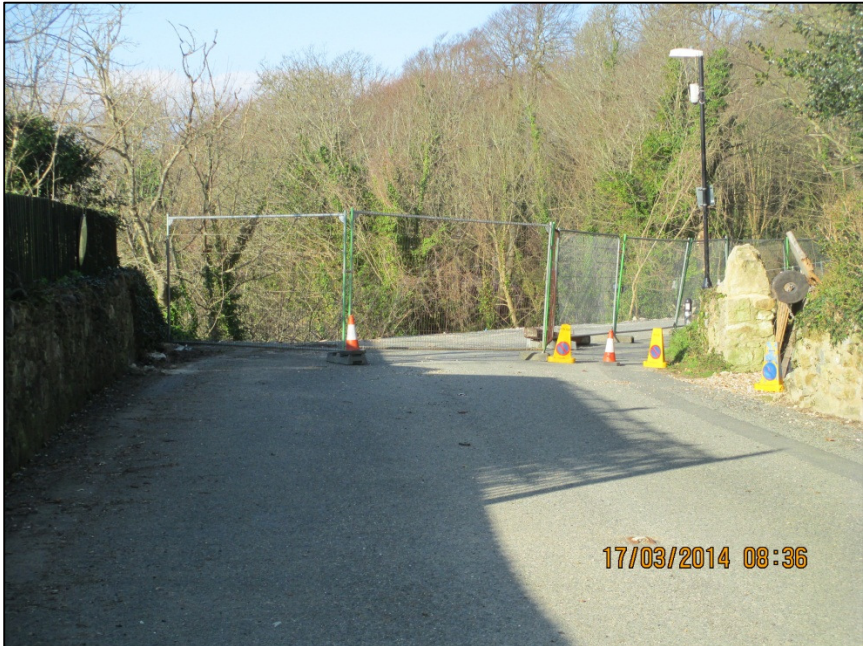
**Figure 2c.** Site 10  
Caravan Park Geological  
Failure: Barriers at the  
eastern extent of the  
site.

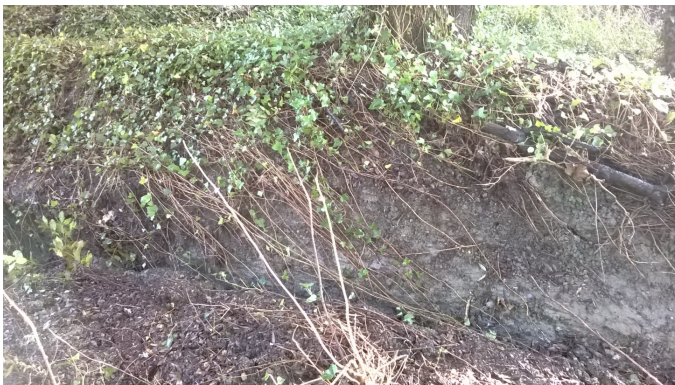
**Photo 1**

LARGE CRACKS A FEW METERS DEEP CURVES UP TO 1M HIGH IN PLACES. 5-10 BLOCKS DEVELOPED. LARGEST ~ 2M WIDE.  
LARGE CRACKS APPROX 500MM DEEP PERPENDICULAR TO PLANE OF MOVEMENT.  
JUMP SCALE MOVEMENT SURVEY BY EXTERIOR BOUNDS. (PHOTO 1)

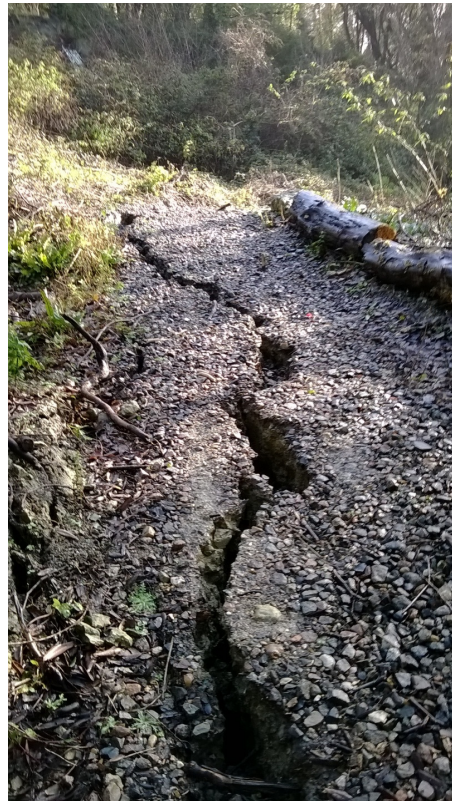
**Photo 3**

On the way back up, I mapped the tension cracks and failures that were visible from the footpath as accurately as possible. The footpath winds its way down the landslide following the top of the scarp slopes, and so the damage to the path was very visible. Movement was seen from approximately halfway up the landslide all the way to the road, with the most severe movements occurring lowest down the landslide. Movement tended to be shown as large cracks with large drops in the ground surface lower down the landslide, and as developing tension cracks as you moved closer towards road level. Tension cracks up to 1m wide were seen in the lower slopes, with a change in height of up to 1m (Photo 1). As we progressed up the footpath, there were areas where a number of blocks had formed, with an approximate height difference of 1m between blocks (Photo 2). Just below the level of the road large tension cracks were evident in the footpath, with up to 300mm differential movement (Photo 3).

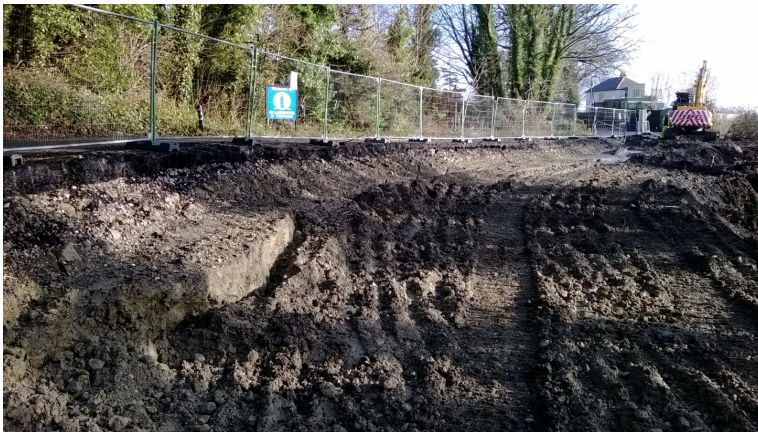
**Photo 4**

At road level, a long tension crack was evident in the excavation made for the installation of the anchor blocks (Photo 4). From the western end of the site the crack followed the curve in the road at the base of the temporary cut, and then turned downslope before the caravan park (Photo 5). A total of seven tension cracks had appeared in the road surface. The longest two, approximately 10m and 15m long respectively, are cracks that have re-opened having previously been sealed. Differential movement is 20mm. The remaining cracks are generally all new cracks in the road surface, and not in the same location as a historic crack (Photo 6).

TENSION CRACK IN EXCAVATED AREA. APPROX 500MM DEEP TENSION CRACK 100MM - 200MM WIDE. (PHOTO 4)

LARGE TENSION CRACK 150MM DEEP TO 300M WIDE. (PHOTO 4)

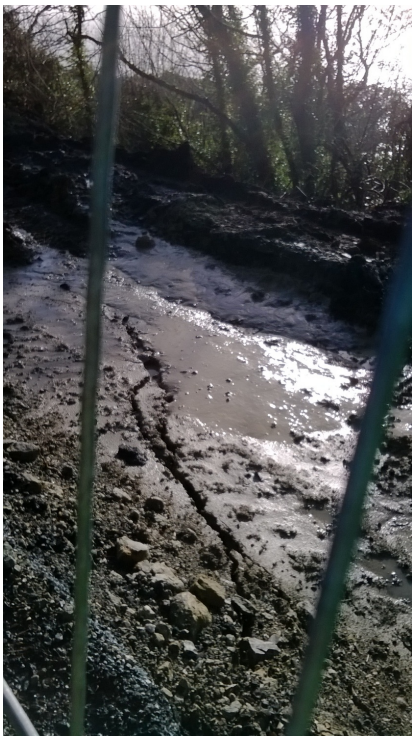
**Photo 5**

TENSION CRACK SLIDES LOCAL TUCK AT TOP OF TENSION CRACK. TENSION CRACKS APPROXIMATELY 100MM WIDE. ROAD.  
SCALED TENSION CRACK OK.  
TENSION CRACK CUTS ACCESS EXCAVATED AREA. (PHOTO 5)

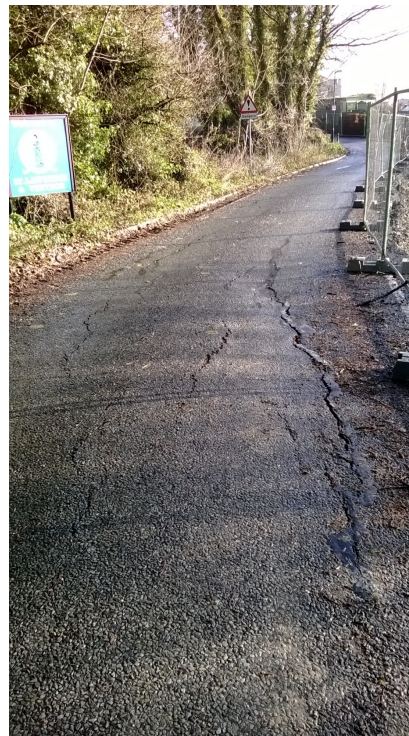
**Photo 6**

PHOTO 6  
TENSION CRACKS IN ROAD. A FEW IN PLACE OF OLD CRACK.
