#### GEOLOGICAL FAILURE REPORT: RED ZONE 9 WOODLANDS

Title			Geological Failure F	Repor	t – Red Zone 9: Woodlands
Version Number		4			
Document	Status		Final		
Date of Ne	xt Review		June 2014		
Version	ersion Report Author Report		Checked		Report Approved
4					
				I	
Approved for Island Roads Services Limited		Date		Signed

# ISLE OF WIGHT HIGHWAYS PFI WOODLANDS SITE 9 UNDERCLIFF DRIVE GEOLOGICAL FAILURE

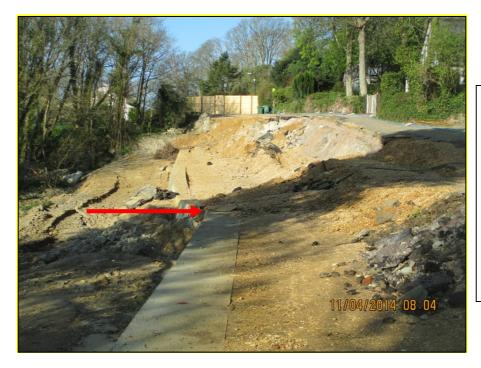
Figure 1a. Site 9
Woodlands
Geological
Failure. Location
at which the
failure cuts
across the
completed
ground beam
(red arrow).

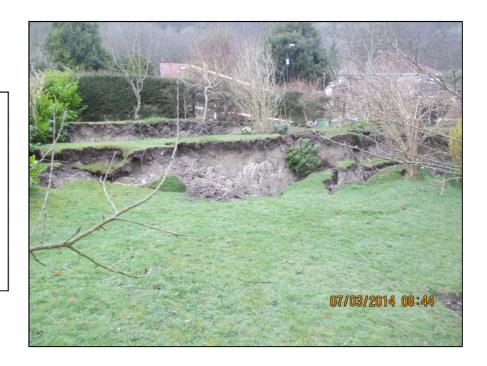
Figure 1b. Site 9
Woodlands
Geological
Failure.
Backscarp of the
failure cutting
across into the
garden of
Allenmore.

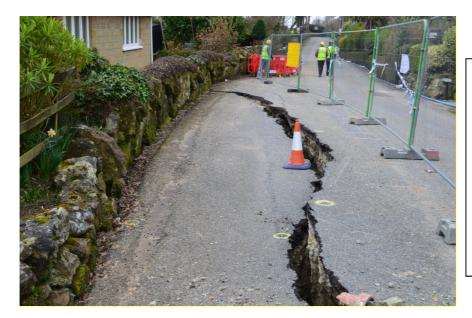
Figure 1c. Site 9
Woodlands
Geological
Failure. New
failure in the
west bound
carriageway
outside the
property
Allenmore

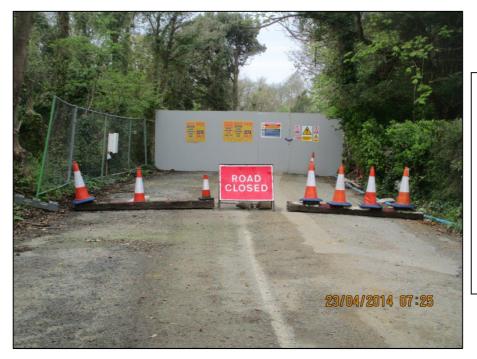
Figure 2a. Site 9
Woodlands
Geological
Failure.
Hoarding,
barriers and signs
in place at the
eastern extent of
the site.

Since the area is now impassable the area has been made safe by placing barriers at both the eastern and western ends with two sections of hoarding to prevent pedestrian access. Warning/danger signs have been attached to the outside of the hoarding and the access has been padlocked. Running adjacent to the hoarding is a section of Heras fencing in place to restrict access around the side of the hoarding. Three railway sleepers have also been placed outside the site with cones and a road closed sign. Inside the site the area has been completely cleared of all site cabins, construction equipment, vehicles and barriers. Photos of the current condition of the site are given in Fig. 2a, 2b and 2c.

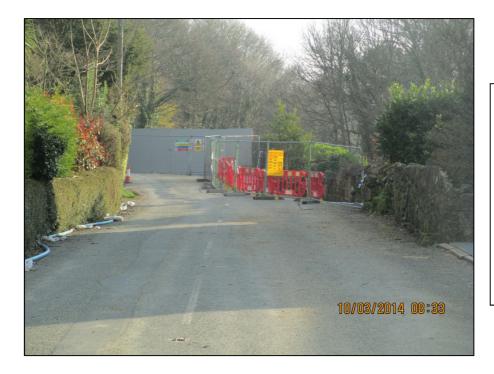
Figure 2c. Site 9
Woodlands
Geological
Failure.
Hoarding,
barriers and signs
in place at the
western extent
of the site.

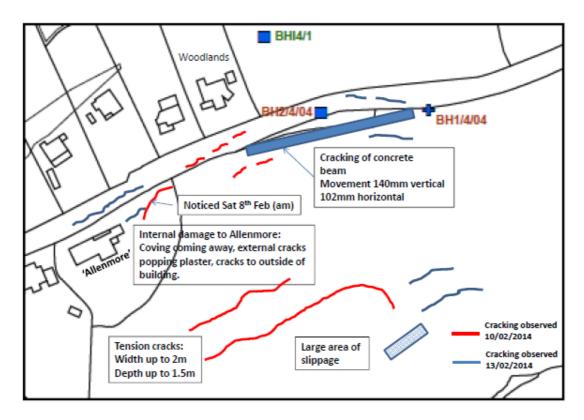
- Tension cracking was first reported on 8 February 2014 at "Allenmore".
- An inspection of the site was carried out on 10 February 2014. The first tension cracks were observed to extend between "Woodlands" and "Allenmore" in the road surface (shown in red) and had in three days extended both east and west.
- The tension cracks initially appeared as either re-opening of existing features or as hairline cracks.

- The westward extension of the tension cracks were aligned below and around "Allenmore". The tension crack in "Allenmore" driveway initially dropped approximately 100 mm in two days and external and internal damage was evident. Displacement then increased to 400 mm, and has since increased further. The north western corner to the foundations had moved along the dpc layer (Photo A1).

- New hairline tension cracks had developed along the Undercliff Drive to the western end of "Allenmore" (13 February 2014). These features continued to open up and displacement gradually developed from hairline to 200 mm wide on 17 February 2014.

- The tension crack opposite "Woodlands" and 30 metres east of "Woodlands" opened by 50 mm to 100 mm between 13 February and 17 February 2014 and began to show signs of downslope displacement.

Figure 2 Summary of tension cracking observed on 10 and 13 February 2014

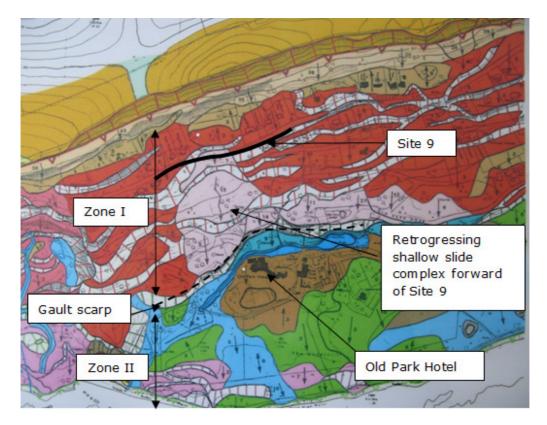
Site 9 Woodlands and Site 10 Caravan Park, whilst situated immediately adjacent to each other and within the landslide complex, are subject to two different landslide mechanisms. An extract of the published Geomorphology Map (Sheet 5) is reproduced in Figure 3. This shows Site 9 to

be located in the head scarp position of an area of multiple rotational block failures that lies immediately above a retrogressing mudslide complex. The retrogressing slide complex extends approximately 160 metres downslopes of Site 9. This is in contrast to Site 10 where the mudslide complex extends to the shoreline. A zone of rotational blocks forms a feature separating the landslide complexes downslope of each site.

Figure 3 Extract of Geomorphology Map Site 9 and Site 10

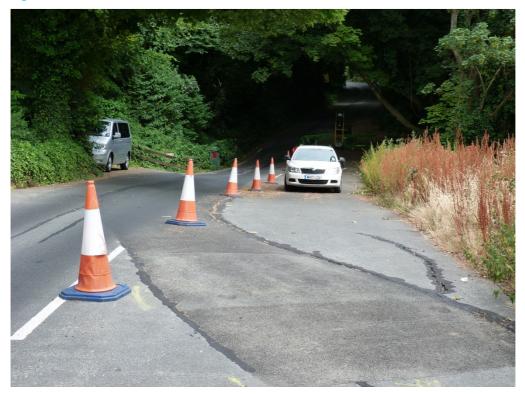
Figure 6 View of Site 9 taken on 24 July 2013 showing resurfacing carried out prior to contract award

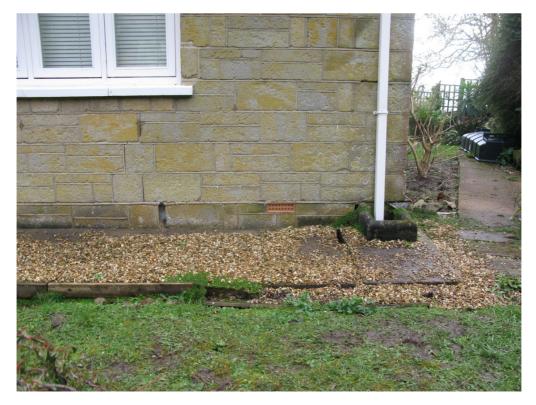
A 1 1 Photo of north west corner of Allenmore showing foundation displacement

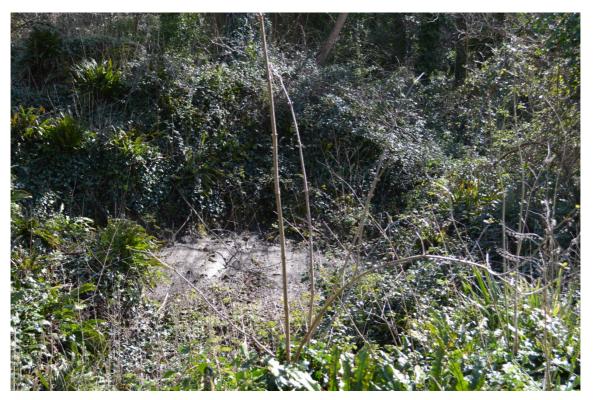
- Tension cracks 2 metres wide and 1.5 metres deep found downslope between "Allenmore" and the western half of the ground anchor beam (approximately downslope of where tension cracking was found in Undercliff Drive) on 10 February 2014 (estimated to be 50 metres to 75 metres forward of the site). During the second visit these features were not evident; this may have been due to the vegetation cover or possibly that further ground movement has closed them up.

A 1 2 Shallow sliding Downslope of the Site

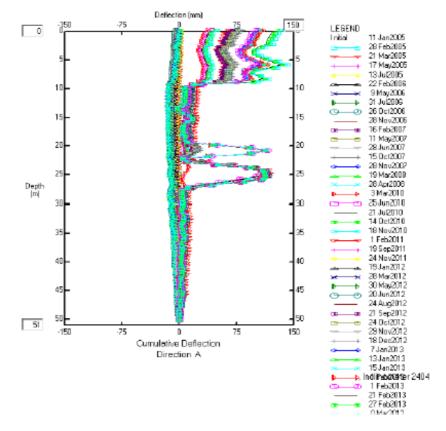
Appendix B- 10 Inclinometer 2404 Incremental Plot. This instrument was severed due to ground movement during January/February 2013.

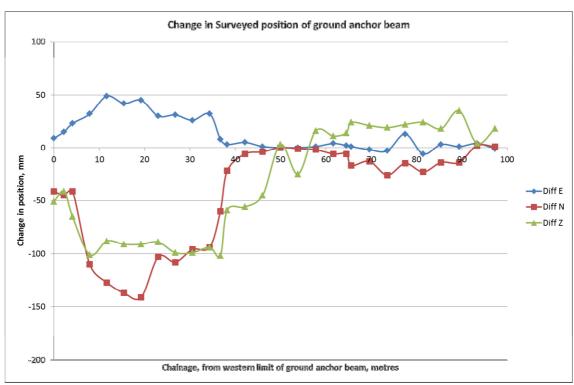
- The ground anchor beam had multiple hairline cracks at its mid-point (13 February 2014). The beam was subsequently mechanically cut before the larger scale movement began, to save as much of the beam as possible.

Appendix B- 12 Change in Ground Anchor Beam Level from construction to 14th February 2014 (Movement direction: Diff E: Easting, Diff N: Northing, Diff Z: Level).

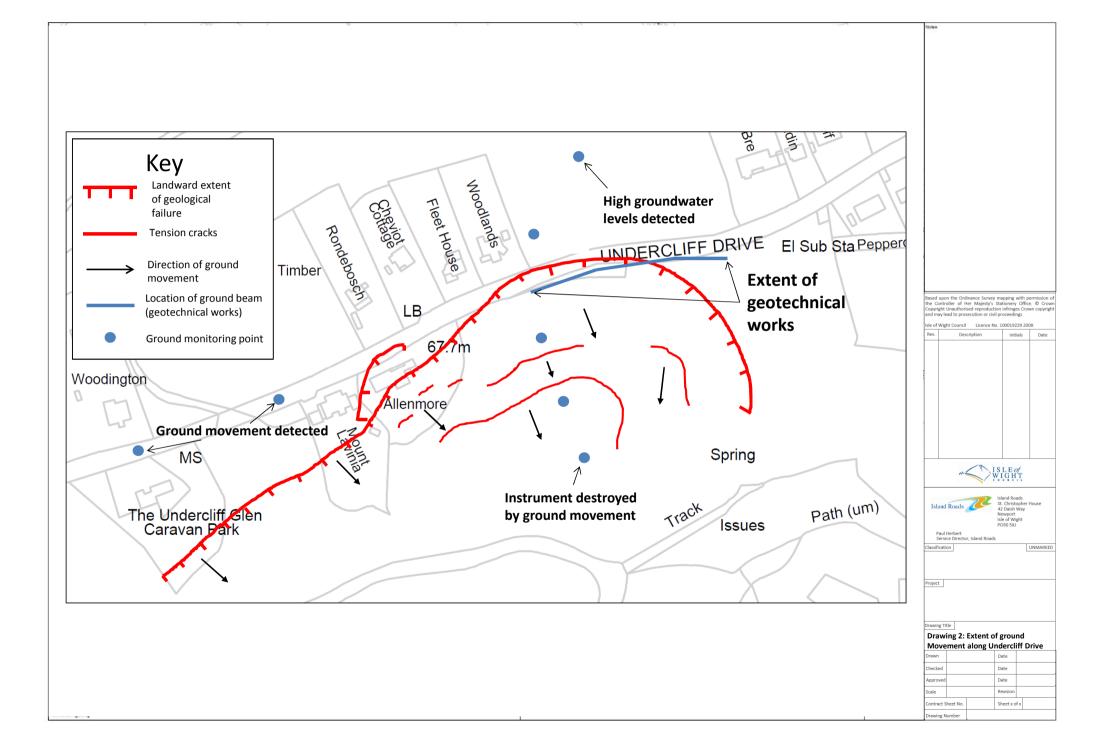
# Drawing 2 – Extent of Ground Movement Along Undercliff Drive (2014 Event)

In addition to the information given in Appendix 1, a plan showing the extent of the ground movement caused by reactivation of the landslide along Undercliff Drive over January/February 2014 is shown in Appendix 3. The main line of the failure cuts across the completed ground beam (part of the geotechnical works), and behind it through the centre of the original carriageway along pre-existing cracks (Fig. 1a). The failure then cuts across into the garden and driveway of the property 'Allenmore' (Fig. 1b) and extends into the garden of 'Mount Lavinia'. The line of failure can then be traced across this property to the south side of the Undercliff Glen Caravan Park. A separate new area of failure developed within the west bound side of the road immediately outside the property 'Allenmore' (Fig. 1c) and can be traced through the corner of the property and into the garden of the property 'Mount Lavinia'.
