Isle of Wight Council

Ventnor to Niton Options Study

Undercliff Drive Geotechnical Options Appraisal

December 2009

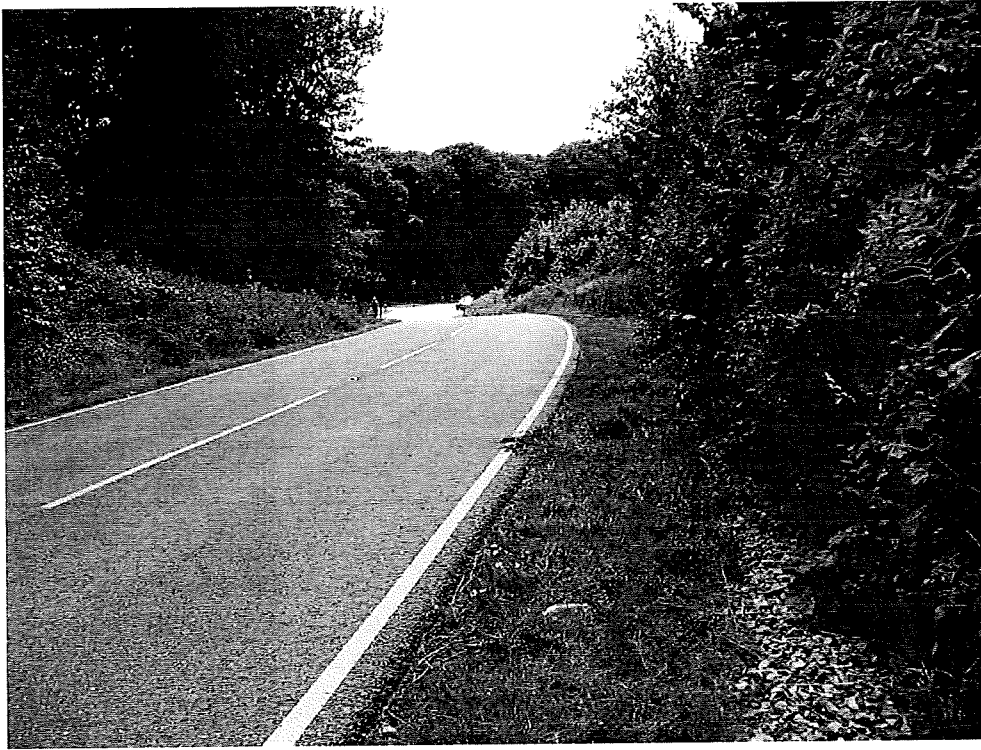
During a walkover of the new length of road in July 2009, no evidence of cracking or change in gradient of the new section of road surface was evident (Plate 1). Walkover inspection of the 2001 landslide headscarp identified that localised ground movement is still occurring both around the headscarp and lower down the slope within the landslide body (below the grounds of The Orchard) and this was observed in December 2008 (Halcrow, 2008). The evidence includes open tension

Plate 1: Road condition, Area 1 Beauchamp

No remediation options are recommended at this time, but recommendations for regular walk-over surveys, updating of the landslide geomorphology mapping and continued investment and maintenance of the geotechnical monitoring systems are recommended.

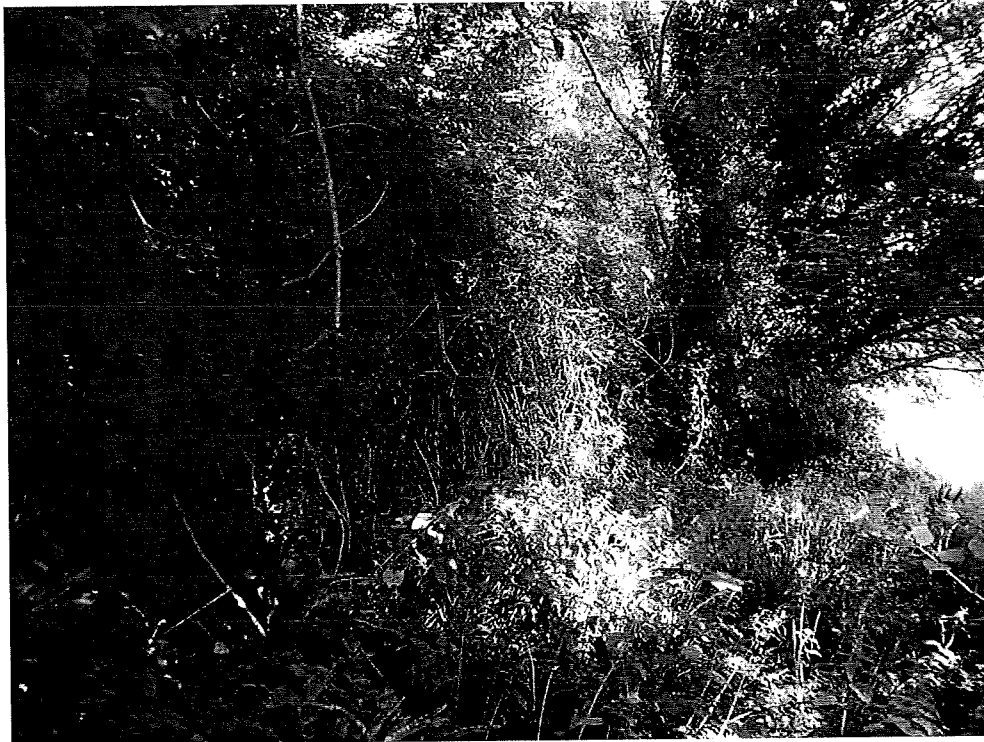
A site inspection was conducted along the road and, where safe and free access was possible, along the retaining wall immediately beneath the road (Plate 2). Areas of surface cracking and one significant change in gradient were identified along the road; these were recorded and are shown in Figure 4.1.

The shear surface extends across the road carriageway and through the lower retaining wall which is also damaged (cracking and bulging) as a result of ongoing ground movement; vegetation growing from the wall has exacerbated the damage and pre-failure/collapse of the wall. Deep seated ground movement is affecting the slopes immediately beneath the wall.

Plate 2: Retaining wall, Area 2 Mirables

The dry stone retaining wall beneath the road at this location shows evidence of bulging and cracking. A structural survey of the wall is recommended to determine the extent of distress to the wall, its cause and whether or not it is detrimental to the performance of the wall. Distress to the wall may be a result of its age, ground movement, vegetation, dynamic loading from passing traffic, or a combination of all of these and other factors. Once the results of the structural wall survey are known, appropriate maintenance of the wall and repairs should be incorporated within the highways maintenance schedule, if needed. If the cause of the distress is in part due to ground movement, the ground model of the site should be borne in mind when options are considered i.e. the design of any repairs should be flexible and accommodate as much ground movement as possible.

Cosmetic improvements for a dry-stone wall can include pointing (incorporating weep holes and leaving some joints unpointed). Larger scale repair techniques include grouting, soil nailing, thickening the retaining wall and permanent buttressing. The option of constructing an embankment downslope would provide support to the wall, but would add additional load onto the upper tier of the landslide system and so would not be appropriate.

If the survey shows that reconstruction of the wall is required, a technology should be used which can accommodate differential ground movement. Reconstruction systems could incorporate rebuilding the wall as a dry stone wall, use of gabions or use of reinforced earth systems with a stone facing. Lightweight fill could be incorporated in the road construction and geotextile or steel strip reinforcement may be used to provide tensile reinforcement where movement can be expected to occur. Recommendations for regular walk-over surveys, updating of the landslide geomorphology mapping and continued investment and maintenance of the geotechnical monitoring systems are recommended.

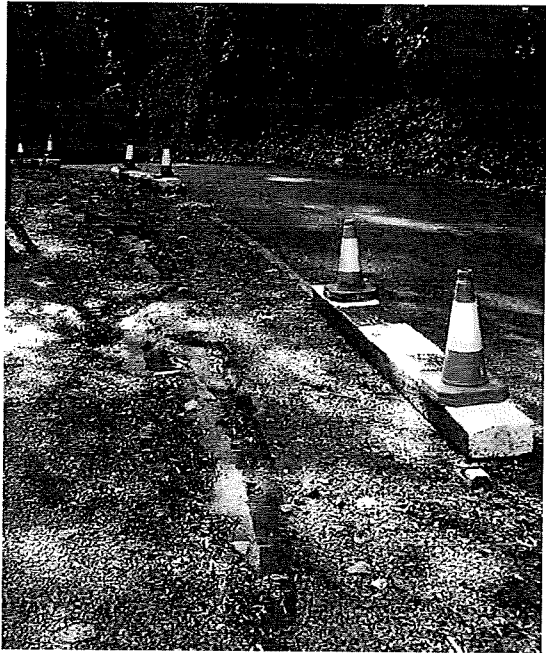
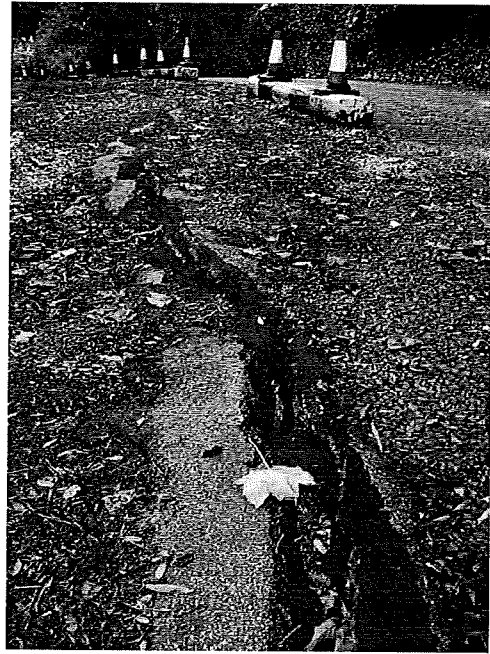
Arcuate tension cracks were recorded on both the westbound and eastbound lanes with evidence of previous patch repairs. The tension cracks have re-opened on the westbound lane providing evidence that ongoing ground movement is continuing in this area (Plate 3). Inspection of the mudslide beneath the road revealed little evidence of any recent significant movement, although the oversteepened scarp slopes adjacent to the caravan park are continuing to retrogress locally (Plate 4).

Plate 3: Crack damage observed in the westbound carriageway, Area 3 Undercliff Glen

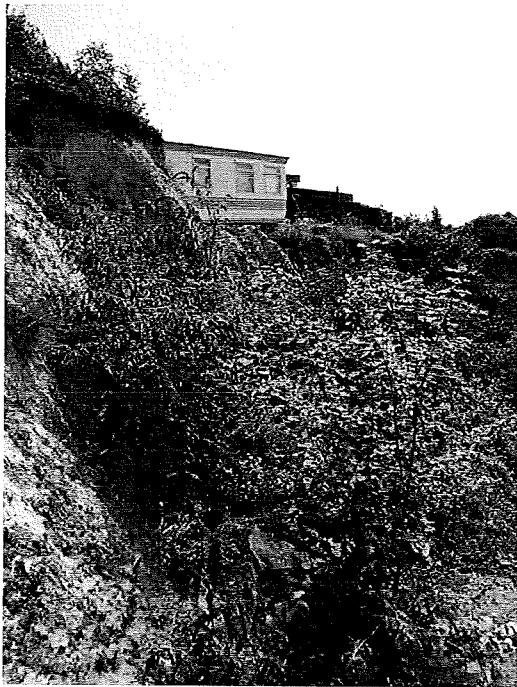
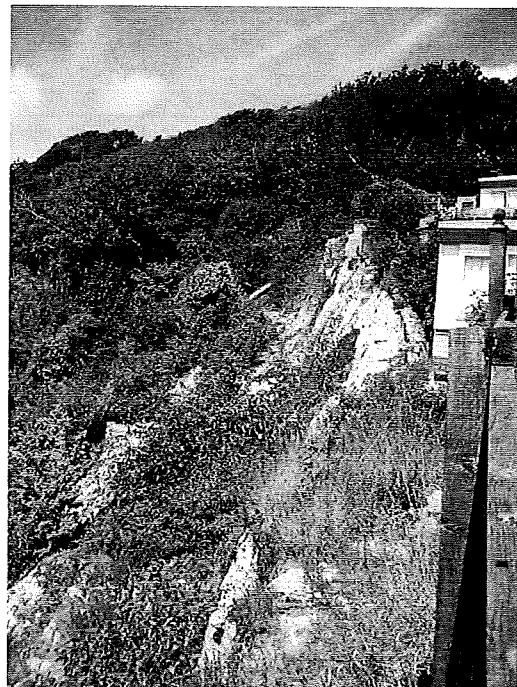
Plate 4: Landslide headscarp, Area 3 Undercliff Glen

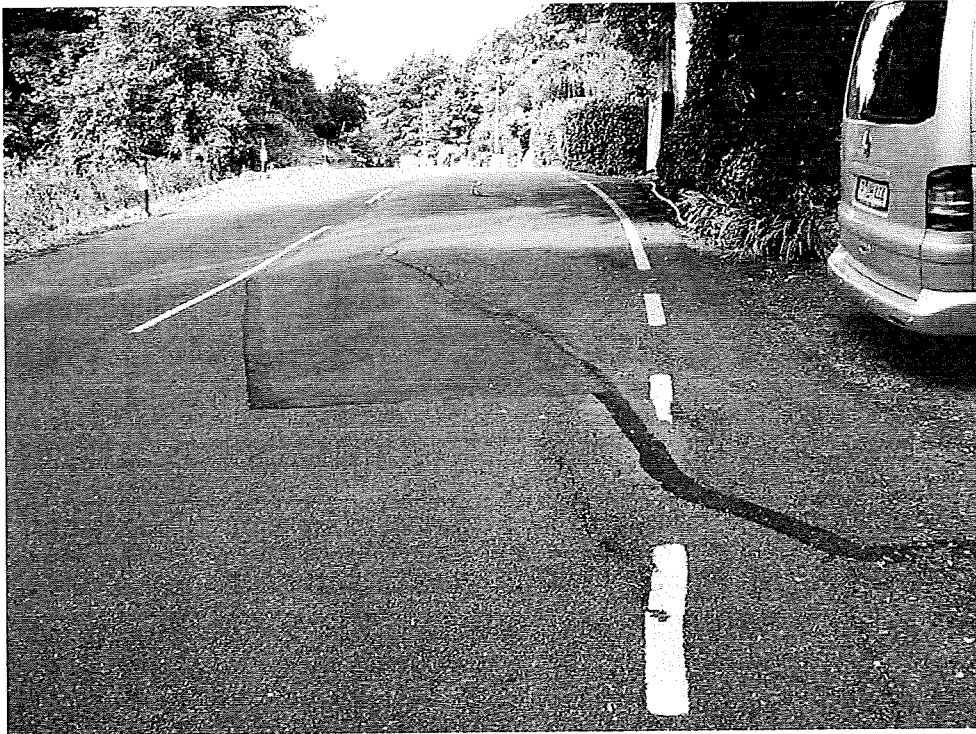
Plate 5: Cracking along lateral shear, Woodlands Area 4

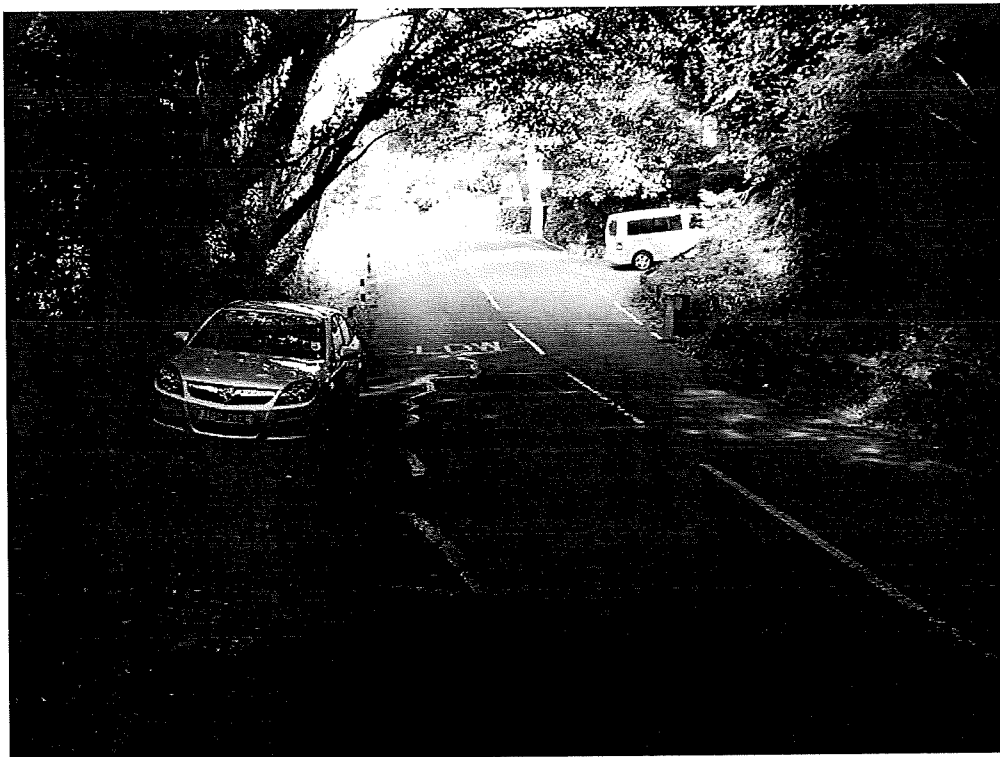
Plate 6: Depression at mudslide headscarp, Woodlands Area 4

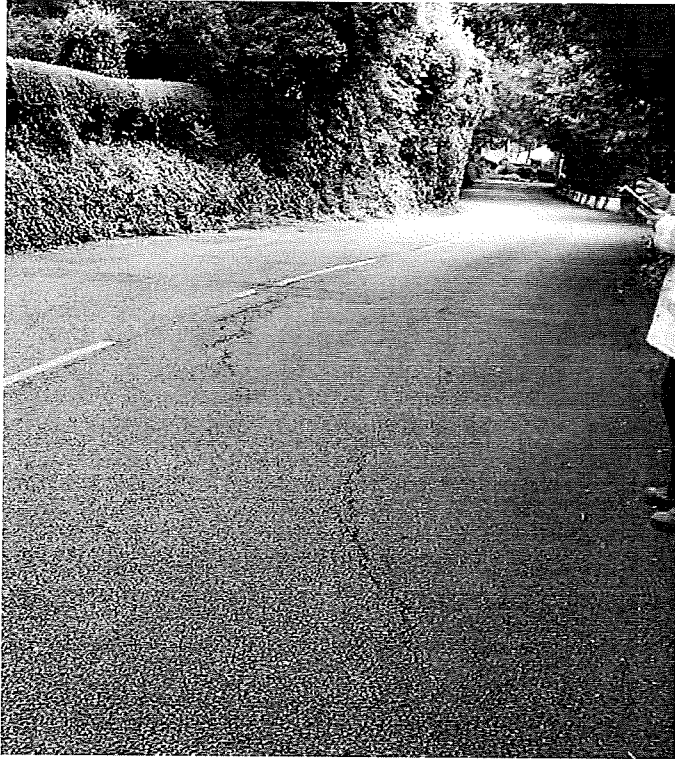
Plate 7: Localised cracking in westbound carriageway, Area 5 St Lawrence West

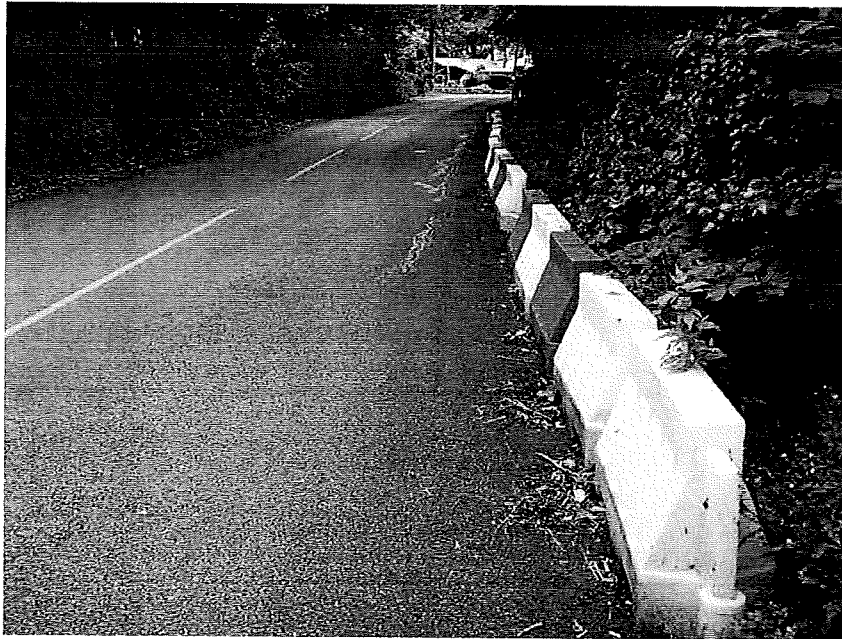
Plate 8: Localised cracking in westbound carriageway, Area 5 St Lawrence West
