# Ventnor Options Appraisal

Technical Report

Revision 5

Isle of Wight Council

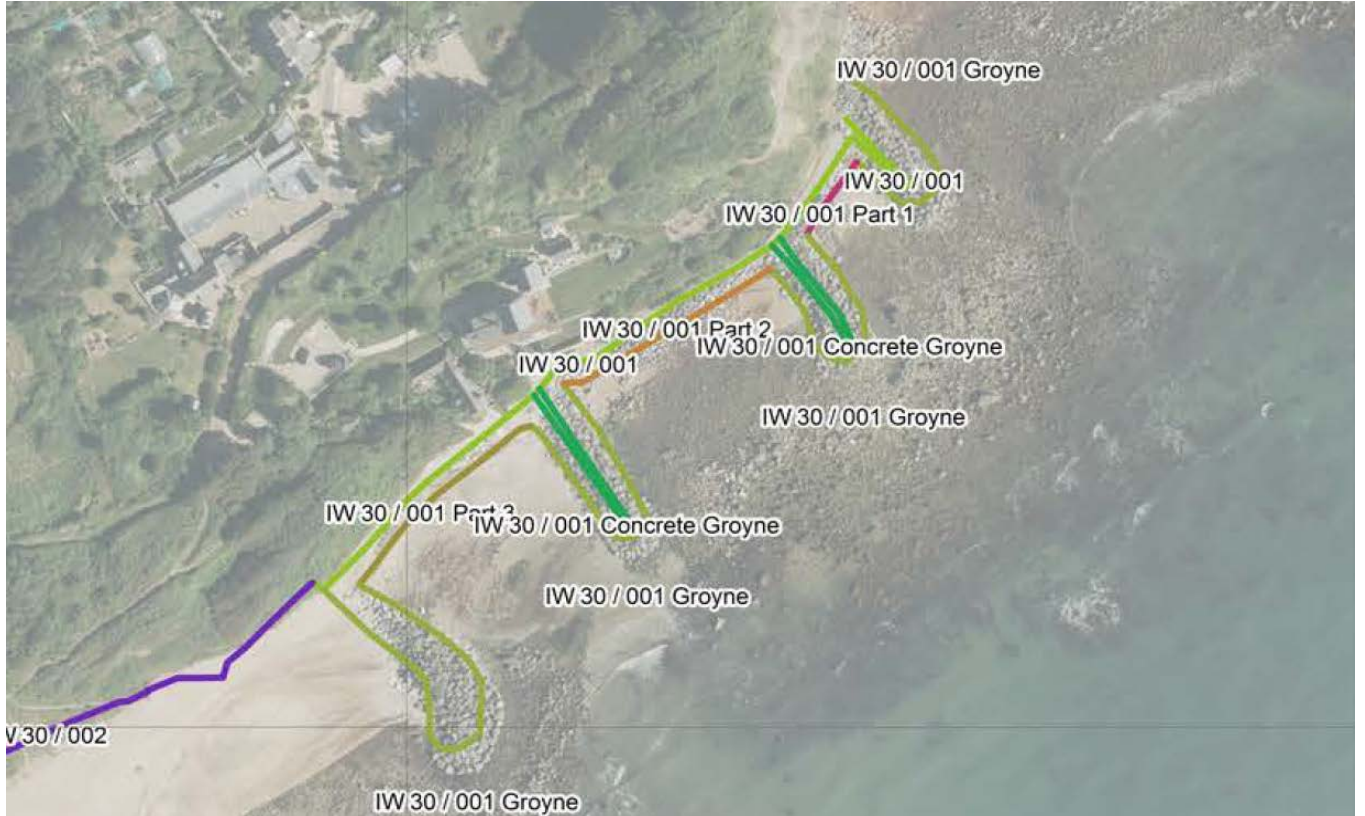
<i>Defence ID</i>	<b>IW 30 / 002</b>	<i>Description</i>	<b>Monks Bay – central bay and breakwater</b>		
<i>Construction</i>	Rock groyne to the east with detached breakwater and maintained beach				
<i>Element Length</i>	142 m	<i>Crest Details</i>	2.2mOD (rock) 3.0mOD (beach)	<i>Maintenance</i>	IoW Council
<i>Foreshore</i>	Shingle beach with some sand and offshore reef	<i>Structure dependency on foreshore</i>			Medium

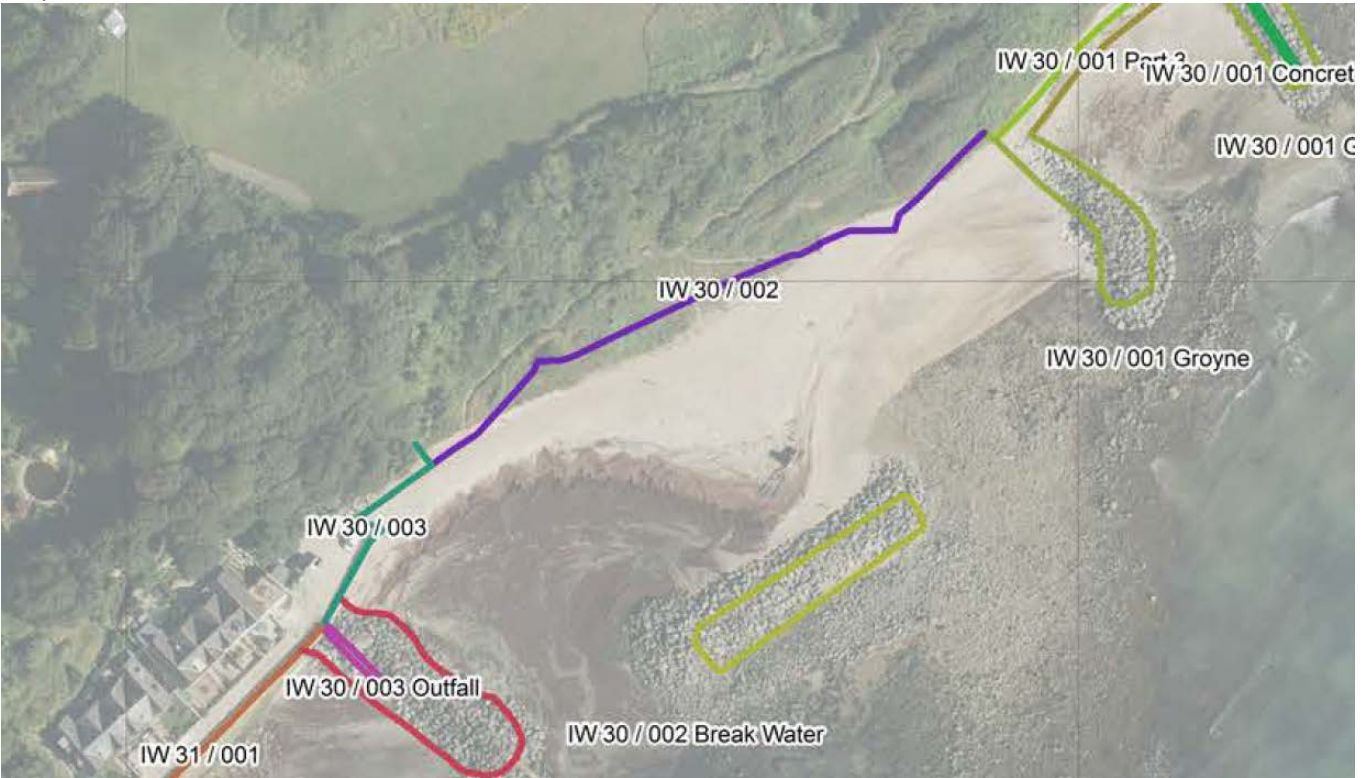
<i>Defence ID</i>	<b>IW 30 /003</b>	<i>Description</i>	<b>Monks Bay – western end of bay</b>		
<i>Construction</i>	Concrete seawall and ramp, rock groyne and outfall				
<i>Element Length</i>	54 m	<i>Crest Details</i>	Unknown	<i>Maintenance</i>	IoW Council
<i>Foreshore</i>	Shingle/rock		<i>Structure dependency on foreshore</i>		Medium

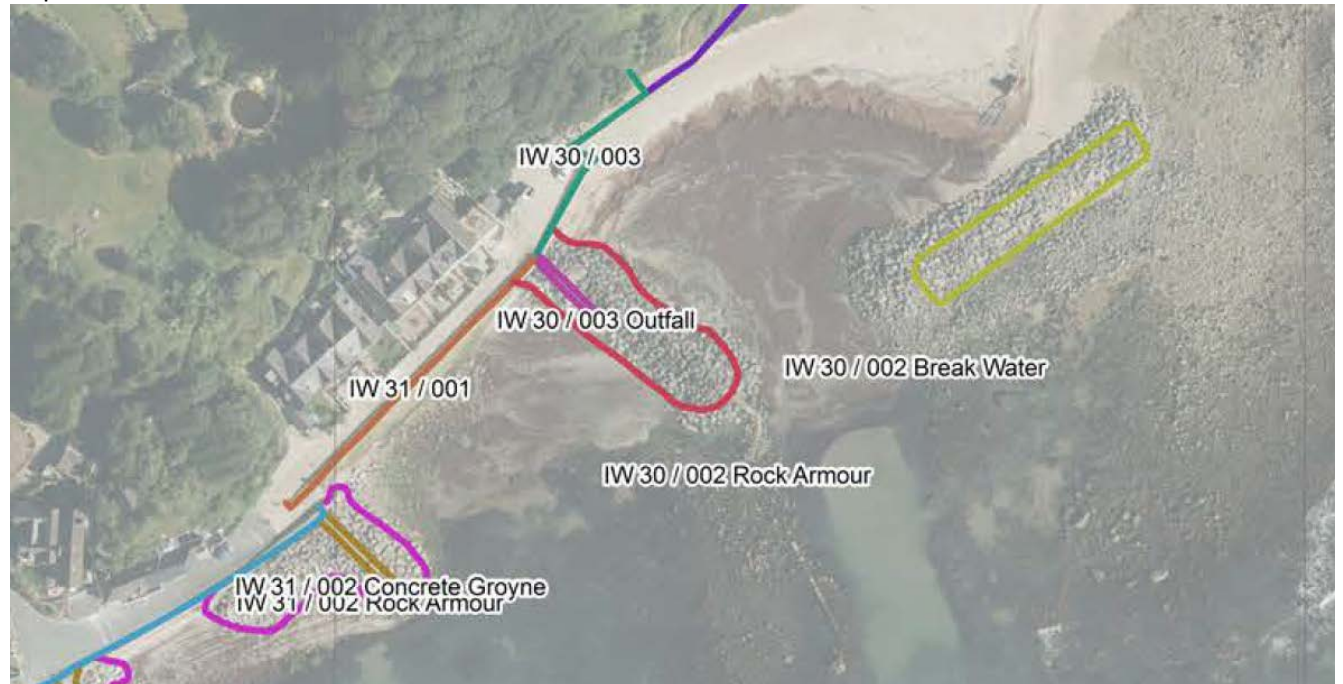
<i>Defence ID</i>	<b>IW 31 / 001</b>	<i>Description</i>	<b>Bonchurch – eastern bays</b>		
<i>Construction</i>	Concrete seawalls and rock groynes (rock surrounding old concrete groynes)				
<i>Element Length</i>	73 m	<i>Crest Details</i>	4.5mOD	<i>Maintenance</i>	IoW Council
<i>Foreshore</i>	Shingle/boulders		<i>Structure dependency on foreshore</i>		Medium

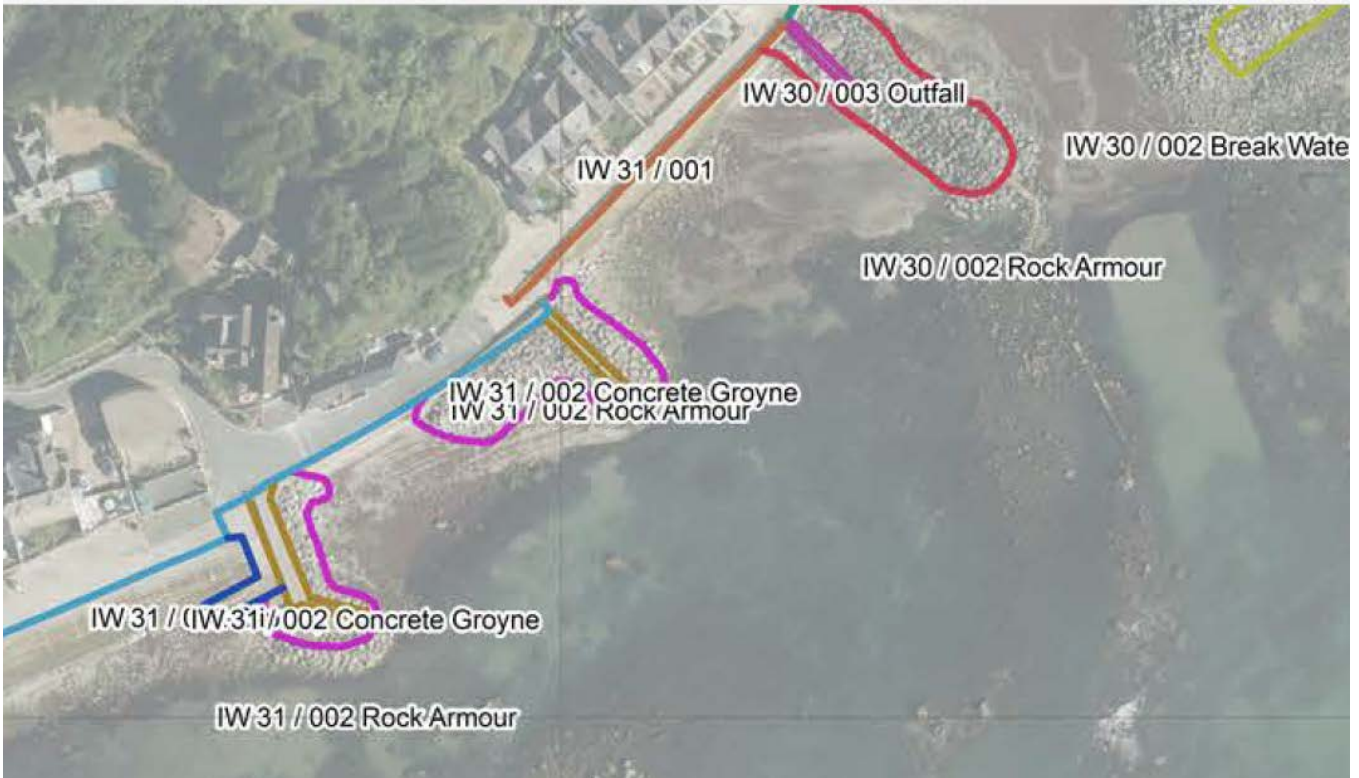
<i>Defence ID</i>	<b>IW 31 / 002</b>	<i>Description</i>	<b>Bonchurch – cliffs</b>		
<i>Construction</i>	Concrete seawall with beach control rock groynes at bay ends. Seawall is stepped with rock armour at toe.				
<i>Element Length</i>	910 m	<i>Crest Details</i>	+4.1mOD	<i>Maintenance</i>	IoW Council
<i>Foreshore</i>	Shingle/boulder/rock		<i>Structure dependency on foreshore</i>		Medium

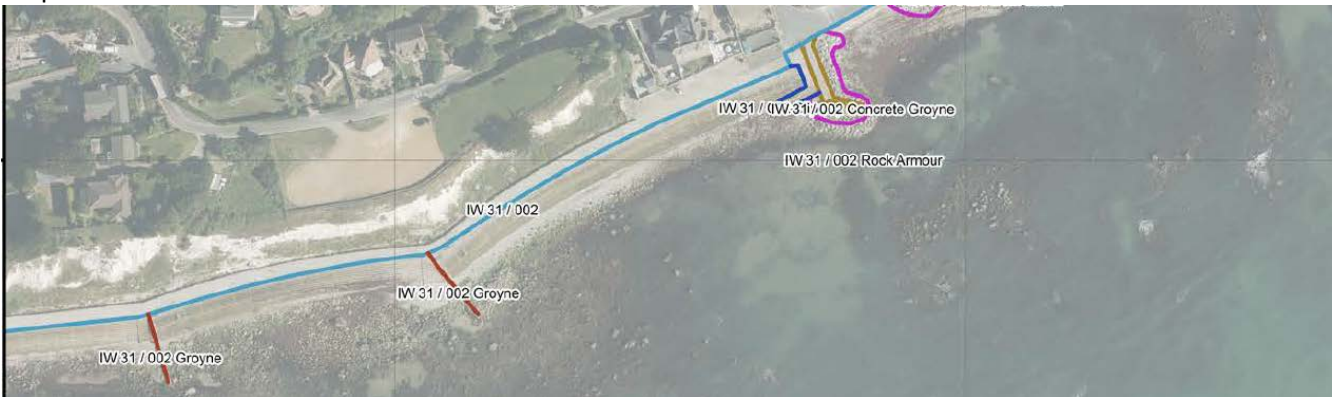
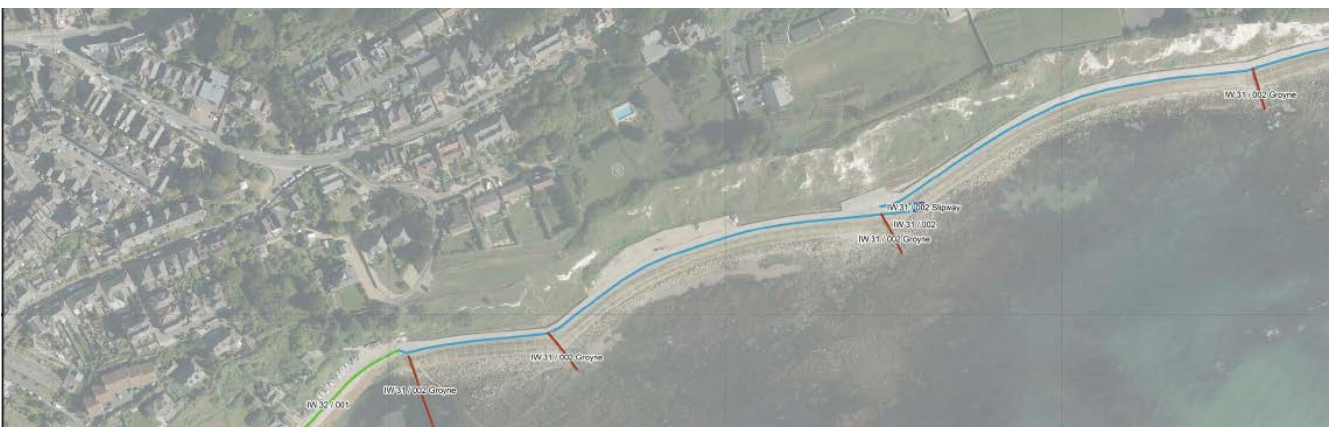
<i>Defence ID</i>	<b>IW 32 / 001</b>	<i>Description</i>	<b>Wheelers Bay – eastern section</b>		
<i>Construction</i>	Concrete return wall over concrete revetment with wide apron and sheet piled toe.				
<i>Element Length</i>	133 m	<i>Crest Details</i>		<i>Maintenance</i>	IoW Council
<i>Foreshore</i>		<i>Structure dependency on foreshore</i>		High	
<b>Susceptibility of Defence Elements to Failure Mode and Condition Assessment</b>		<b>Concrete revetment</b>			<b>Overall</b>
Structure instability from undermining		High			High
Foundation failure – global instability		High			High
Foundation failure – settlement		Low			Low
Wave forces on structure (unit instability)		Low			Low
Joint failure and material washout		Med			Med
Structure material failure – toe		High			High
Structure material failure – main defence		Med			Med
Wave overtopping – structural instability		Low			Low
Wave overtopping – flooding		Med			Med

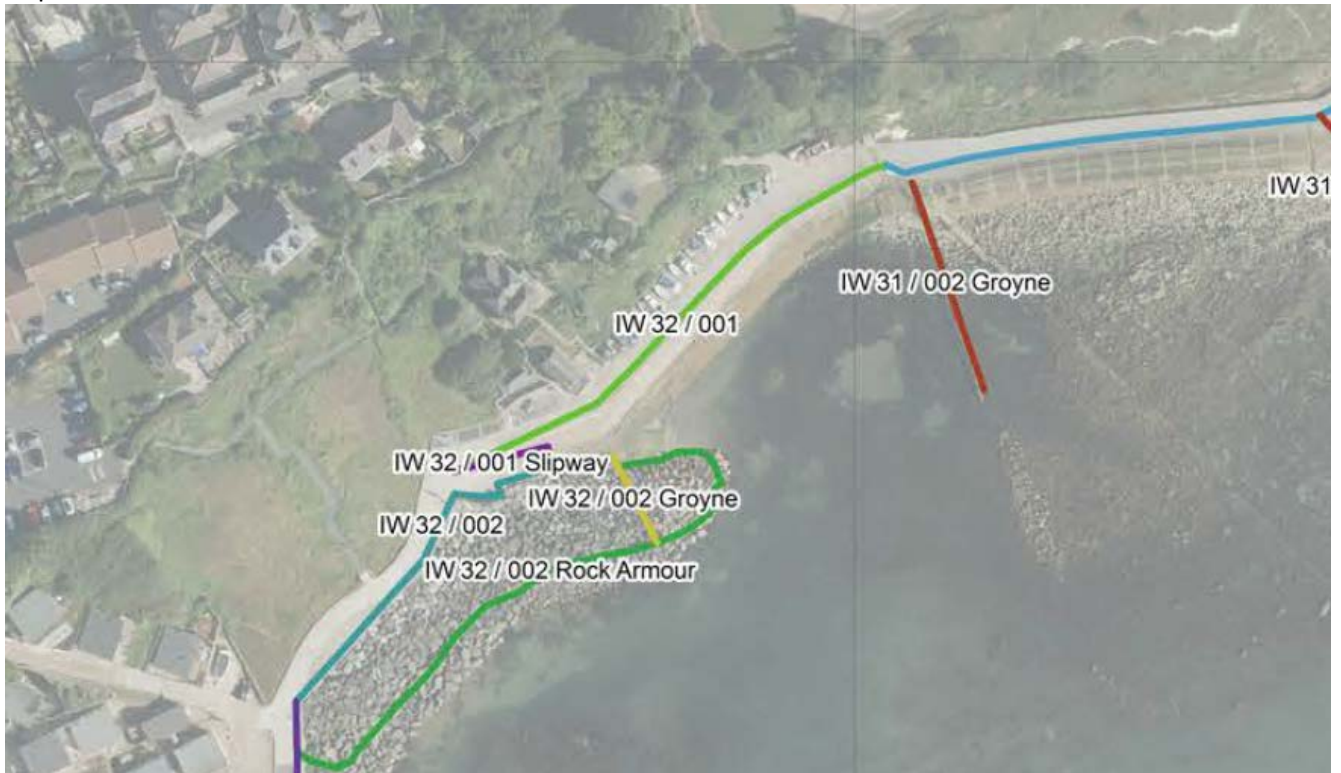
<i>Defence ID</i>	<b>IW 32 / 002</b>	<i>Description</i>	<b>Wheeler's bay – western section</b>		
<i>Construction</i>	Concrete seawall fronted by rock revetment with slipway				
<i>Element Length</i>	90 m	<i>Crest Details</i>	4.3mOD	<i>Maintenance</i>	IoW Council
<i>Foreshore</i>	Boulders	<i>Structure dependency on foreshore</i>			Low

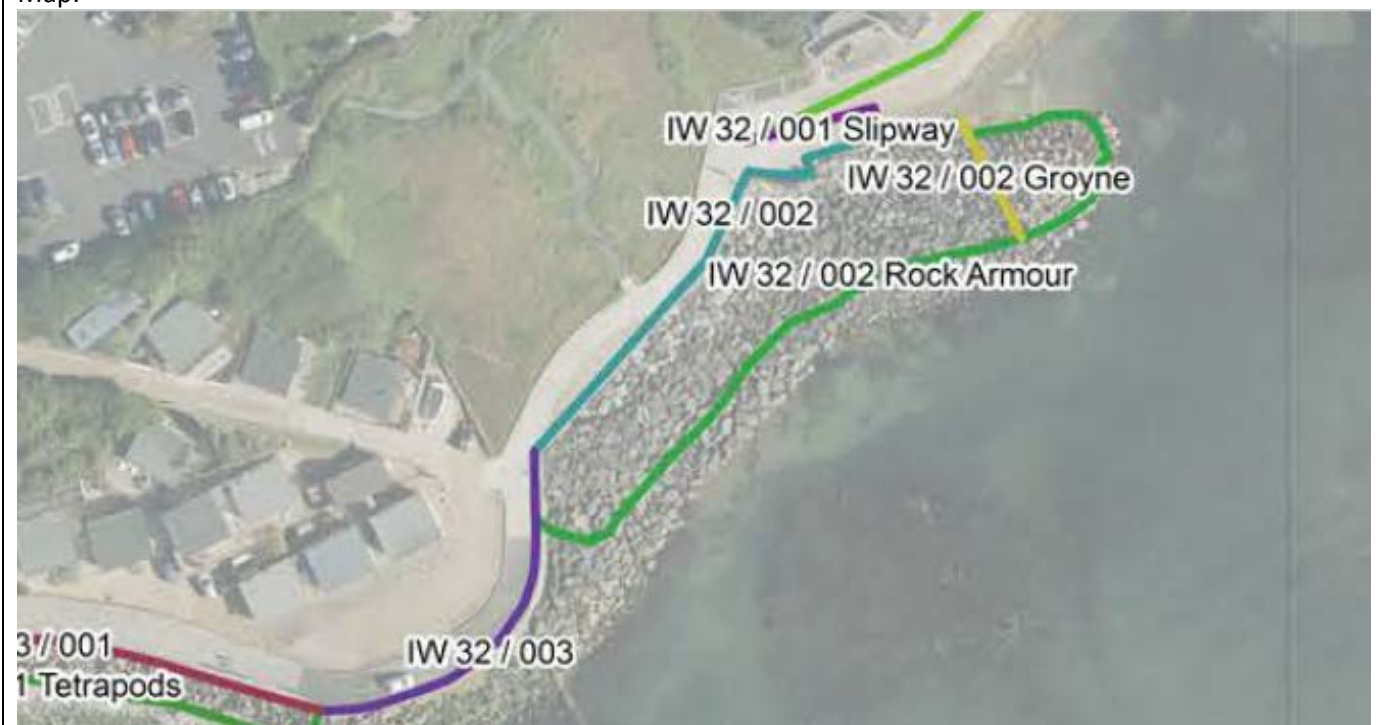
<i>Defence ID</i>	<b>IW 32 / 003</b>	<i>Description</i>	<b>Whealers Bay - point</b>		
<i>Construction</i>	Concrete seawall with rock armour at toe				
<i>Element Length</i>	60 m	<i>Crest Details</i>	4.1mOD	<i>Maintenance</i>	IoW Council
<i>Foreshore</i>	Boulders		<i>Structure dependency on foreshore</i>		Medium

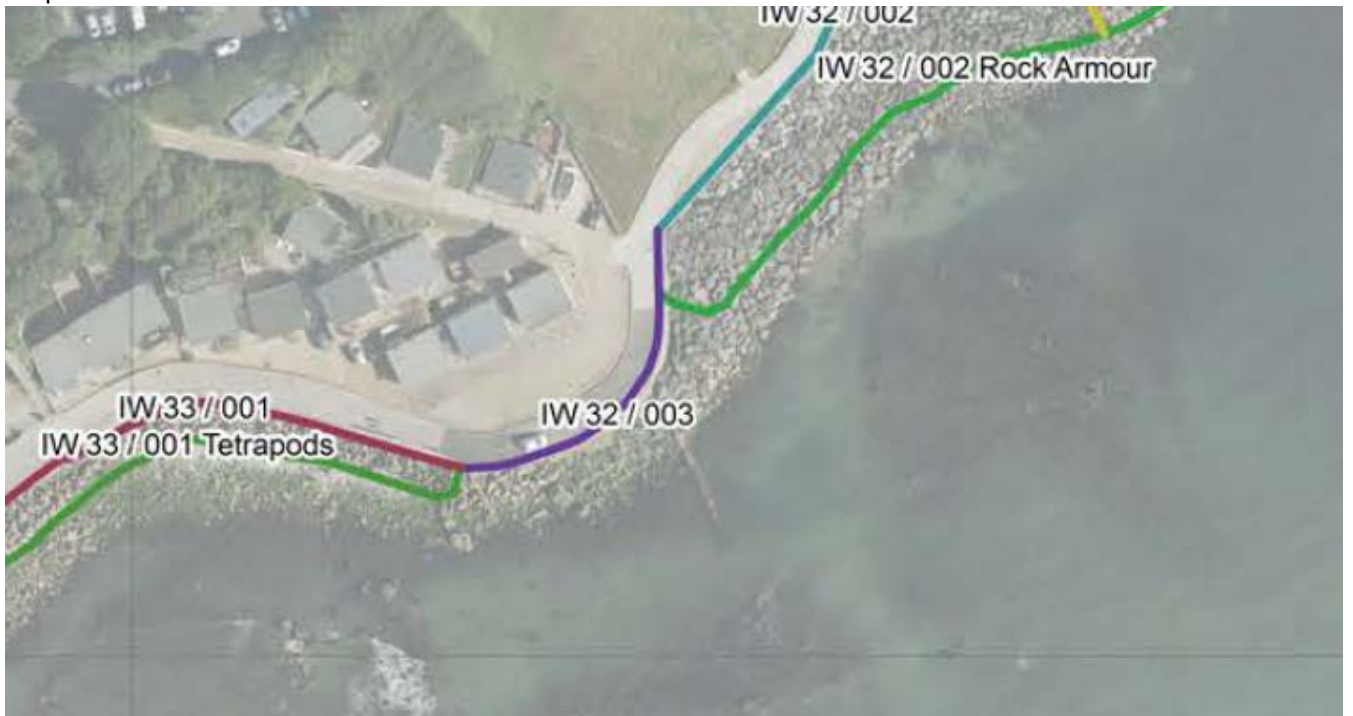
<i>Defence ID</i>	<b>IW 33 / 001</b>	<i>Description</i>	<b>Eastern Cliffs – eastern section</b>		
<i>Construction</i>	Concrete seawall, promenade and concrete Tetrapods at base of the wall				
<i>Element Length</i>	119 m	<i>Crest Details</i>	5.6mOD	<i>Maintenance</i>	IoW Council
<i>Foreshore</i>	Rock and boulders		<i>Structure dependency on foreshore</i>		Med
<b>Susceptibility of Defence Elements to Failure Mode and Condition Assessment</b>					
	<b>Concrete seawall</b>	<b>Tetrapods</b>			<b>Overall</b>
Structure instability from undermining	Low	Low			Low
Foundation failure – global instability	High	Med			High
Foundation failure – settlement	Med	Med			Med
Wave forces on structure (unit instability)	Low	Med			Med
Joint failure and material washout	Med	N/A			Med
Structure material failure – toe	Unknown	N/A			Unknown
Structure material failure – main defence	Low	Med			Med
Wave overtopping – structural instability	Low	N/A			Low

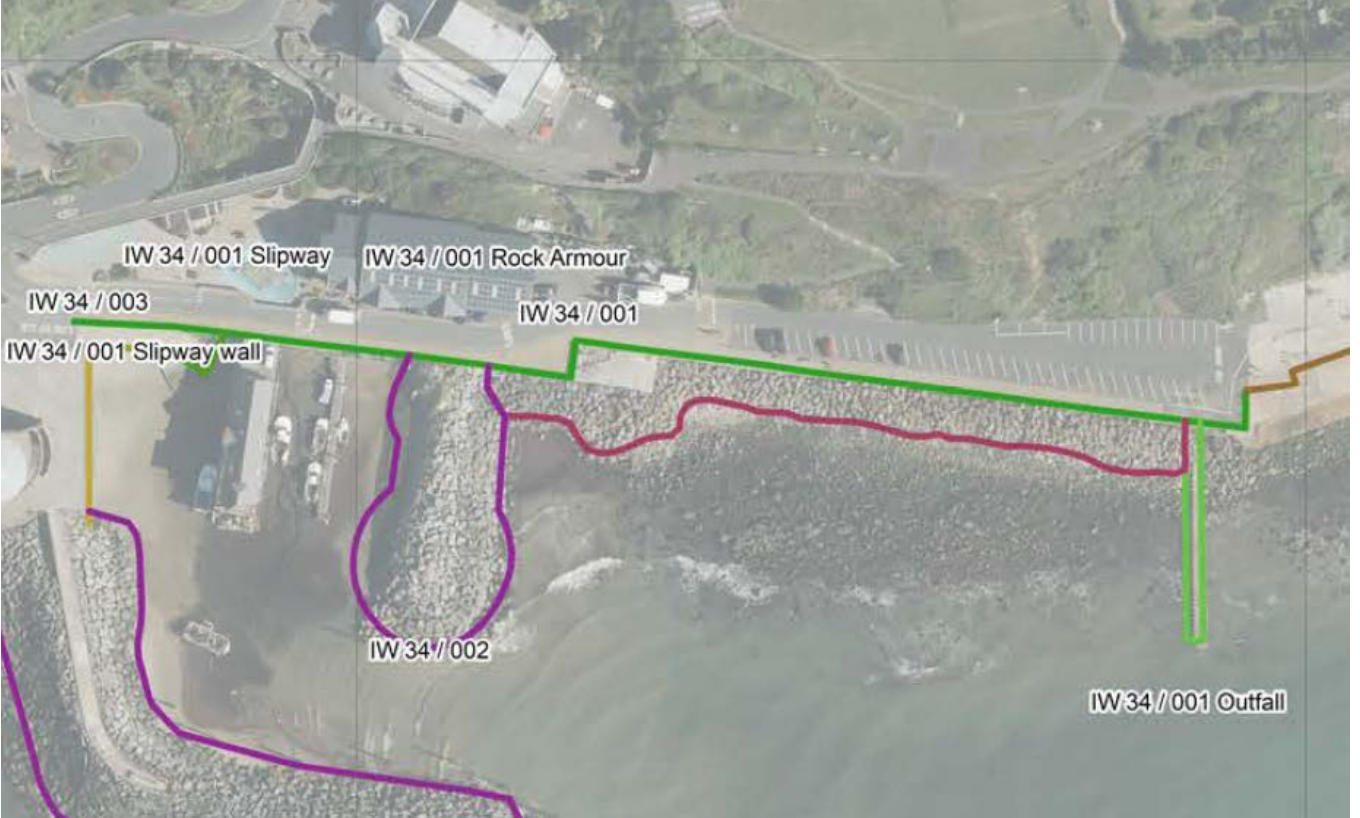
<i>Defence ID</i>	<b>IW 34 / 002</b>	<i>Description</i>	<b>Ventnor Haven - breakwaters</b>		
<i>Construction</i>	Rock breakwater arms to harbour.				
<i>Element Length</i>	504 m	<i>Crest Details</i>	5.5mOD	<i>Maintenance</i>	IoW Council
<i>Foreshore</i>	Unknown		<i>Structure dependency on foreshore</i>		Low

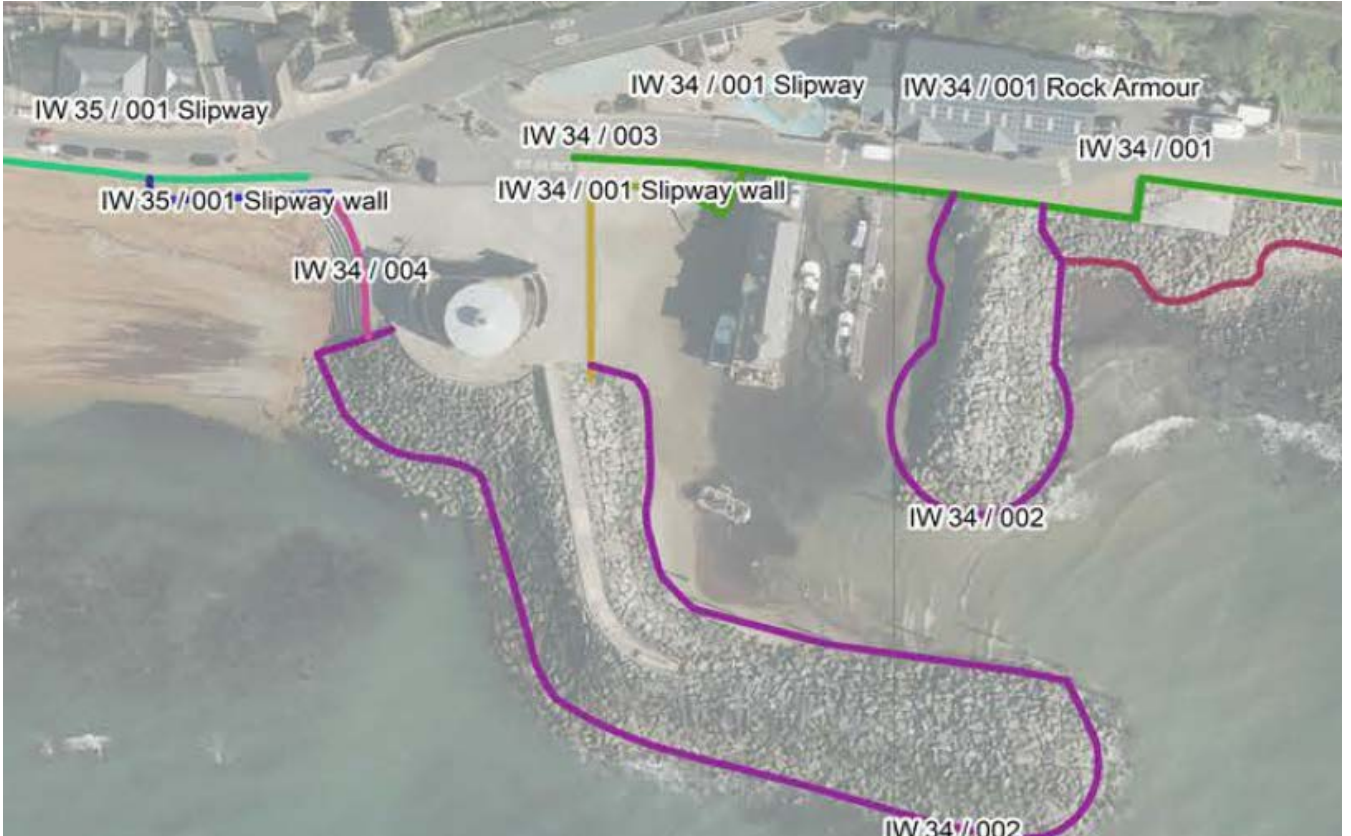
<i>Defence ID</i>	<b>IW 34 / 003</b>	<i>Description</i>	<b>Ventnor Haven – pumping station</b>		
<i>Construction</i>	Masonry wall fronting pumping station				
<i>Element Length</i>	38 m	<i>Crest Details</i>		<i>Maintenance</i>	Southern Water
<i>Foreshore</i>	Shingle/Sand		<i>Structure dependency on foreshore</i>		Low

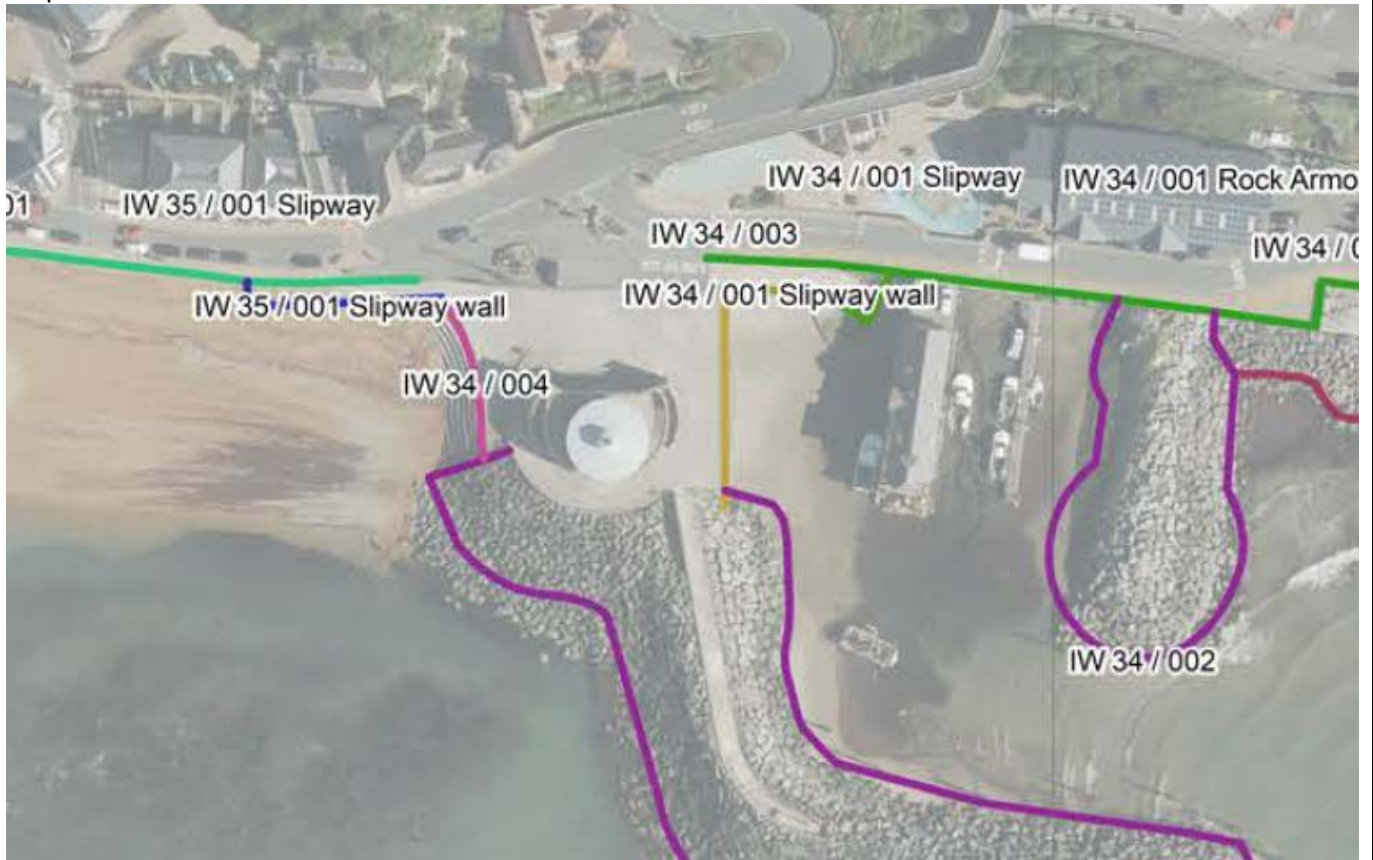
<i>Defence ID</i>	<b>IW 34 / 004</b>	<i>Description</i>	<b>Ventnor Haven – stepped revetment</b>		
<i>Construction</i>	Concrete stepped revetment				
<i>Element Length</i>	29 m	<i>Crest Details</i>	6.0mOD	<i>Maintenance</i>	Southern Water
<i>Foreshore</i>	Sand/shingle		<i>Structure dependency on foreshore</i>		Med

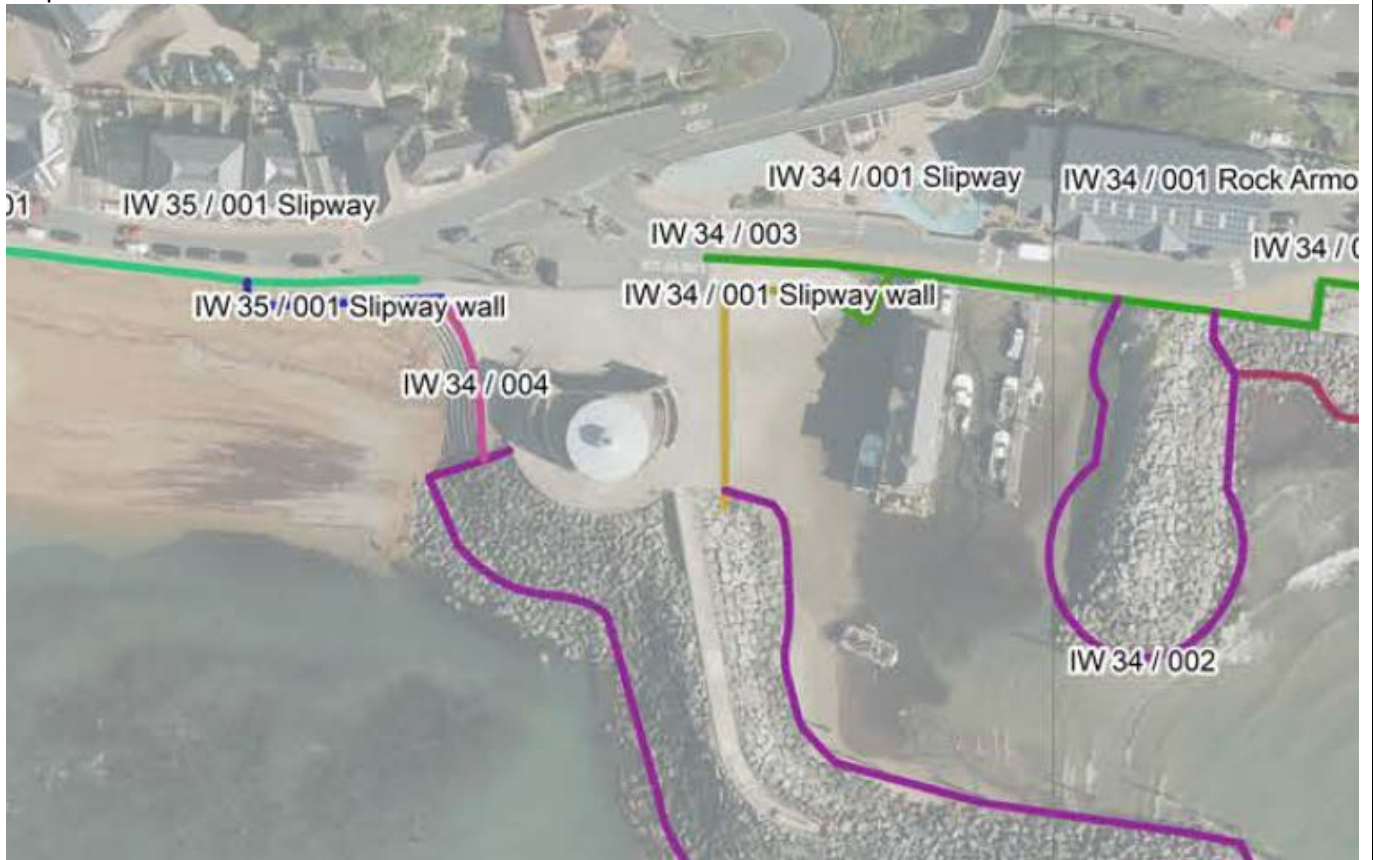
<i>Defence ID</i>	<b>IW 35 / 001</b>	<i>Description</i>	<b>Ventnor Bay</b>			
<i>Construction</i>	Concrete seawall with stone facing and slipway					
<i>Element Length</i>	302 m	<i>Crest Details</i>	4.5mOD	<i>Maintenance</i>	IoW Council	
<i>Foreshore</i>	Sandy beach with splays of brown flint and chert shingle	<i>Structure dependency on foreshore</i>			Med	
<b>Susceptibility of Defence Elements to Failure Mode and Condition Assessment</b>		<b>Concrete seawall</b>			<b>Overall</b>	
Structure instability from undermining		Med			Med	
Foundation failure – global instability		Med			Med	
Foundation failure – settlement		Low			Low	
Wave forces on structure (unit instability)		Low			Low	
Joint failure and material washout		Low			Low	
Structure material failure – toe		Low			Low	
Structure material failure – main defence		Low			Low	
Wave overtopping – structural instability		Low			Low	
Wave overtopping – flooding		Med			Med

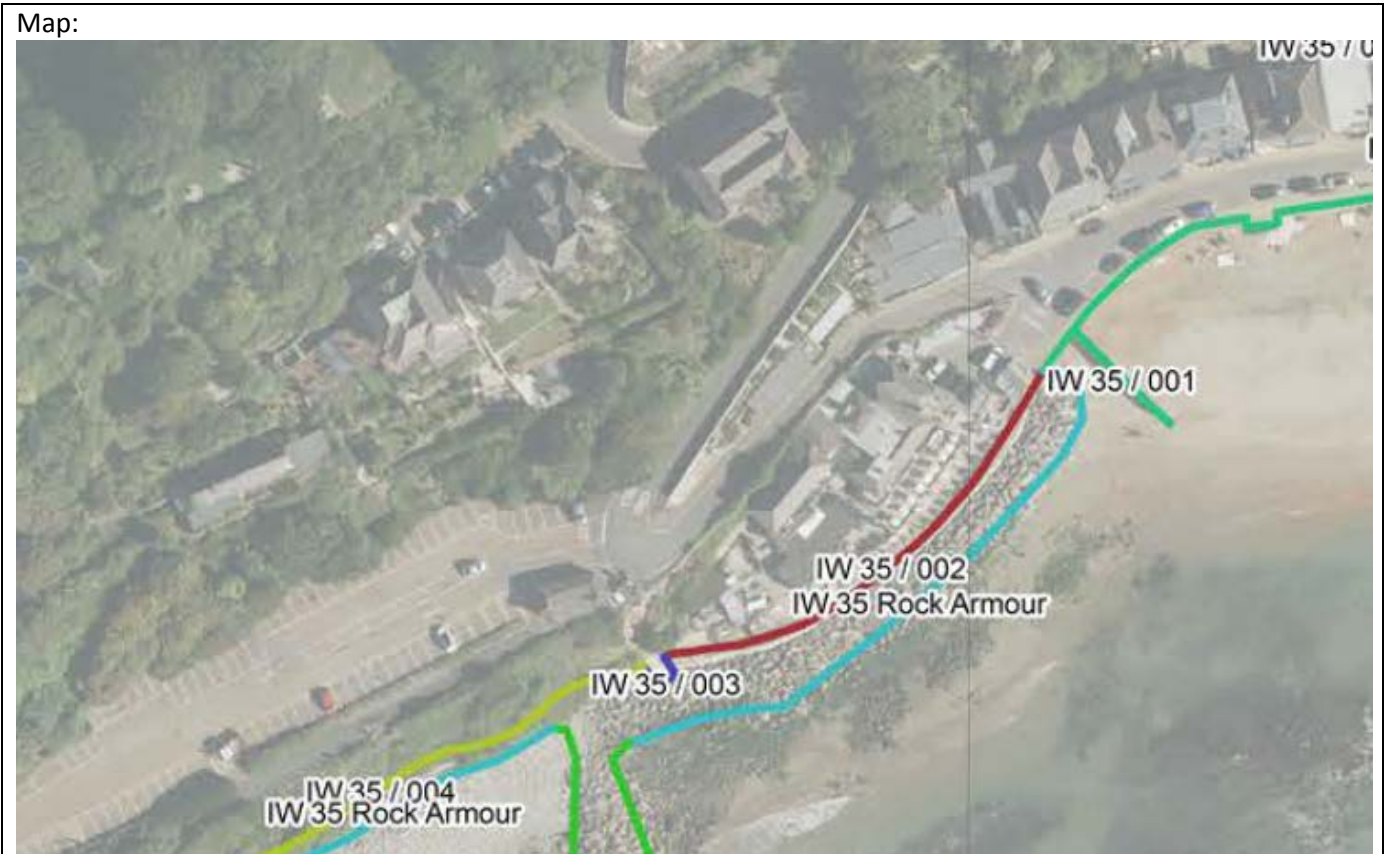
<i>Defence ID</i>	<b>IW 35 / 003</b>	<i>Description</i>	<b>Western Cliffs – eastern section</b>		
<i>Construction</i>	Stone masonry wall, concrete toe encasement and low rock revetment				
<i>Element Length</i>	12 m	<i>Crest Details</i>	Unknown	<i>Maintenance</i>	IoW Council
<i>Foreshore</i>	Boulders		<i>Structure dependency on foreshore</i>		Medium

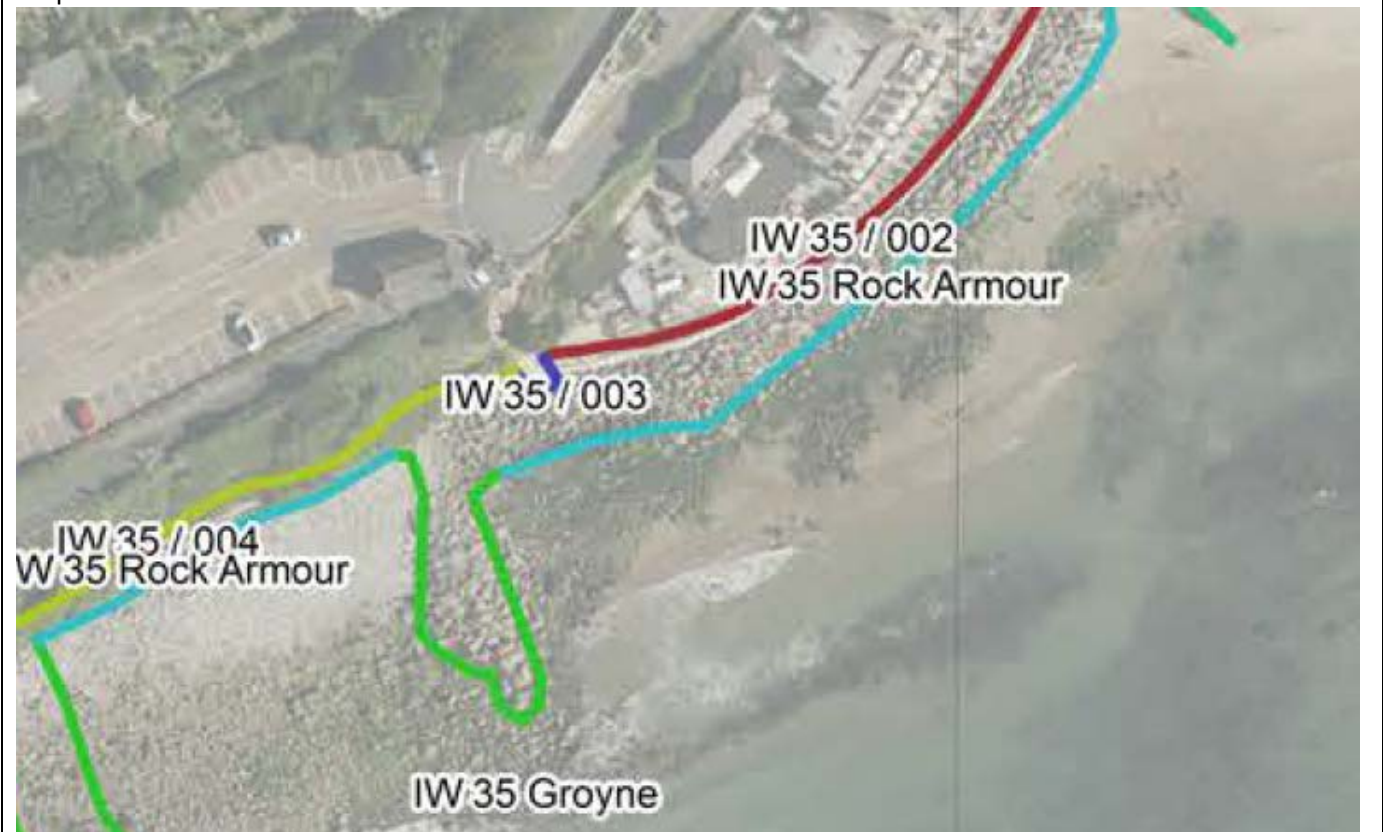
<i>Defence ID</i>	<b>IW 35 / 004</b>	<i>Description</i>	<b>Western cliffs – below car park</b>		
<i>Construction</i>	Concrete block wall with wave return and low rock revetment				
<i>Element Length</i>	104 m	<i>Crest Details</i>	2.3mOD	<i>Maintenance</i>	IoW Council
<i>Foreshore</i>	Boulders		<i>Structure dependency on foreshore</i>		Medium

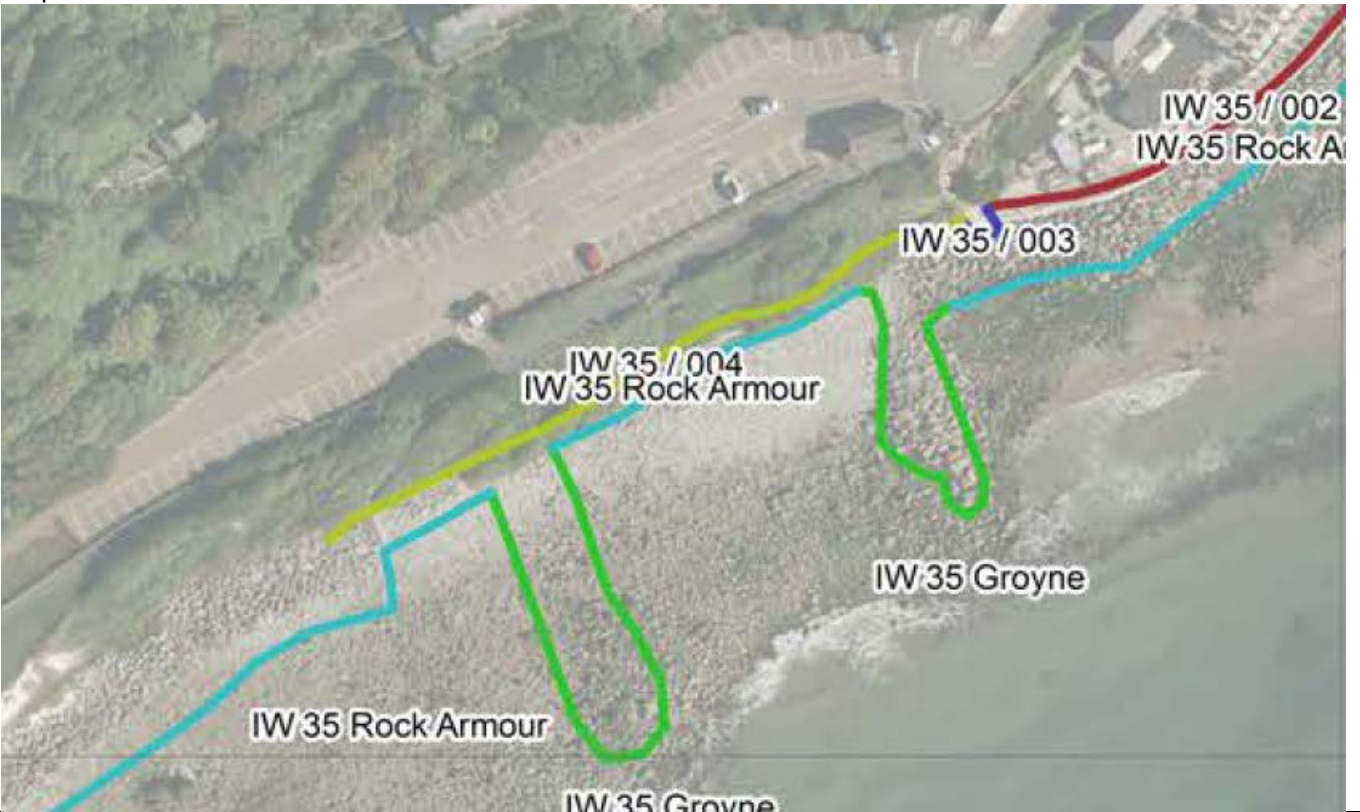
<i>Defence ID</i>	<b>IW 35 / 005</b>	<i>Description</i>	<b>Western Cliffs – central &amp; western section</b>		
<i>Construction</i>	Rock groynes and low rock revetment at cliff base				
<i>Element Length</i>	615 m	<i>Crest Details</i>	4.5mOD	<i>Maintenance</i>	IoW Council
<i>Foreshore</i>	Boulders		<i>Structure dependency on foreshore</i>		Low

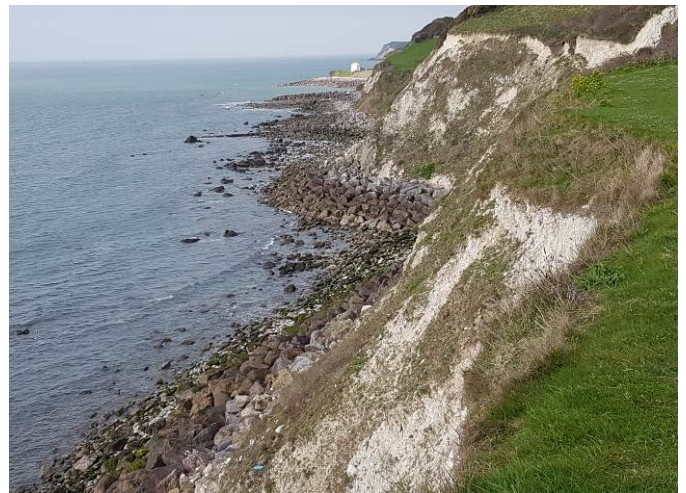
<i>Defence ID</i>	<b>IW 36 / 001</b>	<i>Description</i>	<b>Castle Cove</b>		
<i>Construction</i>	Rock revetment flanked by rock groynes fronting concrete road with setback gabion splash wall.				
<i>Element Length</i>	231 m	<i>Crest Details</i>	4.0mOD	<i>Maintenance</i>	IoW Council
<i>Foreshore</i>	Cobbles		<i>Structure dependency on foreshore</i>		Low

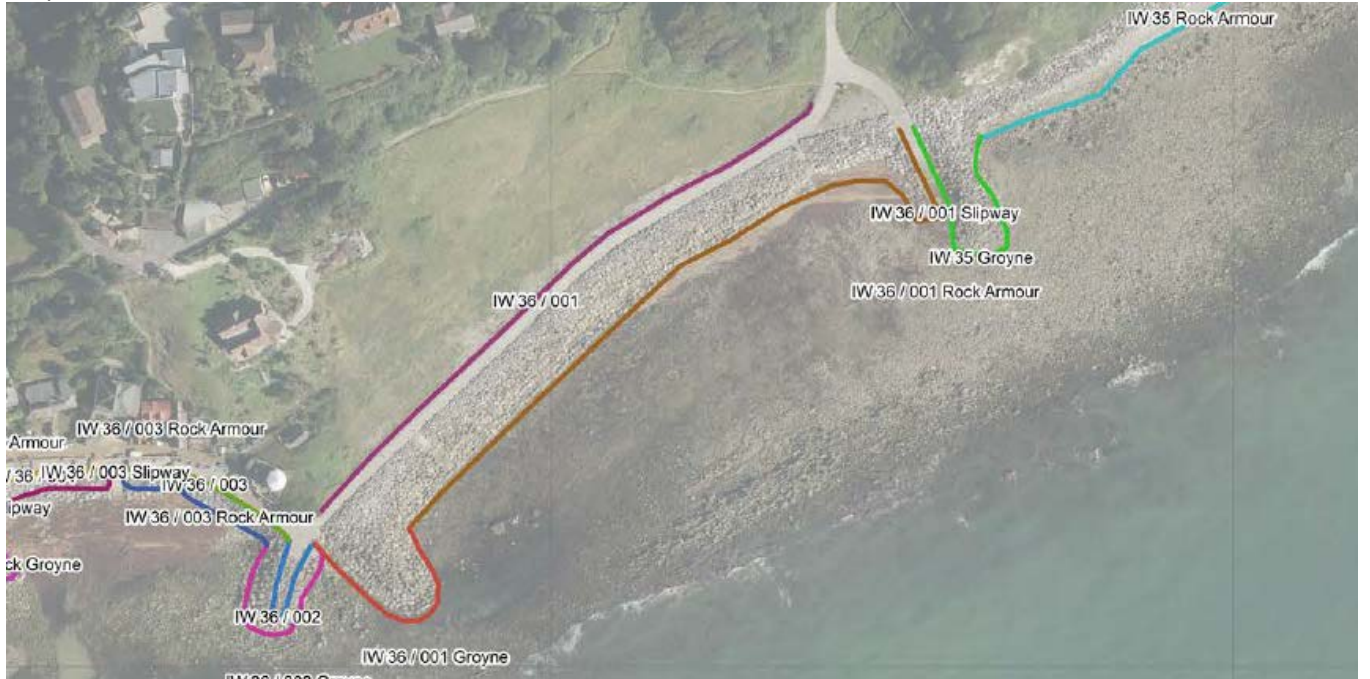
<i>Defence ID</i>	<b>IW 36 / 002</b>	<i>Description</i>	<b>Steephill Cove - terminal groyne</b>		
<i>Construction</i>	Rock groyne				
<i>Element Length</i>	7 m	<i>Crest Details</i>	2.95mOD	<i>Maintenance</i>	IoW Council
<i>Foreshore</i>	Boulders		<i>Structure dependency on foreshore</i>		Low

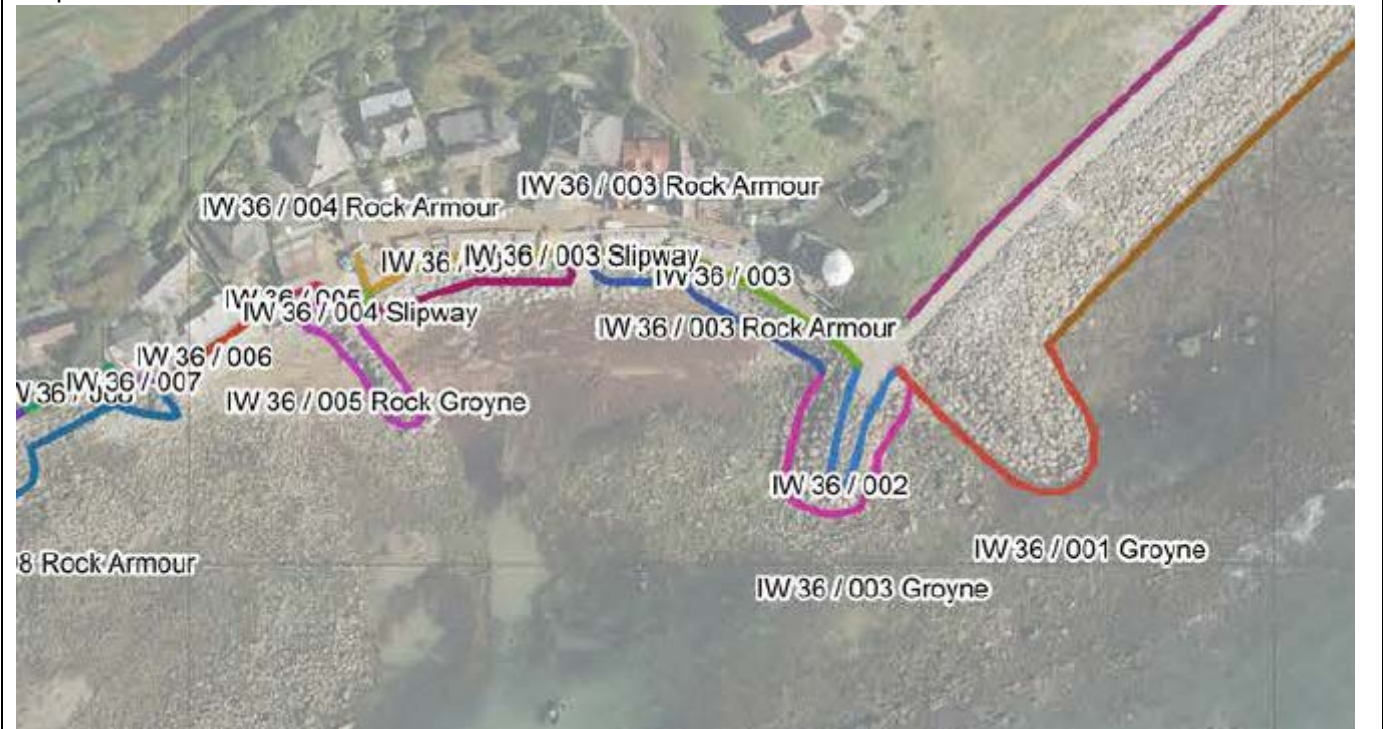
<i>Defence ID</i>	<b>IW 36 / 003</b>	<i>Description</i>	<b>Steephill Cove – eastern section</b>		
<i>Construction</i>	Sheet piles wall encased with concrete, fronted with Purbeck stone with set back splash wall.				
<i>Element Length</i>	60 m	<i>Crest Details</i>	4.0mOD	<i>Maintenance</i>	IoW Council
<i>Foreshore</i>	Sand/shingle with boulders	<i>Structure dependency on foreshore</i>			Med

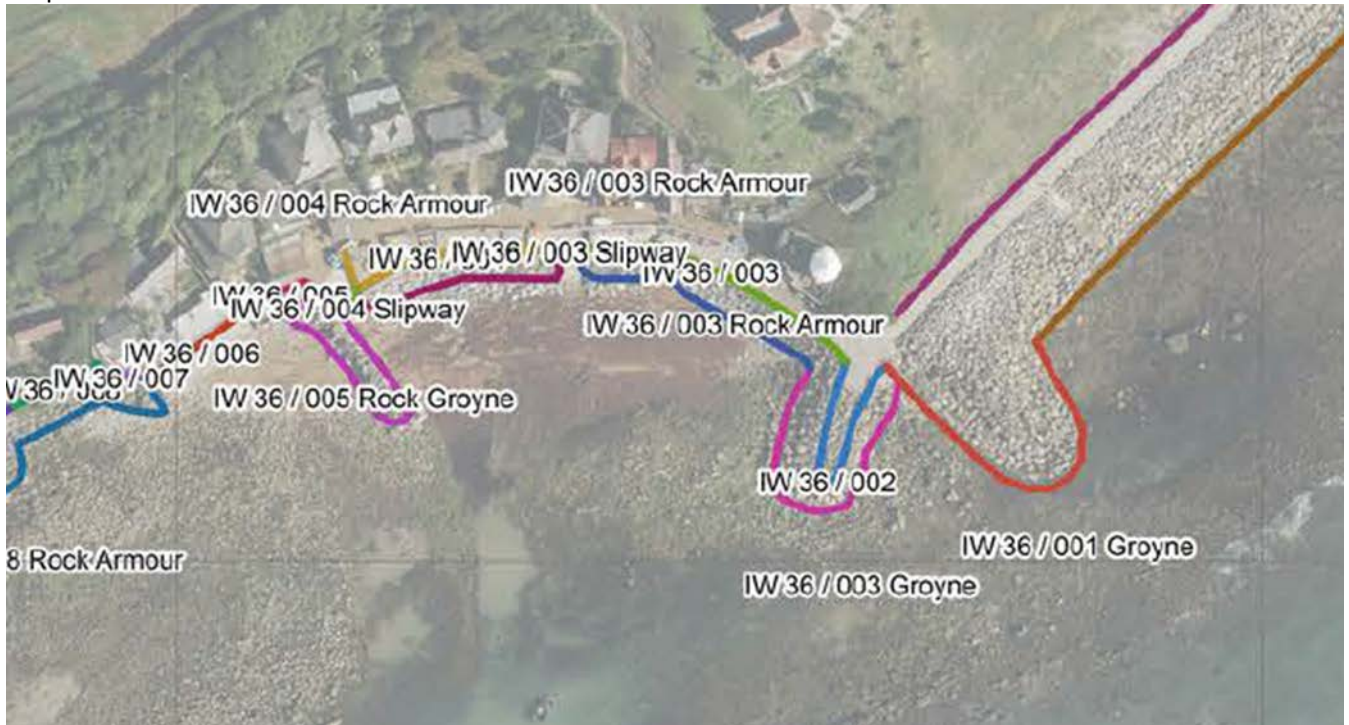
<i>Defence ID</i>	<b>IW 36 / 004</b>	<i>Description</i>	<b>Steephill Cove – central section</b>		
<i>Construction</i>	Encased concrete apron, concrete/stone walls, concrete slipway and rock armour revetment				
<i>Element Length</i>	51 m	<i>Crest Details</i>	4.25mOD	<i>Maintenance</i>	IoW Council
<i>Foreshore</i>	Sand/shingle		<i>Structure dependency on foreshore</i>		Med

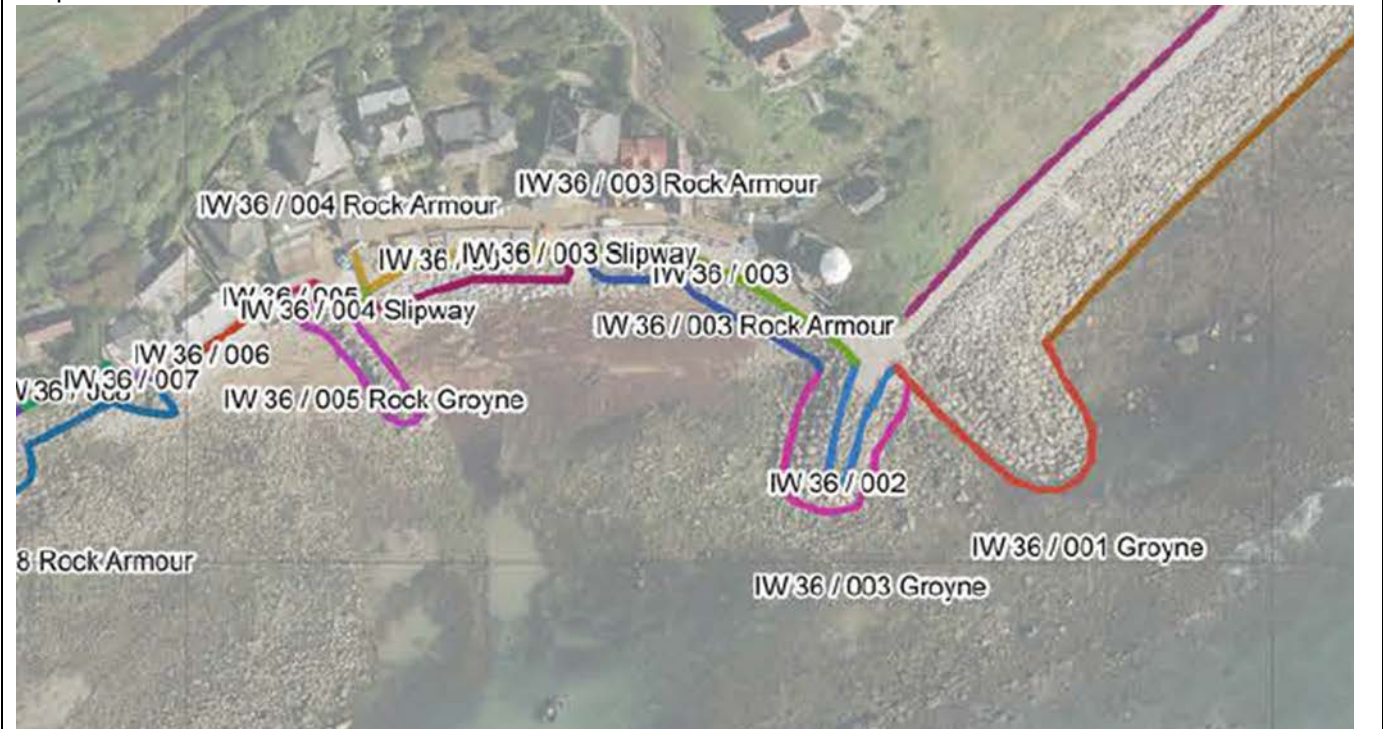
<i>Defence ID</i>	<b>IW 36 / 005</b>	<i>Description</i>	<b>Steephill Cove – rock groyne</b>		
<i>Construction</i>	Rock groyne				
<i>Element Length</i>	23 m	<i>Crest Details</i>	Unknown	<i>Maintenance</i>	IoW Council
<i>Foreshore</i>	Sand/shingle and boulders		<i>Structure dependency on foreshore</i>		Low
