# Ventnor Options Appraisal

Technical Report

Revision 5

Isle of Wight Council

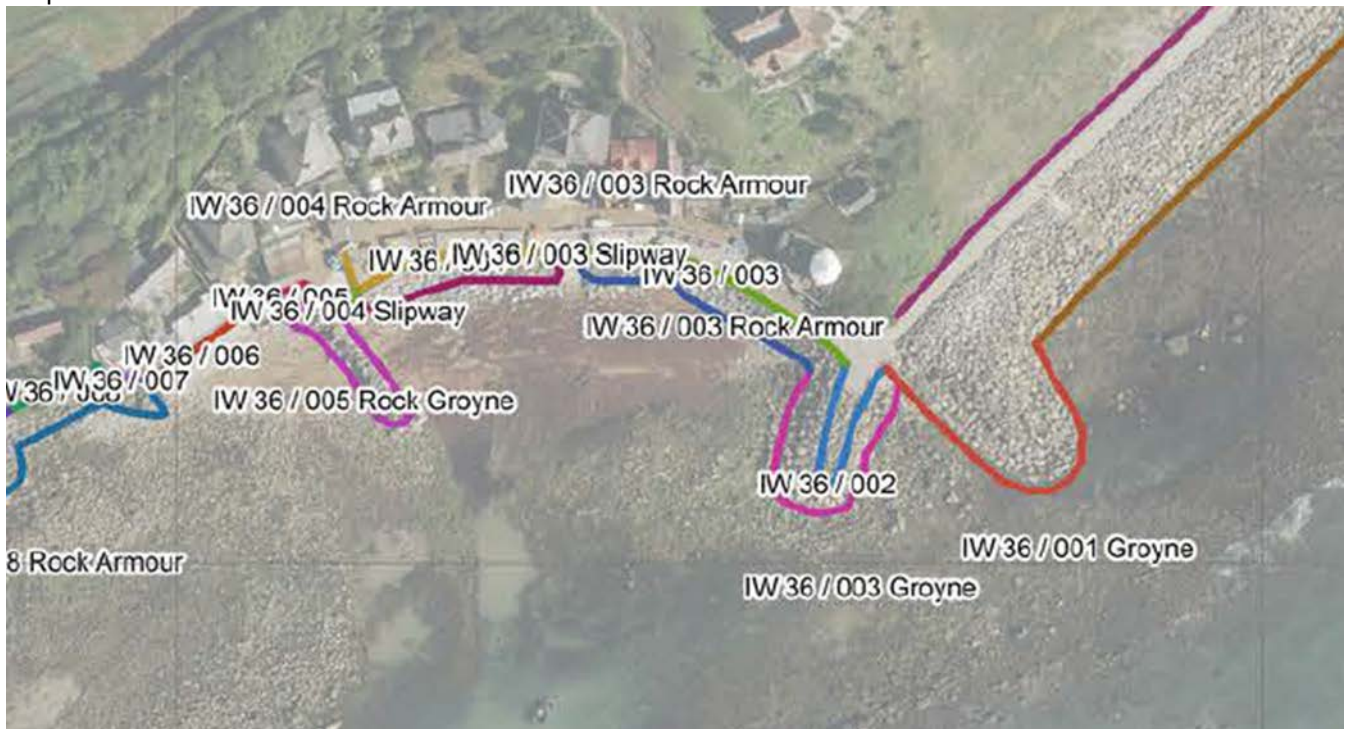
<i>Defence ID</i>	<b>IW 36 / 006</b>	<i>Description</i>	<b>Steephill Cove – western section</b>		
<i>Construction</i>	Concrete stepped wall fronting masonry wall				
<i>Element Length</i>	21 m	<i>Crest Details</i>	Unknown	<i>Maintenance</i>	IoW Council
<i>Foreshore</i>	Sans/shingle and cobbles		<i>Structure dependency on foreshore</i>		Med

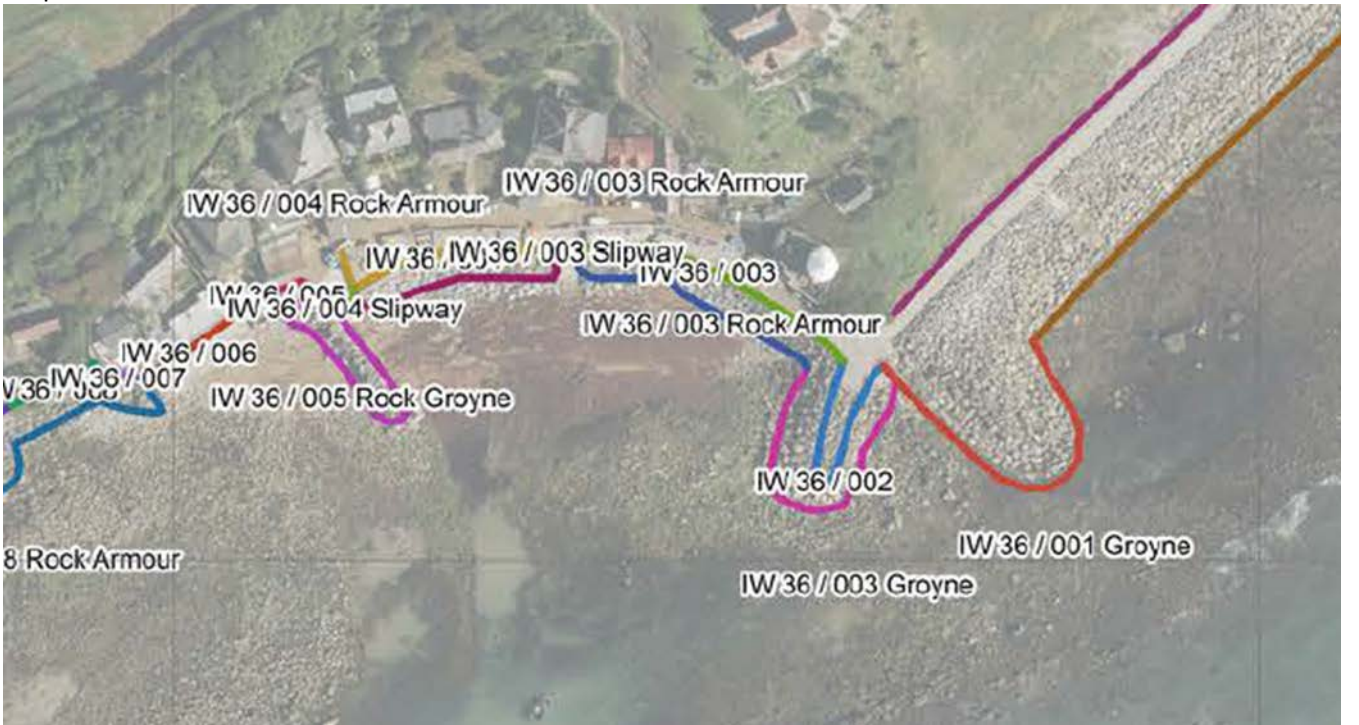
<i>Defence ID</i>	<b>IW 36 / 007</b>	<i>Description</i>	<b>Steephill Cove – western property wall</b>		
<i>Construction</i>	Concrete wall with wave return and toe rock				
<i>Element Length</i>	10 m	<i>Crest Details</i>	Unknown	<i>Maintenance</i>	IoW Council
<i>Foreshore</i>	Boulder		<i>Structure dependency on foreshore</i>		Med

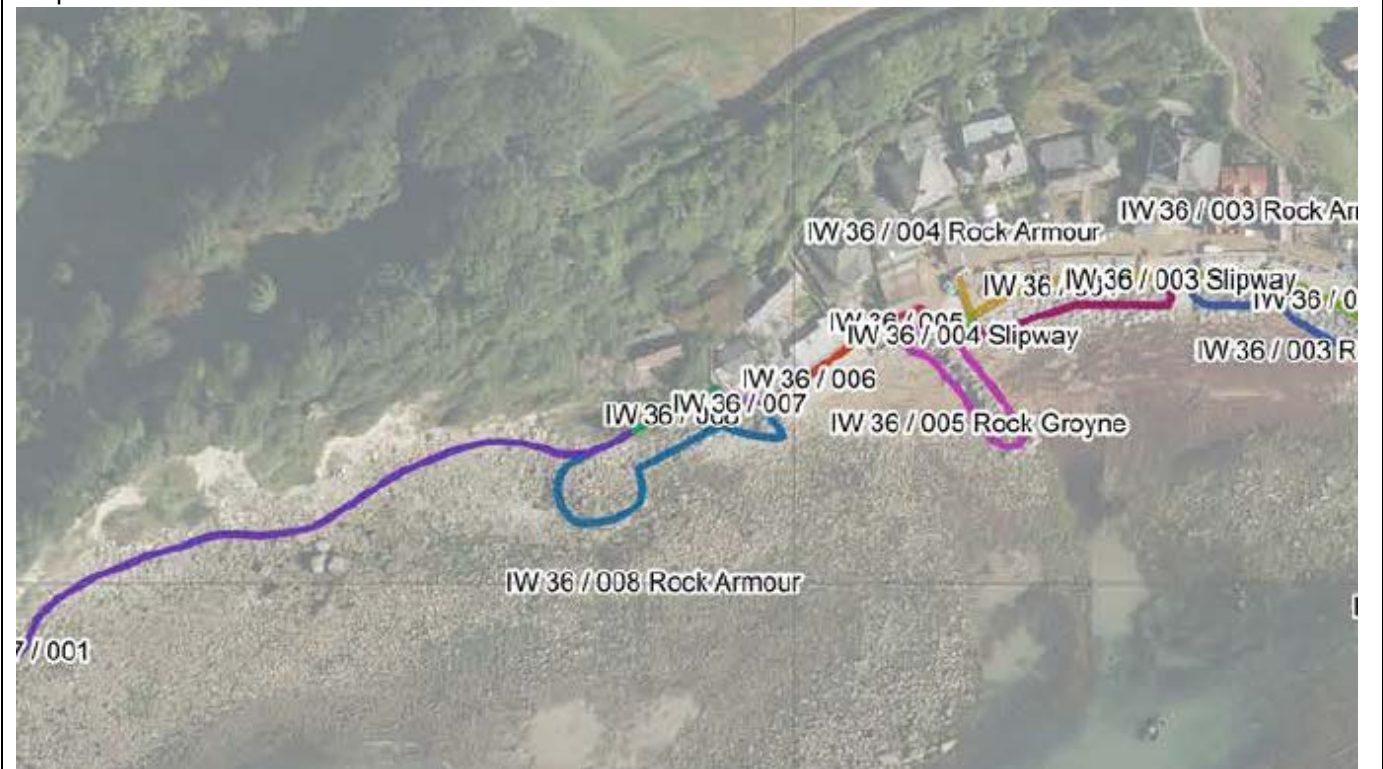
<i>Defence ID</i>	<b>IW 36 / 008</b>	<i>Description</i>	<b>Steephill Cove – western cliffs</b>		
<i>Construction</i>	Concrete wall with rock revetment in front and rock groyne				
<i>Element Length</i>	81 m	<i>Crest Details</i>	4.1mOD	<i>Maintenance</i>	IoW Council
<i>Foreshore</i>	Boulders	<i>Structure dependency on foreshore</i>			Low
