GEOTECHNICAL STUDY AREA G8

BLACKGANG LANDSLIDE, VENTNOR UNDERCLIFF, ISLE OF WIGHT, UK

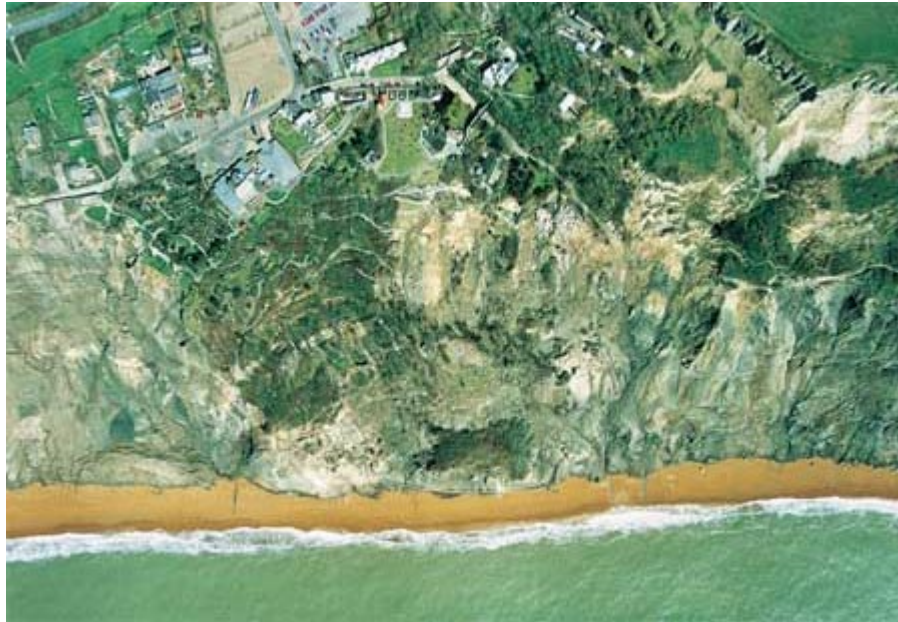
Plate G8 Aerial view of Blackgang landslide, Isle of Wight

In January 1994 the impact of coastal erosion and exceptionally high antecedent rainfall resulted in extensive renewed landslide activity on 170m high cliffs in the Blackgang area of the Isle of Wight (see Plate G8 and Figure G8.1). The ground movements undermined several houses at the top of the cliff, two of which were destroyed along with the loss of secondary access roads and property. The impact of the event raised both national and international media attention. The initial emergency response to ensure public safety and security of the area was co-ordinated by the Council.

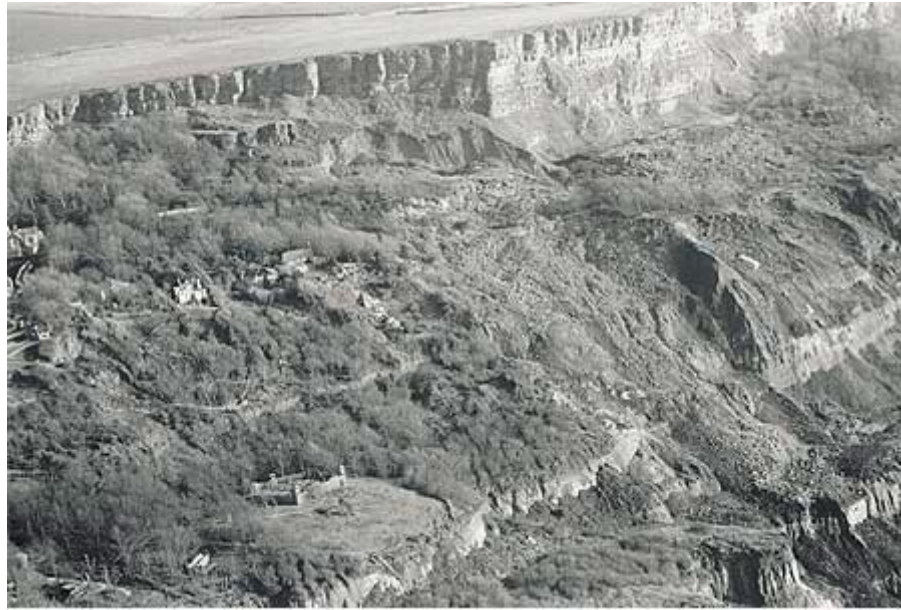
Plate G8a Photo showing the 1994 landslide at Blankgang (County Press)

The area affected by landslide activity in January 1994 was far more extensive than first reported by the media (Plate G8e and G8f). Four landslide systems were all affected by first time or renewed instability. The most notable movements occurred in the Cliff Cottage landslide where a large 150m x 40m wide section of ancient rotational landslides, forming the upper tier of the Undercliff, appeared to have suddenly dropped 15m down the rear scarp. This sudden movement caused the dramatic tilt and damage to Blackgang and Gore Cliff Cottages (Plate G8g) reported on 12 January when the alarm was first raised. A further effect of the deep-seated rotational movement was to shunt thousands of tonnes of landslide debris over a steep scarp slope, along with the Old Blackgang Road and cars and caravans, where charged with high groundwater levels, mudslides rapidly transported the debris to lower benches on the cliff and eventually to the beach.

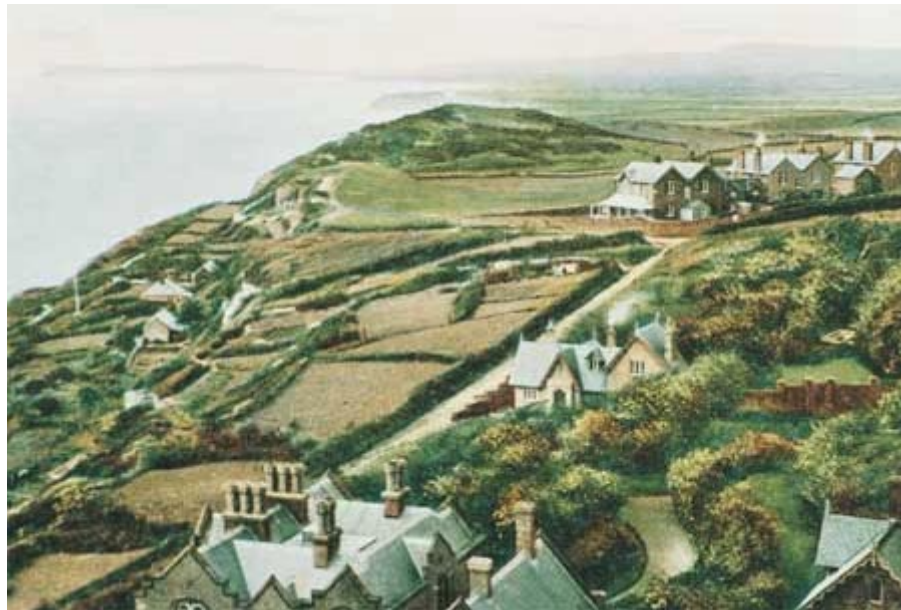
Plate G8b Old colour postcard showing the view looking west across Blackgang in 1890. All the land in the foreground has been lost through coastal erosion and landsliding

Coastal erosion and instability has been taking place at Blackgang for thousands of years, particularly since the last ice age when sea-levels rose dramatically. The Blackgang area was developed in the mid to late nineteenth century with the construction of a series of villas and cottages (Plate G8b); the theme park was opened in 1843. Human influences, including site works and inadequate drainage has assisted nature in speeding up the landslide process in this area. Access to the beach from Blackgang Chine was lost earlier this century due to the rapid recession of the cliff face. In more recent years, cliff-top recession of up to 5m a year (Rendel Geotechnics 1994) has not only led to the dramatic loss of land due to the retreat of the cliffs, but in January 1994, the failure and slumping of land immediately above the cliff-top extended 40m inland, undermining buildings and the Old Blackgang Road.

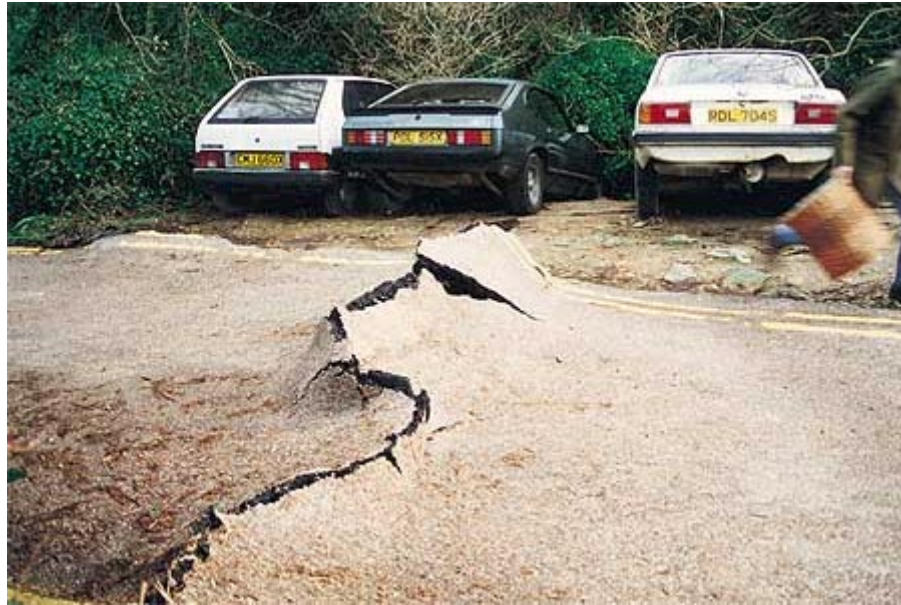
Plate G8e Road damage at Blackgang

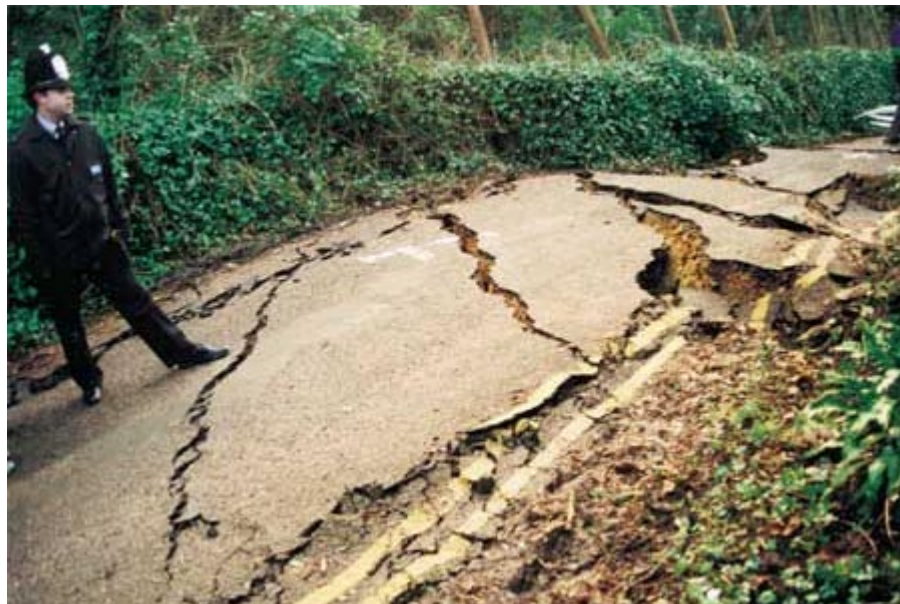
Plate G8e Road damage at Blackgang

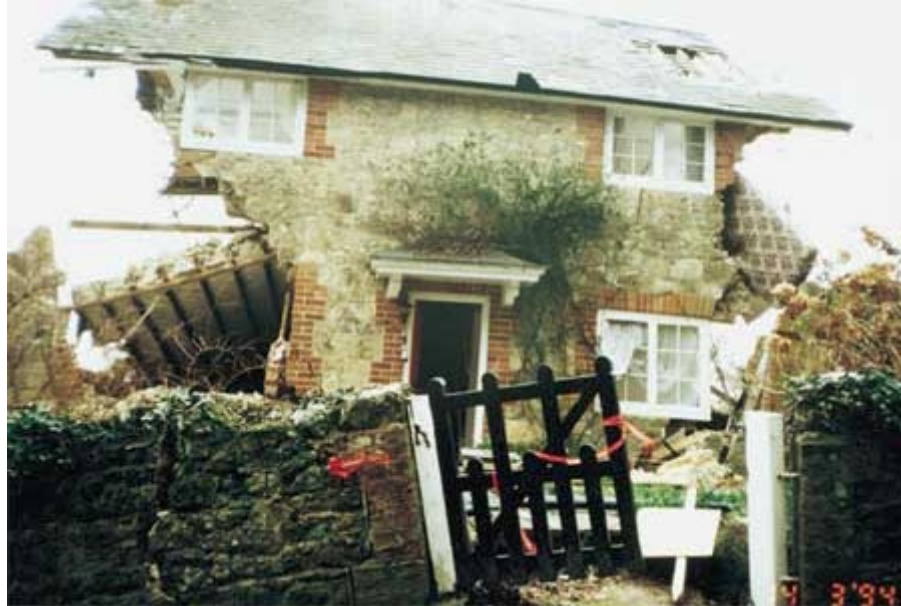
Plate G8g Gore Cliff Cottage, Blackgang
