Monktonmead Section 19 Flood Investigation

Final Report

April 2022

Isle of Wight Council

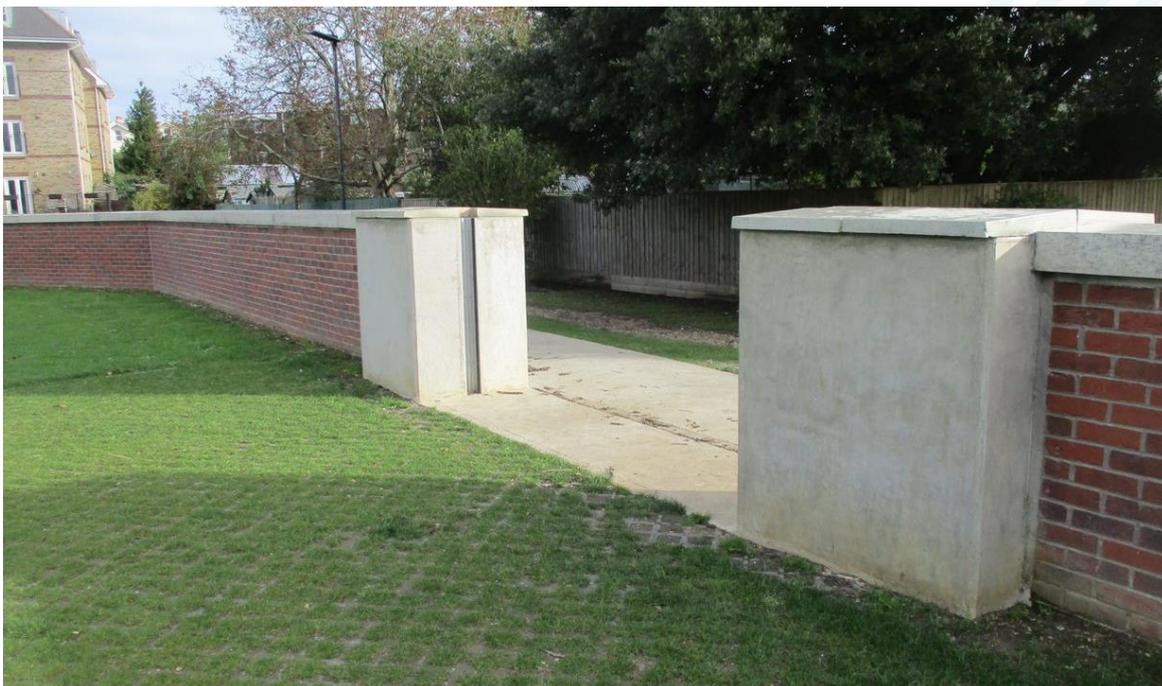
Figure 5-2: Flood walls at Simeon Street Recreation Ground

The Environment Agency has noted that duty officers followed existing procedures during these events and deployed the demountable defences (drop boards) at Simeon Street Recreation Ground during these events. It was also noted that river levels in the Monktonmead Brook did not rise above 2.7m AOD above which internal property flooding has been known to occur.

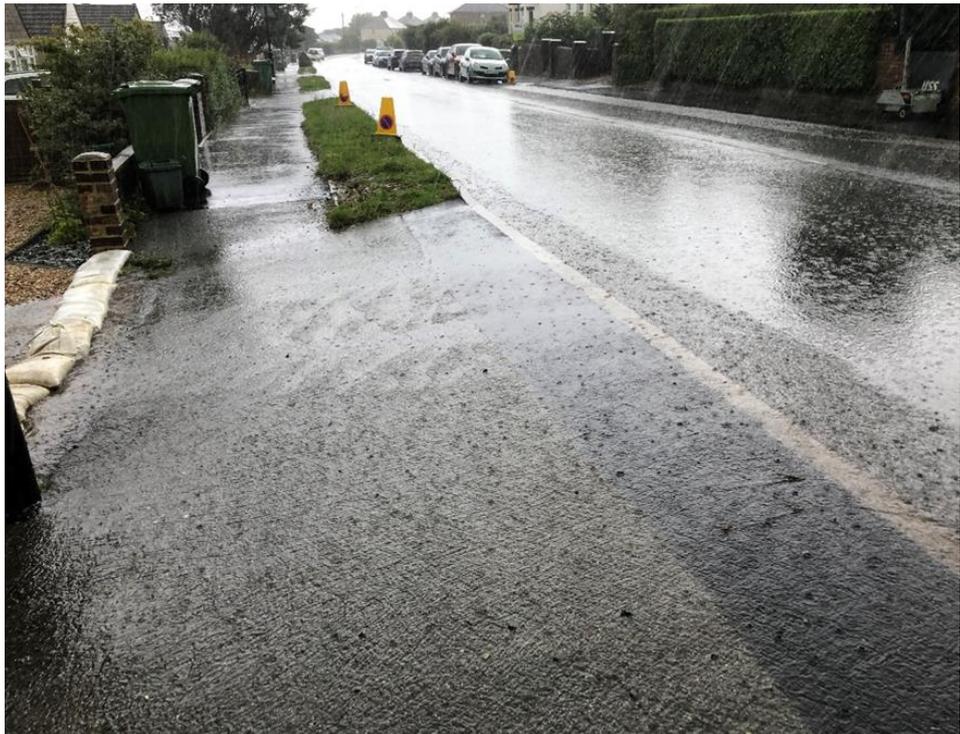
Figure 8-6: Photograph showing highway flooding on Great Preston Road

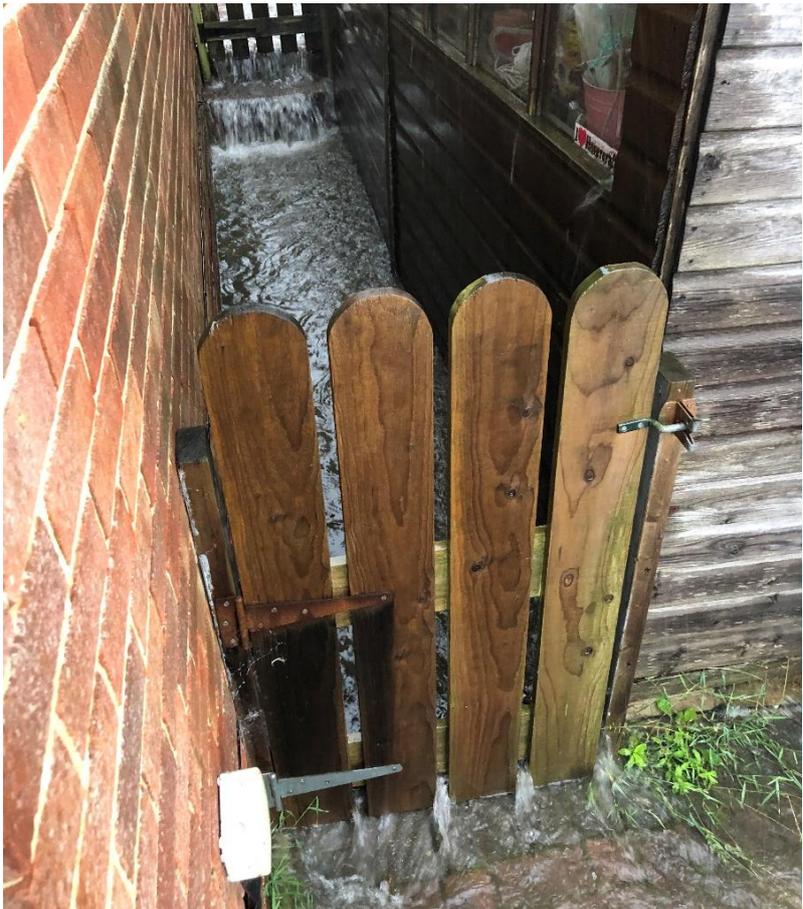
Figure 8-7: Photograph of water flowing along the side of a property on Great Preston Road
