Carisbrooke/Newport

Flood Investigation Report

Document Information	
Document Reference	2013-IWC-LLFA-001-14 / 005-14
Document Revision	
Report Status	FINAL
Date	24 June 2014
Author	W Perera
Checked	
Approved	B Murphy

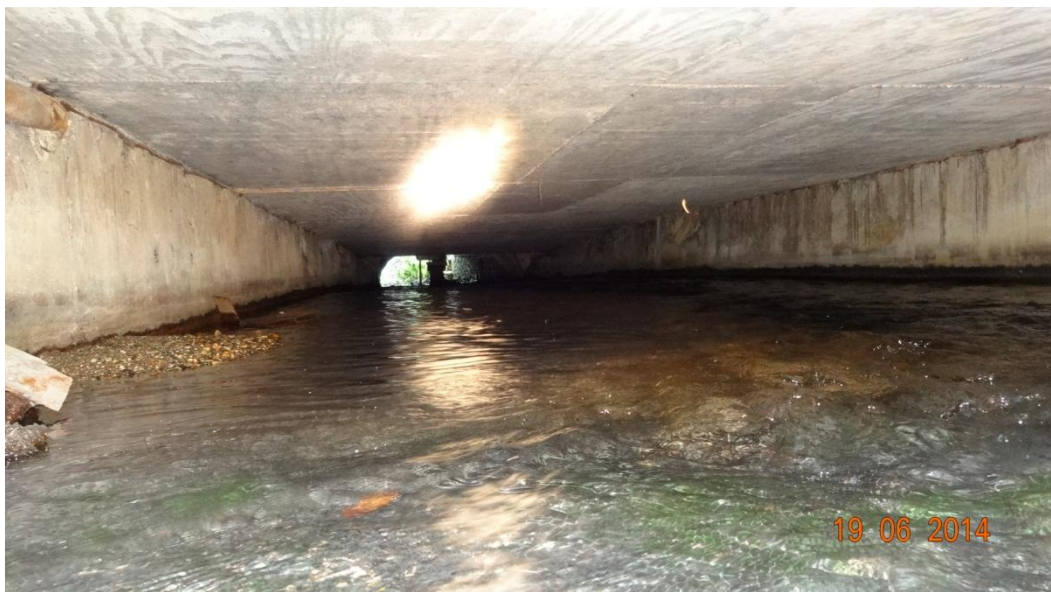
Figure 4: Cedar Hill Culvert

The Isle of Wight Council has requested Island Roads check and CCTV the culvert that runs under the bottom of Cedar Hill. The culvert was inspected by the Island Roads structures team on Thursday 19th June. As you can see from the figure below the shallow and wide culvert is largely clear. There is

a small amount of rubble present on the left side. The far end is difficult to access as it is in private ownership but Island Roads believe that vertical objects present may relate to scaffolding just beyond the structure. This is beyond the IR area of responsibility and would be the riparian owner's responsibility.

The older brick culvert at the far end (the concrete slab roof section is a later improvement) is slightly narrower and could possibly contribute to a funnelling of the flow in extreme conditions which Island Roads believe may be further exacerbated by narrowing of the water course further downstream. In its current state Island Roads are satisfied that no immediate action is required.

6. Liaison between the PFI contract management team and Island Roads to agree an autumn culvert clearing and cleaning programme.
7. The IW Council should continue to liaise with local town and parish councils to ensure that the role and responsibilities of riparian owners are fully understood. This could include a winter alert for local communities via press and radio; information provision and action against landowners who have impeded the flow of a watercourse or who need to clear watercourses.
