# Newport Section 19 Flood Investigation

## Final Report

**Isle of Wight  
Council**

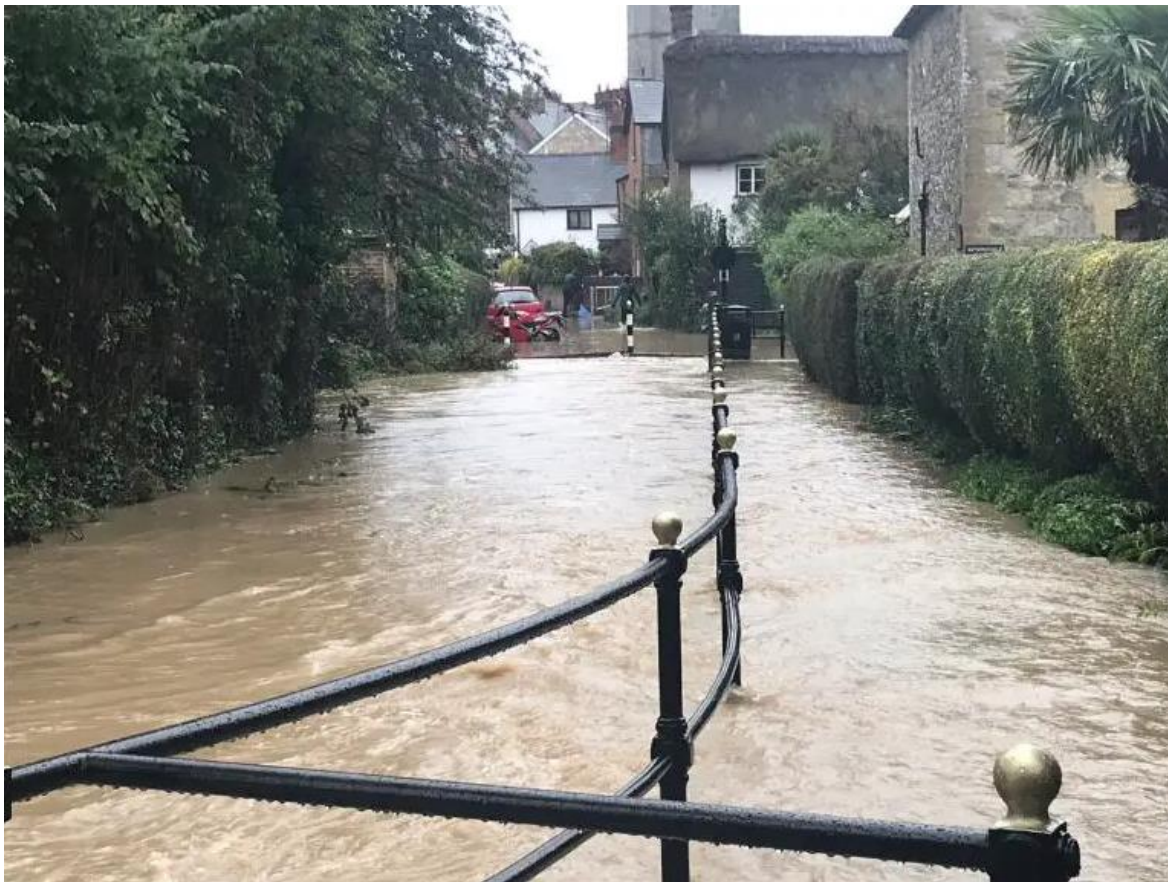
Figure 7-14 Photograph 8, Castle Street ford, looking north (October 2023)

The ford on Castle Street was subject to high water velocity which exceeded the flood barrier depicted in Figure 7-14 flowing freely north up Castle Street. Responses from the community survey indicates that flooding on Castle Street began at 07:00 until 22:00. This aligns with river flow levels at the Carisbrooke gauge, which indicates a peak flow of  $2.22\text{m}^3\text{s}^{-1}$  at 08:22am. Survey information highlighted those flows quickly exceeded the channel capacity of the bridge below the footpath adjacent to the ford, which caused the Lukely Brook to flow out of bank to nearby properties. Further to this, residents from Castle Street highlighted an additional flow of surface runoff from Carisbrook Road. There is a general downward slope along the High Street heading northeast towards Newport town centre. Castle Street and Spring Lane would both receive surface water runoff from this road.

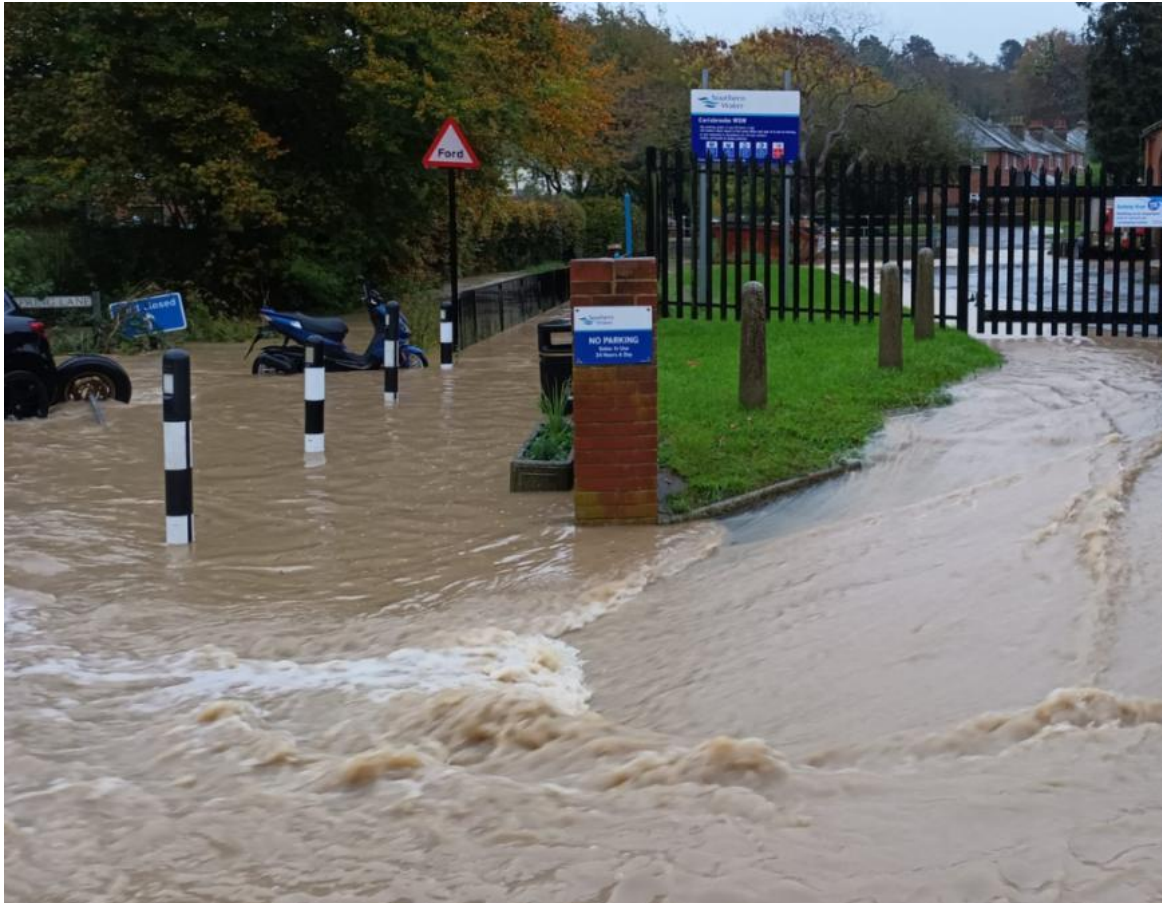
Figure 7-16 Photograph 10, flooding on Spring Lane, looking southeast

An image from the front of Carisbrooke WWTW (Figure 7-16) indicates that flooding was caused by fluvial sources. The water was seen to exceed the channel of the ford on Spring Lane flowing north towards Carisbrooke Road.

Figure 7-16 highlights that the flooding to properties on Carisbrooke Road originated in the rear gardens, which back onto the Lukely Brook. The FMfP indicates that these properties are in Flood Zone 3, which further indicates the fluvial flood risk. High levels of rainfall experienced on the 25 October 2023 caused increased volume and velocity of water in the Lukely Brook which led to channel exceedance.

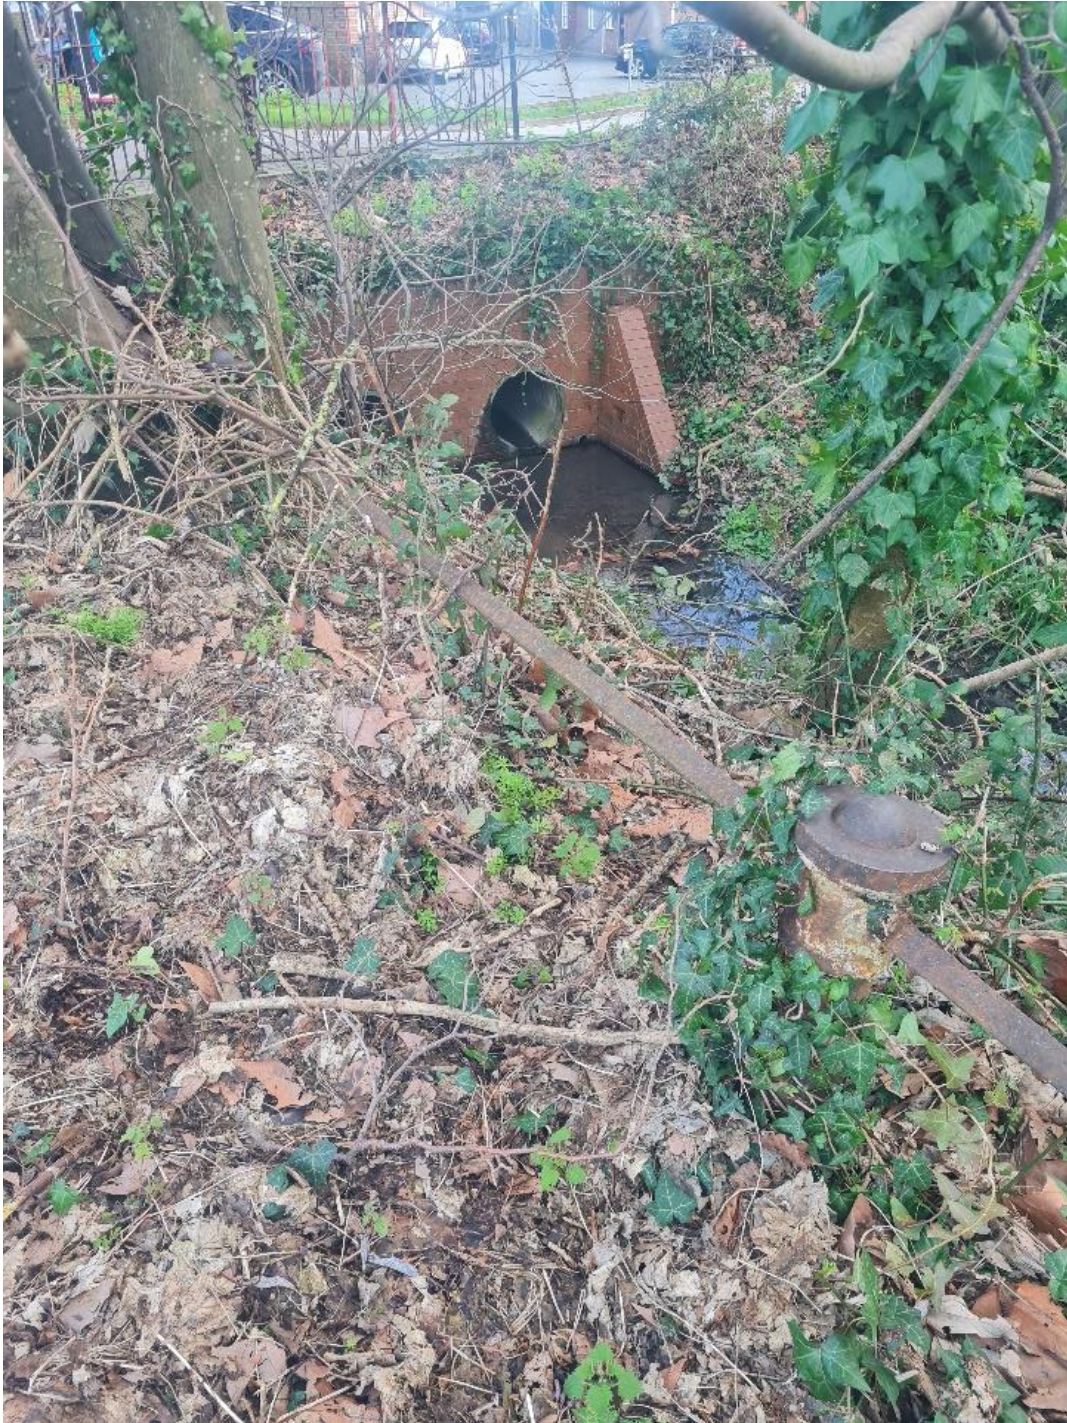
*Figure 7-17 Photograph of twin culvert on the ordinary watercourse at Mill Court*

The intense rainfall on 25 October 2023, coupled with a high tide, resulted in elevated river levels. Located about 0.5km north of the estuary head, Mill Court likely faced the effects of tidal locking during this flood event. The rise in water levels, together with impeded river drainage, is expected to have put pressure on the channel's capacity near this site. Consequently, these conditions would have significantly influenced the impacts of flooding at the Mill Court building.

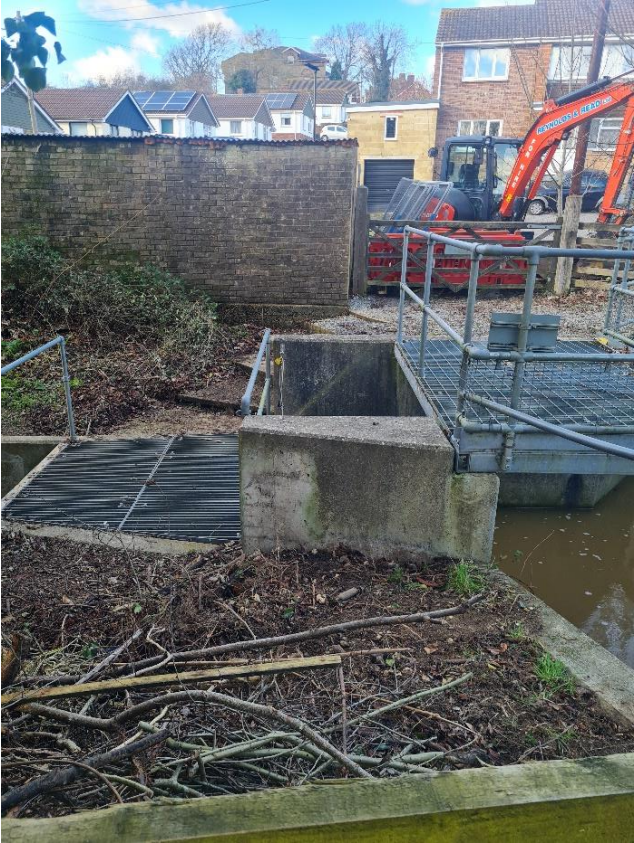
Figure 7-19 Photograph of debris screen on Gunville Stream, near Hunnyhill Aquatics

The site visit highlighted that a debris screen had been present on the upstream end of a culvert on the Gunville Stream, 55m east of Hunnyhill. On 26 February 2024, this was found to be removed. Upon discussion with the Environment Agency, it was established that this debris screen was removed due to blockages, which caused the Gunville Stream to backup. The top portion of the debris screen remains in place and monitored. Two arch culverts, each with a diameter of 1400mm, defined the confluence of the Gunville Stream into the Lukely Brook. Based on the EAs comments from the event it is understood that debris may have caused a blockage at this location during the storm on 25 October. Hunnyhill is situated approximately 0.45km upstream of the estuary head and consequently likely experienced the impacts of tidal locking. Tidal locking would have increased river levels upstream, causing water to exceed channel capacity.

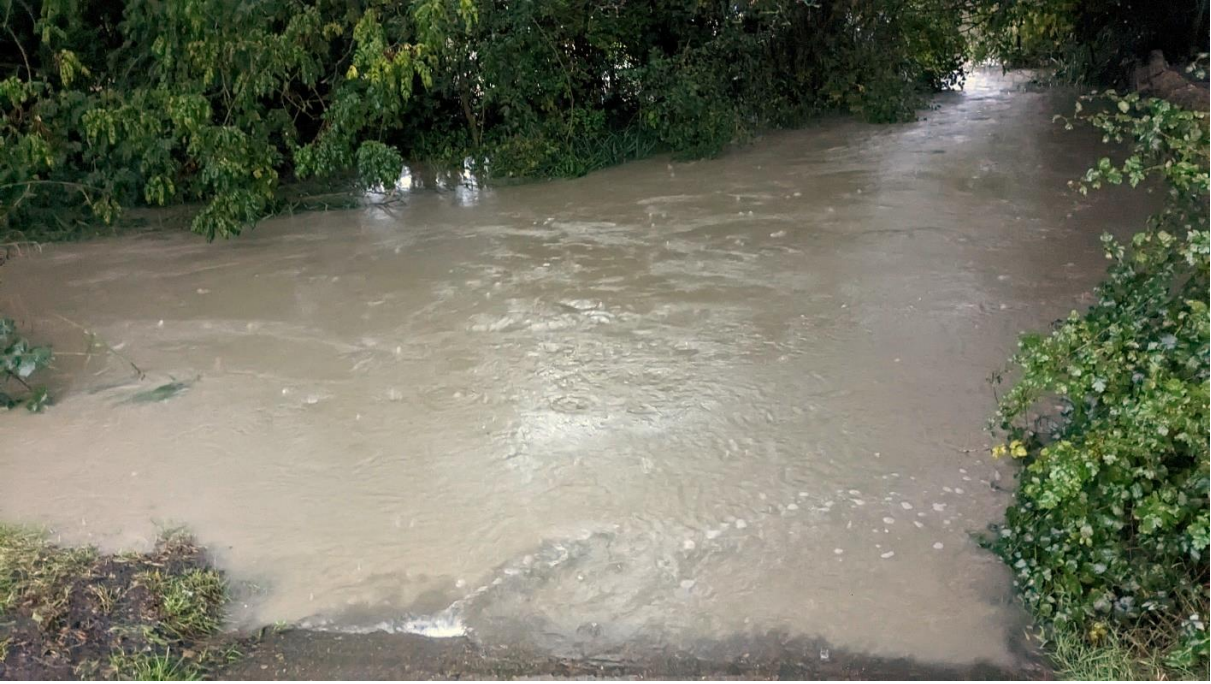
Figure 7-22 Photograph of Lukely Brook, view from rear garden of Caesars Road property.

The flooding on 25 October caused minor damage to rear gardens on Caesar's Road as seen in Figure 7-22. Residents highlighted the mental health implications, such as stress and nerves during following rainfall events, in particular highlighting their concern upon receiving Environment Agency flood alerts.

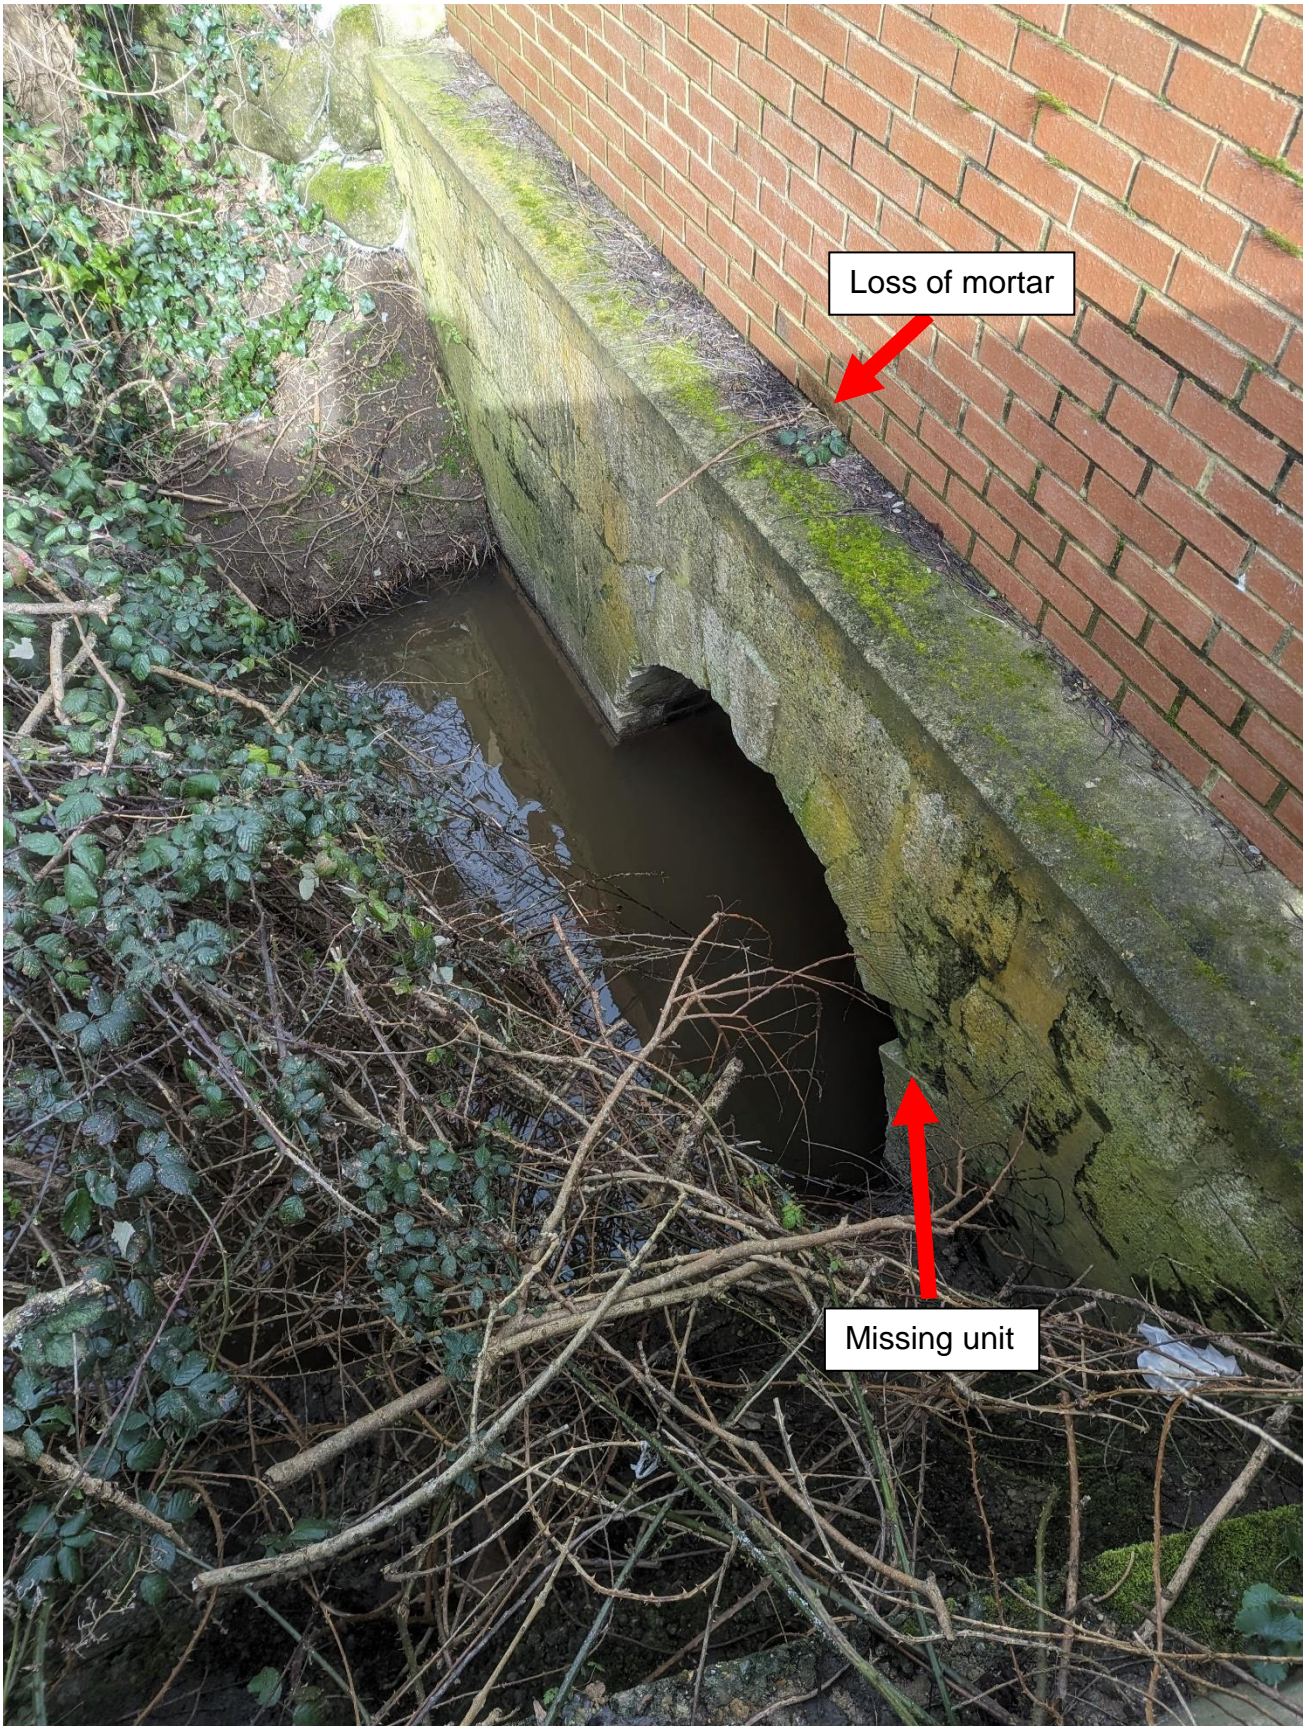
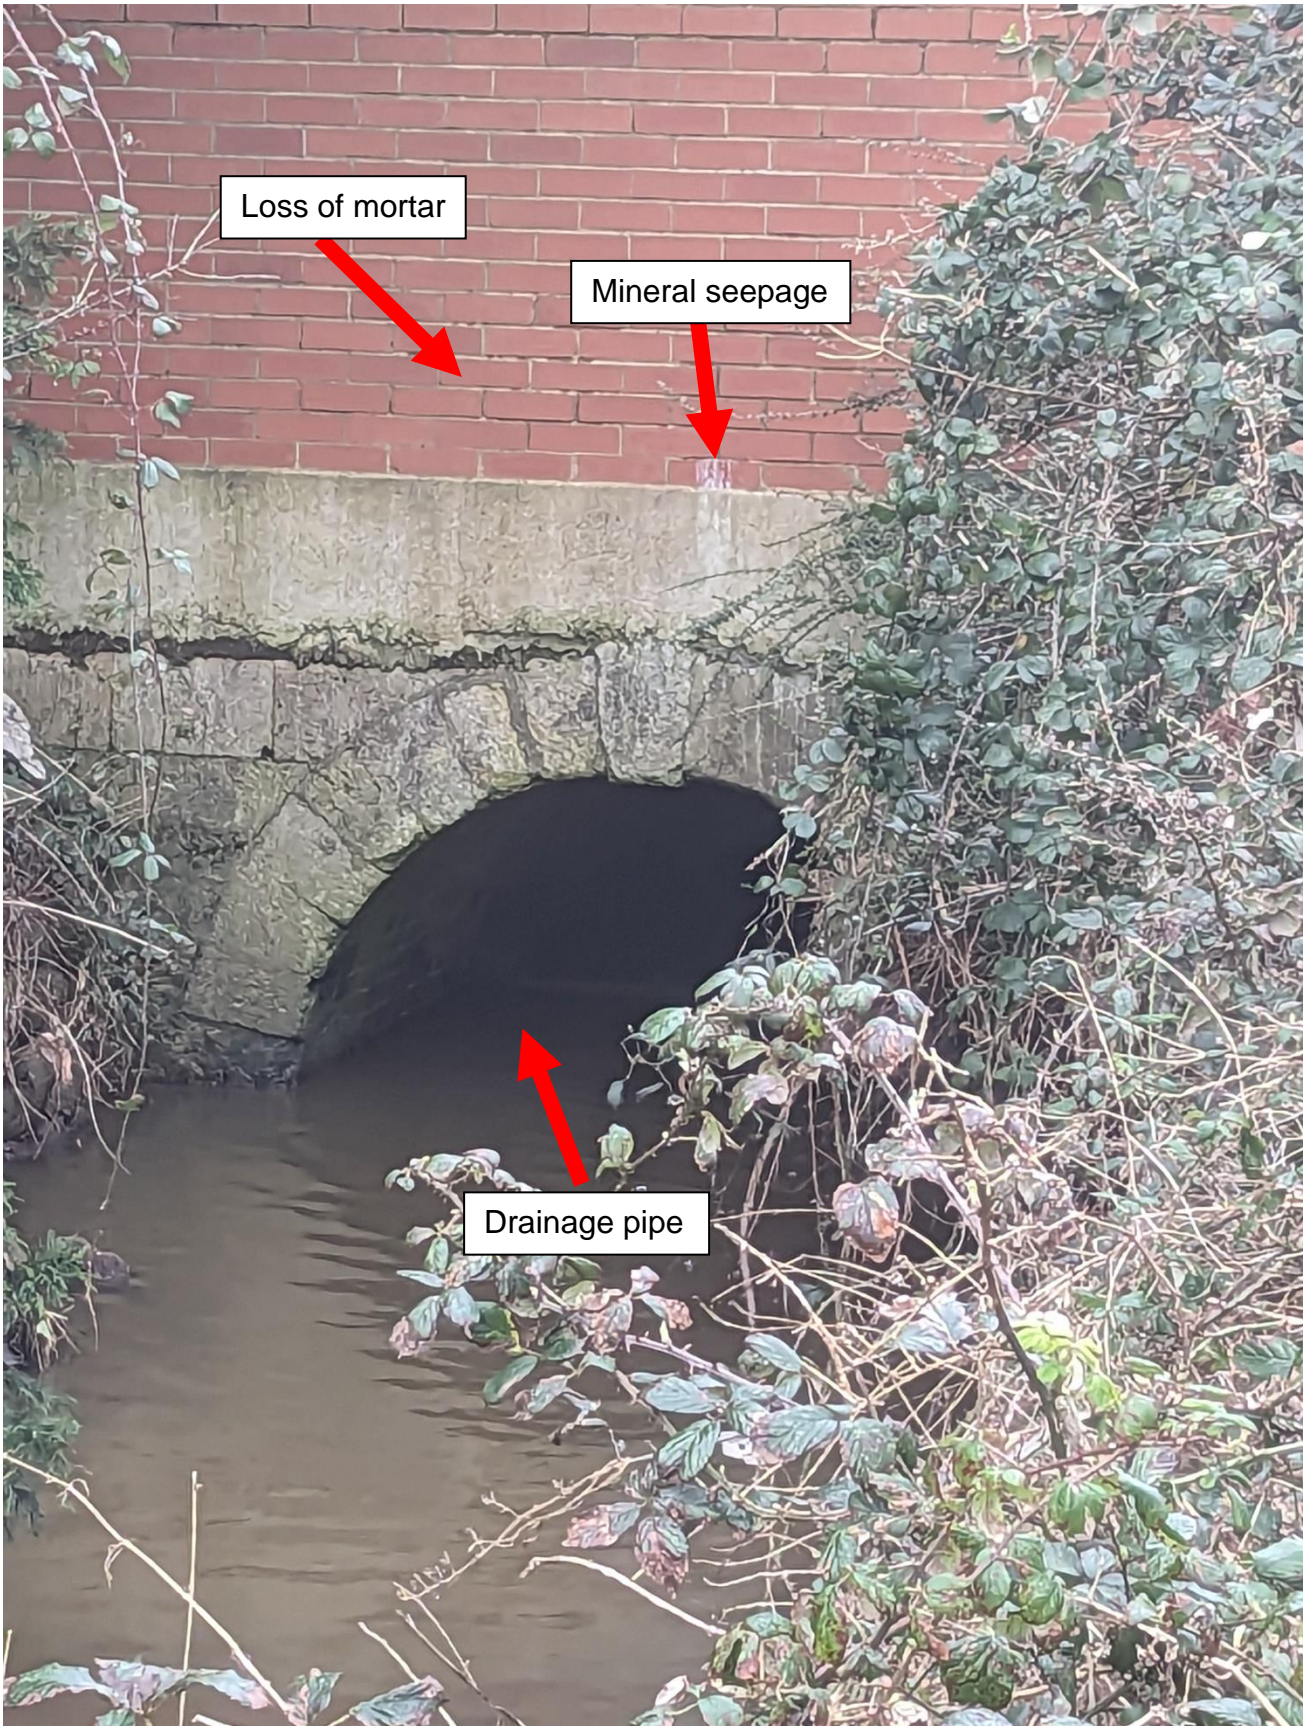
Further comments: There is a pipe on the left side of the downstream end of the culvert barrel where water continuously flowed into the watercourse during the survey. On both ends of the culvert the concrete material is spalling and has some erosion in places. Was unable to fully see the culvert barrel, but from point of view some daylight was visible through the culvert barrel. It is recommended to undertake a full CCTV inspection for the culvert barrel to see if any structural damages are present or there are any debris build up inside.

Figure 8-1 Upstream headwall of culvert – picture was taken from the right bank of the asset in front of the back garden of the Ash Lane properties

Figure 8-2 Downstream headwall of culvert - picture was taken from the public footpath on left bank

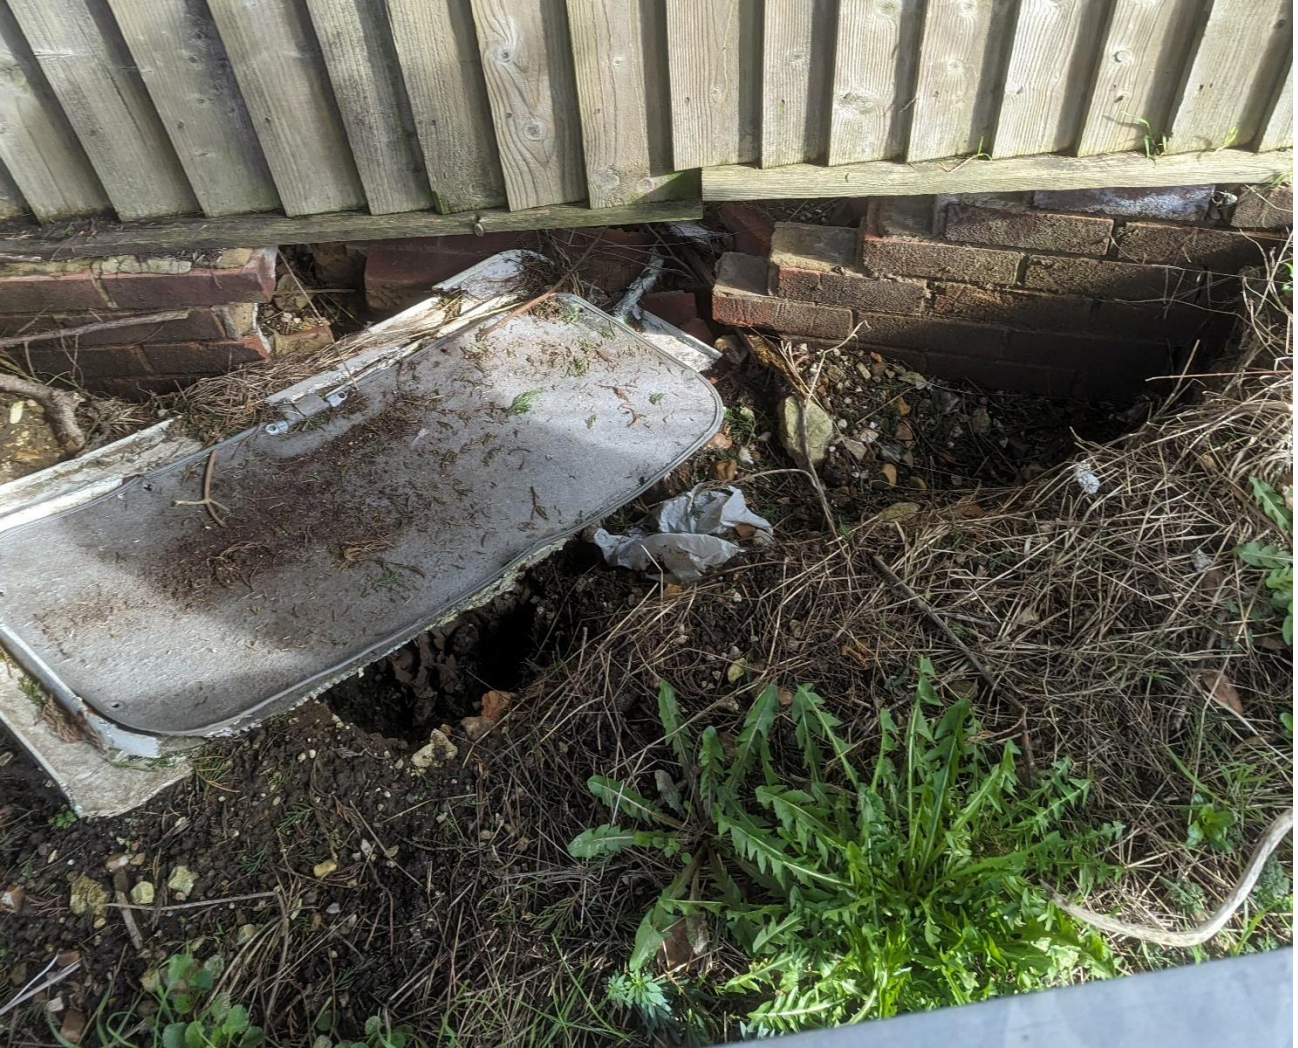
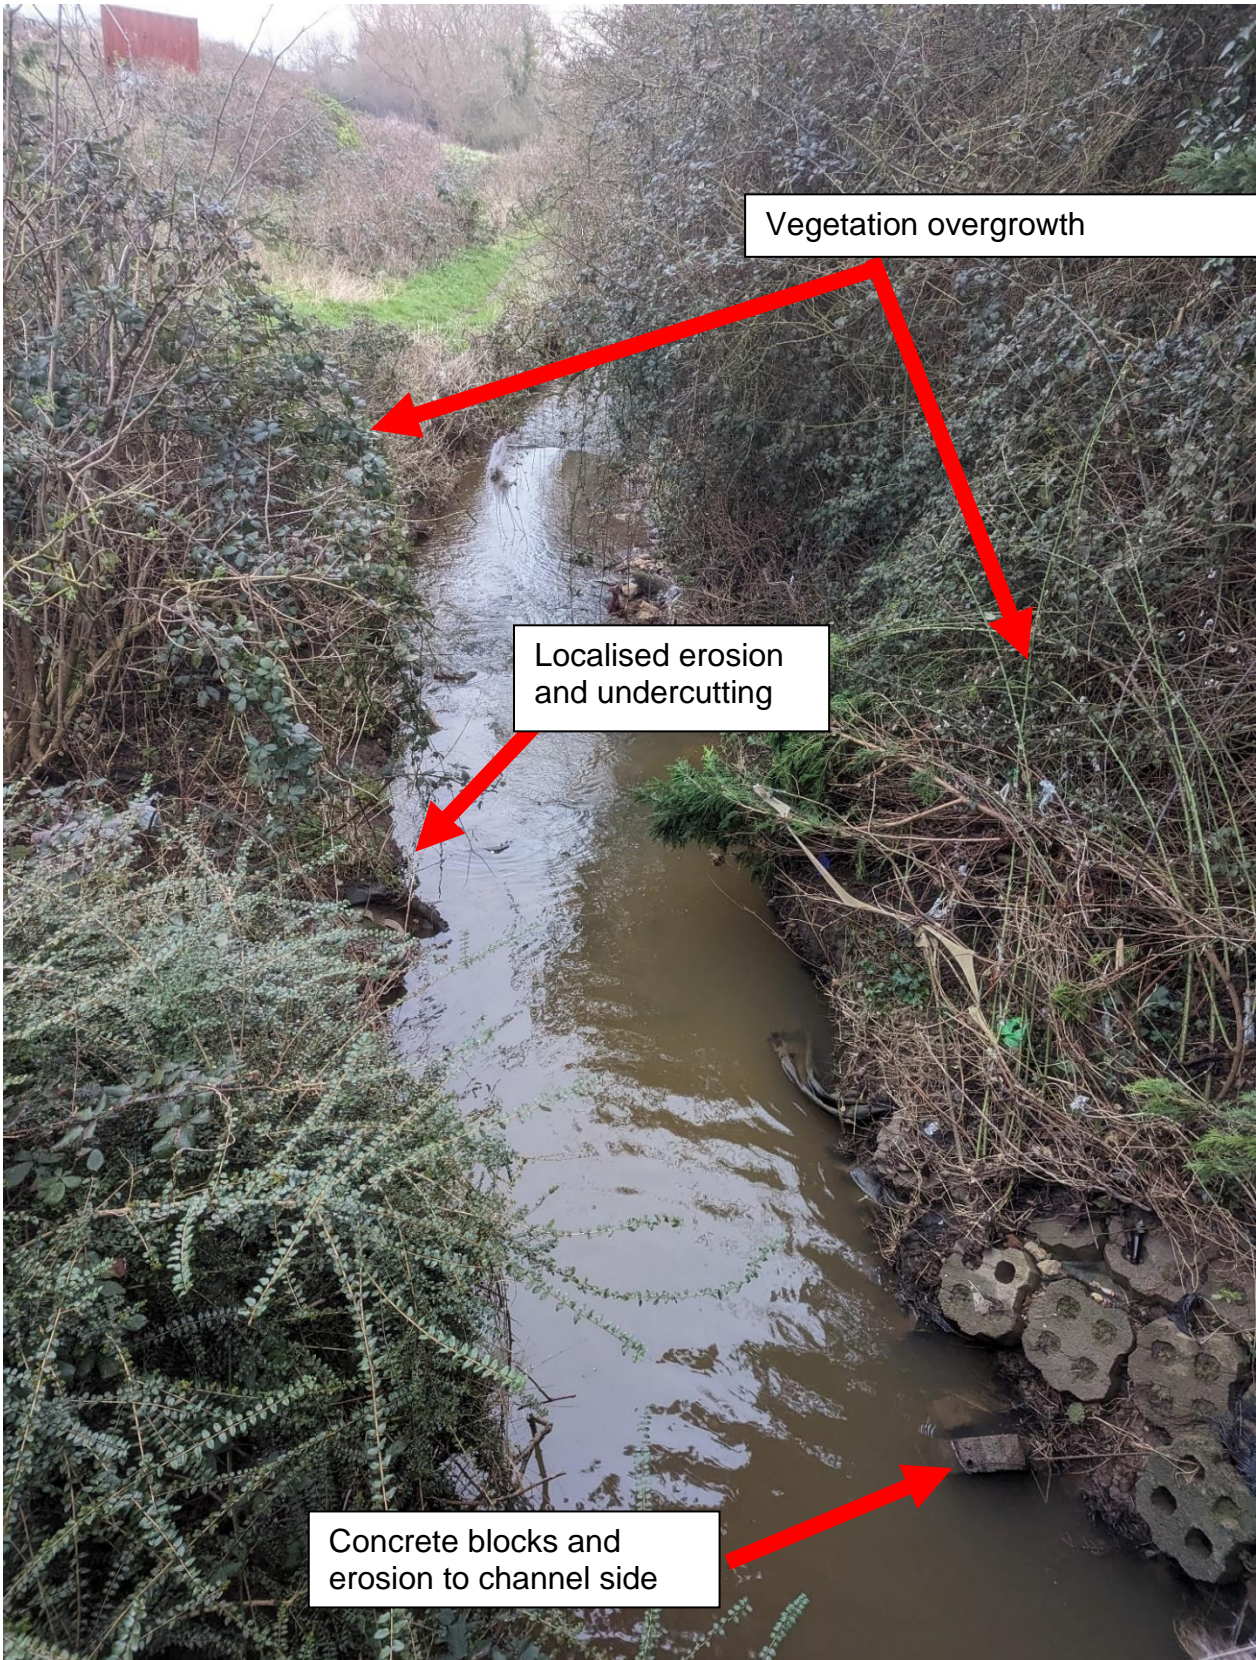
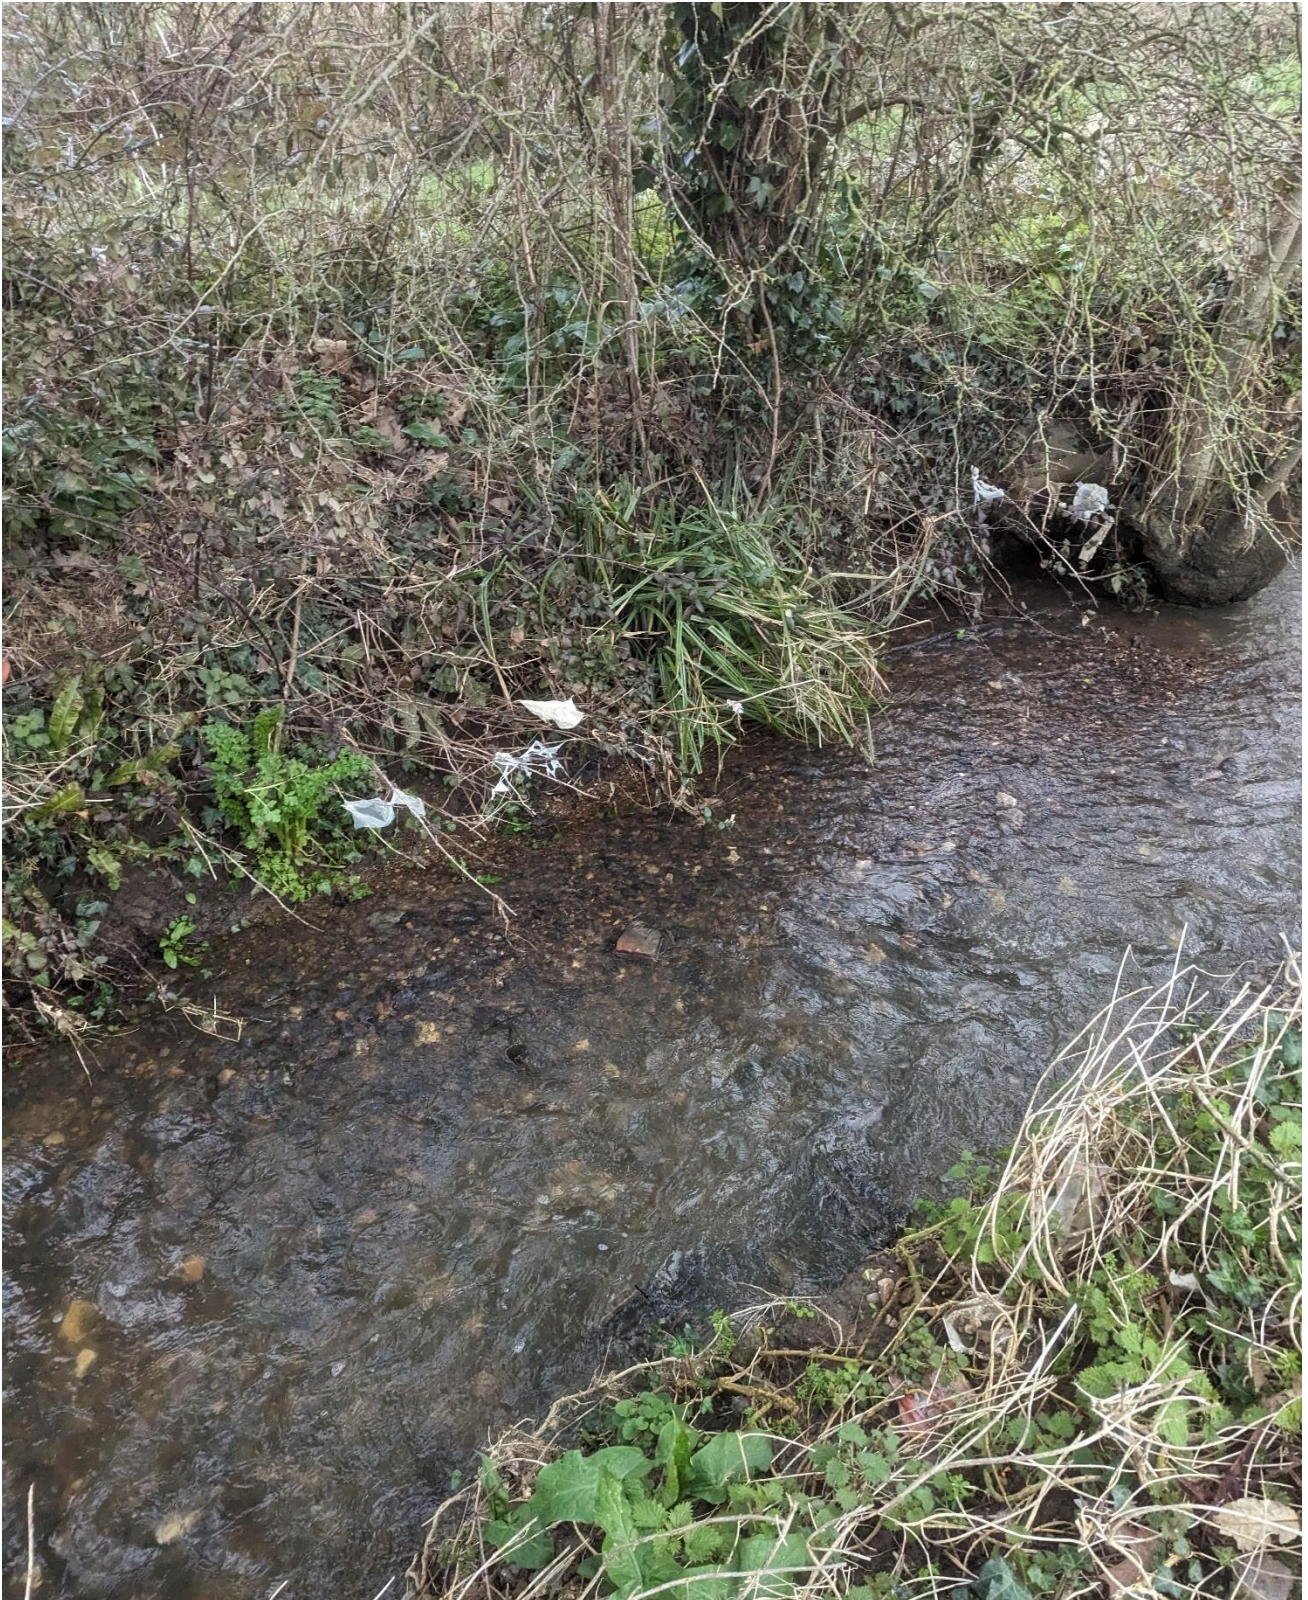
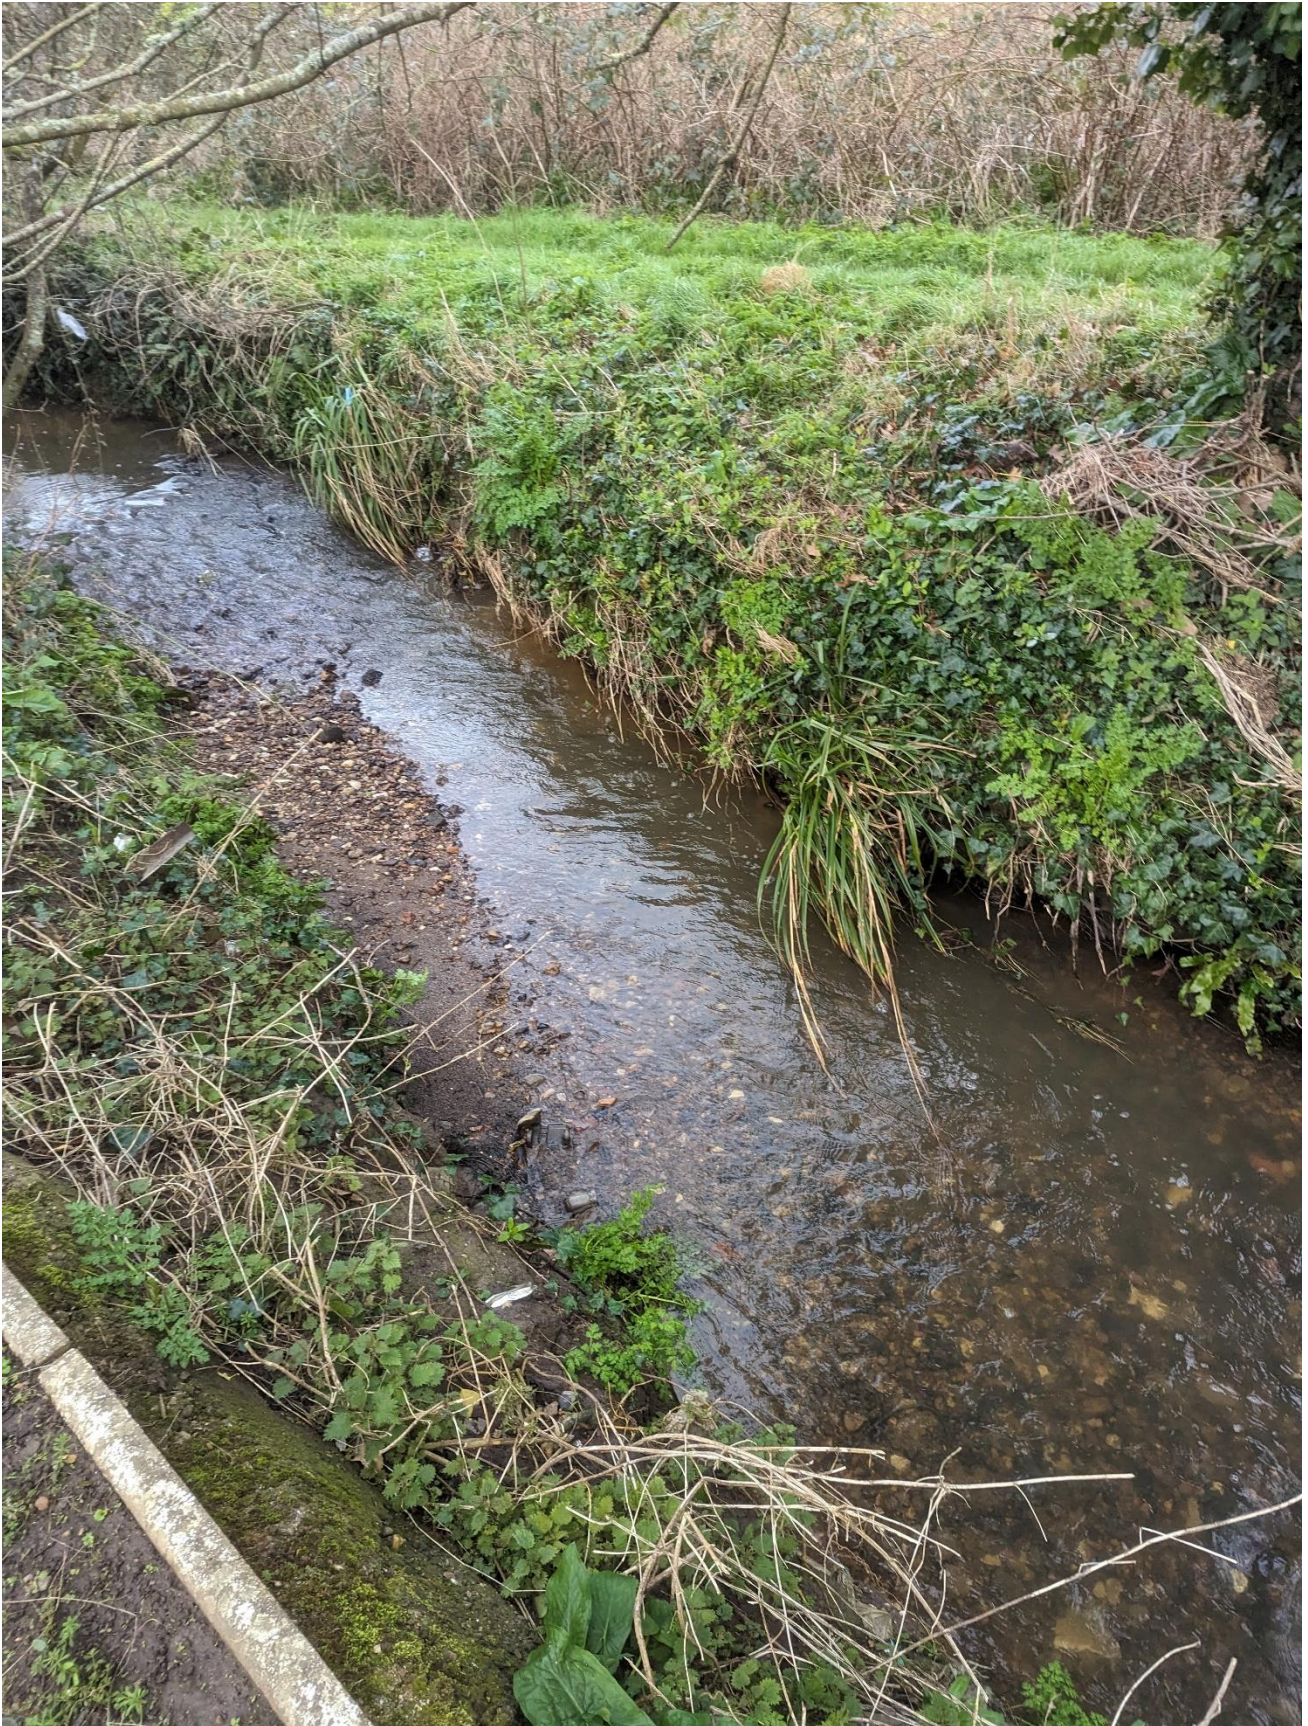
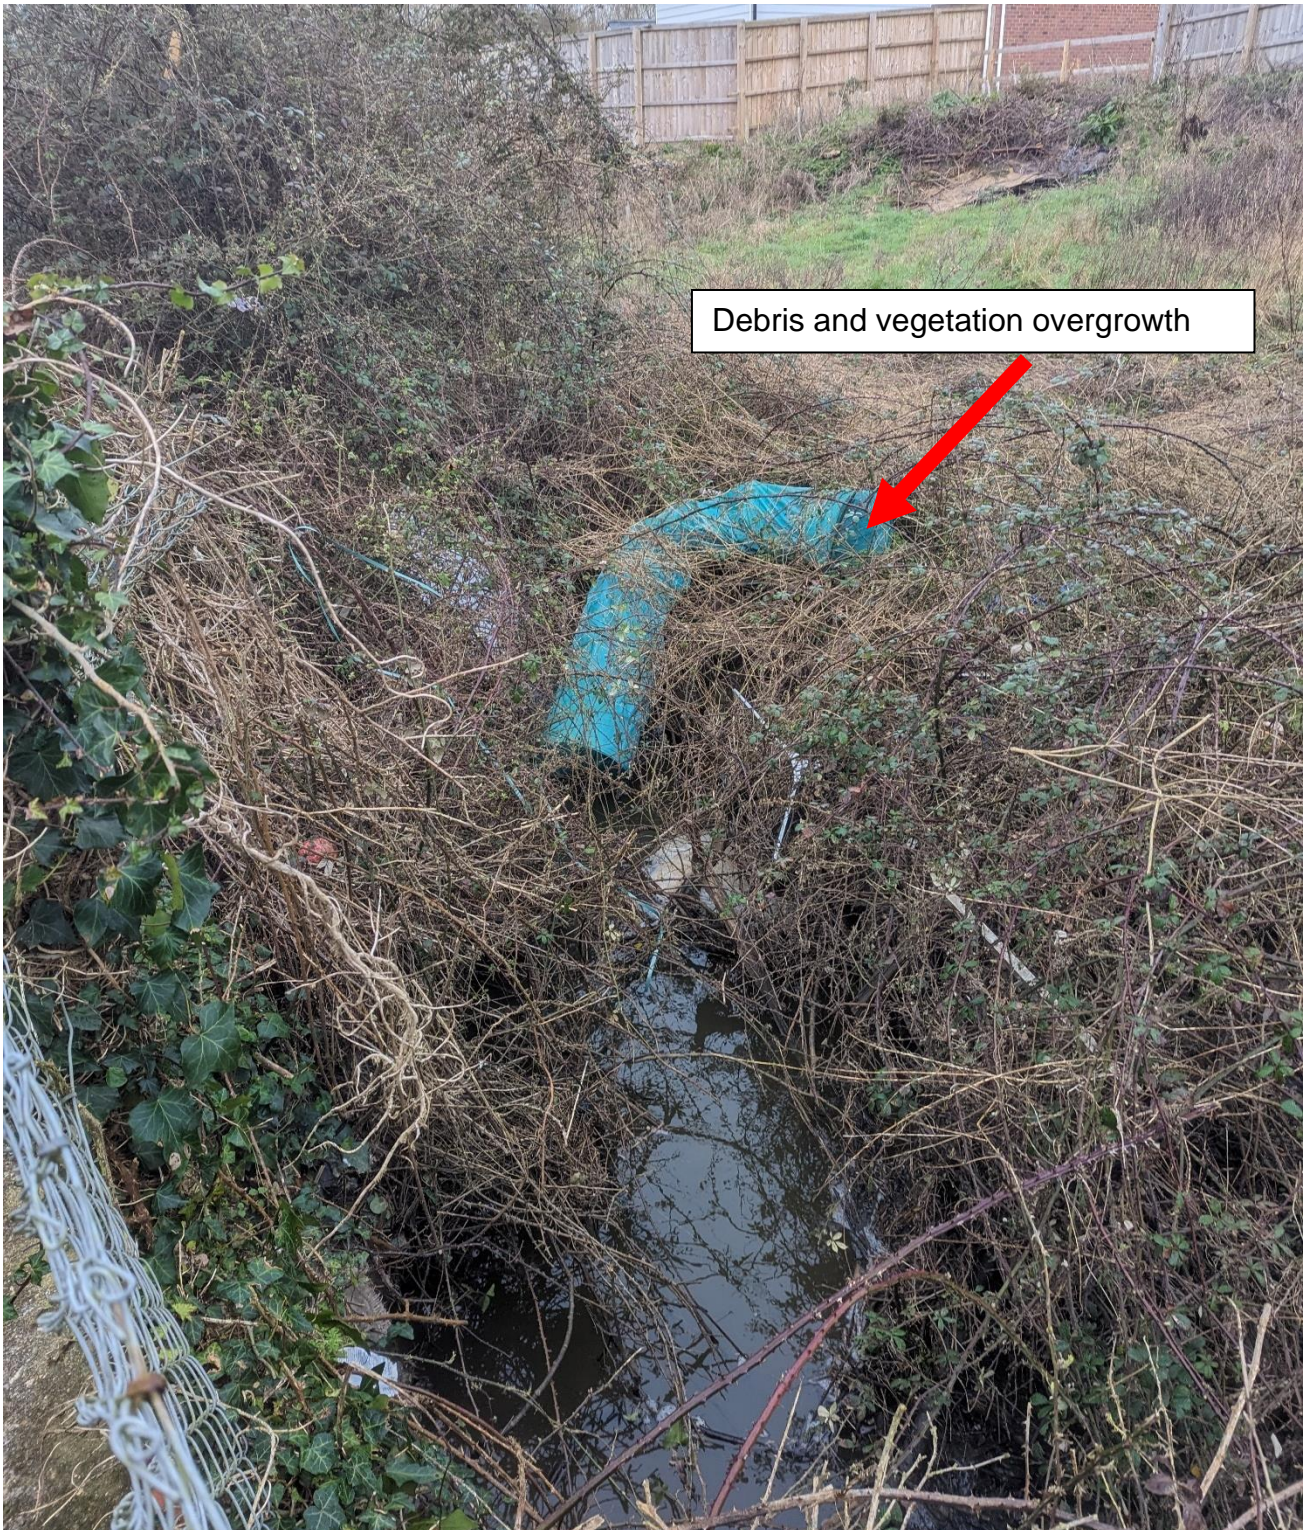
Further comments: asset seems to have no maintenance. The channel is silted and heavily overgrown in sections, with a mature tree causing some obstruction of conveyance upstream of Gunville Road bridge (Figure 8-8). Significant number of debris are present in channel (Figure 8-7), Channel side has localised undercutting and erosion.

Figure 8-3 Right bank of natural high ground behind Ash Lane properties

Figure 8-4 Watercourse looking downstream from the Gunville Road highway bridge, right bank with the concrete blocks

Figure 8-5 Downstream end of watercourse - image taken from right bank, facing downstream towards the left bank of the watercourse

Figure 8-6 Downstream end of watercourse - image taken from the right bank and facing upstream towards the left bank

Figure 8-7 Upstream end of the watercourse – image taken from the right bank behind the back garden of Ash Lane properties, facing upstream.

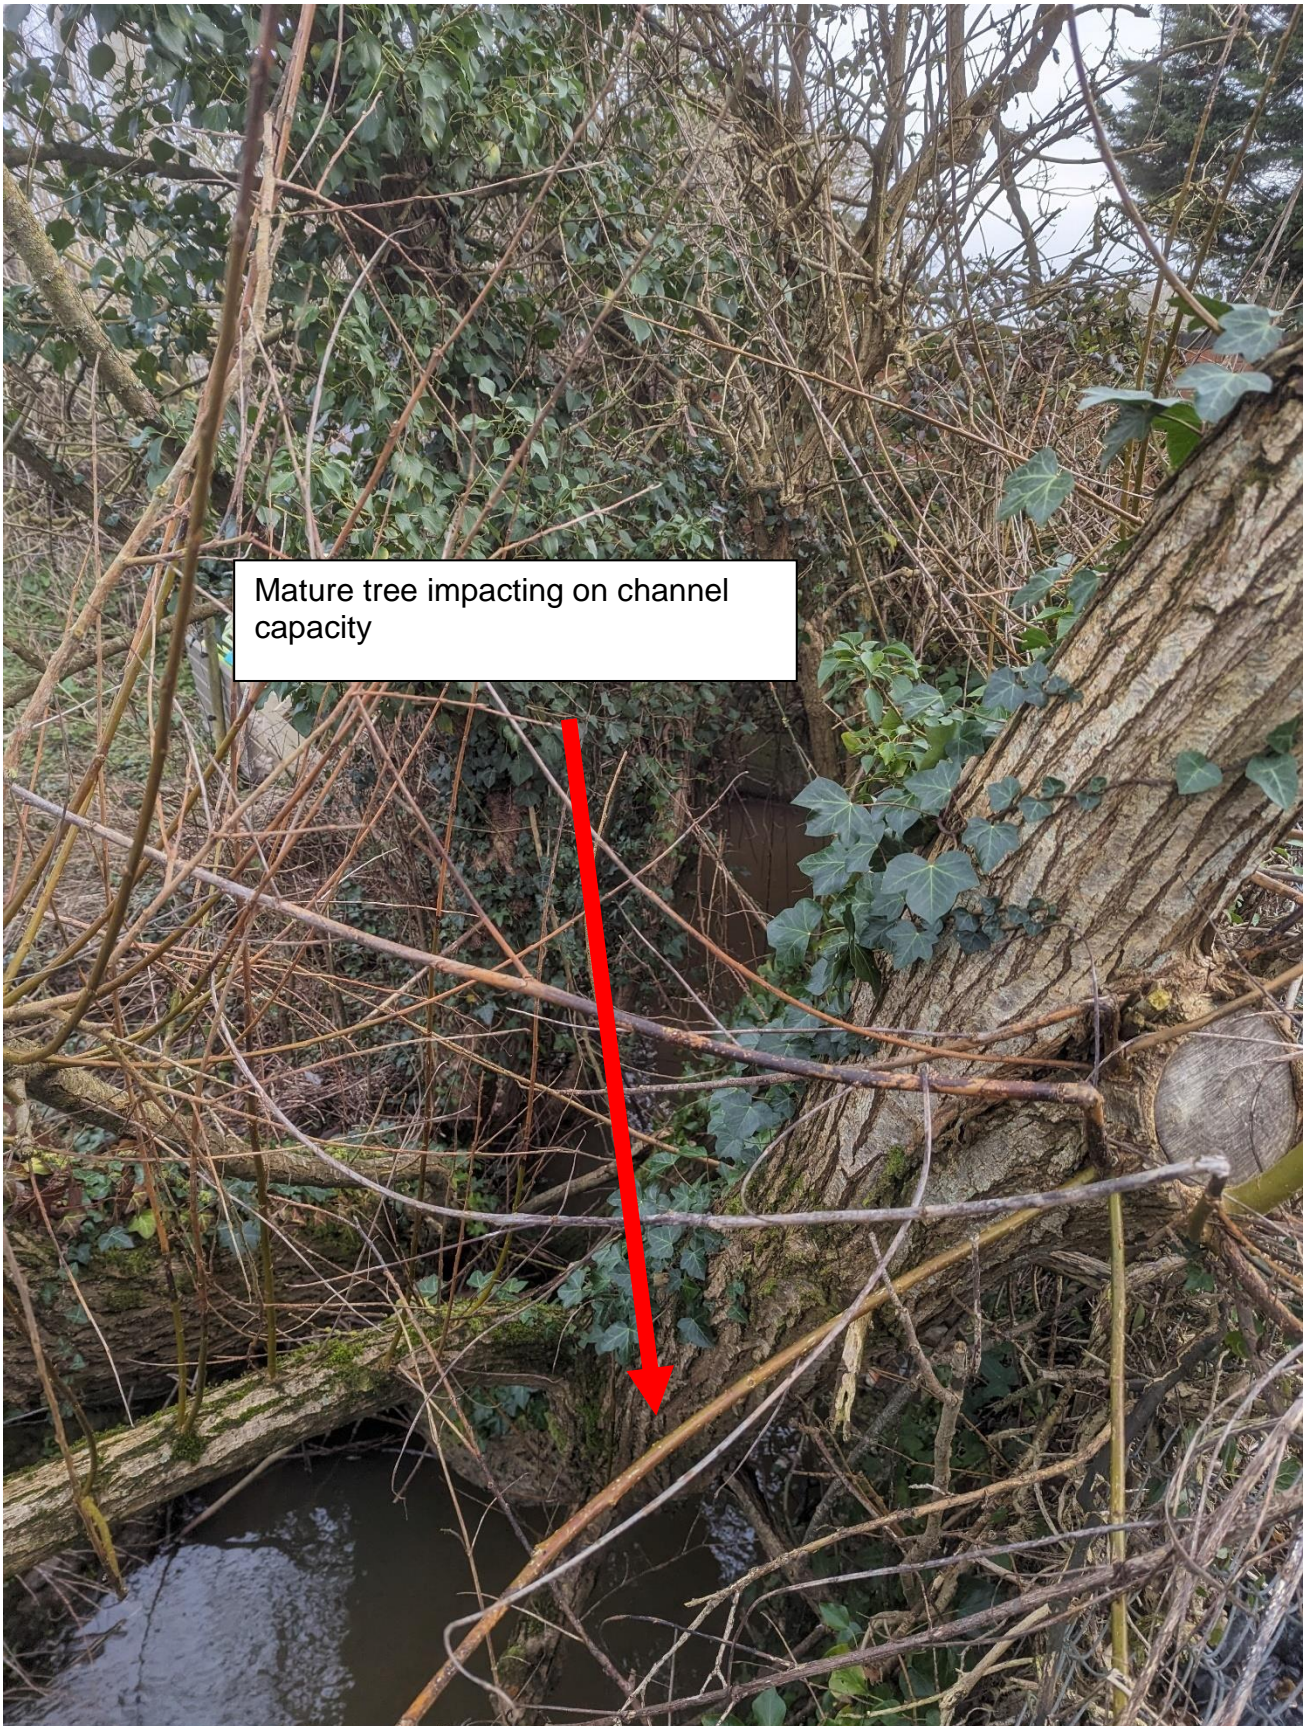
Figure 8-8 Upstream end of the watercourse – image taken from the right bank behind the back garden of Ash Lane properties, facing downstream.

Mature tree impacting on channel capacity
