# Newport Section 19 Flood Investigation

## Final Report

**Isle of Wight  
Council**

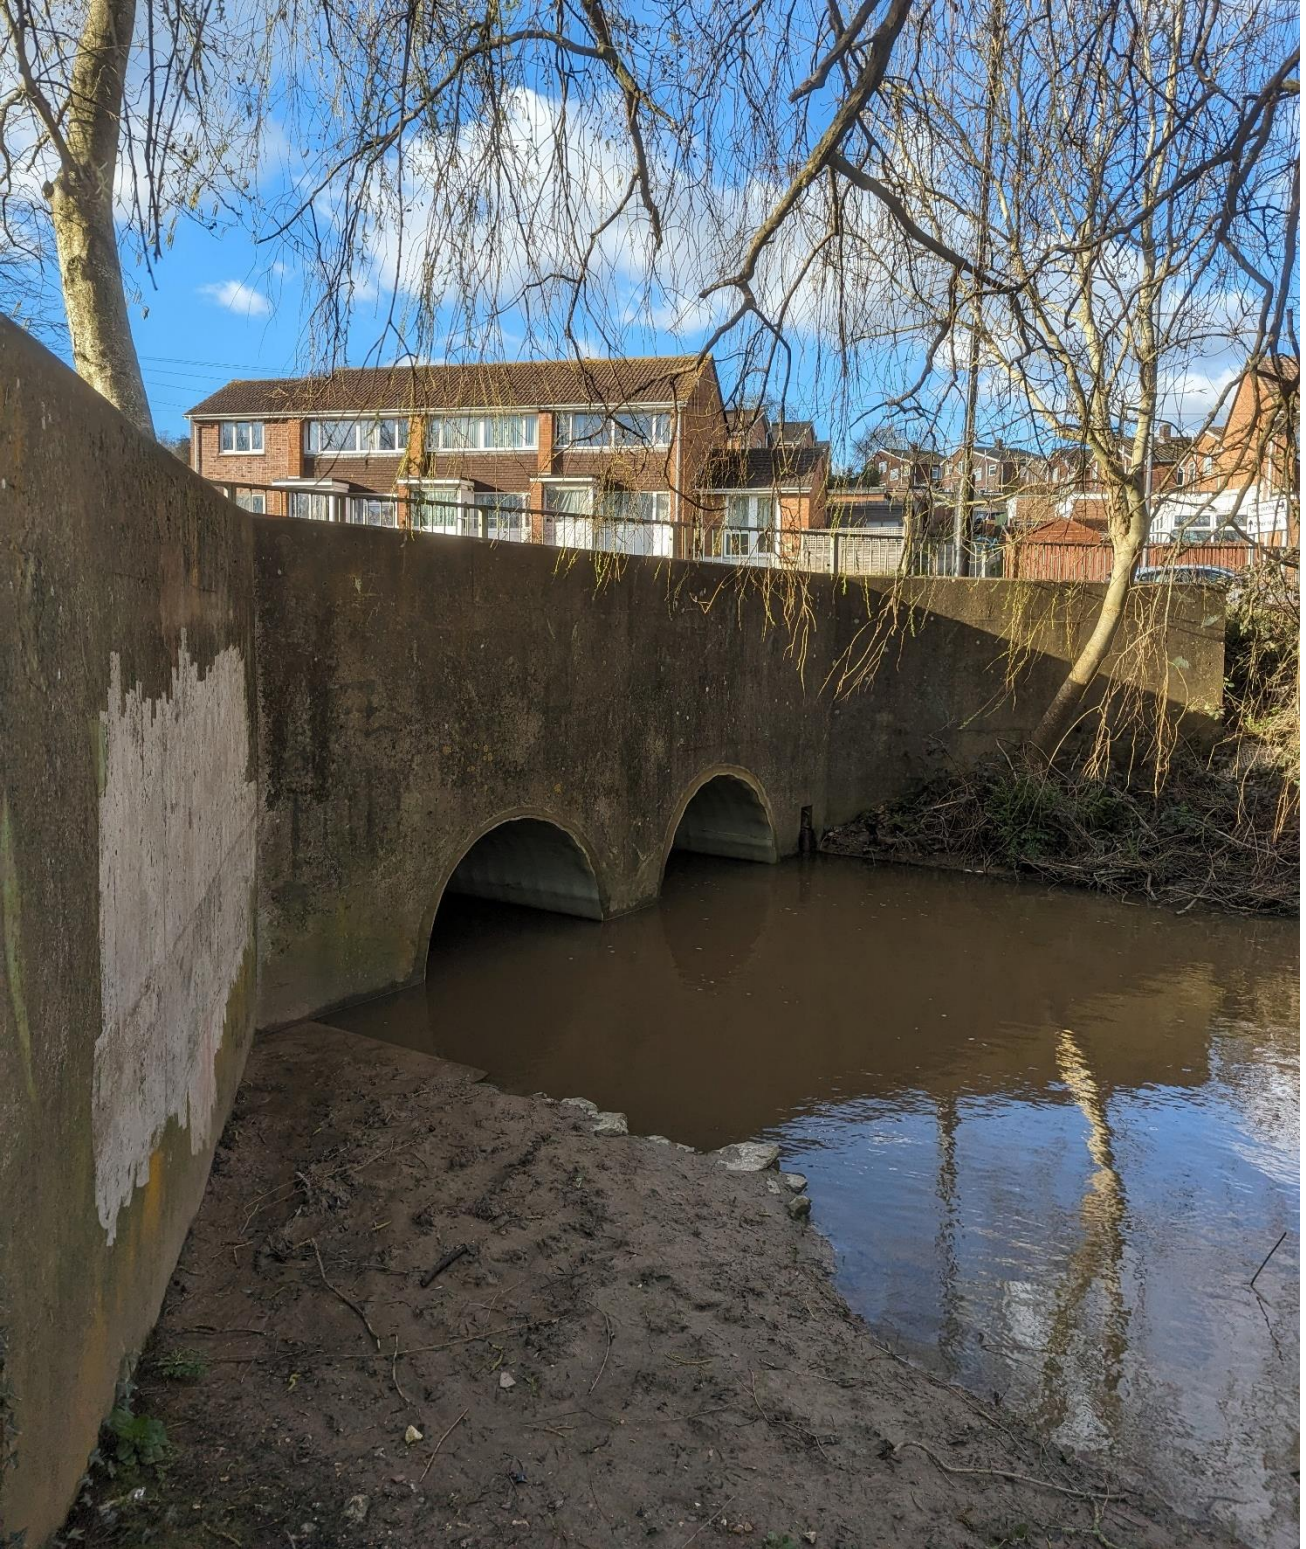
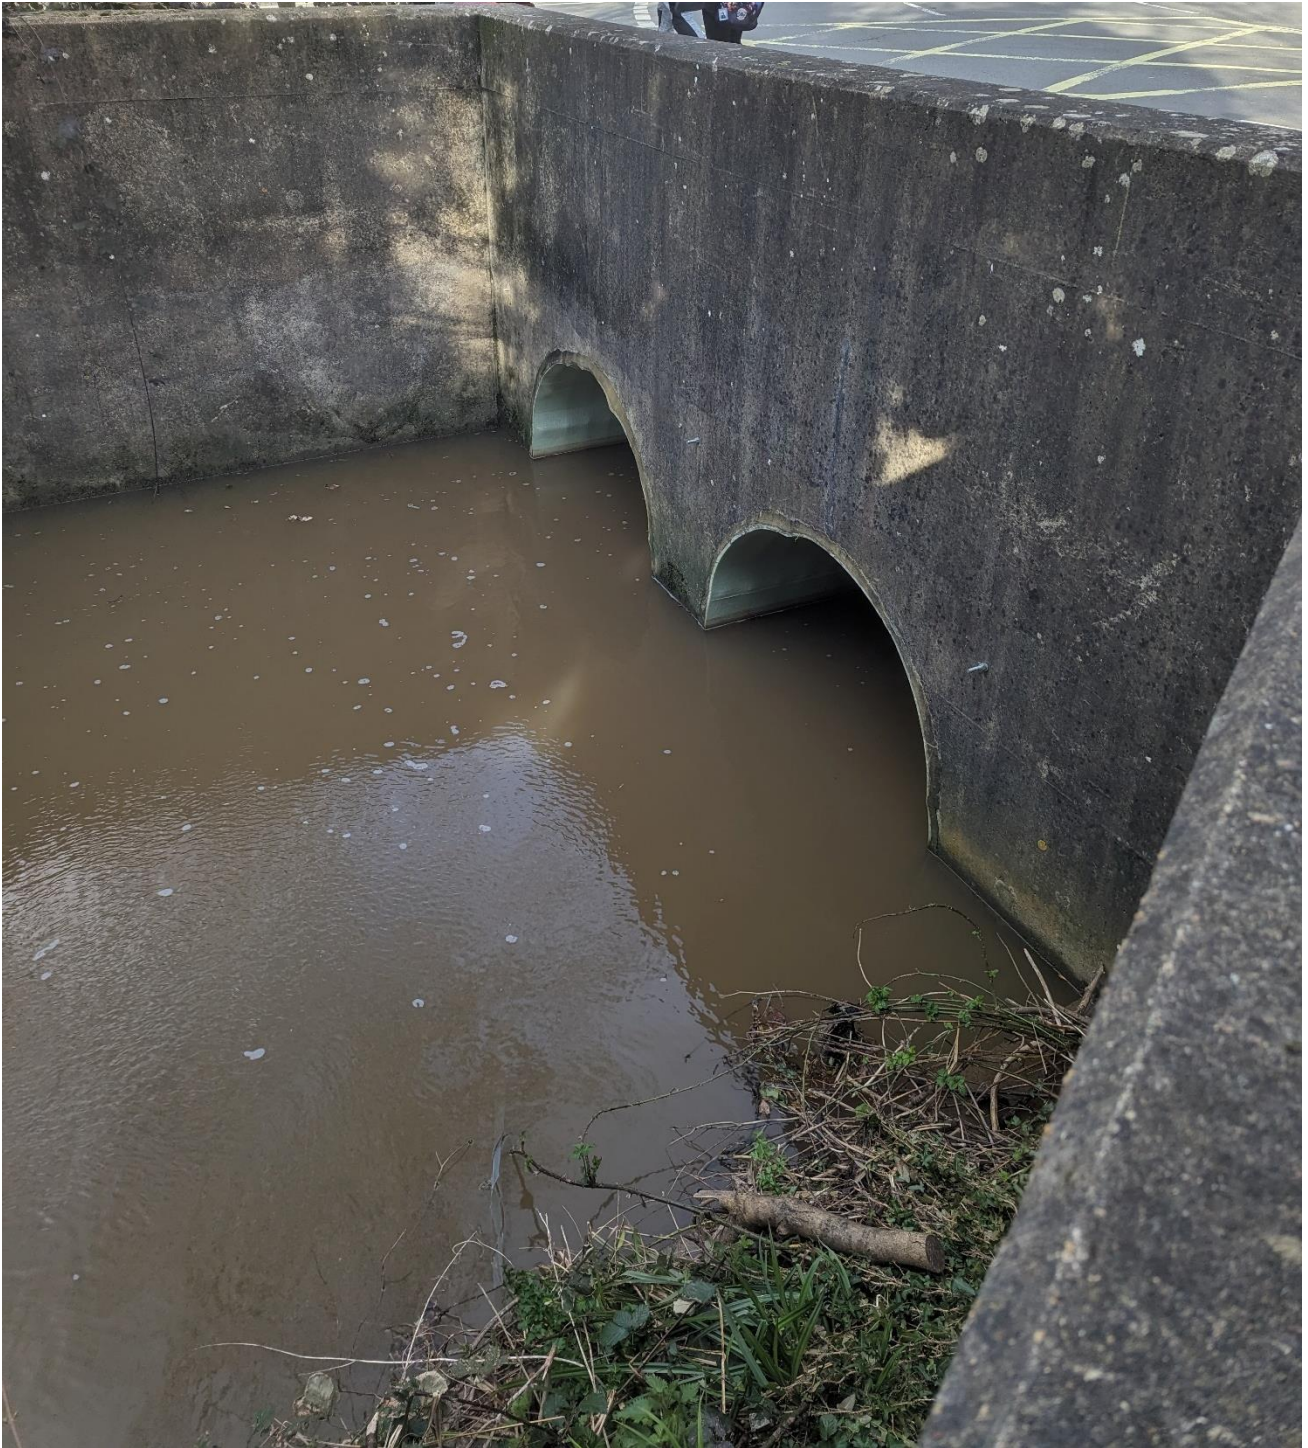
Further comments: No major damages from point of view. Concrete headwall spalling and honeycombing. Unable to fully see culvert barrels, therefore a full CCTV inspection to be carried out.

Figure 8-9 Downstream headwall and twin culvert connecting to St James St Duck Pond

Figure 8-10 Upstream headwall and twin culvert along the watercourse
