## Photos of the Totland Landslide, December 2012

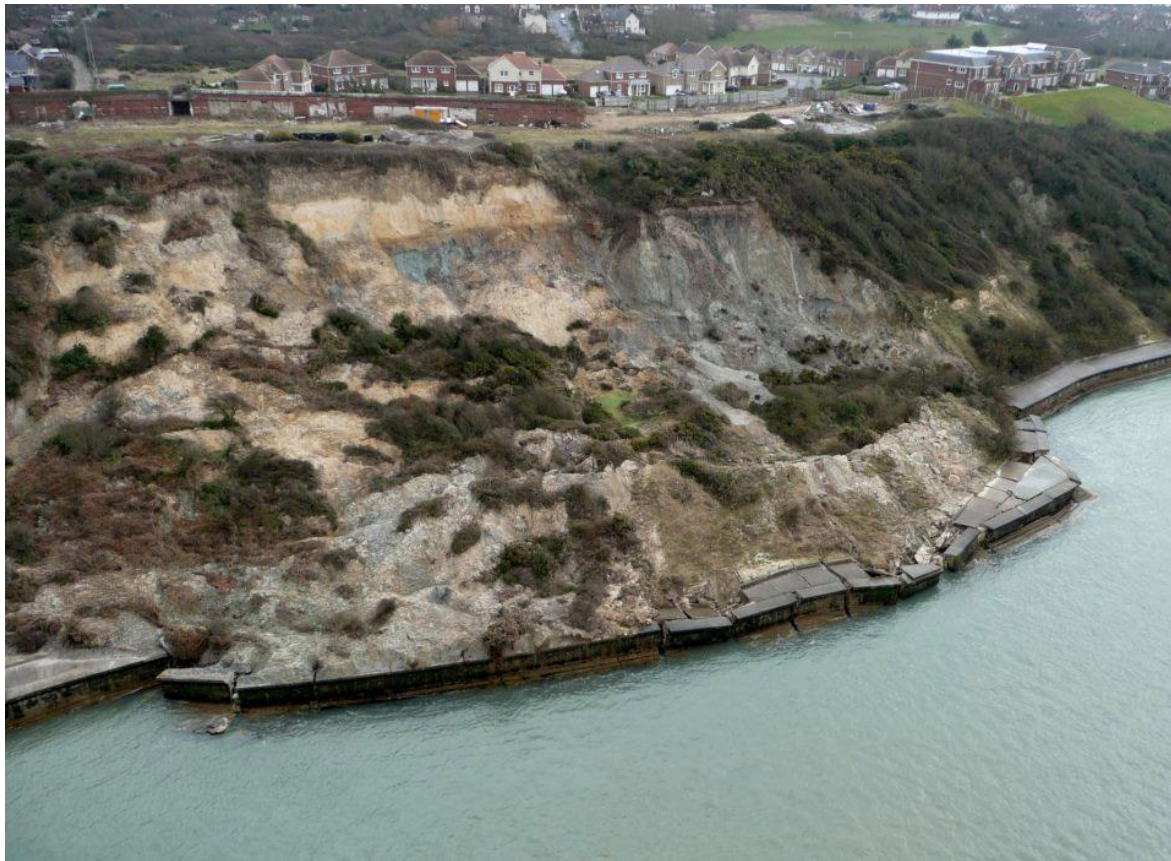
Photo: IOW Coastguard.

March 2013: The following photo of the Totland seawall was taken by the Coastguard in Spring 2013. It shows how far out the seawall was pushed following the landslide in late December 2012. The length of seawall affected was approximately 120 metres.

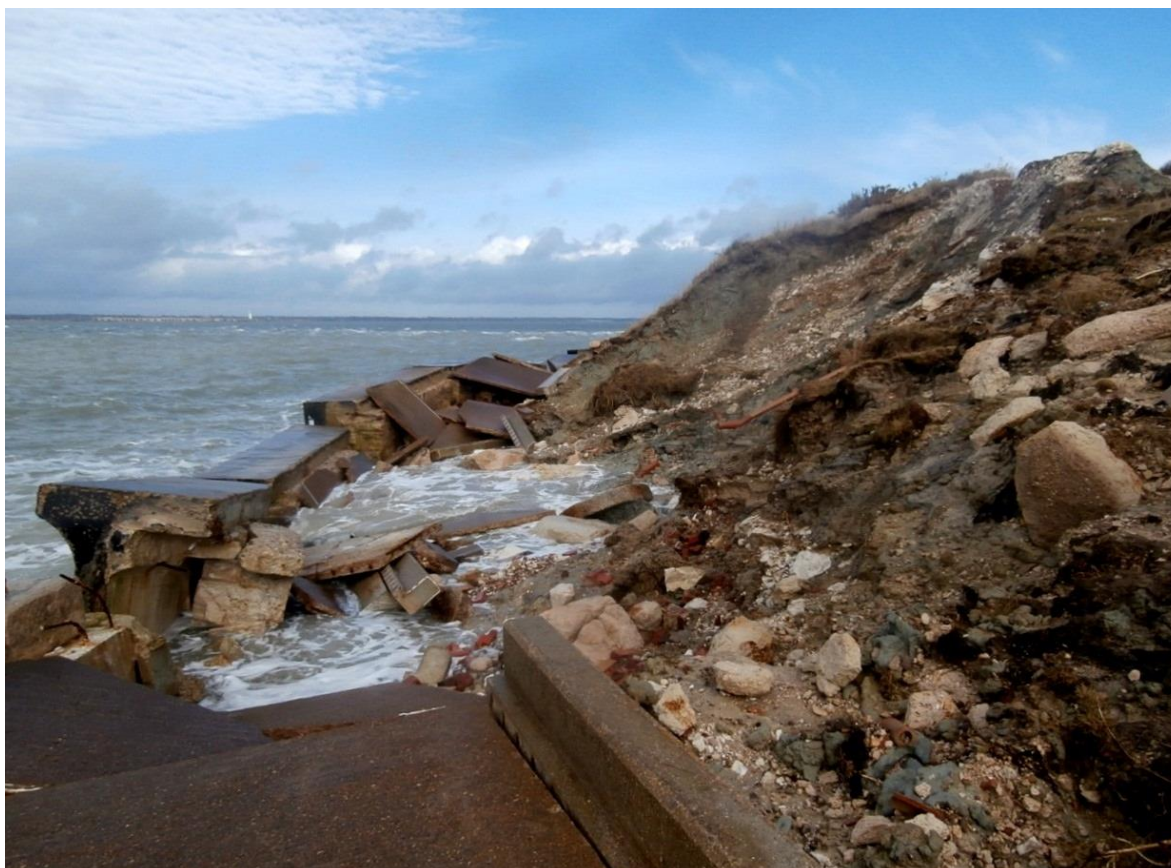
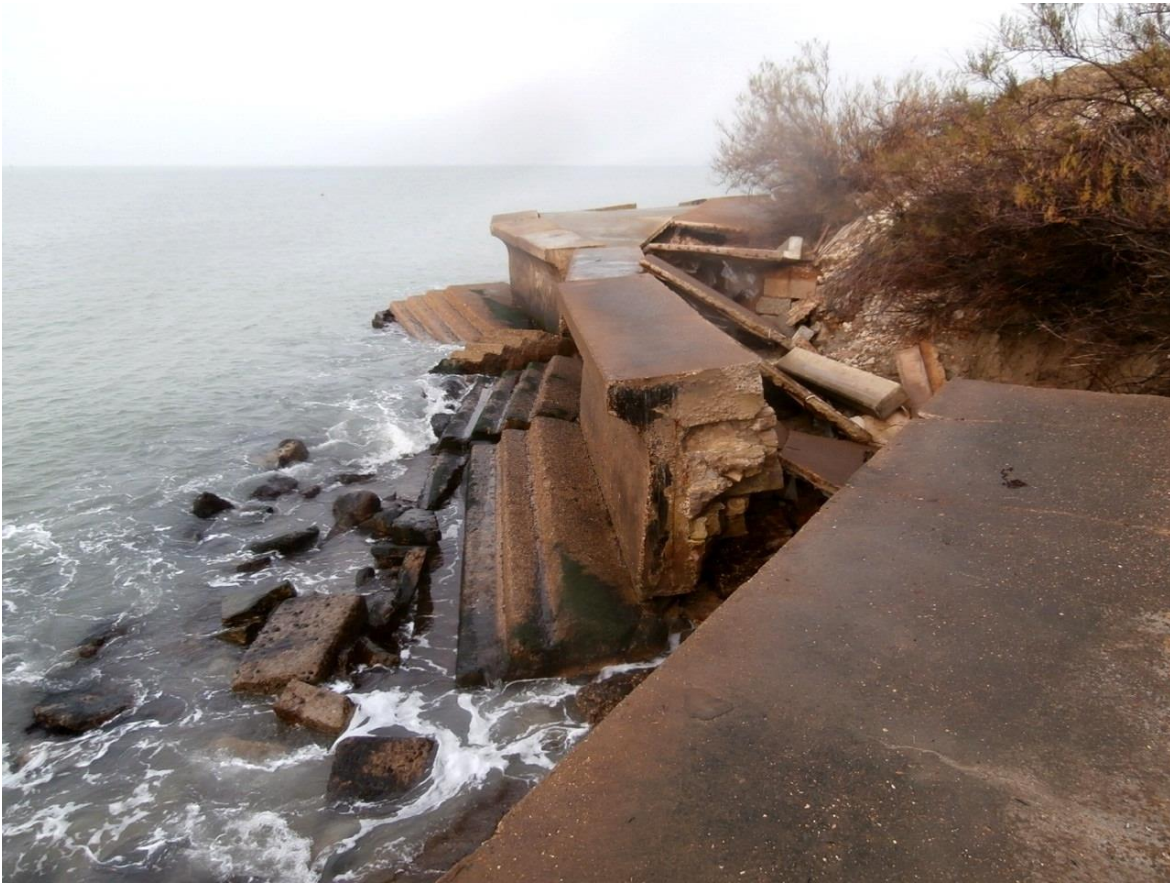
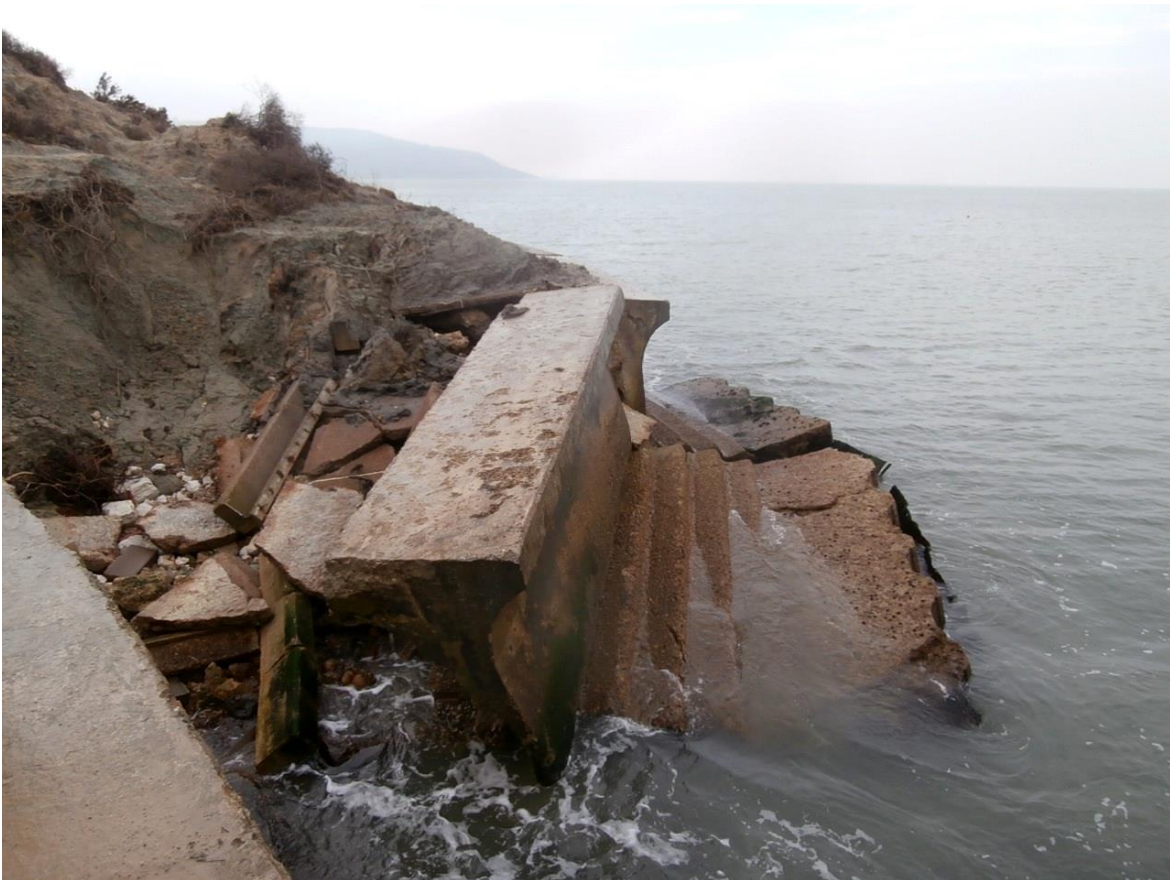
January 2014: The following photos show damage to the seawall, taken in December 2013 (IW Council):
