Ventnor to Niton Options Study

Addendum to Geotechnical Options Appraisal -  
Lowtherville Graben

Report No. TH364

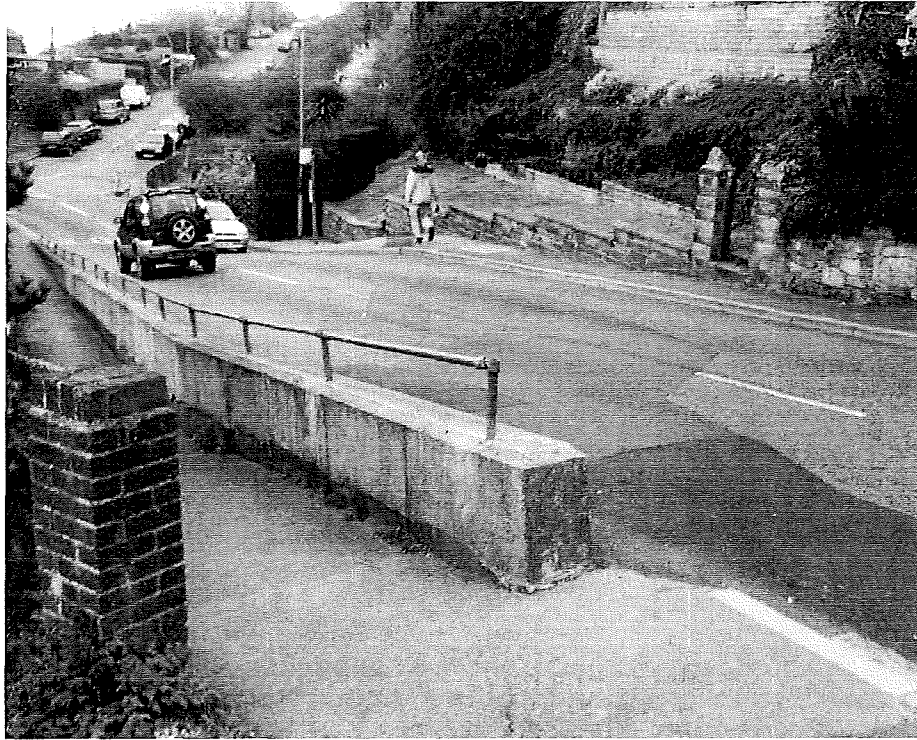
Figure 4a, Looking south down B3327 to Steephill Down Road, north side of graben

Remedial measures to date at Lowtherville graben comprise reactive filling of the graben feature as it settles plus patch-and-mend of the road surface when and where cracks appear. There is evidence of past engineering measures, for example, the construction of a low concrete retaining wall to support the filled road and separate it from the adjacent footpath on the east side of the road. Distress is evident at the site from ground movement, for example, distortion and cracking of adjacent walls, cracking of retaining walls, cracking of the concrete base to the handrail, patched areas in the road and contrasting road gradients throughout the site. Some photographs of the site are shown as Figures 4a, 4b, 4c and 4d.

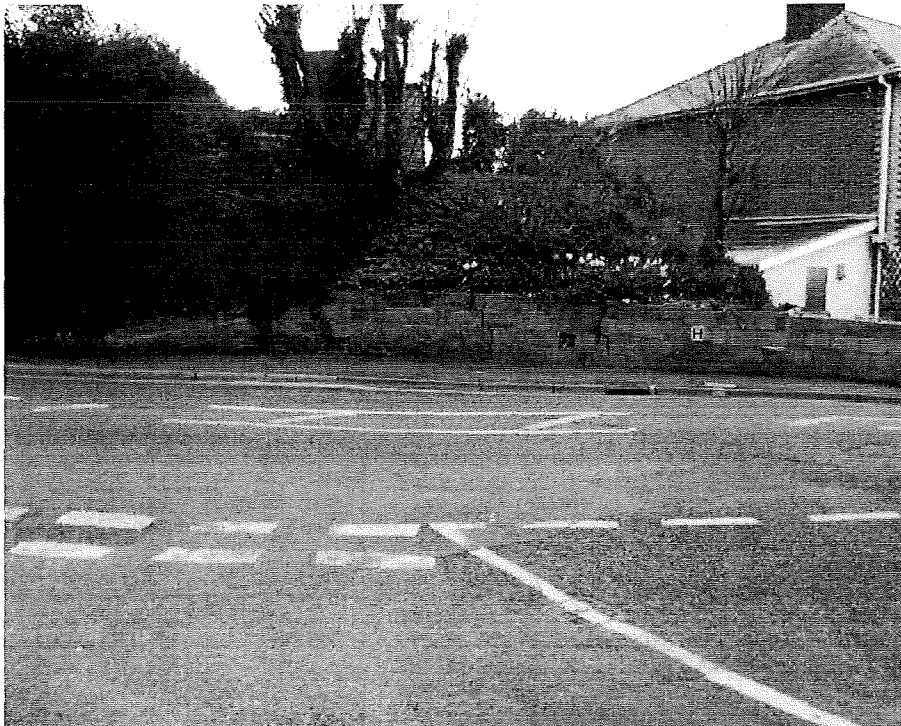
Figure 4b, Movement and cracking of wall at south side of graben opposite Upper Gills  
Cliff Road

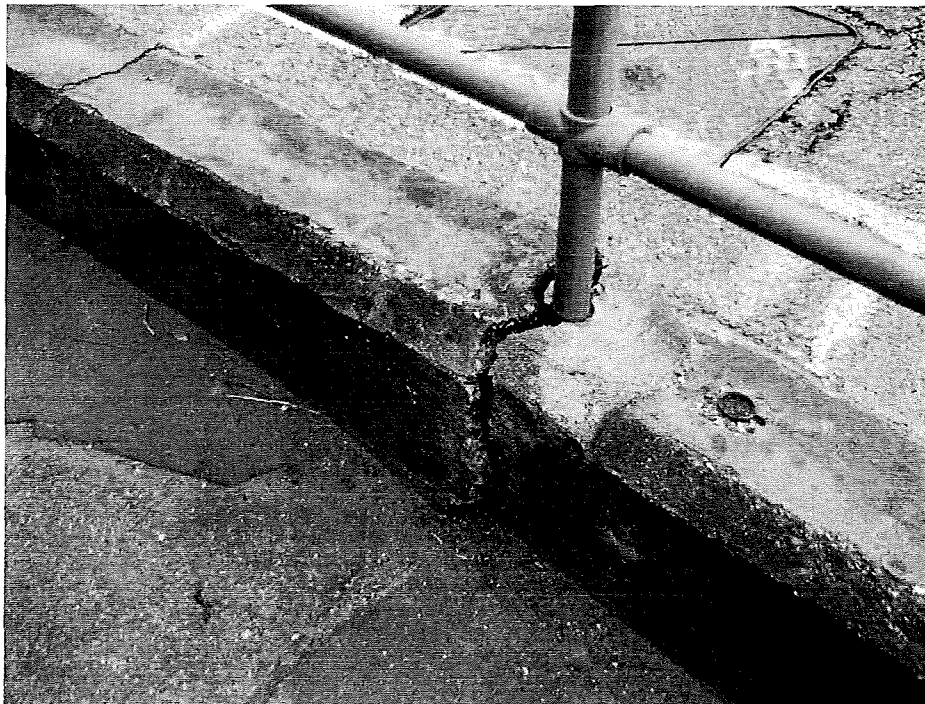
Figure 4d, Cracking of rigid handrail base, north side of graben
