Bembridge Section 19 Flood Investigation

Final Report

May 2022

Isle of Wight Council

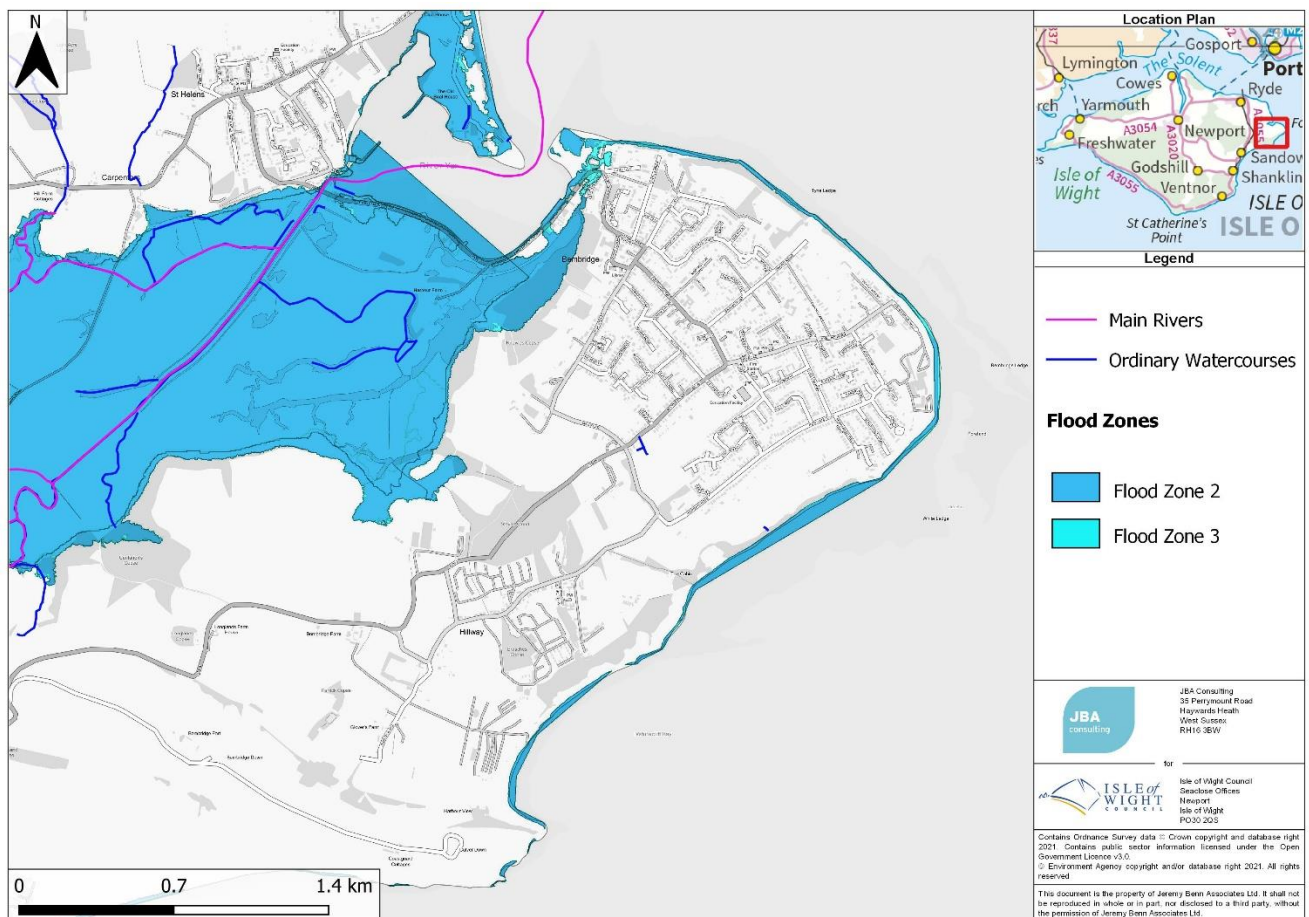
Figure 4-1: Risk of flooding from rivers and sea

In the study area, the risk of flooding from rivers and sea is limited to a small area in the west of Bembridge including Solent Landing, Harbour Strand, Station Road and Beach Road. The area surrounding the Eastern Yar, Brading Marsh, Bembridge harbour and the coastline of Bembridge is Flood Zone 2. It should be noted that these Flood Zones represent undefended flood risk and therefore do not consider existing flood defences.

It is noted that, whilst low-lying areas of Bembridge are at risk of tidal flooding, the June 2021 flood event was not due to tidal or fluvial flooding.

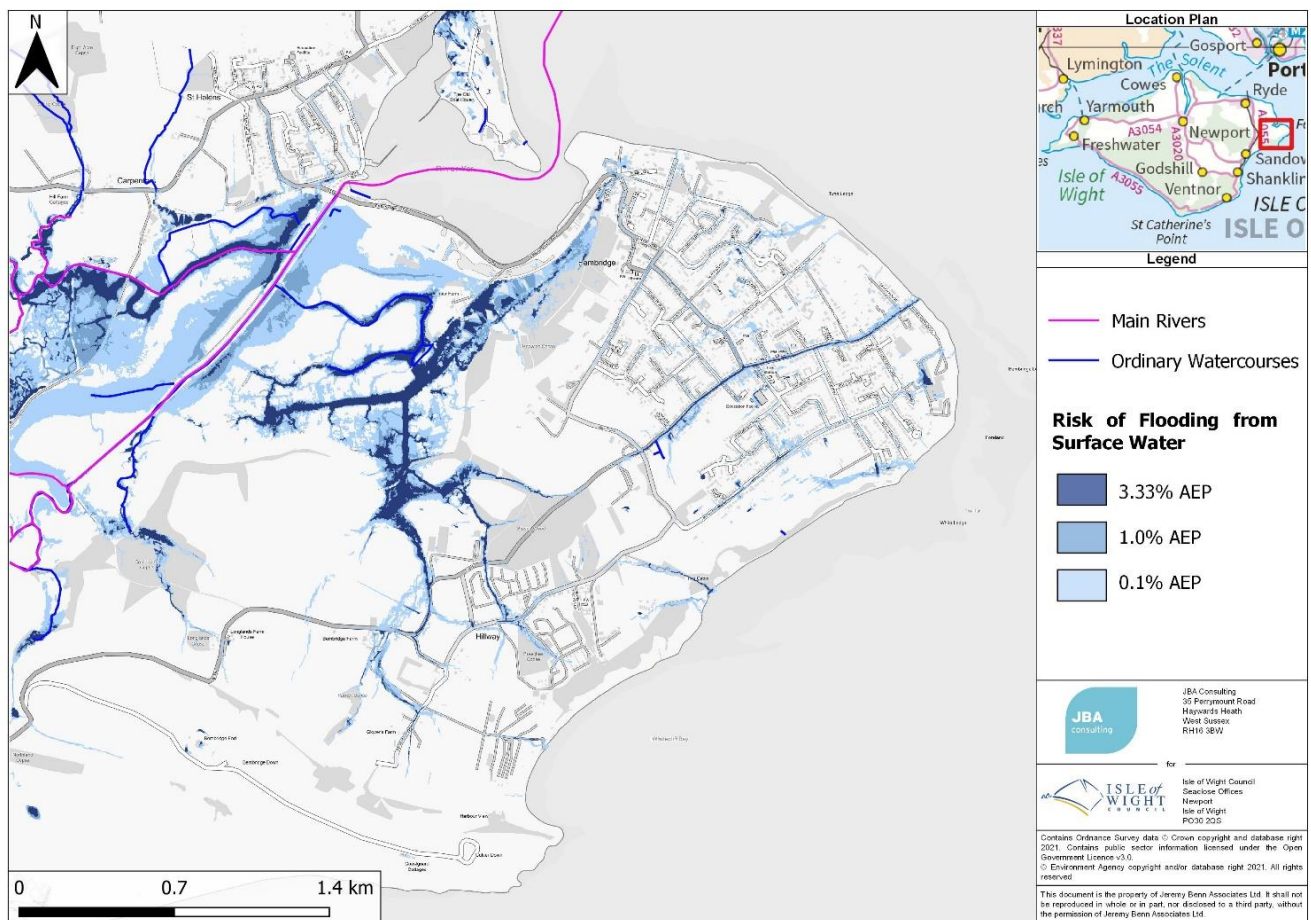
Figure 4-2: Risk of flooding from surface water

Surface water flow routes within the Parish predominantly originate from the steep chalk slopes situated to the south. Further mapping showing the study areas in detail is included in Appendix A.

Distinct flow routes are shown in Figure 4-2 and Appendix A from the northern side of the chalk outcrop at the high-risk event representing the watercourse at Bembridge Farm starting at Glover's Farm and Parrick's Copse, The Glover's Farm and Parrick's Copse pathways flow in a northerly direction before converging at Bembridge Farm.

The flow path at Steyne Road is shown in Figure 4-2 above as a largely constrained flow path following the route of Steyne Road to Lane End before flowing out to sea. The upstream convergence of flows from the roundabout at Steyne Road is shown clearly in the photographs in Figure 4-3.

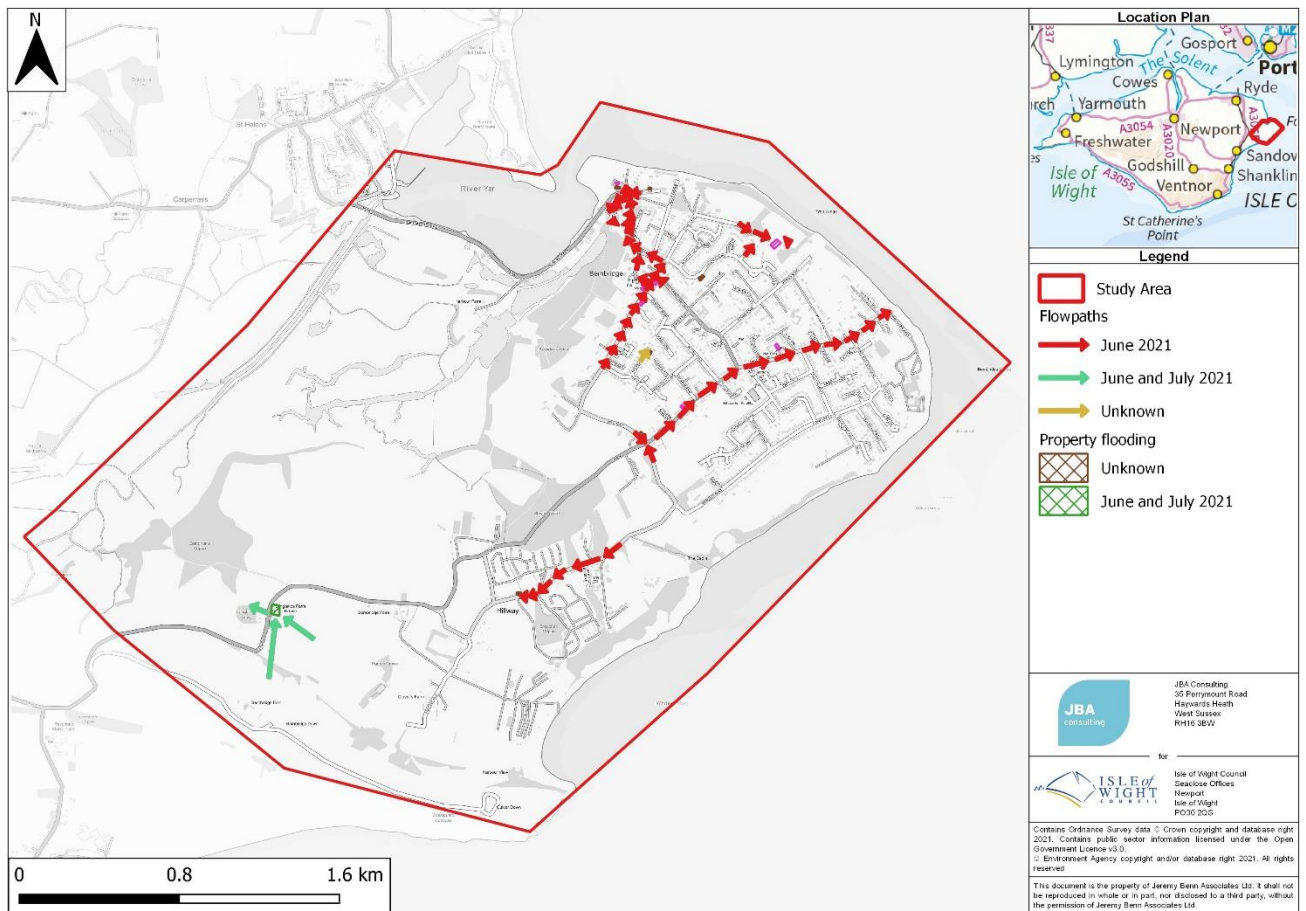
Figure 8-1: Overview of sources, pathways and receptors

We analysed all available information to determine the main sources of the flood water, the pathways it took and the main receptors. These are summarised and described in the following sections. Figures 8-1 and 8-2 provide an overview of the flow paths during the flood event on 28 – 29 June 2021.

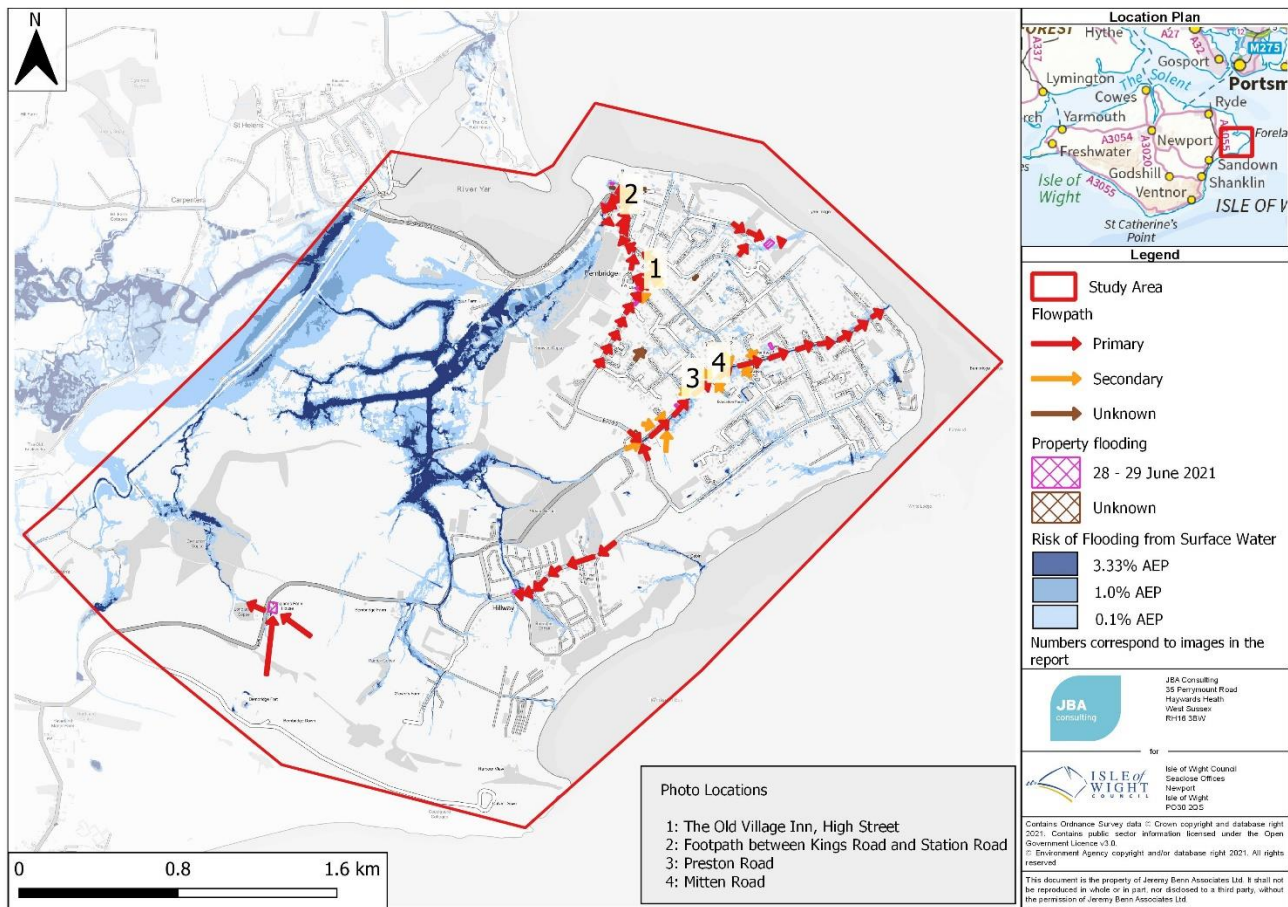
Figure 8-2: Sources, pathways and receptors for June 2021 event

Figure 8-2 demonstrates the pathways of the water during the flood event on the 28 to 29 June 2021. The Risk of Flooding from Surface Water map (Figure 4-2) identifies surface water flow routes and areas of ponding which reflect the flood pathways. In this pathway, roads, footpaths and gardens act as conduits for the flood water.

There were four main pathways in the Bembridge area. This included the High Street down to Solent Landing/Station Road; Steyne Road to Lane End Road; pathways from Bembridge Down to Longlands Farm and in a south westerly direction along Hillway Road. The source-pathway-receptor overview for the 28 to 29 June 2021 event is shown in Figure 8-2 below. Flow paths are separated into primary pathways, where reported and modelled flood information provides a good evidence base, and secondary pathways which are indicated by modelled information but with limited alternative information.

A secondary flow path may have formed along Love Lane and Tyne Walk, as shown in Figure 8-2. Flooding was reported on Love Lane at the transition from highway to bridleway, and property flooding may have occurred although no additional information regarding the flood mechanism at this location was provided. In addition, no reports of flooding were received from Tyne Walk, where the RoFSW mapping indicates that flooding may have occurred. The single report of flooding in Meadow Drive is believed to relate to foul water, suggesting exceedance of the public sewer. It is therefore possible, but not conclusive, that the convergence of surface water flows from Tyne Walk and Love Lane followed the preferential flow route to the coast with the possible addition of flows from the surcharged sewer.

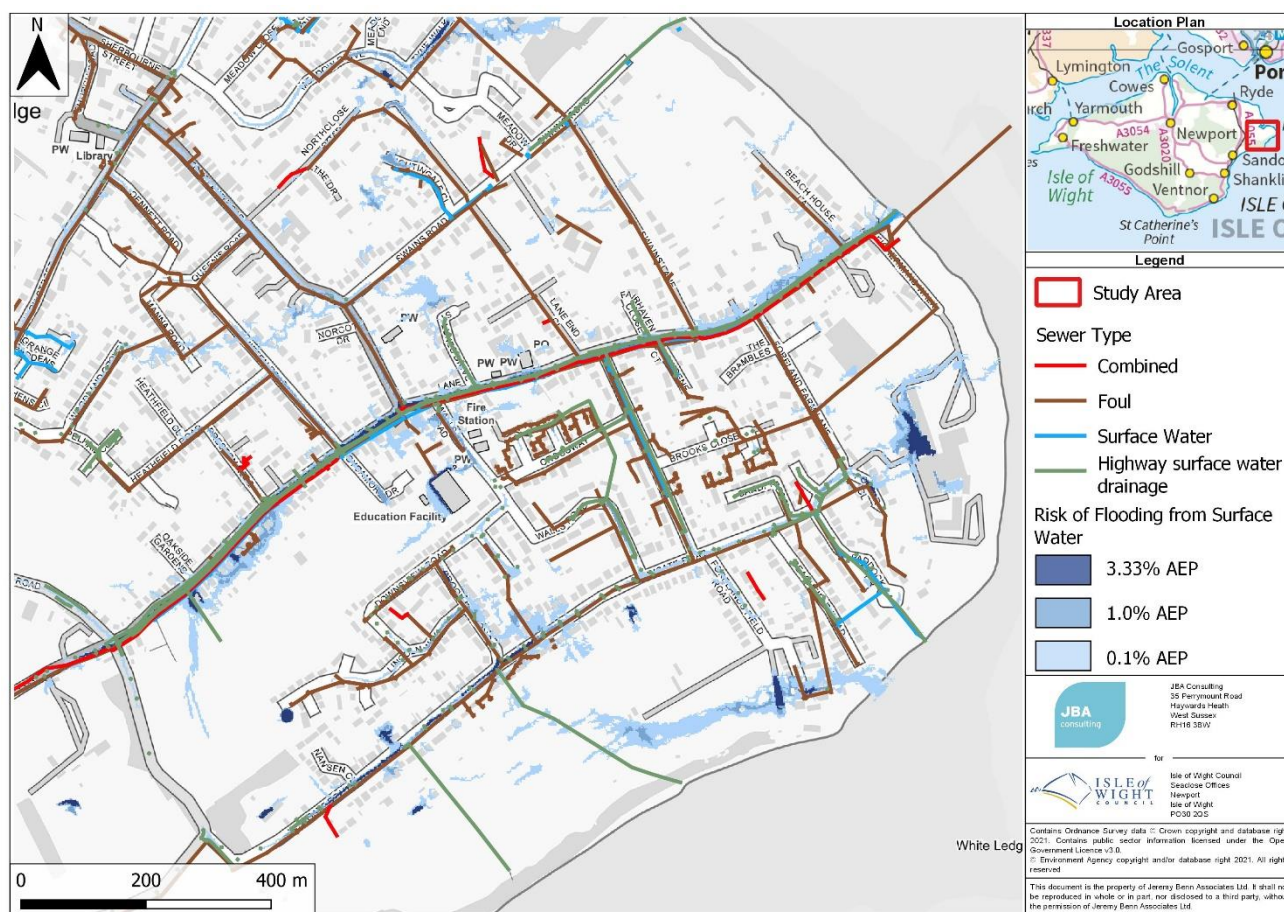
Figure 9-2: Sewer network and highways drainage around Steyne Road

The sewer system along Steyne Road is shown to be combined (as shown in Figure 9-2) and the highway drainage system also appears to discharge to the combined sewer network.

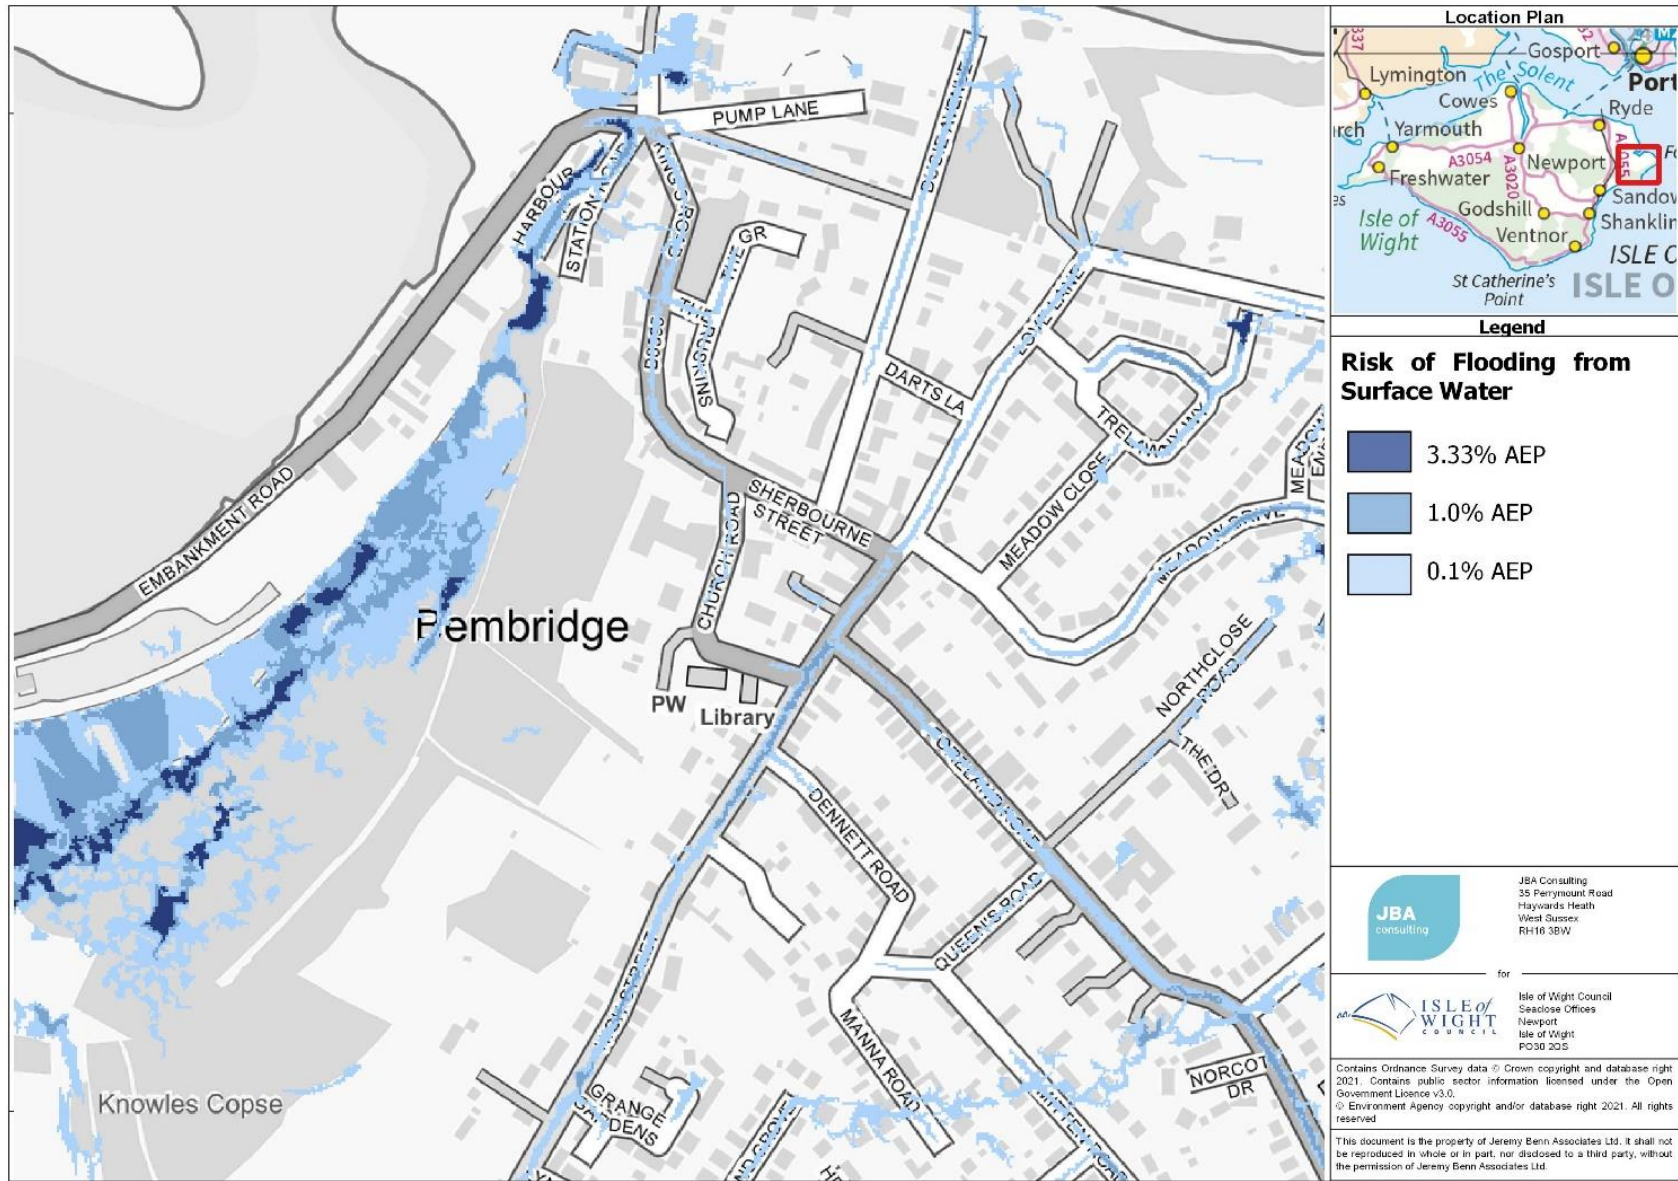
Figure 11-3: Risk of flooding from surface water from High Street to Solent Landing

In medium risk rainfall events, the RoFSW mapping shows surface water flooding on High Street in the vicinity of Dennett Road, with a flow path from Bembridge High Street in low probability (0.1% annual probability events) predicted to flow down King's Road towards Solent Landing (Figure 11-3).

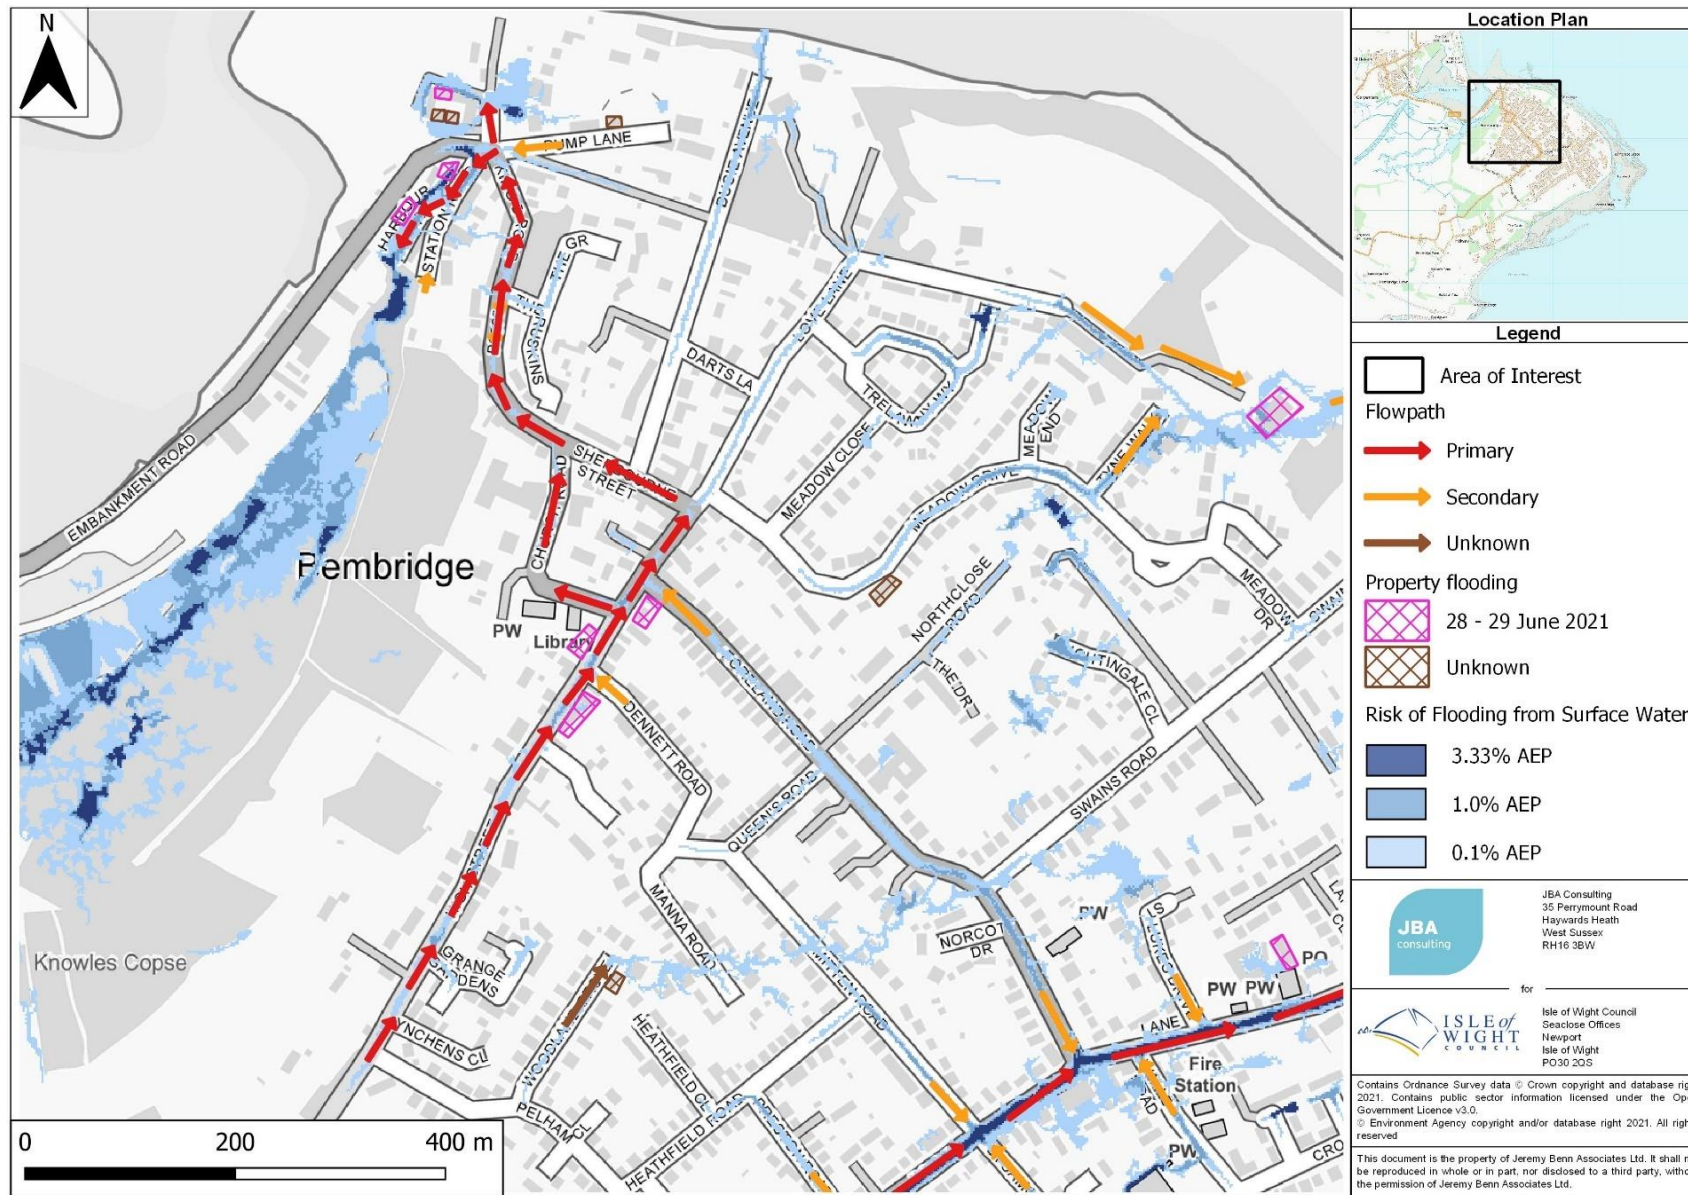
Figure 11-6: Sources, pathway and receptors - High Street to Solent Landing

Surface water flowed northwards from High Street down Church Road and Sherborne Street to Kings Road which was described as “a river” by a local resident. The surface water then followed the steep topography, converging with surface water flows from Pump Lane to the south west at the Pilot Boat Inn. The joint surface water flow path then continued towards Beach Road; Solent Landing; Station Road and Harbour Strand (Figure 11-6) where it contributed to flooding of residential properties.
