Isle of Wight Council

**Cowes to Gurnard Coastal Slope Stability Study
Ground Behaviour Assessment
August 2000**

Halcrow Group Limited

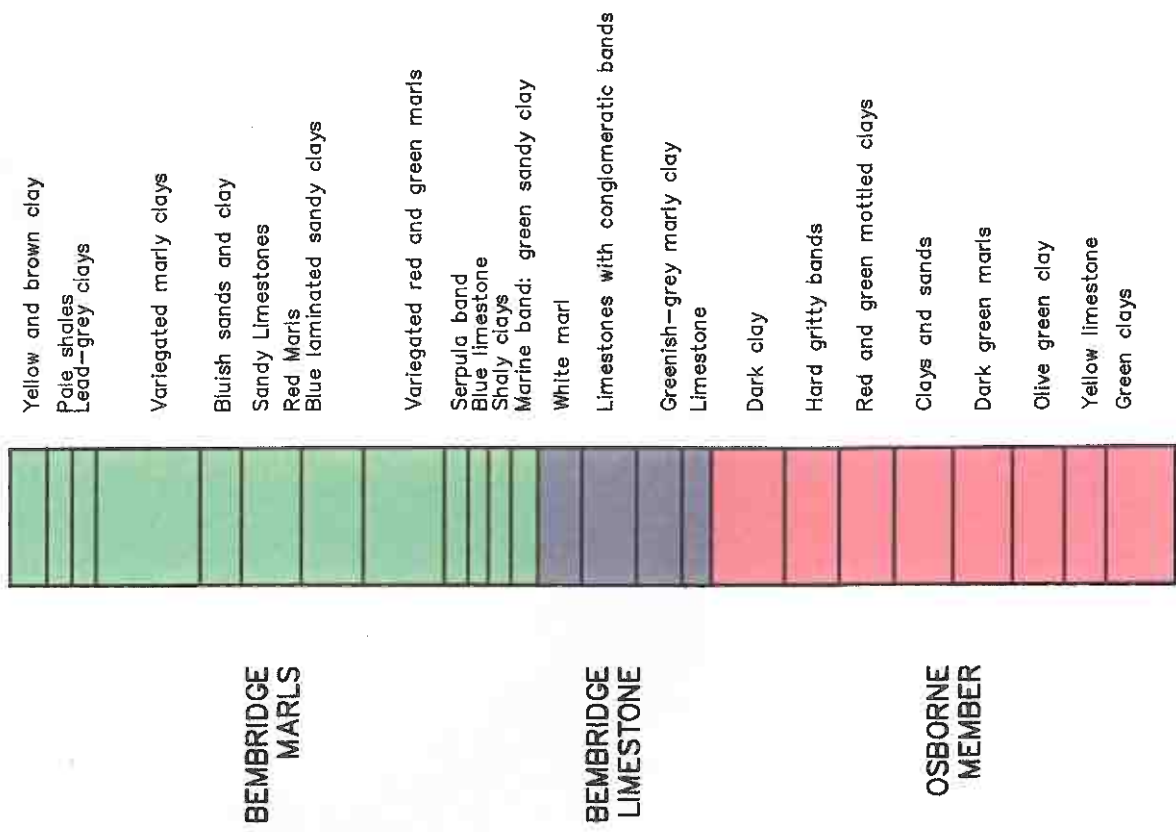
Figure 3 Geological Formations and Generalised Column

The solid strata to be found in the study area are summarised in Figures 3 and 4 along with their approximate thickness. They include the Osborne Member and Bembridge Formations, comprising Bembridge Limestone and Bembridge Marls, overlain by superficial Plateau Gravel.

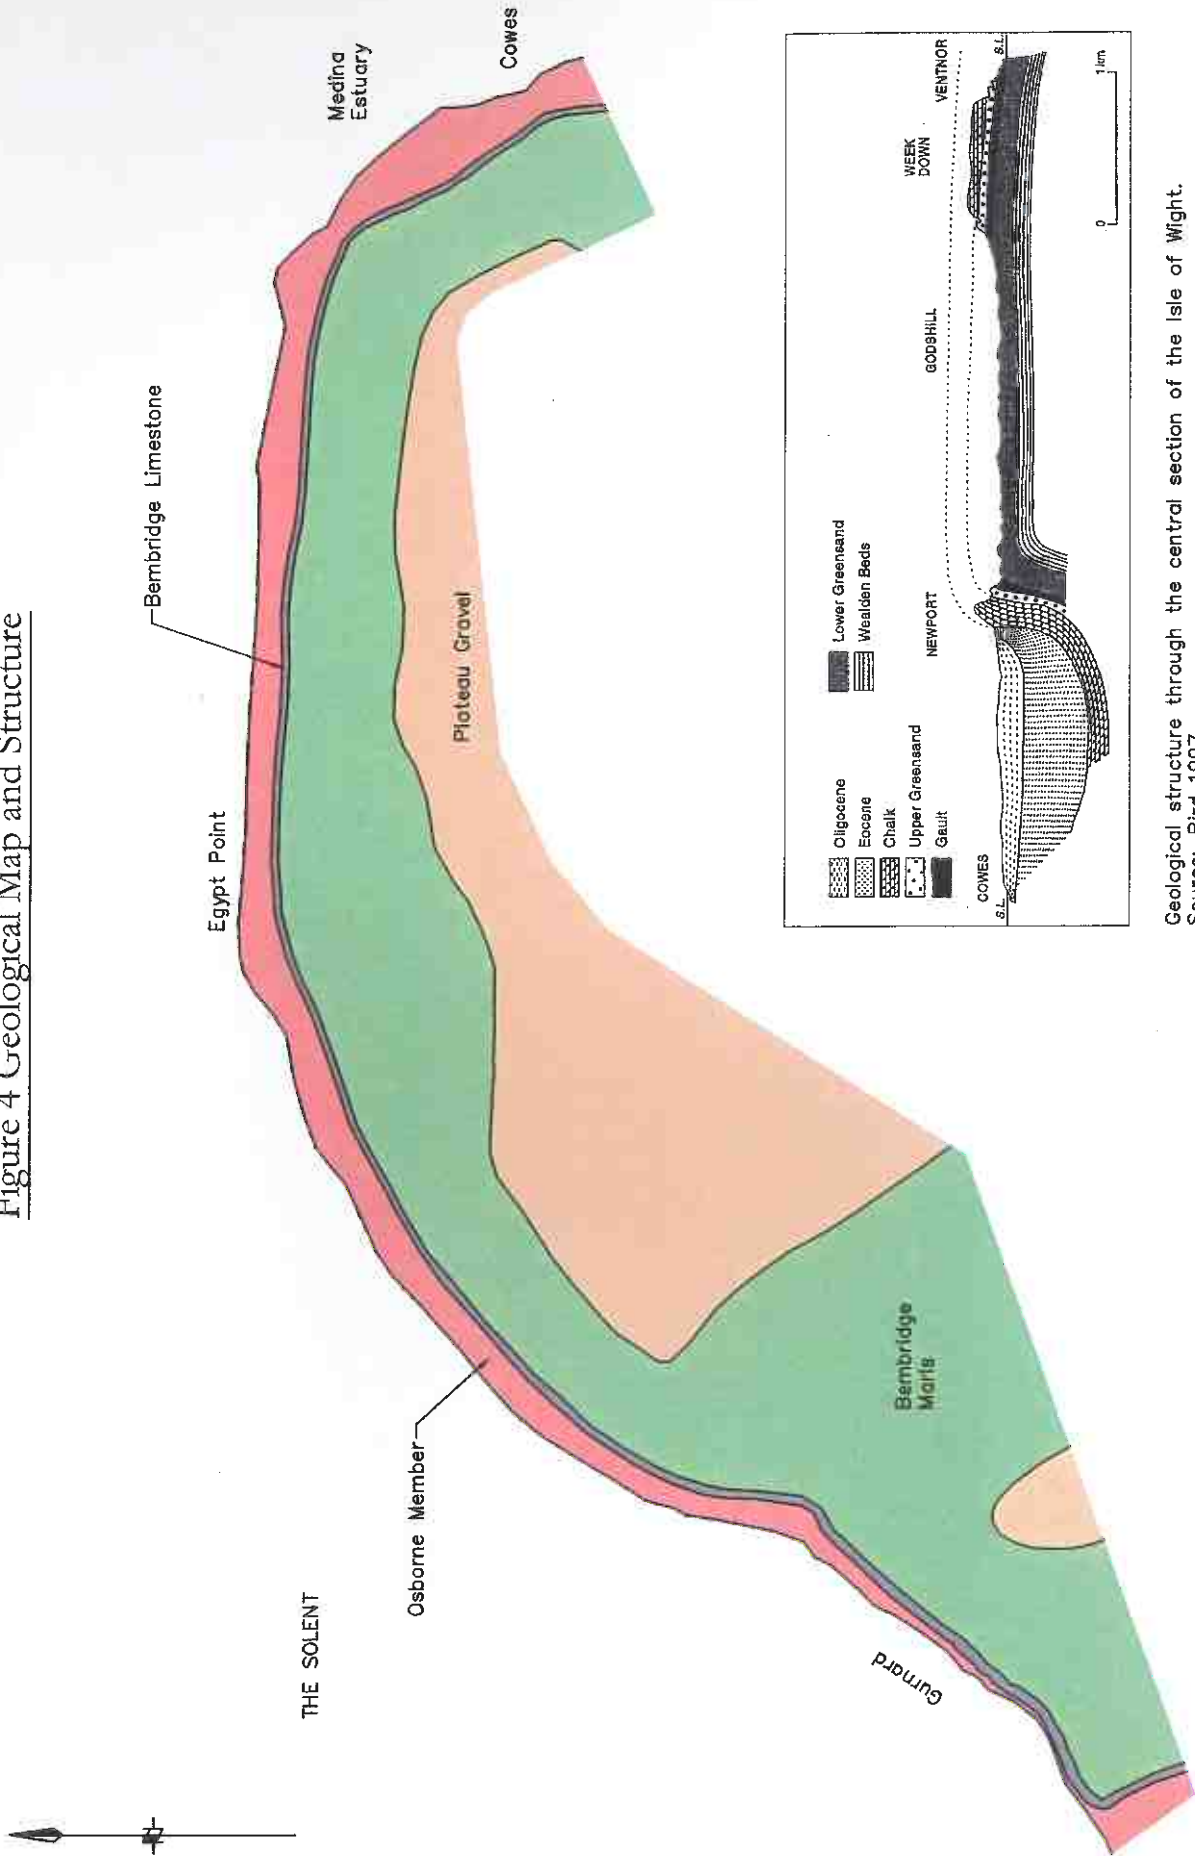
Figure 4 Geological Map and Structure

The **Bembridge Limestone** is about 5 to 8m thick, thinning to the west. They comprise massive beds of pale limestone with intercalated greenish clays. The limestones outcrop at the base of the coastal slopes, typically above sea level (Figure 4). They are jointed and may have been displaced by slope instability where they are encountered within 5m of the ground surface. The limestone, albeit thin, provides a relatively coherent stratum within otherwise incoherent clay strata.

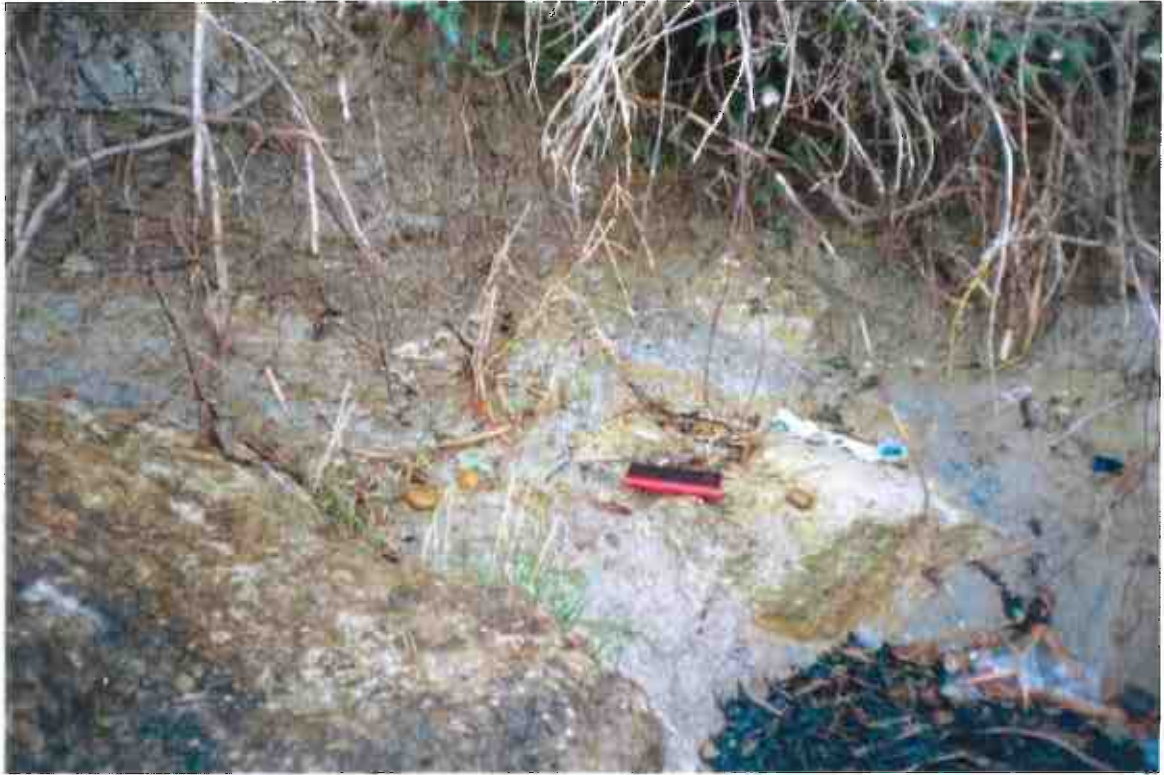
Plate 9 Osborne Marls Exposed at Gurnard Cliff

The oldest stratum, the **Osborne Member**, is 22 to 23m thick in the north of the Isle of Wight. The unit consists of brackish and freshwater clays and marls, some highly coloured red and green, and discontinuous bands of concretionary limestone, shells and fish beds. The strata outcrop at the base of the coastal slopes, where they have been exposed by coastal erosion in places (Plate 9) and extend below sea level.
