GROUND MOVEMENT IN VENTNOR, ISLE OF WIGHT

A SUMMARY OF THE STUDY OF LANDSLIDE PROBLEMS IN VENTNOR, CARRIED OUT FOR THE DEPARTMENT OF THE ENVIRONMENT (Research Contract No. PECD 7/1/272)

Geomorphological Services Limited

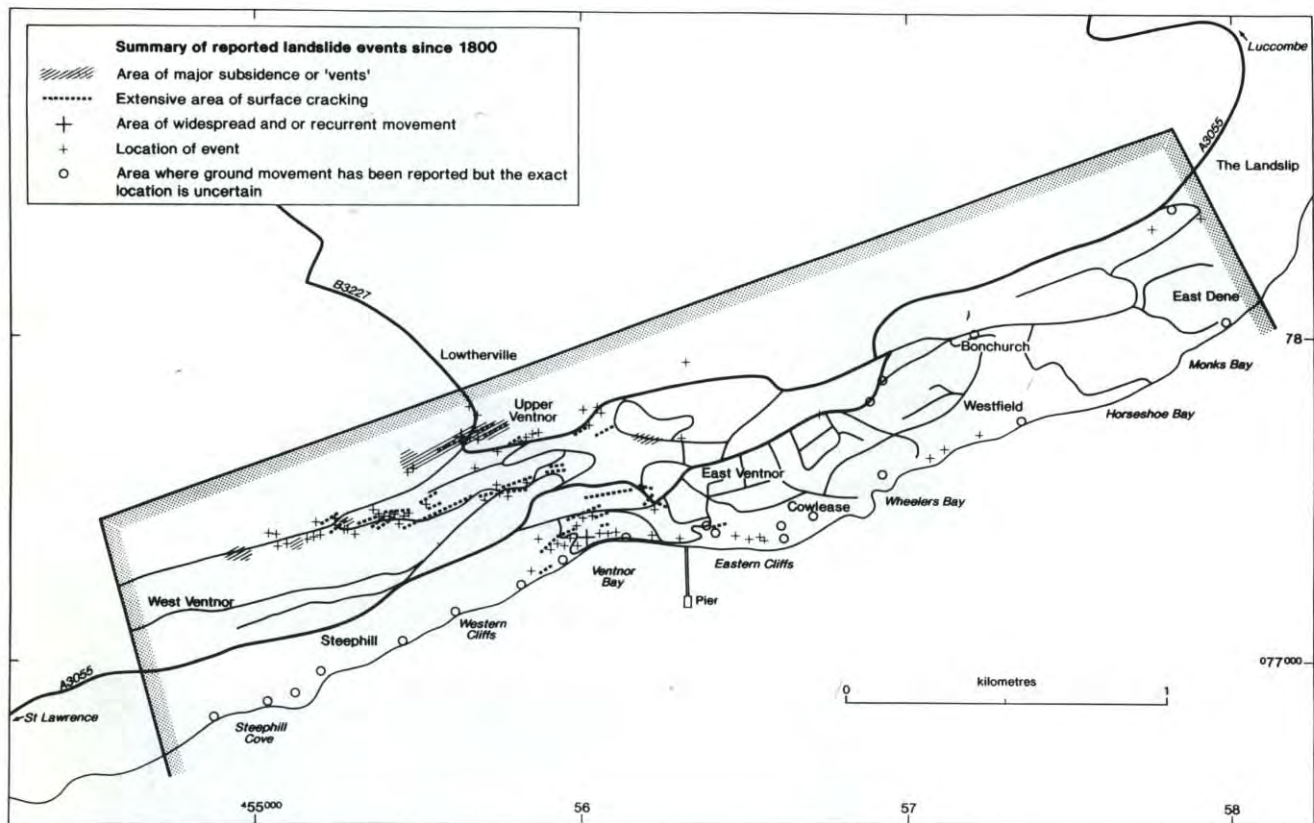
Figure 1: Summary of reported landslide events since 1800

the Havensbush play area where slow settlement seems to have been an almost continuous problem. Besides resulting in road repairs almost every year, a number of properties, including a sub-Post Office, were so badly damaged that they had to be demolished. Elsewhere, ground movement has recently resulted in further cracking along Bath Road and damage to property and services along both The Esplanade and Castle Court.

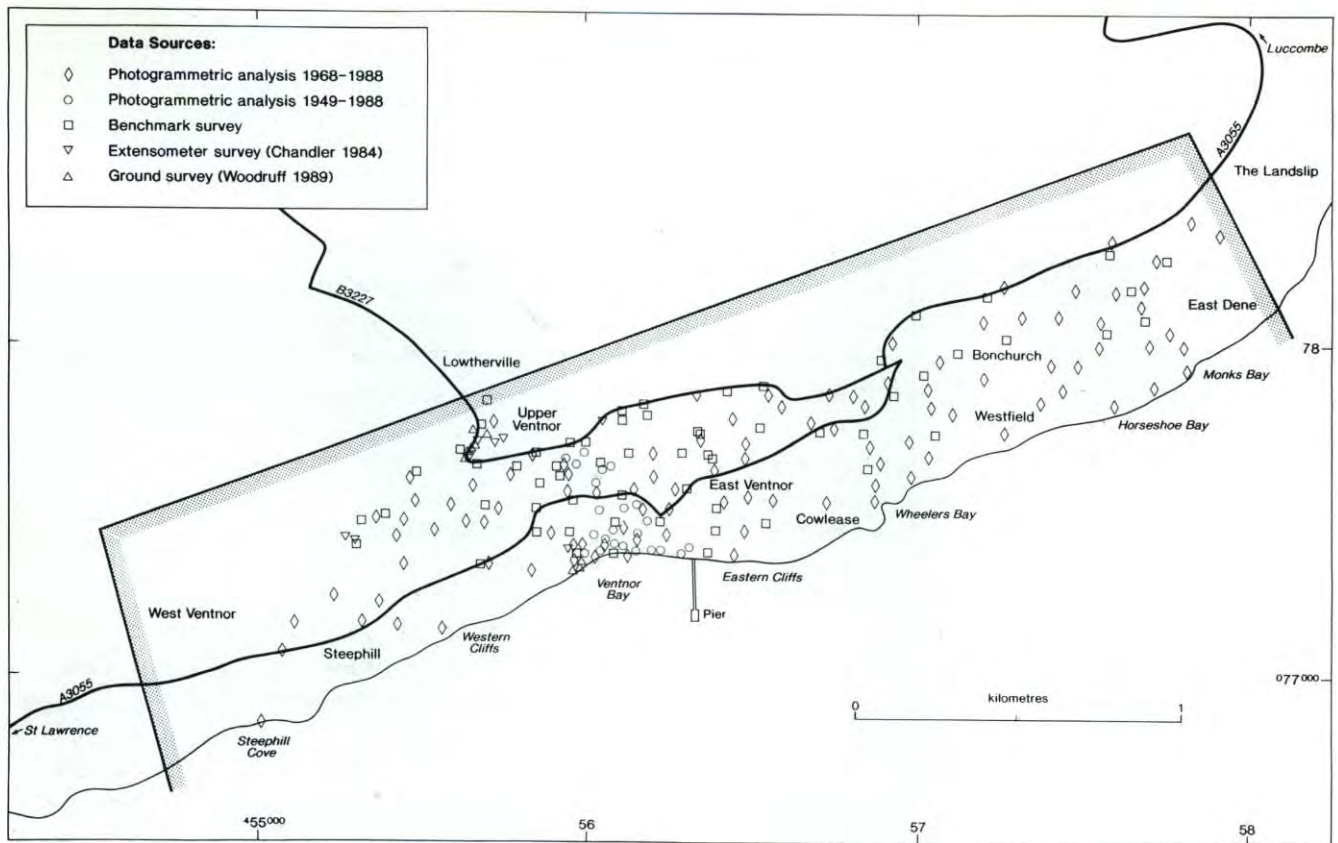
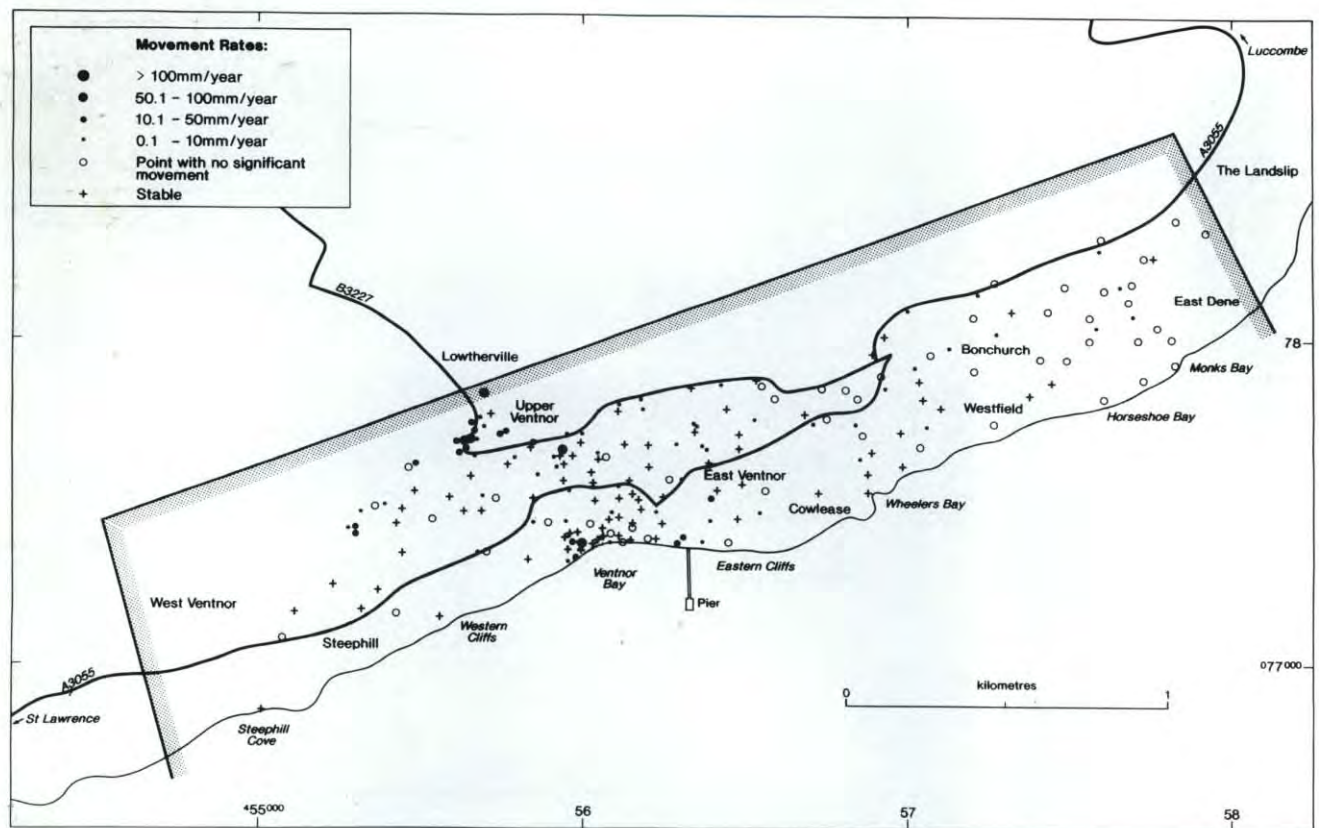
Figure 2: Ground movement rates in Ventnor

In 1982-1983 Martin Chandler¹ monitored short-term movement across cracks at seven sites in Upper Ventnor and one site along Bath Road. He measured the differential movement between pairs of reference studs on either side of a crack. The average annual movement rates were:

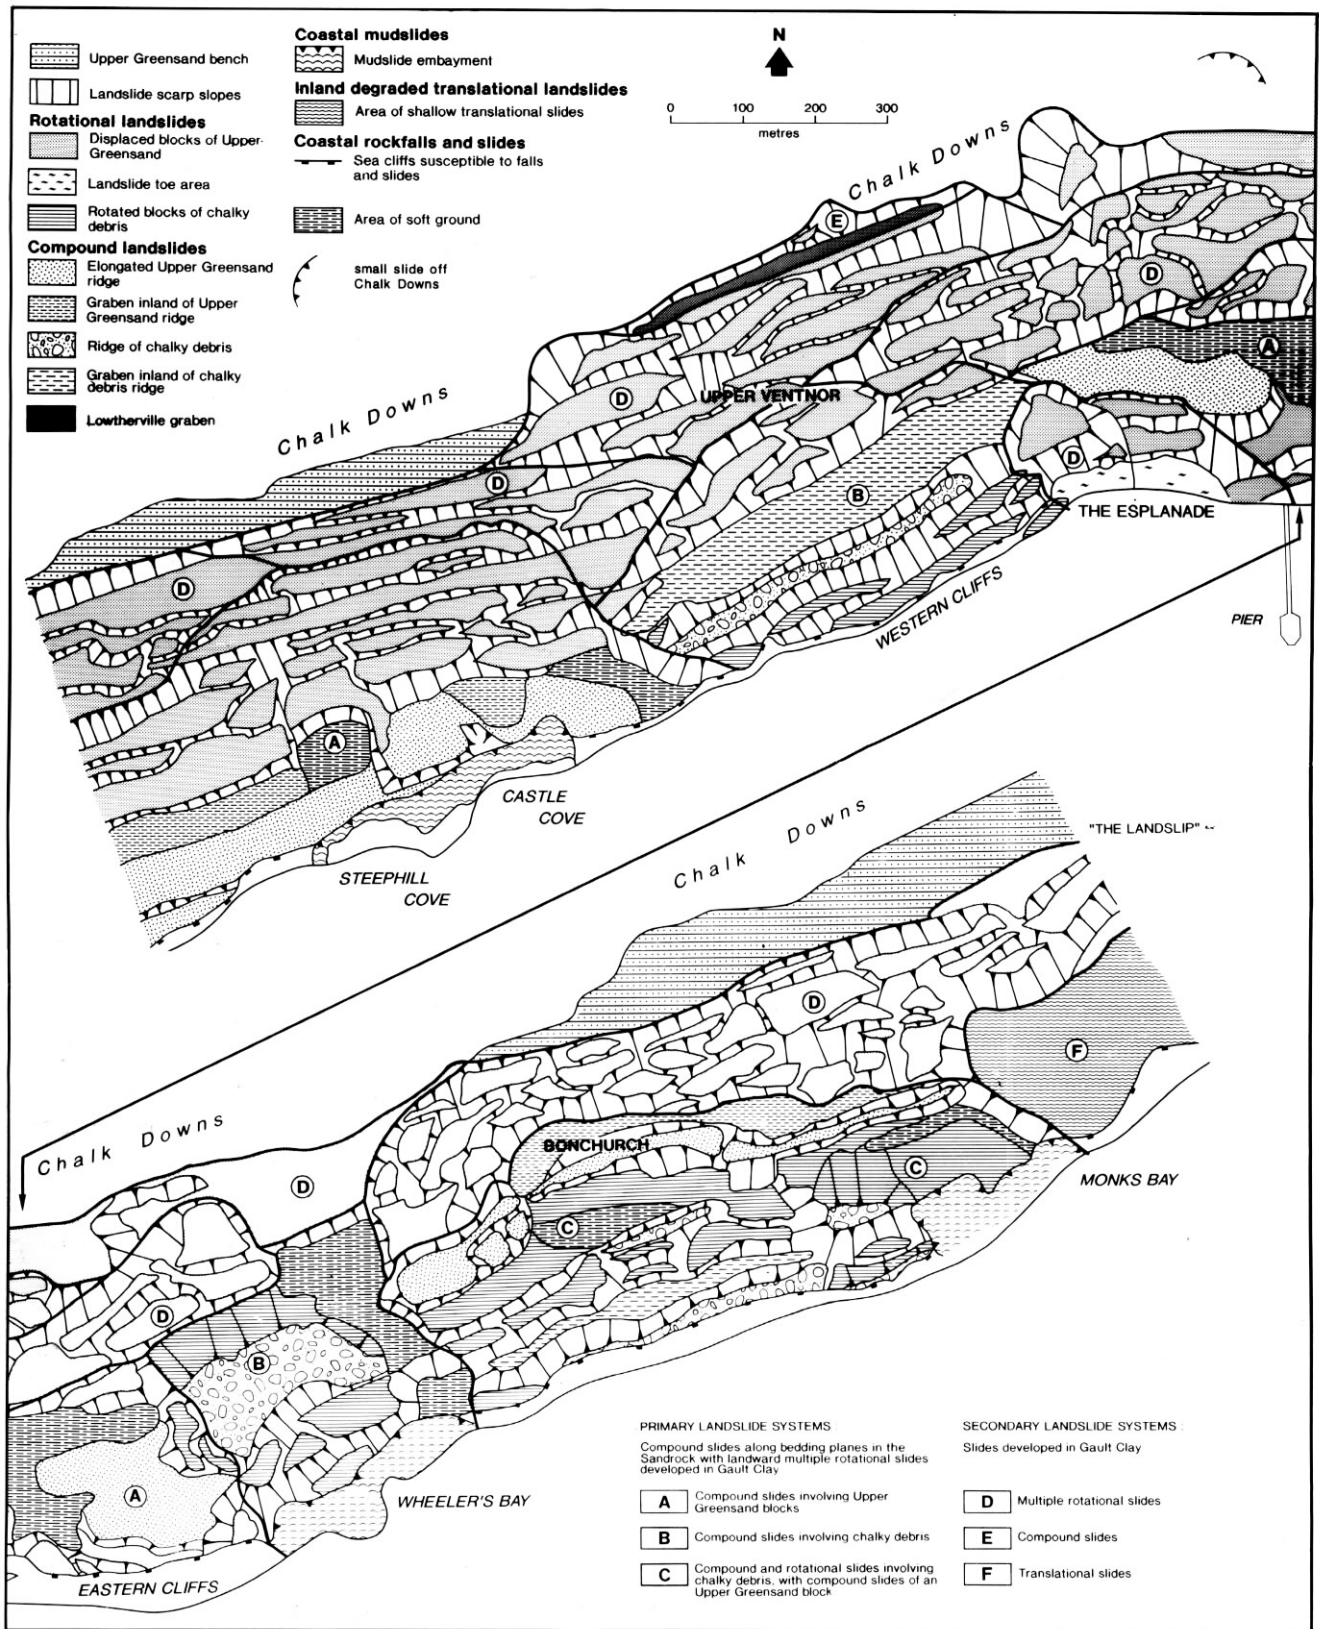
Figure 5: Summary geomorphological map of the Undercliff at Ventnor

The **Upper Greensand bench** lies immediately below the Chalk Downs. This is a narrow (60-180m wide), gently seaward-sloping bench. It is not a continuous feature, being absent from the central part of the area. Where present, the bench varies in elevation along its length, indicating that it is partly displaced by sliding. Over a long period of time the movement of the landslide features downslope has led to the removal of lateral support for the bench. This has resulted

in the formation of open joints ('vents') and slight subsidence (increasing seaward) of the intervening blocks.

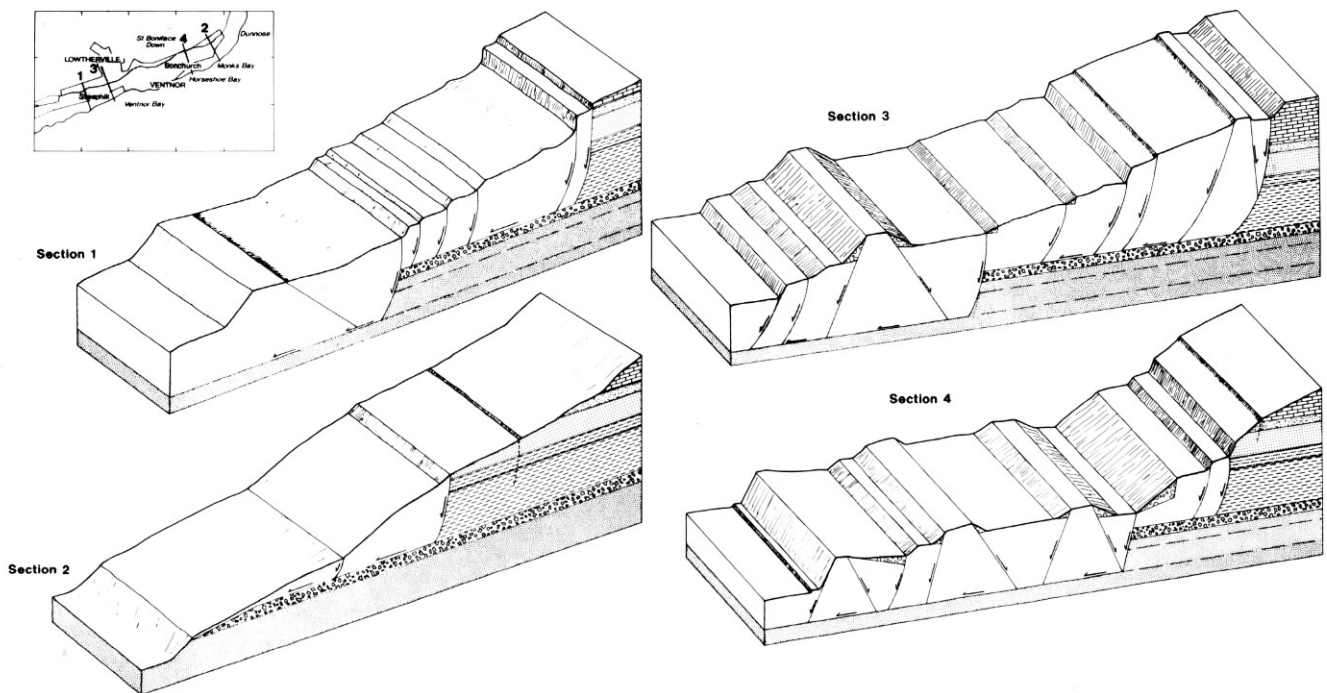
Figure 6: Schematic sections through the Undercliff

Zone I; compound failures along clay layers within the Sandrock in the seaward part of the Undercliff, following the St Catherine's Point model⁴.

Zone II; multiple rotational or compound failures, to the landward, on slip surfaces within the Gault Clay, following the Gore Cliff model where the basal slip surface is 15-18m above the base of this unit³.

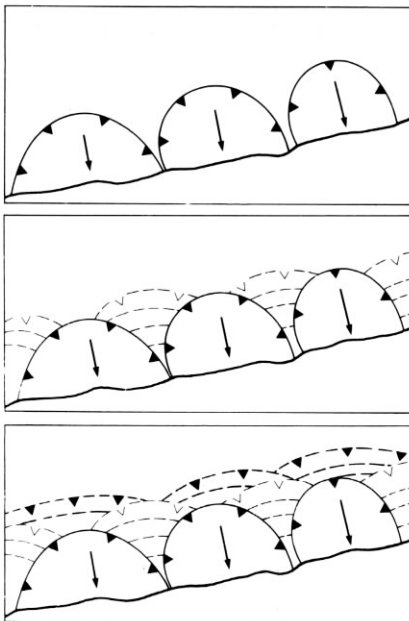
Figure 7: The development of the Undercliff. **Top:** development of deep-seated primary slides **Middle:** unloading of spurs leading to multiple rotational failure **Bottom:** further unloading leading to retrogressive multiple rotational failure

The formation of the Undercliff is believed to be related to the interplay of climatic changes and sea level rise over the last 20,000 years or so. During periods of low sea level in the last "ice age" the coastal slopes became fronted by large aprons of landslide debris which would have acted as a natural protection to the slopes. However, the rise in sea level after the ice melted would have caused parts of the aprons and even the coastal slopes to be eroded away. As a result of this erosion, the slopes probably became partially destabilised and major deep-seated landslides developed on the lower sections (Zone I). The curved backscars of these lower slope landslide systems appear to have isolated a series of broad, triangular spurs. These spurs have subsequently failed as a result of the unloading on either side caused by movement of the earlier slides (Zone II; Figure 7). In this way a pattern of closely related landslide systems has developed (Figure 5) in response to the gradual unloading of the lower portions of the Undercliff.

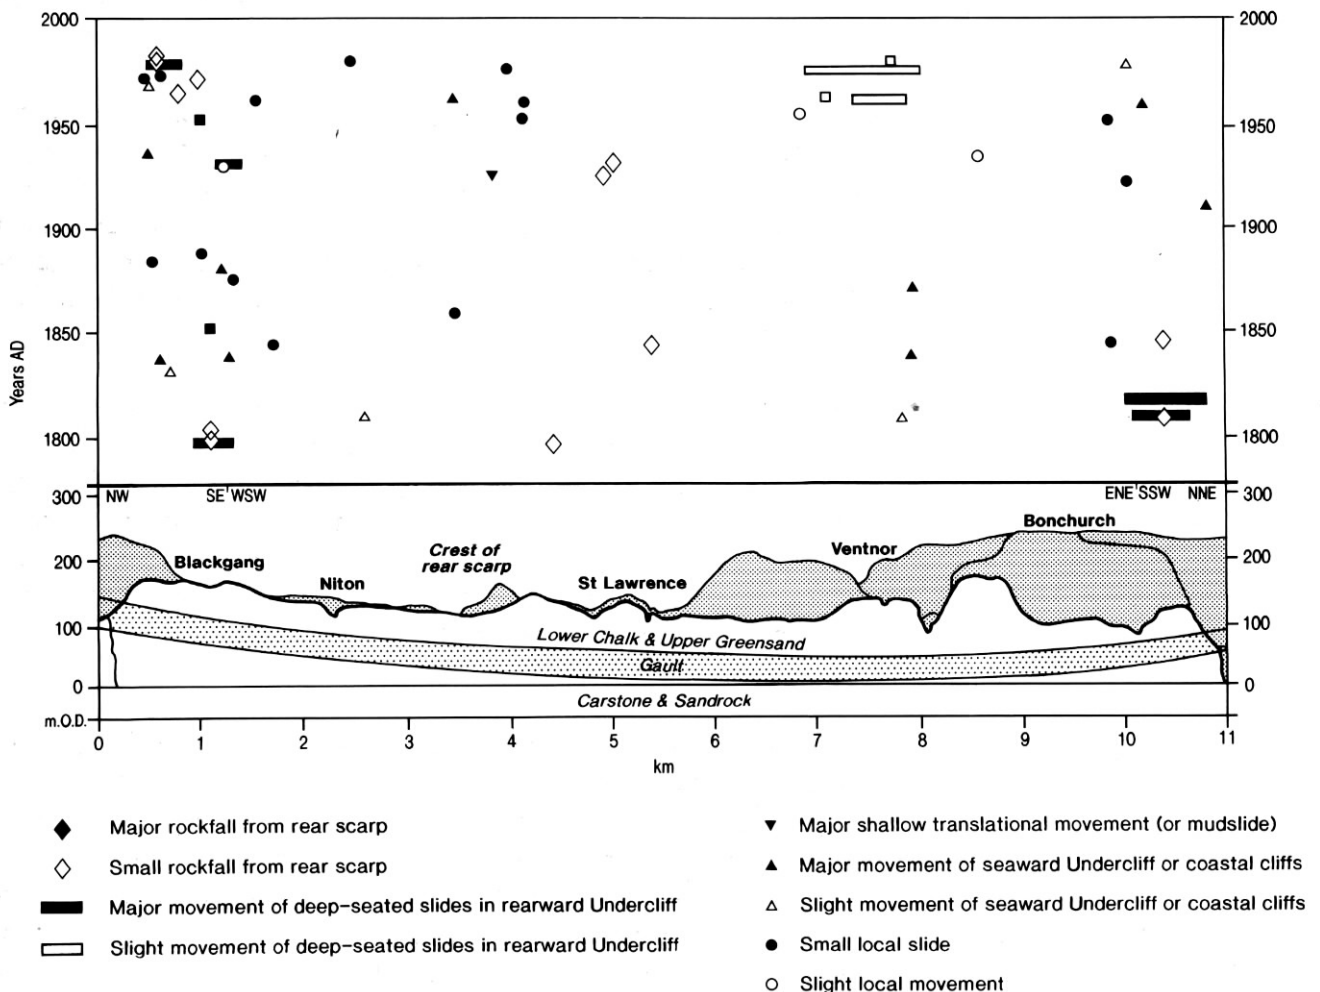
Figure 8: Landslide activity along the Undercliff (after Hutchinson 1965)

The fact that all parts of the Undercliff do not show similar frequencies or magnitudes of landslide activity emphasises the importance of other factors than just coastal erosion. The most active sections over the last 200 years have been the western and eastern ends (Blackgang and Dunnose, respectively), with considerably less movement in the intervening areas. This variation is influenced by the presence of a broad concave down-fold (syncline) in the rocks which controls the height of the Gault Clay relative to sea level¹. The two most active areas occur where the clay is at its highest elevation along the coast (Figure 8).

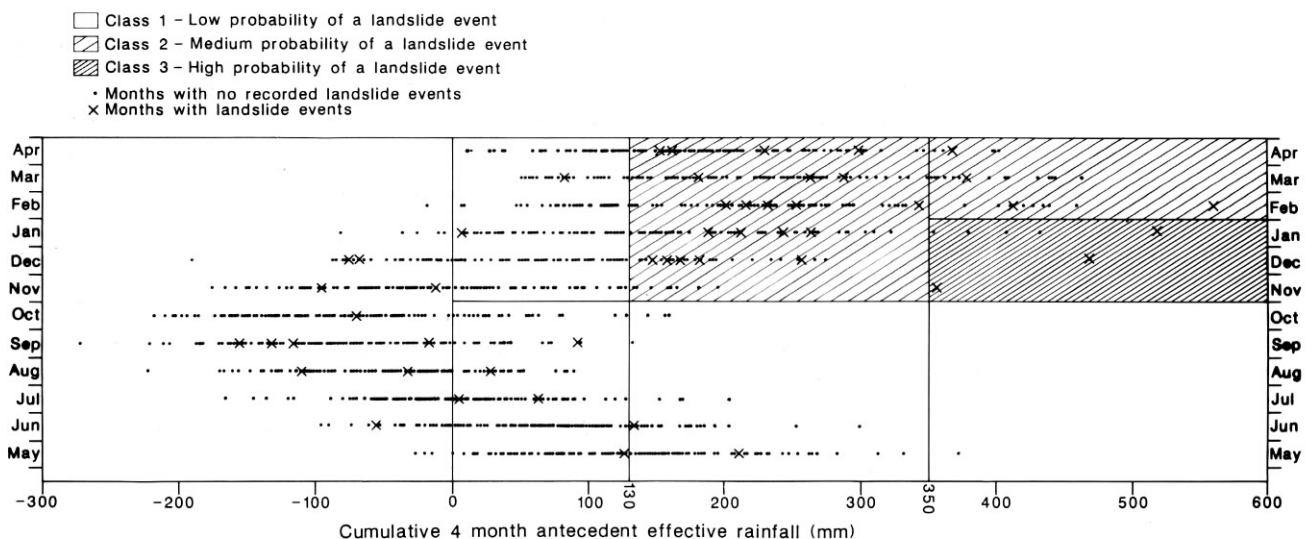
Figure 9: The relationship between antecedent effective rainfall and landslide activity in Ventnor

Class 3 - when there has been a 1 in 1.7 (60%) chance of movement, corresponding to conditions between November and January when the AER exceeds 350mm. Such conditions have occurred 1 year in 22.

Very wet conditions in the autumn are clearly a highly significant factor in explaining the frequency of landslide activity over the last 135 years, with over 80% of all recorded landslide events having occurred during periods when the 4-month AER exceeded 130mm. However, this relationship does not account for the occurrence of all periods of landsliding within Ventnor, as movements have been recorded during periods of very low antecedent rainfall conditions. Such movements may have been either of a type which is less sensitive to long-term rainfall patterns (e.g. coastal falls) or due to human activity.

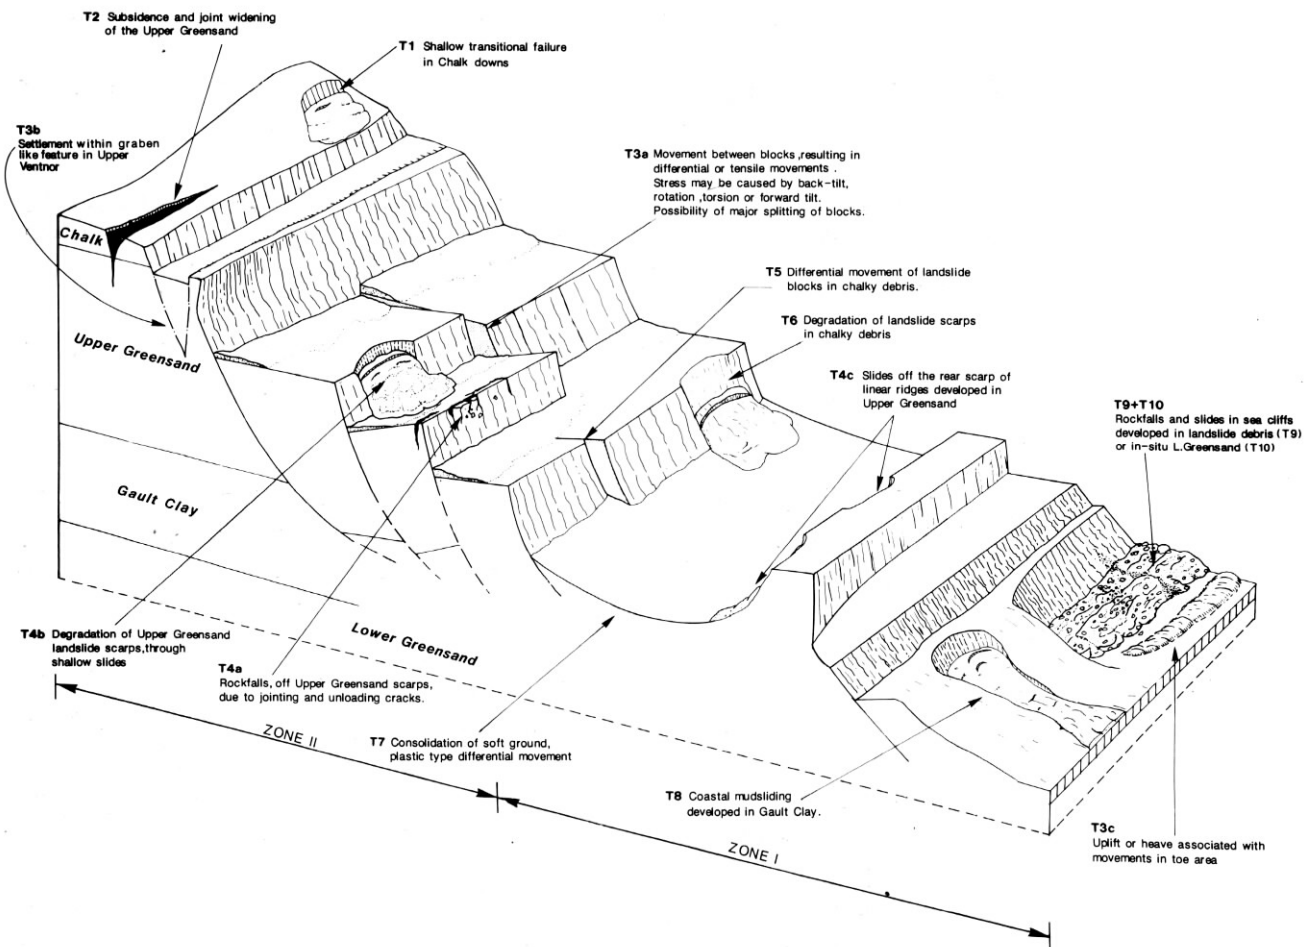
Figure 10: Types of contemporary ground movement in Ventnor

Type 2; slow settlement of the Upper Greensand bench, accompanied by joint widening and the development of vents. The most widely reported example occurred along Whitwell Road in 1954^{2,3} (Chapter 1).

Type 3; differential movement of Upper Greensand blocks, including:

Type 3a; rotation, forward tilt, torsion and differential settlement. This type of movement has taken place in many parts of the town, most notably in Upper Ventnor. Clear examples of such movements were reported along Gills Cliff Road, Ocean View Road, Castle Road and Zig Zag Road in the winter of 1960-1961⁴.

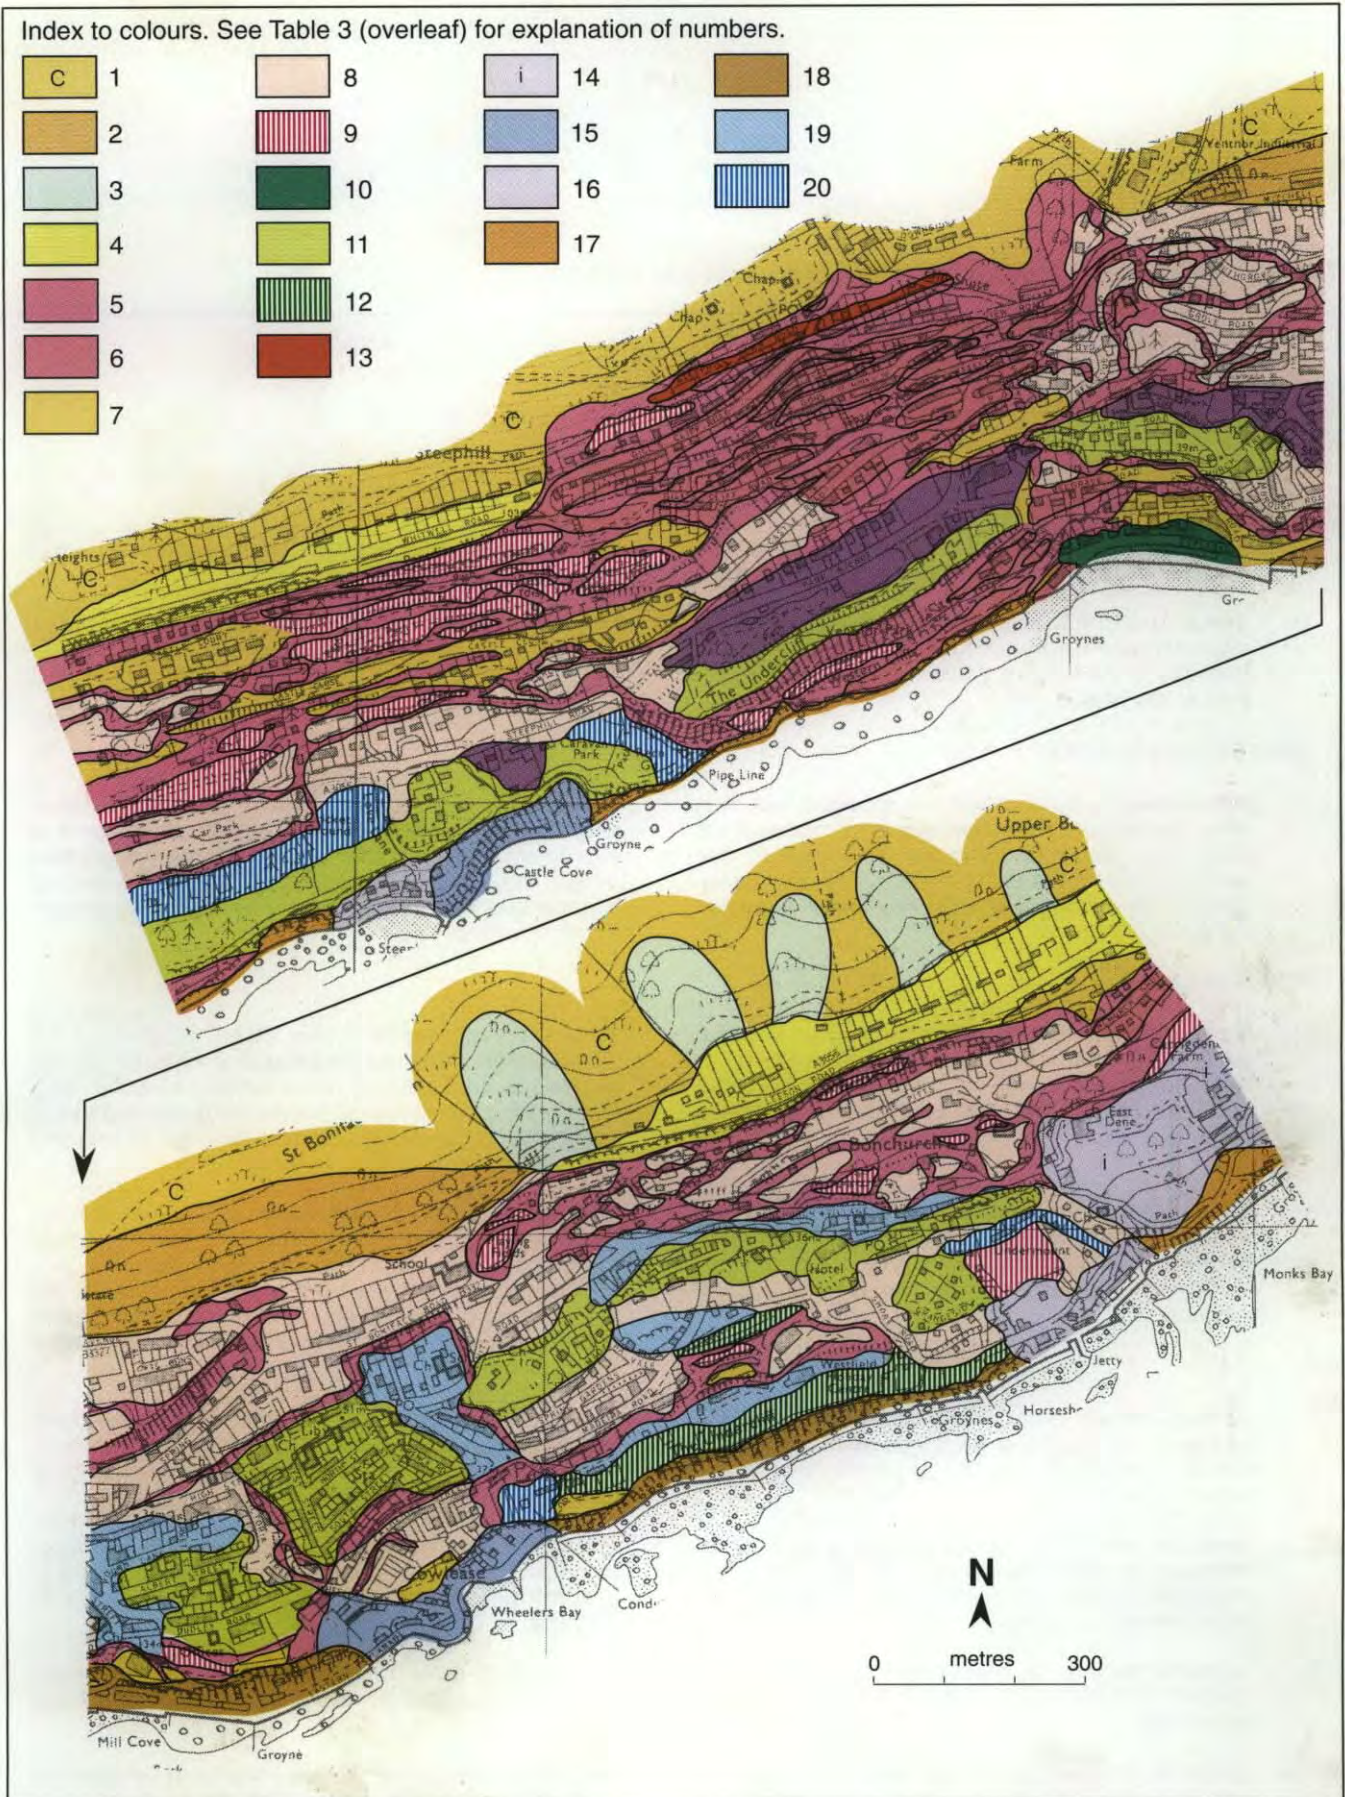
Figure 12: Summary ground behaviour map

The ground behaviour map was produced at 1:2,500 scale but has been generalised for the purposes of Figure 12 (with an accompanying legend in Table 3). The map is a synthesis of the following information:
