## **Isle of Wight Shoreline Management Plan 2**

### **Appendix C: Baseline Process Understanding** **C2: Defence Appraisal**

December 2010

**Coastal Management;**  
**Directorate of Economy & Environment, Isle of Wight Council**

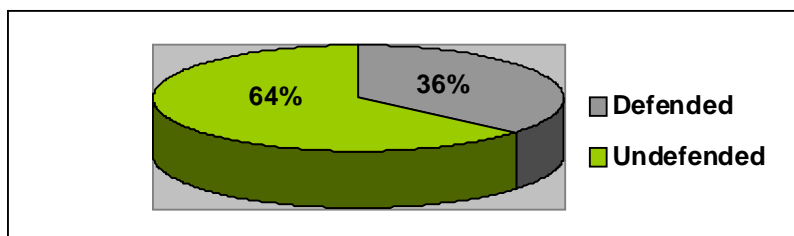
**Chart 2 - SMP2 Frontage Summary – Defended / Undefended**

The Isle of Wight coast line is 36% defended (based on length).

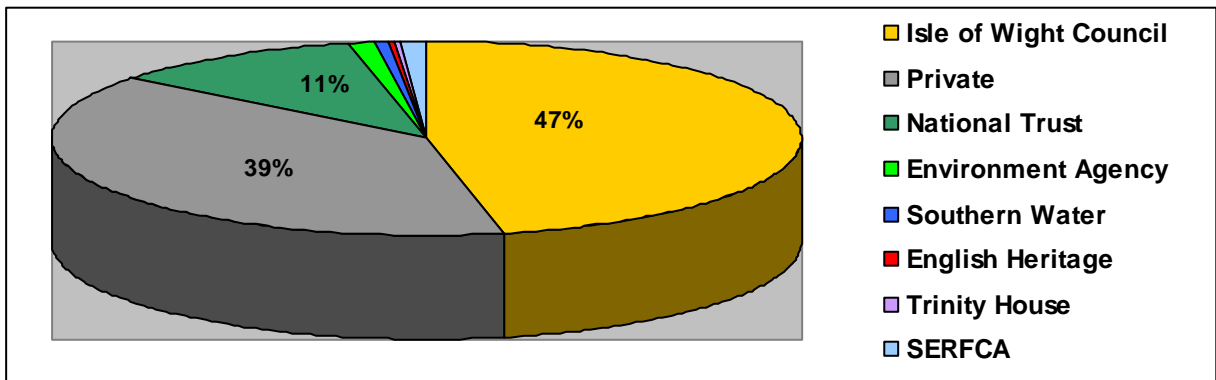
**Chart 3 - SMP2 Frontage Maintainer Summary**

The Isle of Wight SMP2 frontage provides a varied selection of maintainers with the majority of the frontages maintained by the Isle of Wight Council / Private / and The National Trust (47%, 39% and 11% respectively).

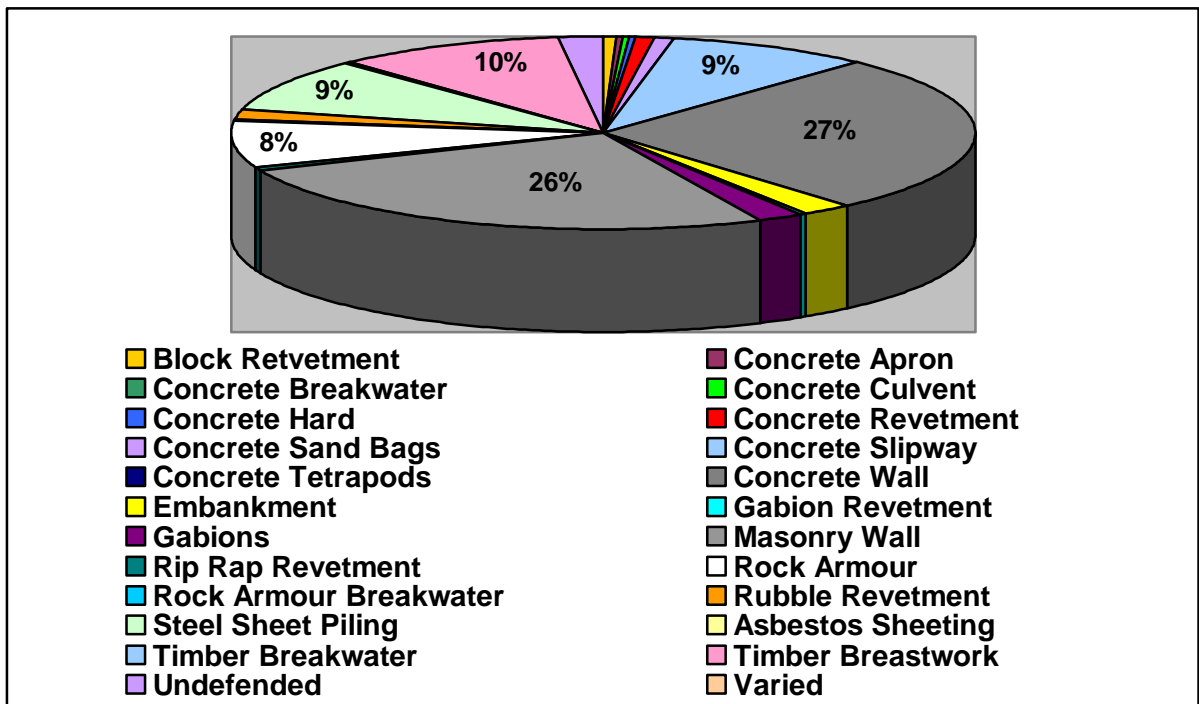
**Chart 4 - SMP2 Defence Element Summary**

The majority of Isle of Wight’s coastline defence elements are classified as Concrete Walls 27% and Masonry Walls 26%.

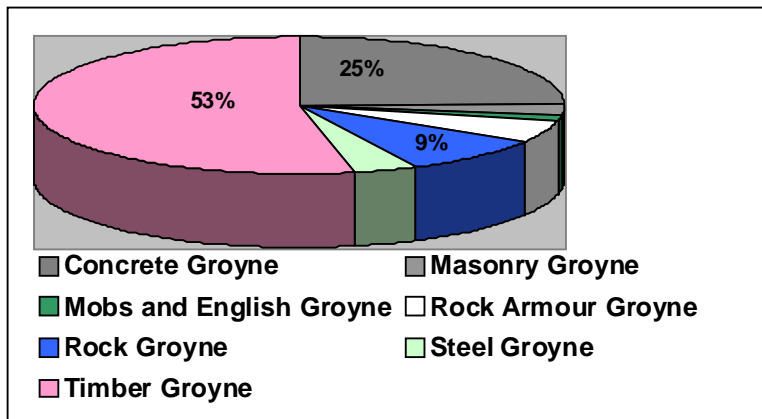
**Chart 5 - SMP2 Groyne Summary**

The Isle of Wight Coastline has 312 effective groyne, with the majority being constructed from Timber 53%.
