**COASTAL LANDSLIP POTENTIAL ASSESSMENT:**

**Isle of Wight Undercliff, Ventnor.**

**REPORT ON THE STUDY OF LANDSLIDING  
IN AND AROUND LUCCOMBE VILLAGE**

GEOMORPHOLOGICAL SERVICES Ltd,

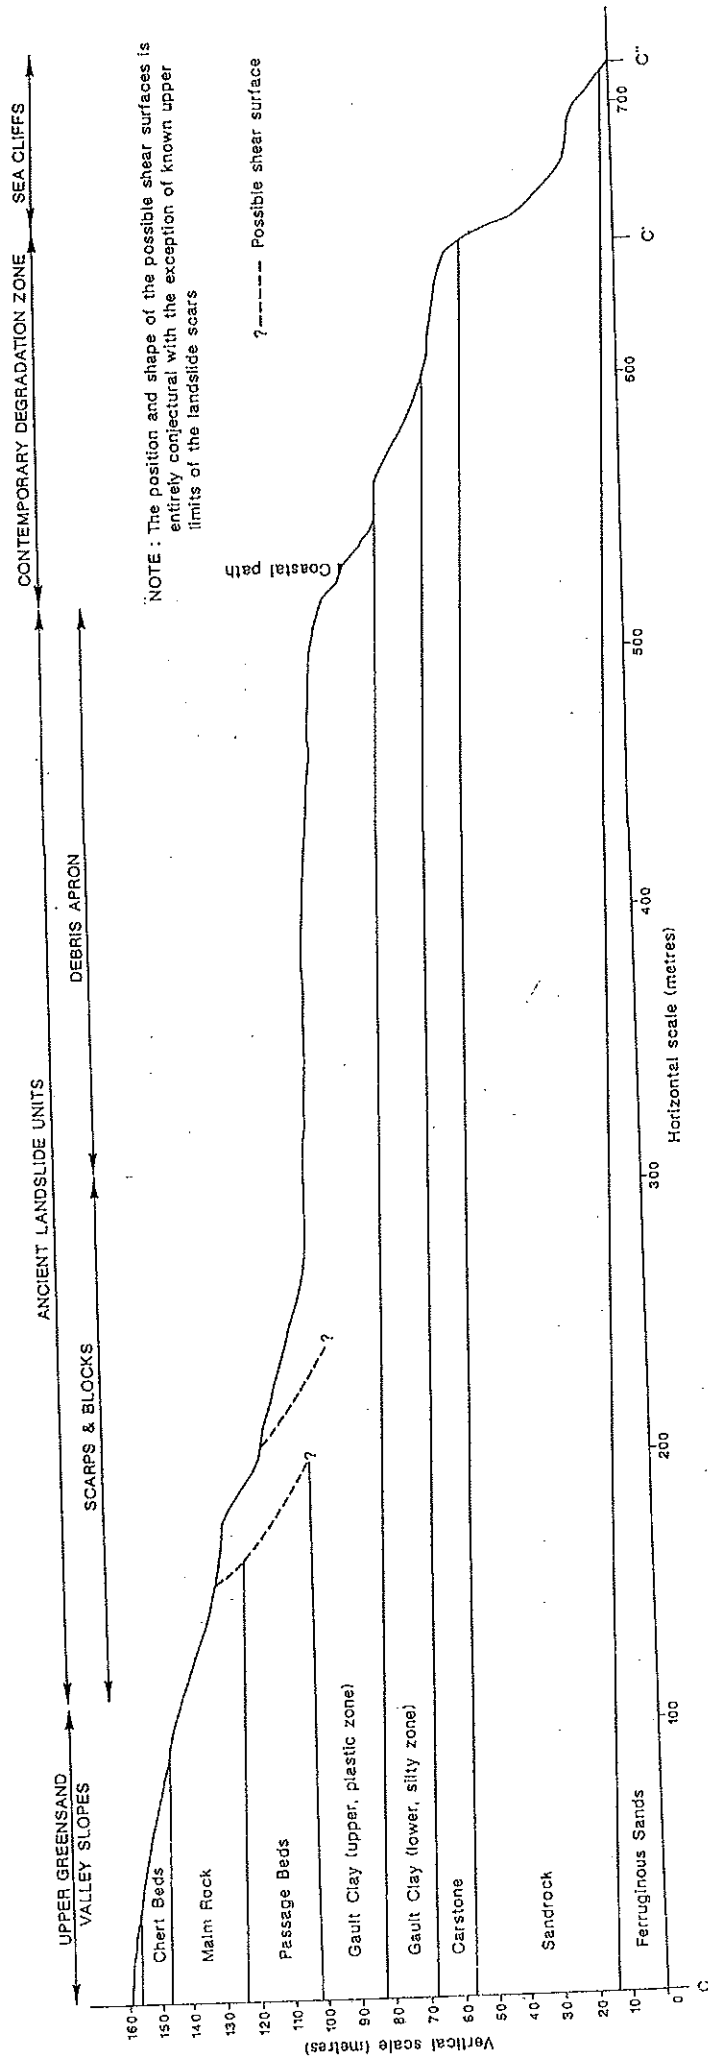
Figure 4.6 Cross-section through the study area (C - C<sup>I</sup> - C<sup>II</sup>).

NOTE : The position and shape of the possible shear surfaces is entirely conjectural with the exception of known upper limits of the landslide scars

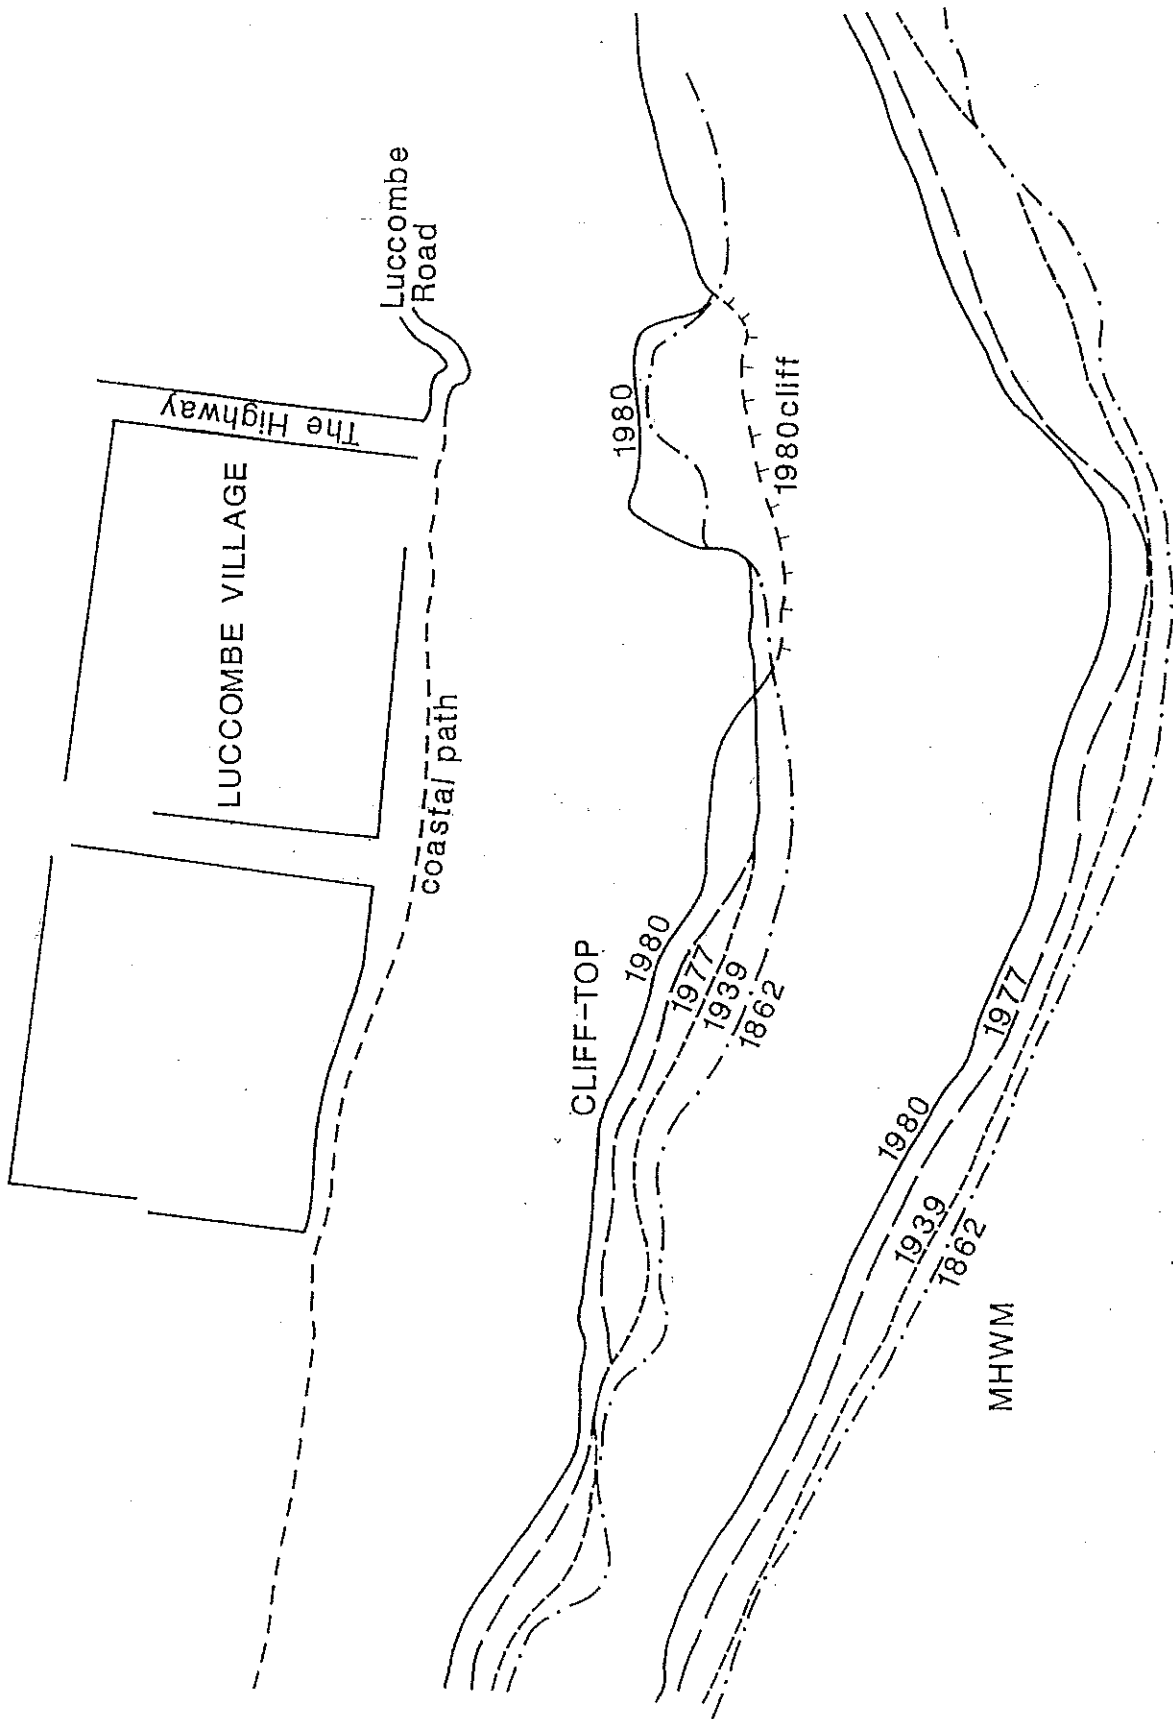
Figure 5.2 Coastal cliff retreat; 1862-1980 (based on Ordnance Survey 25 inch to 1 mile maps, 1862, 1939 and 1977; Huntings Surveys Ltd 1:2,500 scale maps 1980).

- (e) the average rate of cliff retreat over the period 1862-1980 is 26cm/yr, which is in broad agreement with the figure of 30cm/yr suggested by Barrett (1985).

Number of Years	Period		Cliff top recession	MHWM recession
77	1862-1939	max	15 m	8 m
	" "	min	0.5 m	1 m
	" "	mean	12 m	6 m
<b>Mean annual recession</b>			<b>15.6 cm</b>	<b>7.8 cm</b>
38	1939-1977	max	16 m	14 m
	" "	min	0 m	1 m
	" "	mean	12 m	9 m
<b>Mean annual recession</b>			<b>31.6 cm</b>	<b>23.7 cm</b>
3	1977-1980	max	16 m	12 m
	" "	min	4 m	6 m
	" "	mean	7 m	8 m
<b>Mean annual recession</b>			<b>233.3 cm</b>	<b>266.6 cm</b>

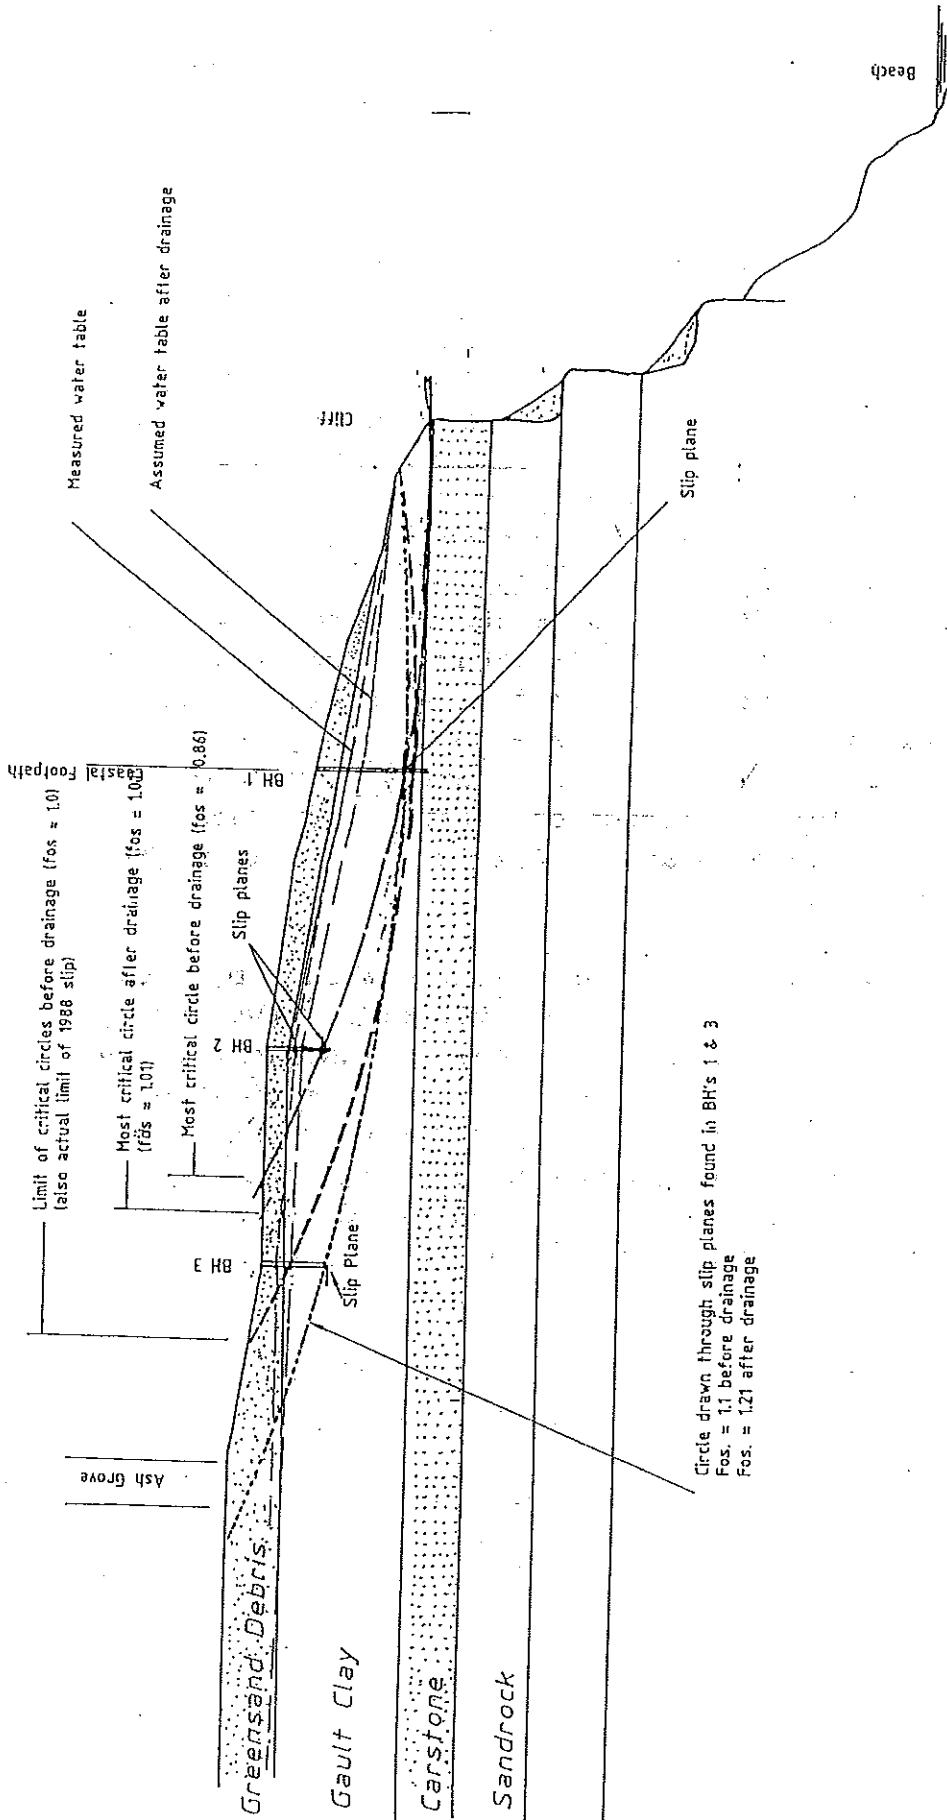
SECTION THROUGH LUCCOMBE

Normal stress	Stress ratio	$\phi_r'$ Degrees
BH 2 DEPTH 16.40 METRES		
100	0.275	15.4
200	0.236	13.3
300	0.227	12.8
400	0.222	12.5
500	0.217	12.2
BH 3 DEPTH 11 METRES		
100	0.221	12.5
200	0.184	10.4
300	0.172	9.77
400	0.162	9.21
500	0.159	9.04

Table 6.2 Ring shear test results, Luccombe (after Woodruff, 1988c).

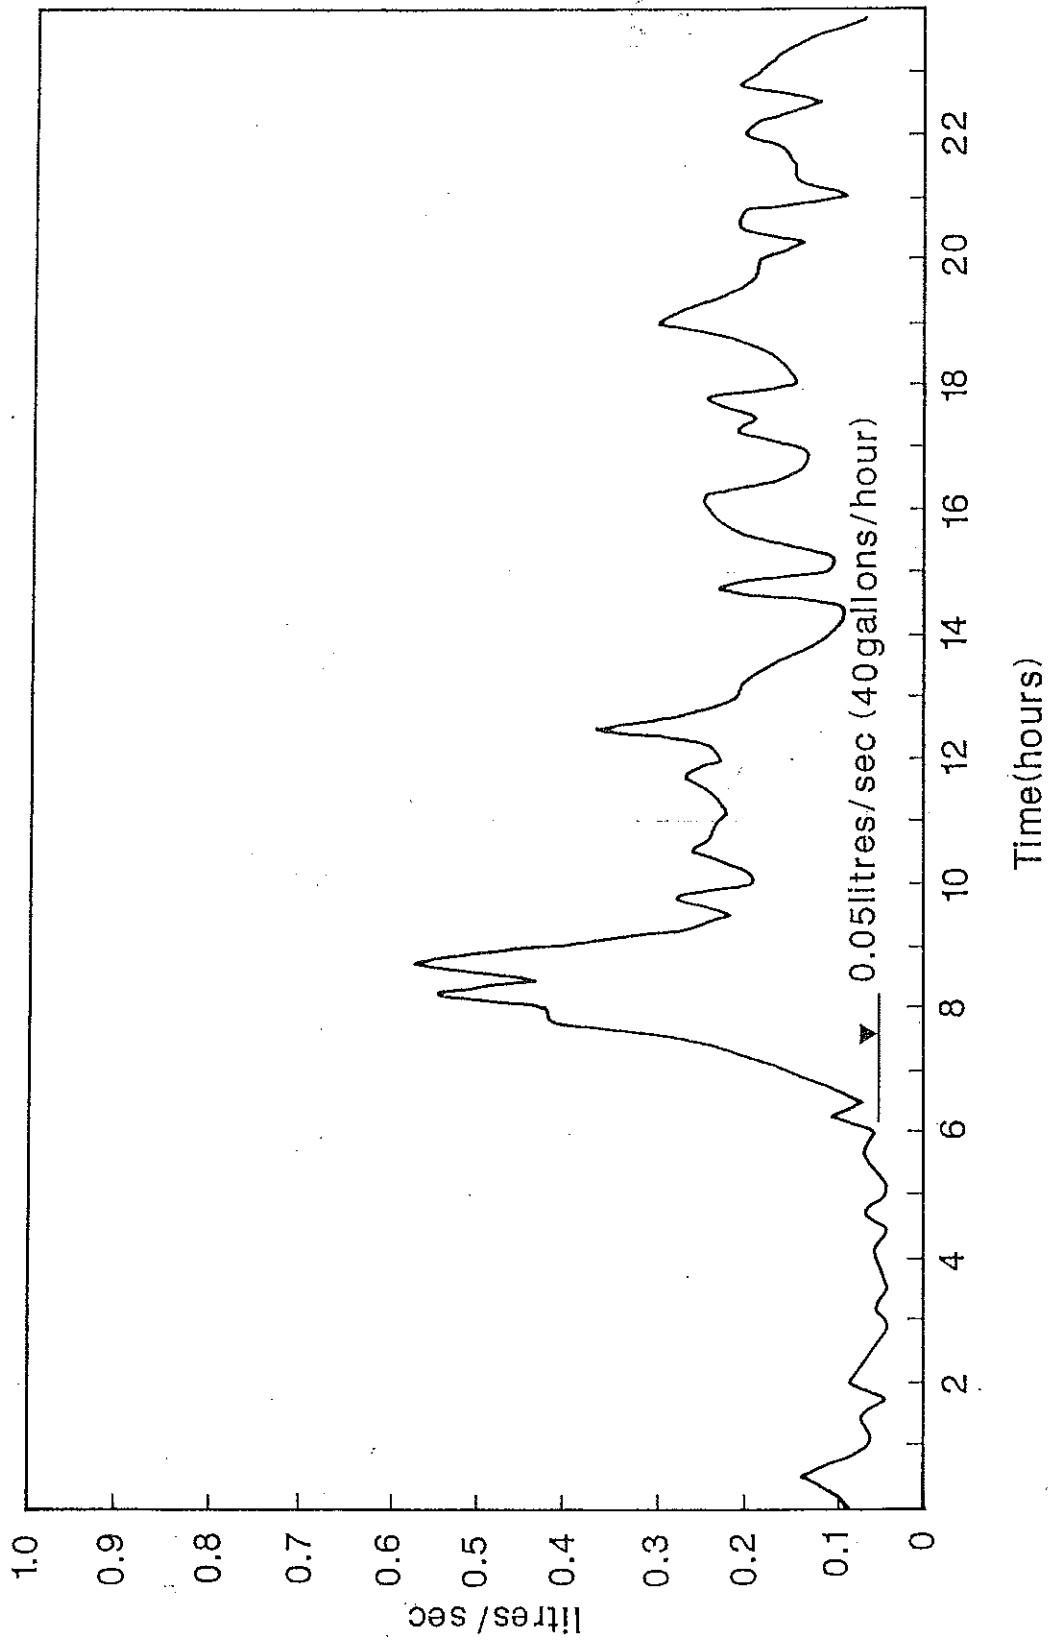
Figure 6.7 24 hour record of discharge from the Lucombe Riding School water supply tank in November 1988.

- (iii) water supply leakage; Luccombe Village is supplied with water from a supply tank close to the Riding School. Southern Water Authority have recently monitored the discharge of water from this supply tank over a 24 hour period in November 1988 (Figure 6.7). The flow chart shows a peak demand of 0.55 litres/sec between 8-9 a.m., 0.2-0.3 litres/sec between 9 a.m. to 1 p.m., roughly 0.15-0.2 litres/sec between 1 p.m. and midnight and a residual demand of 0.05 litres/sec between midnight and 7 a.m. The latter figure, the equivalent of 4,320 litres per day, may be considered to be leakage from the supply network within Luccombe Village i.e. 29% of the total water supplied during the day (c.15,000 litres) is lost through leakage.

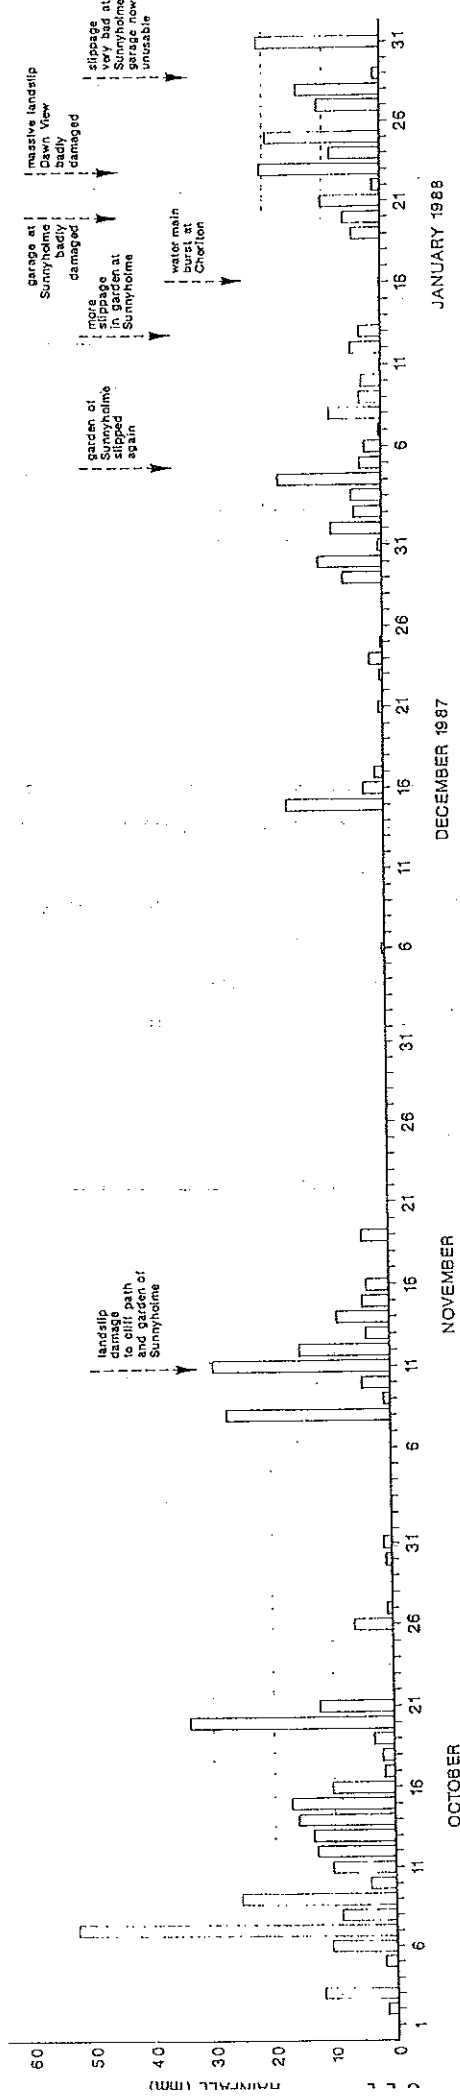
Figure 6.9 Daily rainfall totals for Shanklin Big Meade (October 1987 - January 1988) and sequence of reported landslide events.

Triggering factors initiate landsliding by shifting slope stability conditions from a state of marginal stability to active instability. It is clear that a very significant triggering factor for the 1987-1988 Luccombe Village landslide was a prolonged period of heavy rainfall. The daily records for Shanklin Big Meade (1km from Luccombe 1987 - August 1988\* are presented in Figure 6.9 and Tables H and I (Annex D) which reveals:

levels were close to the surface during the phase of movement. Indeed, the piezometric levels measured by Woodruff (1988c) of between 1.10-2.40m below ground level on March 24 1988 (Table 6.1) are likely to be below the pre-failure levels.

- (i) no reports of landslide activity were made in October, despite the highest rainfall total since 1947;
- (ii) the first reports of movement were made on November 11 after over 60mm of rain had fallen in four days;
- (iii) no movements were reported between November 11 1987 and January 5 1988, corresponding to a relatively rain-free period (only 117.4mm fell during this period);
- (iv) the main phase of movement occurred between January 5 and January 29 1988, although there appears to be little correspondence with large rainfall events (see Figure 6.9).
