# East Cowes - Section 19 Flood Investigation

## Final Report

August 2024

Isle of Wight  
Council

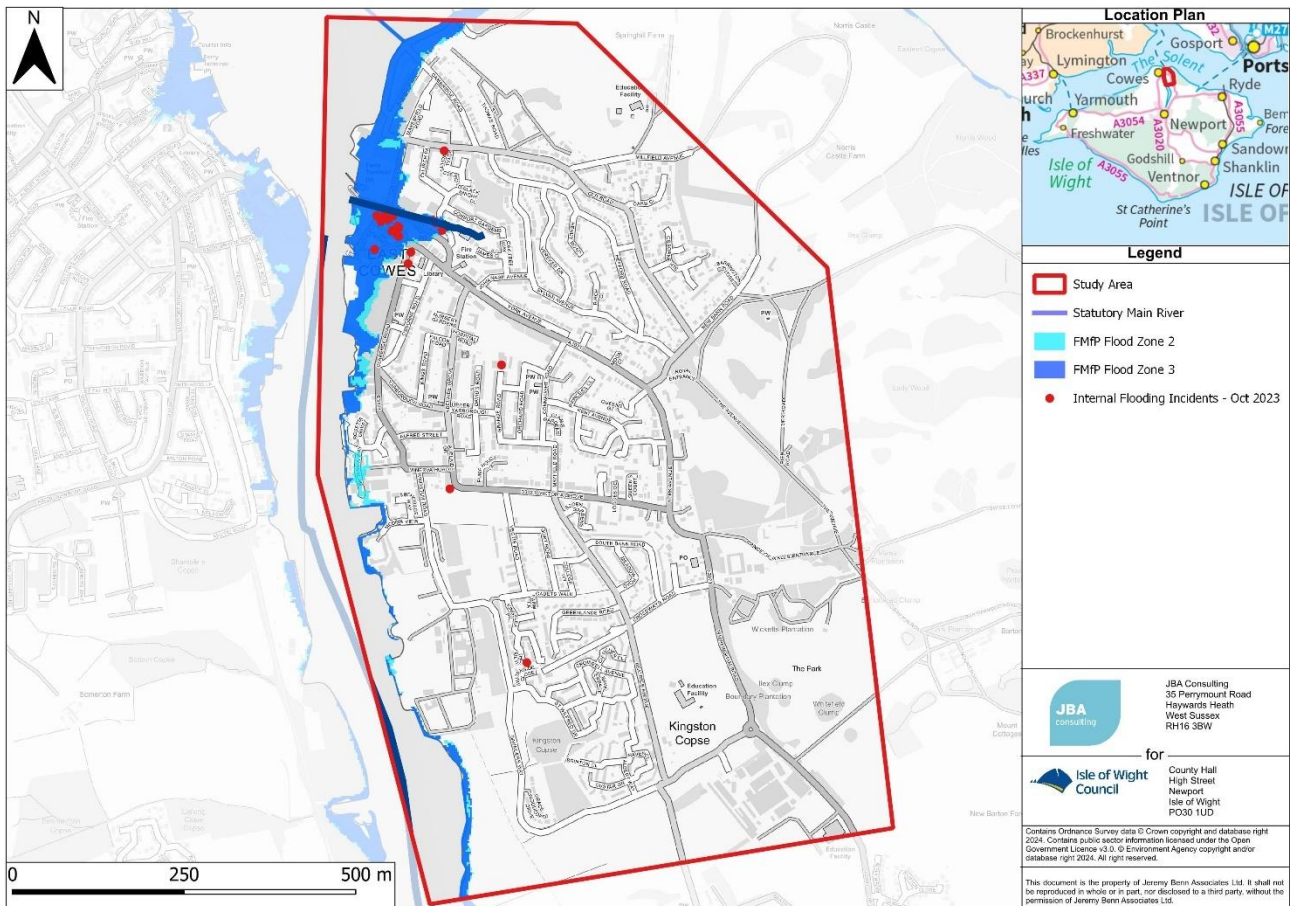
Figure 3-1 Flood Map for Planning Rivers and Sea with external and internal flood incidents in East Cowes

It should be noted that parts of East Cowes that experienced flooding on 25 October 2023, such as Well Road, Castle Street and York Avenue are within the tidal extent of Flood Zones 2 and 3.

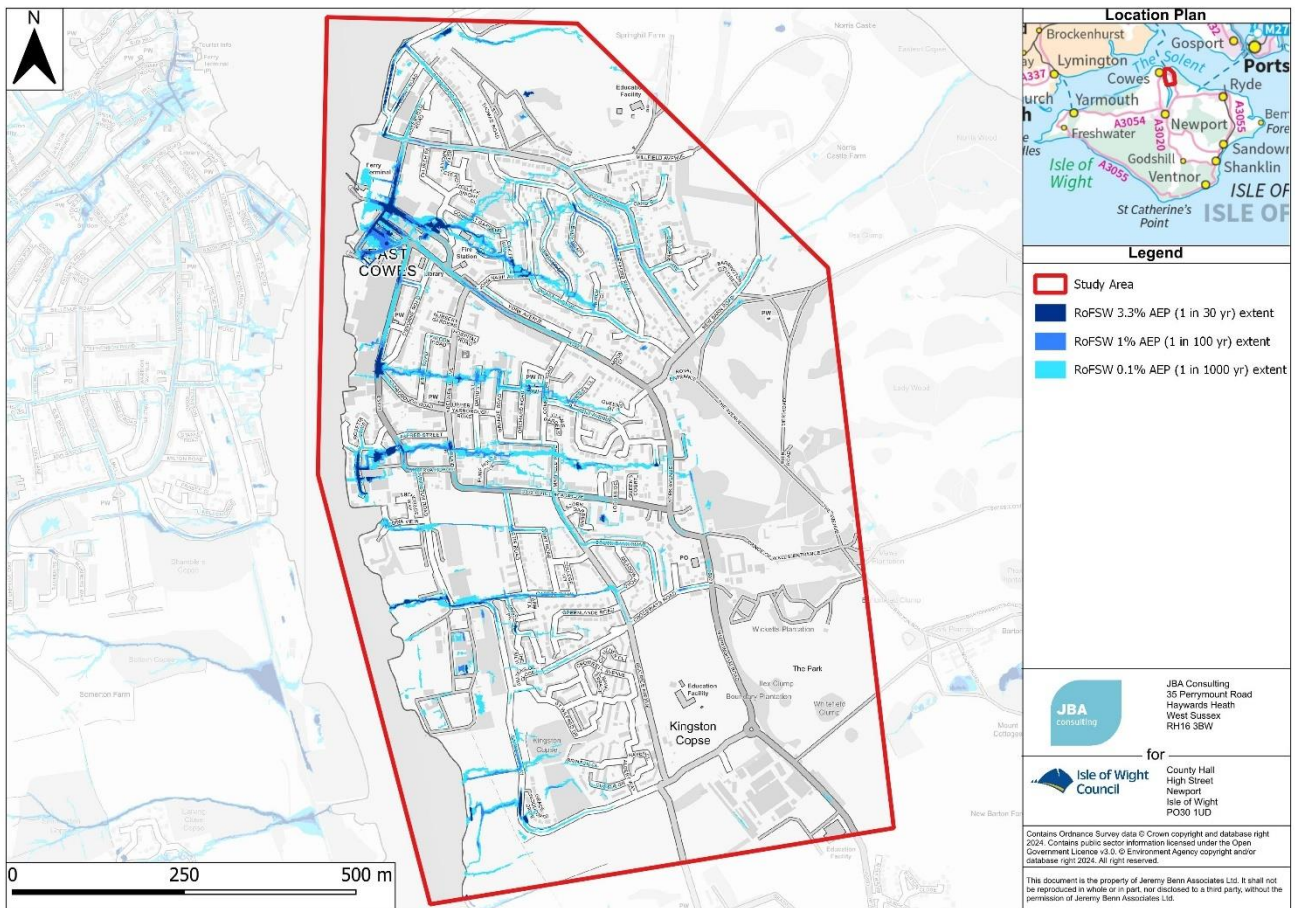
Figure 3-2 Risk of Flooding from Surface Water

There is high surface water flood risk along natural depressions. The highest risk of surface water flooding occurs just off the Ferry Terminal at the surrounding roads, such as Dover Road, Well Road, Castle Street, Marsh Road and Link Road which correspond to the areas impacted by the October 2023 flooding. The Well Road roundabout there has a high risk from surface water flooding. These areas are at risk of flooding during rainfall events with greater than a 1 in 30-year or 3.3% annual occurrence. Other areas within the study area

are also at risk of flooding with greater than a 1 in 100-year event or 1% annual exceedance probability. Figure 3-2 shows a pattern of the surface water flood runoff to low-lying areas from higher elevated areas gathering along the estuary shoreline, affecting the roads identified above, in the centre of East Cowes in and around the points of discharge for watercourses and surface water routes (i.e. following the topographic low points)..

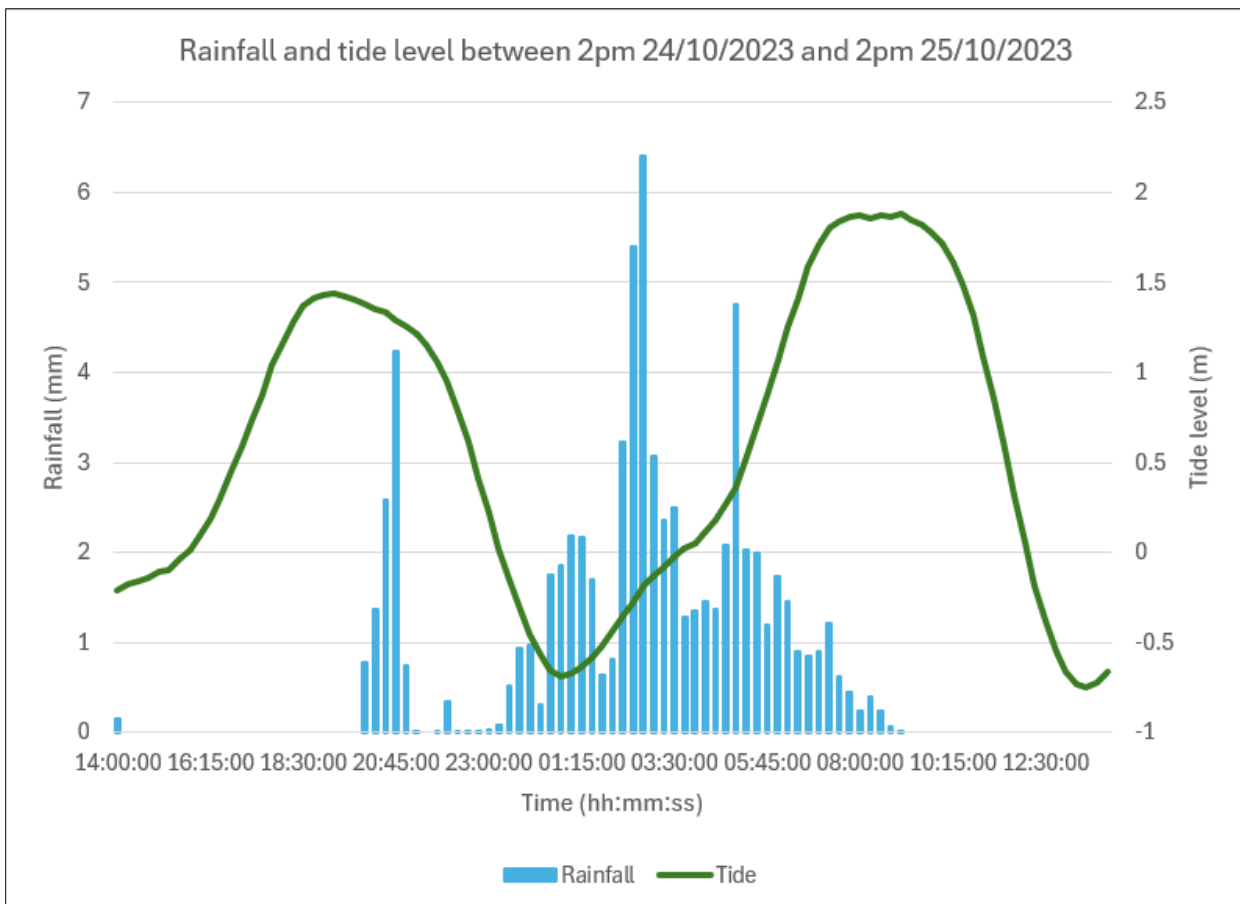
Figure 5-1 Tide level (m) and rainfall (mm) between the 24th and 25th of October 2023

During the flood events in October 2023, the tide was rising which may have resulted in tide locking of the watercourse at Church Path and other drainage systems which discharge into the Medina Estuary. It is understood that tide levels were particularly high during the April 2024 event, although as this investigation has already been progressed this data has not been requested from the Environment Agency.

Heavy rainfall throughout the evening of the 24th and the early hours of the 25th October, likely caused a hydraulic overload of the sewer system. This was likely exacerbated by tide locking of the culverted watercourse (near Church Path) where the highway drainage discharges to and would have led to surface water backing up and flooding the surrounding area.

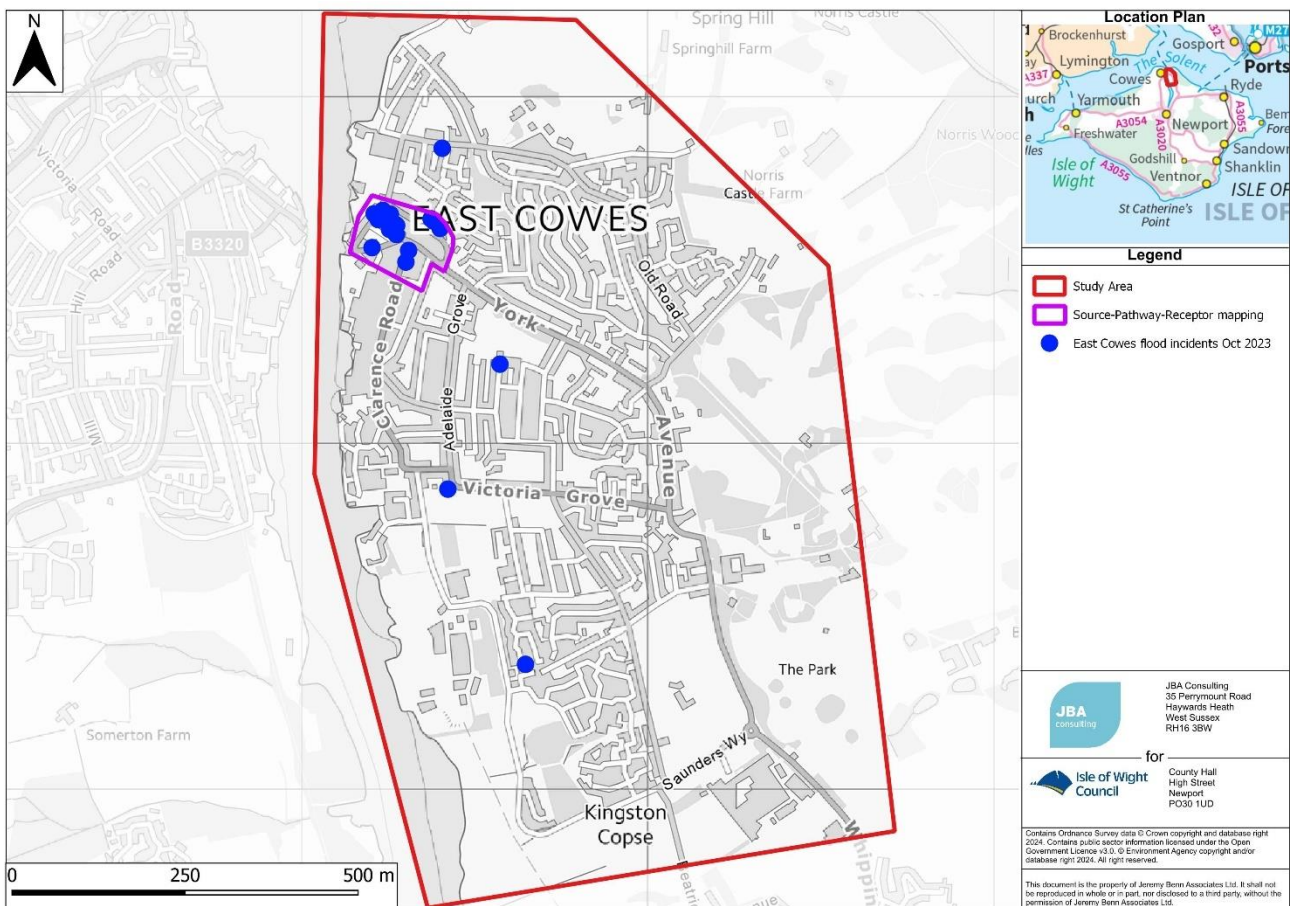
Figure 7-1: Reported flooding incidents in East Cowes following 25 October 2023 event

JBA compiled information from multiple sources regarding flood extent in East Cowes during the 25 October 2023 flooding event. Community surveys and flood grant data was compiled to generate maps which indicated flood patterns. This data indicated that flooding was mostly in the town centre and in the vicinity of York Avenue, Castle Street and Church Path; although there were a smaller number of isolated incidents in other parts of East Cowes.

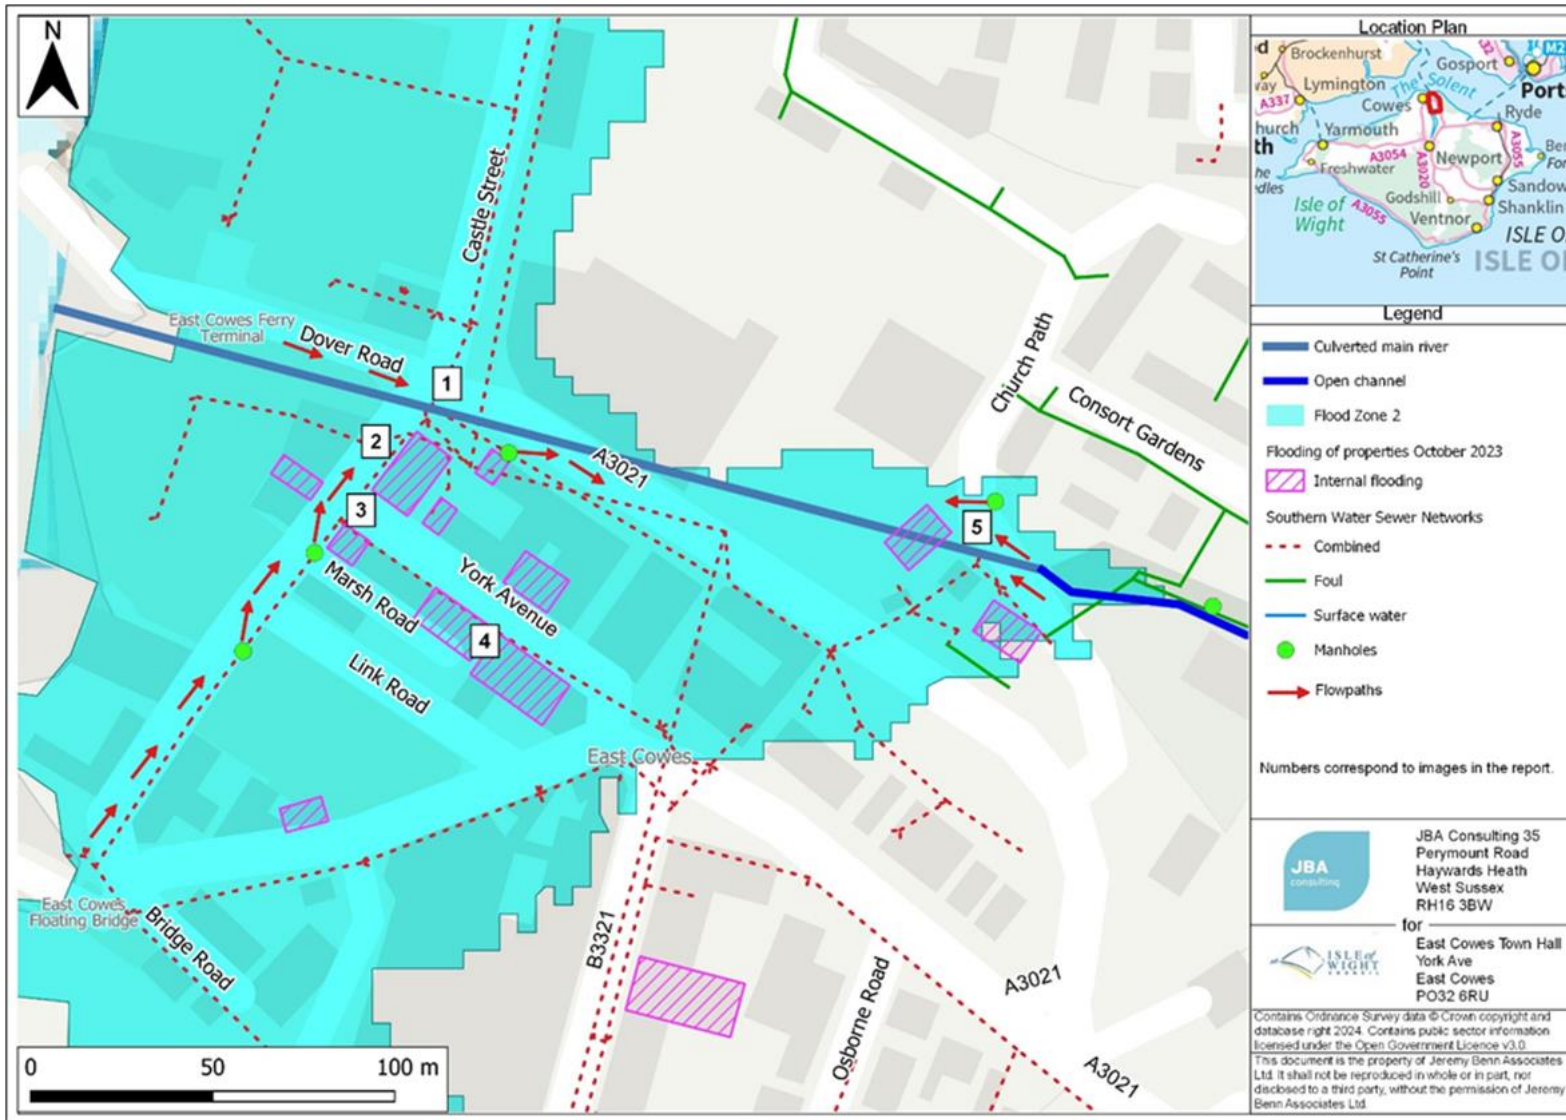
Figure 7-2 Source-Pathway-Receptor map for the flooded area

Figure 7-2 indicates the likely pathways of the water during the flood event based on a combination of information collected, such as community surveys and footage from the event. Flood water likely originated from drainage systems as a result of hydraulic overloading which was likely exacerbated by tide locking and the volume of rainfall entering drainage systems. It is understood this caused manholes in Castle Street, Well Road and Church Path to surcharge and flood these roads with a significant volume of water.

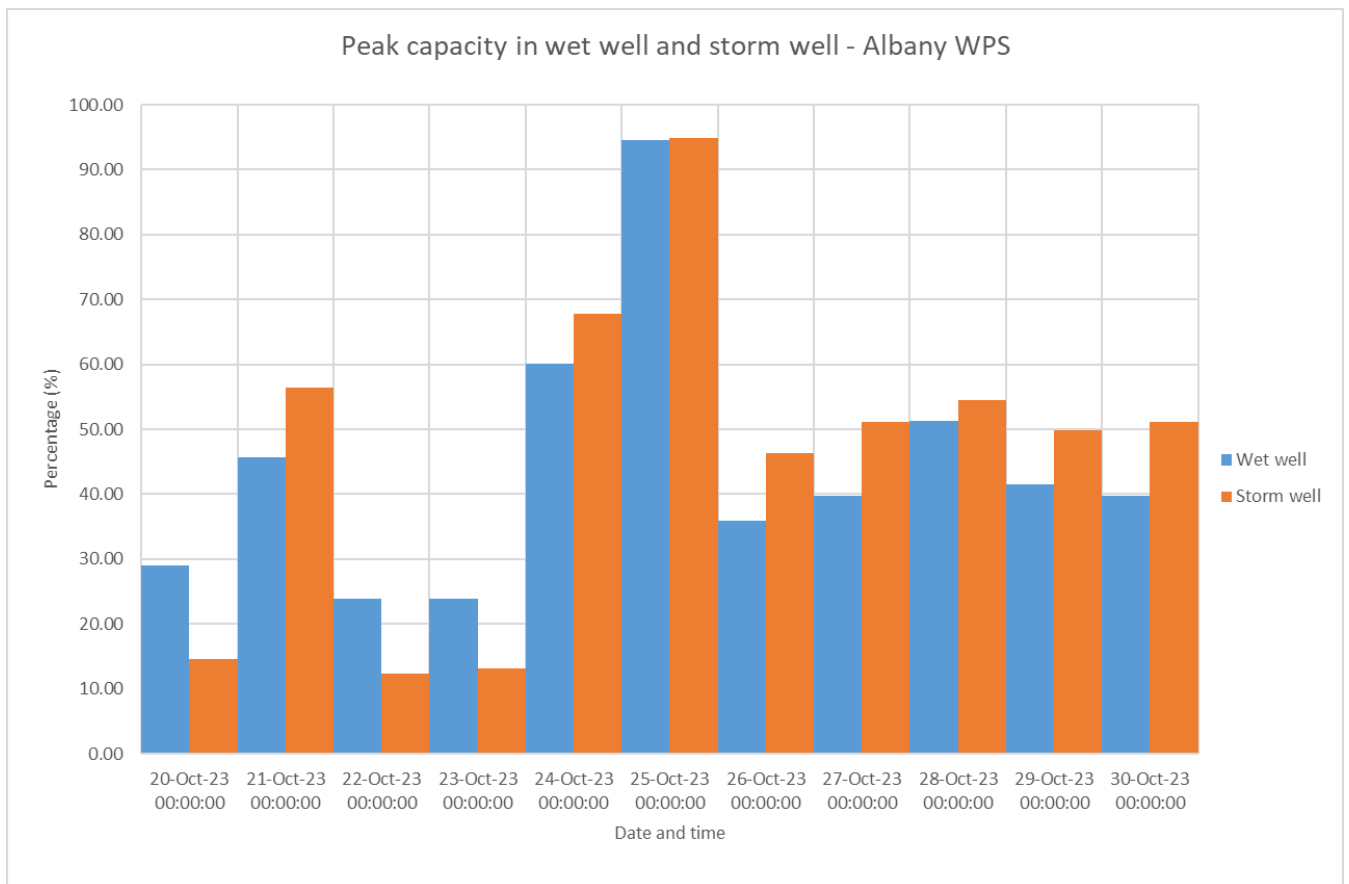
Figure 8-1: Albany Road WPS – wet well and storm well capacity

The majority of flows into the combined sewer network as well as foul flows where there are separate sewer systems are discharged to Albany Road Wastewater Pumping Station. From there, sewage is pumped to Spring Hill Transfer Pumping Station and ultimately pumped to Sandown Wastewater Treatment Works. A review of flow data from the Albany Road WPS was provided by Southern Water from October to November 2023.

It is understood that Albany WPS has two wet wells one for normal dry weather flow or DWF with three pumps working in duty, assist, standby configuration. If the flows to the site
