# Totland to Colwell Bay Landslide Assessment

December 2013

Isle of Wight Council

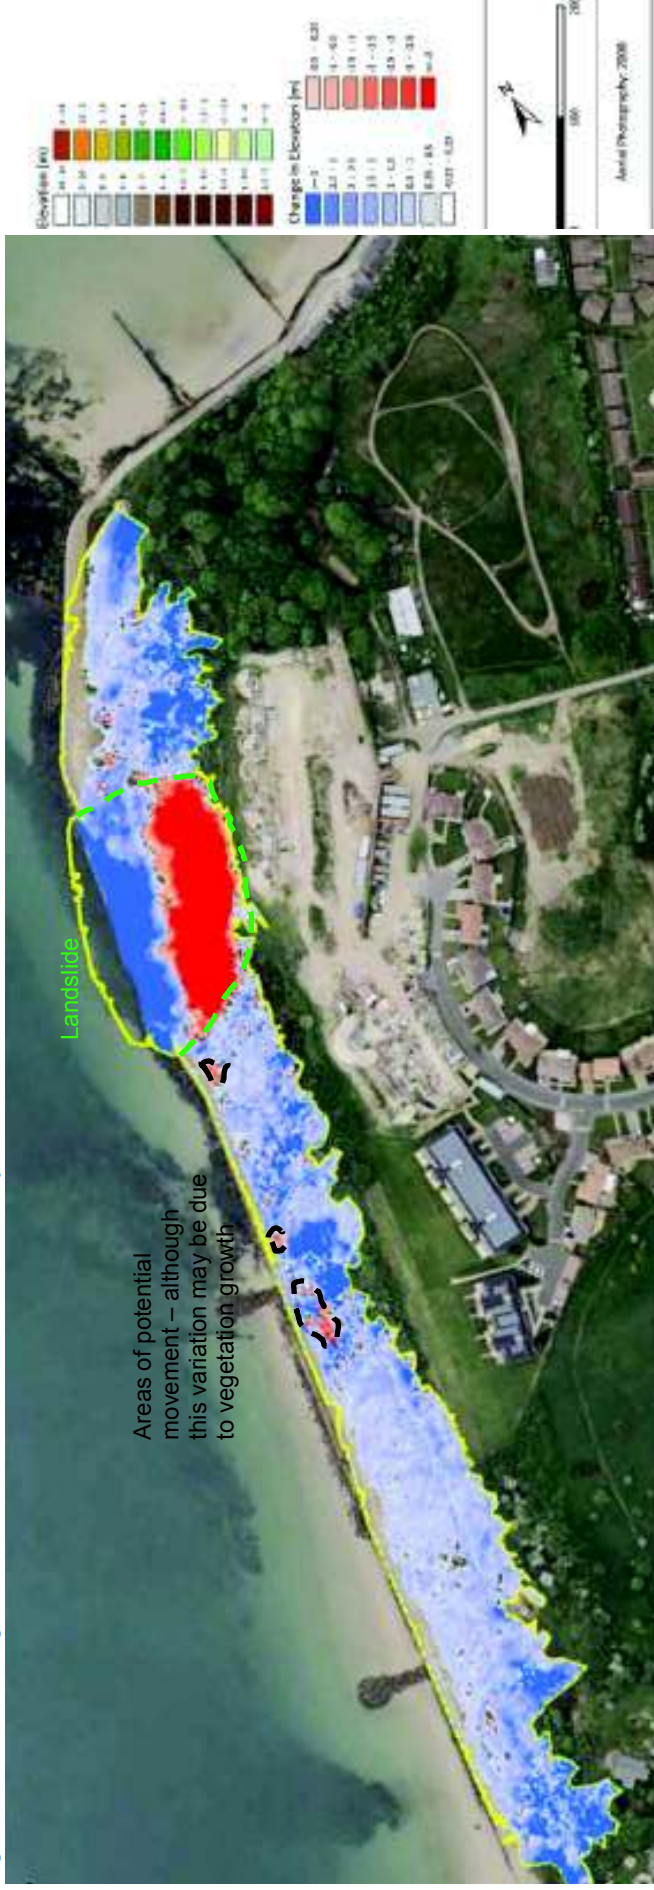
Figure 2.4: The change in cliff volume between 2012 and January 2013. Red values indicate a loss in volume and blue indicate an increase

A laser scan cliff survey carried out by Channel Coast Observatory (CCO) highlights the change in volume of the cliff between January 2012 and January 2013 (Figure 2.4), from this image the true extent of the landslide is highlighted, as well as the areas where the material has slipped from the top of the cliff (red areas) and been deposited on the toe (blue areas).

Furthermore, as is presented in Figure 2.4, there is minor volume change along the frontage during 2012, highlighted by the red colour. This may be due to vegetation growth or be indicative of smaller scale preparatory landslides.

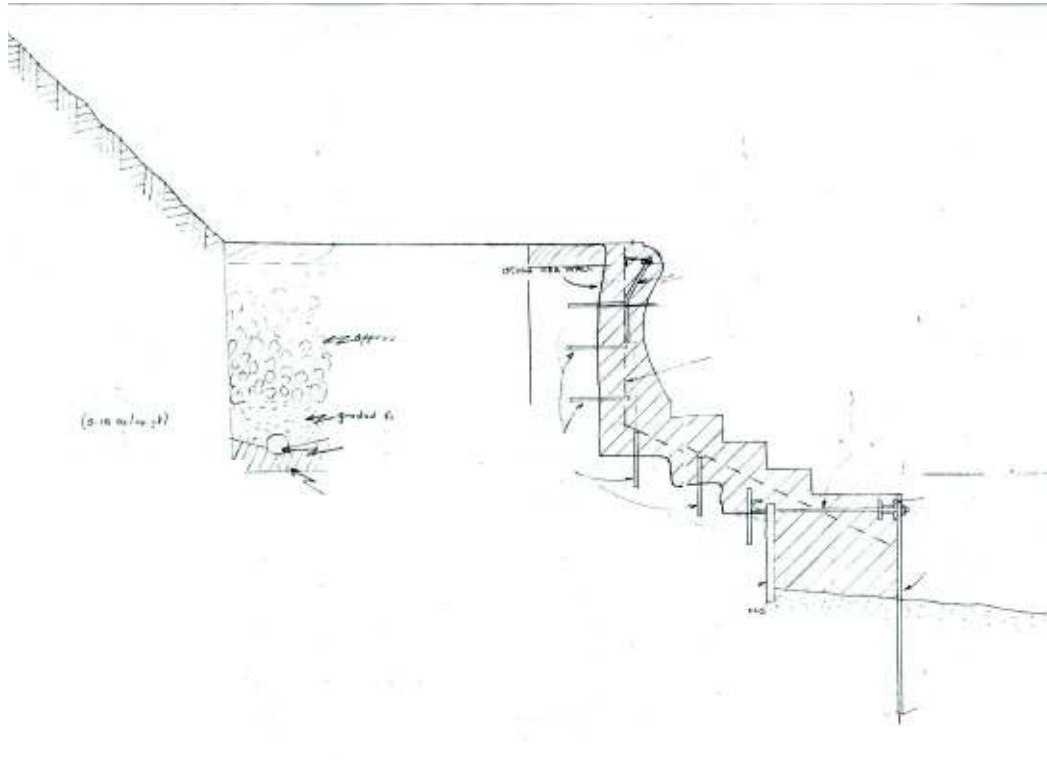
Figure 3.1: Technical drawing of the seawall installed in 1966.

New sea defences were installed in 1966 to account for landsliding/undermining. Along the section of the landslide new 13ft piles were “driven through three foot of beach material and four feet of compacted sand and gravel and three feet into the firm clay base” with the top 3ft above beach level; “a reinforced concrete encasement of the existing wall face” in approximately 5m sections was constructed; “a reinforced concrete protective toe and stepped apron” were added and it was decided to “fill all the cavities with concrete” (Report of County Surveyor- Coast Protection Works Scheme, 1966) (Figure 3.1). The rest of the frontage had the same design; however the piles were reduced to 10ft long.

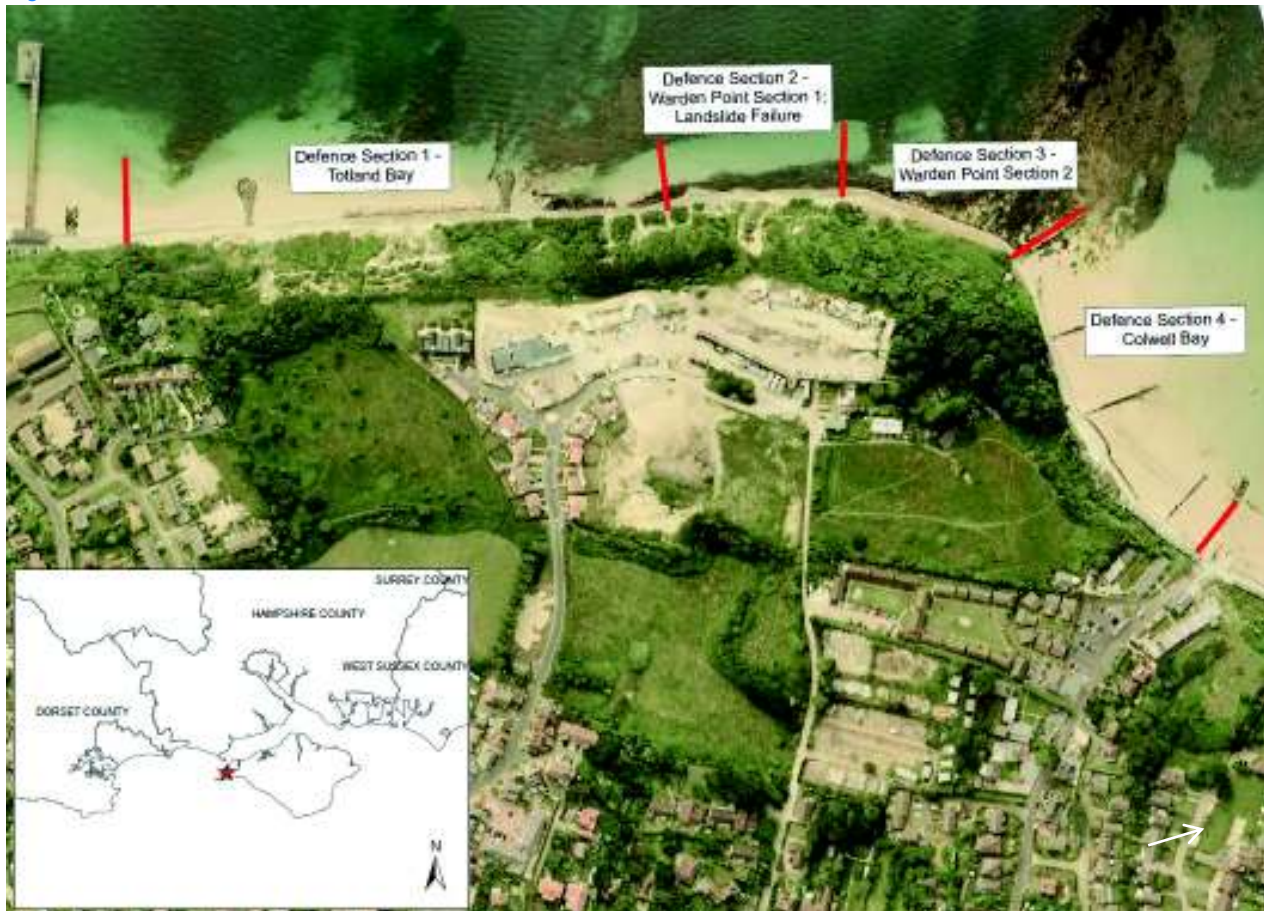
Figure 3.2: The location of the defence sections assessed in the Defence Condition Assessment

The results of the assessment carried out by MM in September 2013 according to the Environment Agency's Condition Assessment Manual (Environment Agency, 2006), are presented in Table 3.2, with the detailed defence condition tables in Appendix A. The defence sections discussed are labelled on Figure 3.2.

Defence section	SMP Policy	Defence Type	Condition Grade
Totland Bay	Hold the line	Concrete Seawall, Rock toe protection and Rock Groynes	Good
Warden Point Section 1 – Landslide Failure	Hold the Line	Concrete Seawall, Rock Toe Protection	Failed
Warden Point Section 2 – Non-Failure Section	Hold the Line	Concrete Seawall	Good
Colwell Bay	Hold the Line	Concrete Seawall, Rock Toe Protection, Timber Groyne	Good. Timber Groyne, fair.

From the condition assessment work, it is assumed that the general condition of the seawall that failed was also in a good condition prior to the landslide event, and it would have been unlikely to demonstrate any visual signs of failure until movement started to occur. The wall in the failed section now offers limited protection to the cliff toe and significant gaps between the seawall units are present (Figure 3.3). In these gaps erosion of the material behind the seawall will occur, particularly during storms. However, the seawall encasement (in 5m sections) did not fail or crack during the movement, but it is unsure if the upper encasement was fixed to the toe as some units show signs of separation (at the wall and stepped apron interface).

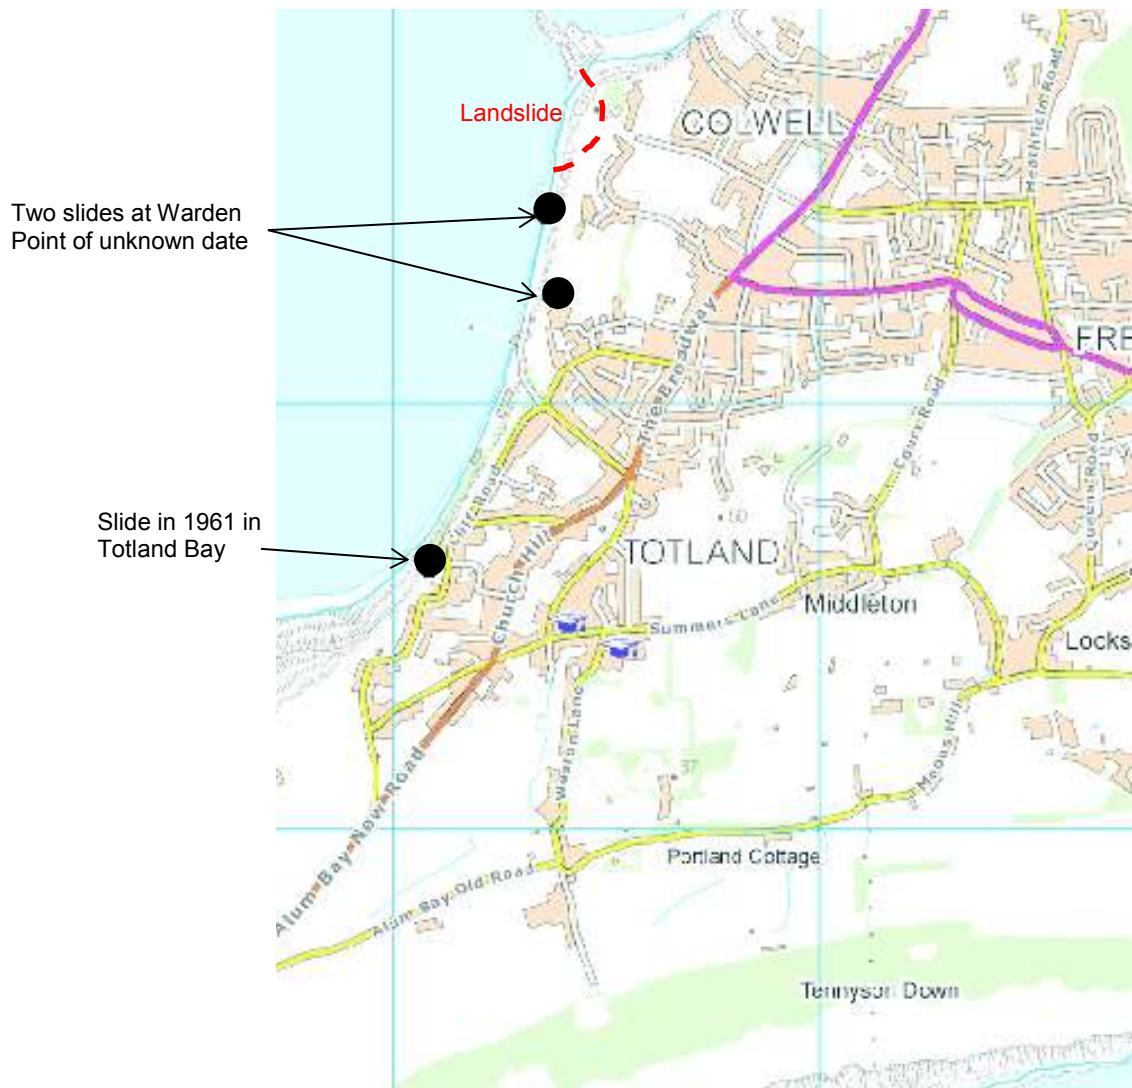
Figure 4.1: Historic Failures within the area

There are few records of historical coastal instability within the area. The British Geological Survey (2013) has noted three past landslides (Figure 4.1). Two slides at Warden Point (unknown dates) and one in 1961 at South Totland Bay. The two slides at Warden Point most probably occurred before the first sea defences were installed in the early 20<sup>th</sup> Century (Isle of Wight Council, 2010), because the area was very susceptible to land sliding due to wave erosion at the base of the cliff (Isle of Wight History Centre, 2013). The slide in 1961 is described by Chandler (1991) 'an early seawall protecting a military installations at the top of the cliff was not maintained and became perforated by a combination of abrasion and corrosion, leading to the under-running of the wall.' The poor quality of the seawall led to the erosion of the toe of the slope and consequently a failure. As a consequence the seawalls were improved in 1966 (refer to Section 3.2). Further instability was noted by SCOPAC (2004) to continue, 'results in occasional extension of debris lobes across the esplanade e.g. winter of 2000/01' (SCOPAC, 2004). In addition recently there have been many smaller cases of slumping and water run-out onto the promenade (Isle of Wight Council, 2010) indicating instabilities and near surface ground movements are continuing.

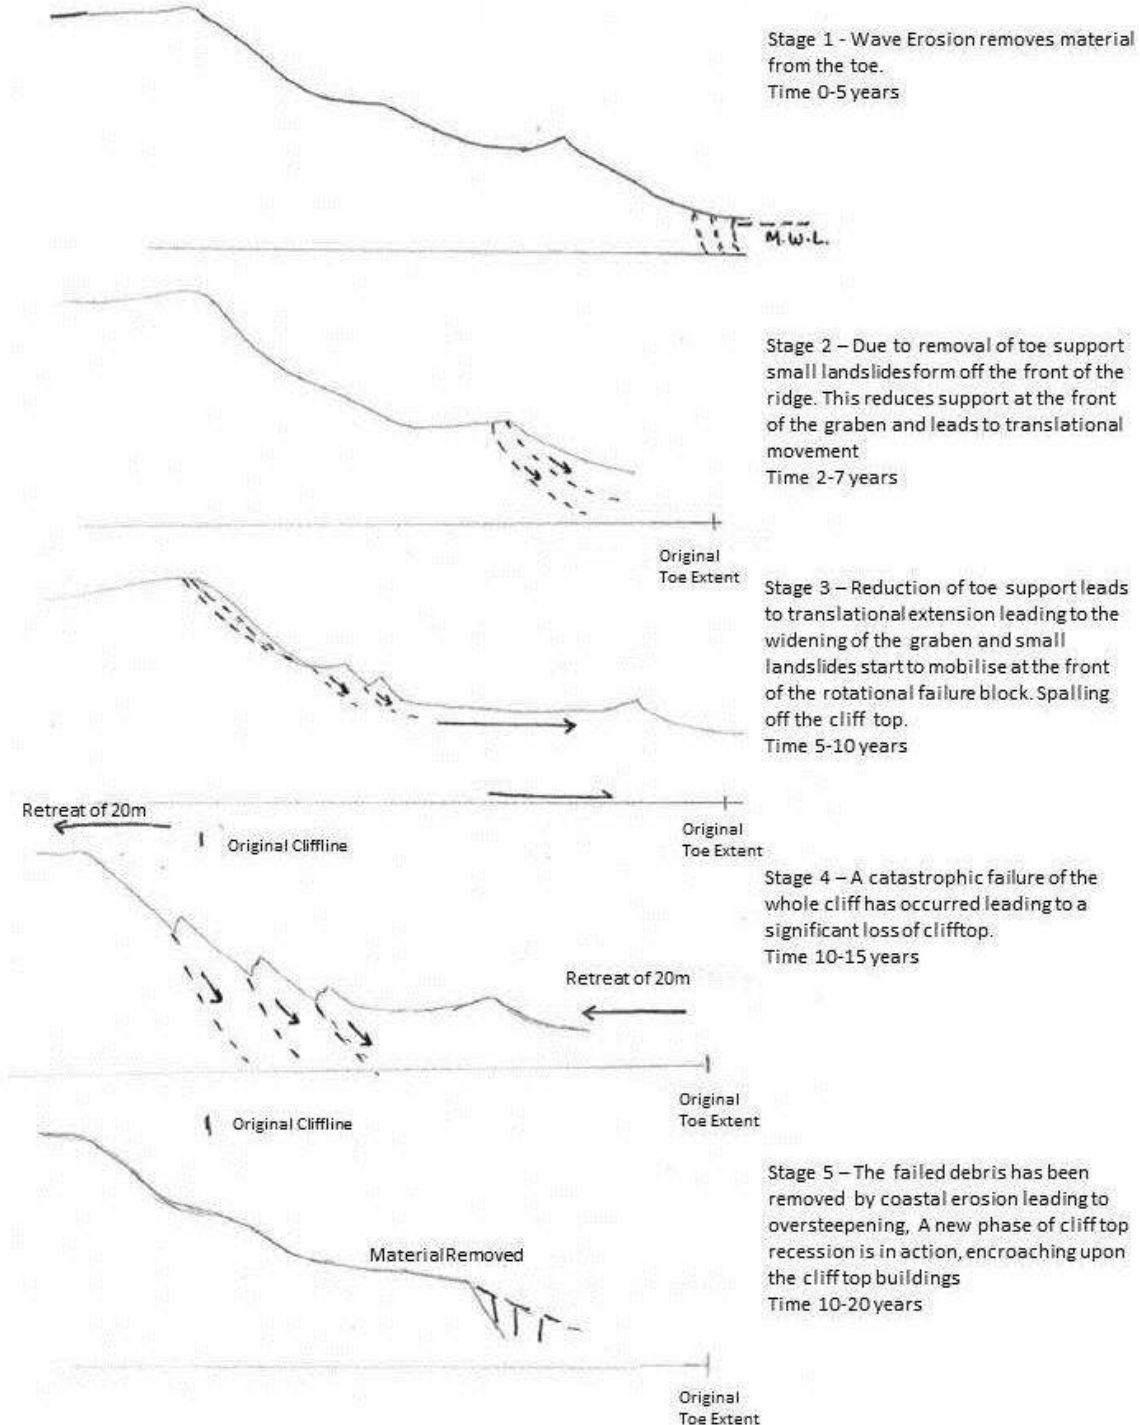
Figure 5.1: Postulated mode of retreat of the cliff of the landslide section if the toe remains unprotected

Under a Do Nothing scenario it is predicted that a large scale failure, like the one in late 2012, will occur on average every 10 years retreating the cliff line landward by ~20m in each event. However between major events there will be smaller movements and erosion in the landslide complex that will lead to this eventual large scale failure. A postulated model of failure (Figure 5.1) has been suggested based on four distinct stages. The ongoing erosion of the toe, caused by wave scour, will lead to destabilisation primarily near the toe, causing smaller mudslides and slips of the front of the slide. The removal of material will reduce toe support to the failed mass behind leading to the release of the translational extension failure. The removal of this large amount of material and reduced toe support will lead to a large scale rotational failure from the landward cliff, as the landslide tries to maintain its equilibrium, resulting in the landward retreat of the cliff to obtain a more stable less steep profile. This process will continue in a cyclic nature unless the toe is protected because the cliff will be in a constant state of disequilibrium.

The process described above puts the Grade II listed gun emplacements on top of the cliff at risk within the next 5-10 years, and if this process is not managed the existing houses which are about 70m from the cliff top will also be at risk within the next 50 years.

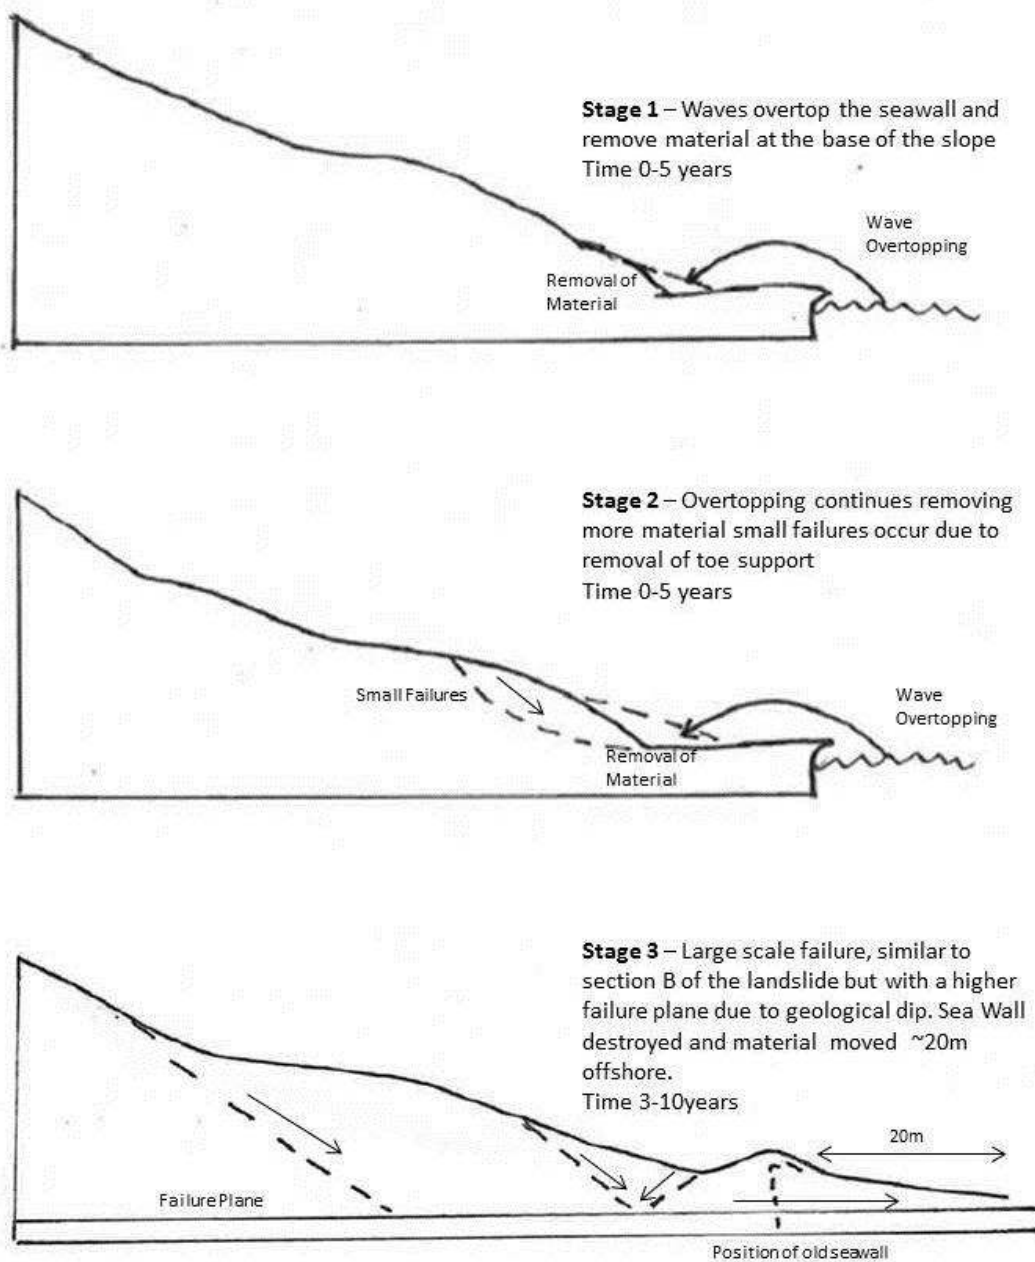
Figure 5.4: Model of mode of potential failure and cliff retreat for the rest of the frontage under the current status.(no mitigation)

Owing to the scour of cliff due to wave action overtopping the seawall, the mechanism of failure shown in Figure 5.4 can be driven. This will eventually lead to a large scale failure, similar in scale to the recent Totland landslide which caused the seawall to move forward 20m, if no intervention is put in place. Following this the mode of cliff retreat would follow the same model as the landslide (Figure 5.1). Objective assessment considers this could occur anywhere along the frontage between the recent landslide and Totland Pier under current conditions.

Following this the landslide will behave and retreat in the same way as the previously failed section (Figure 5.1)

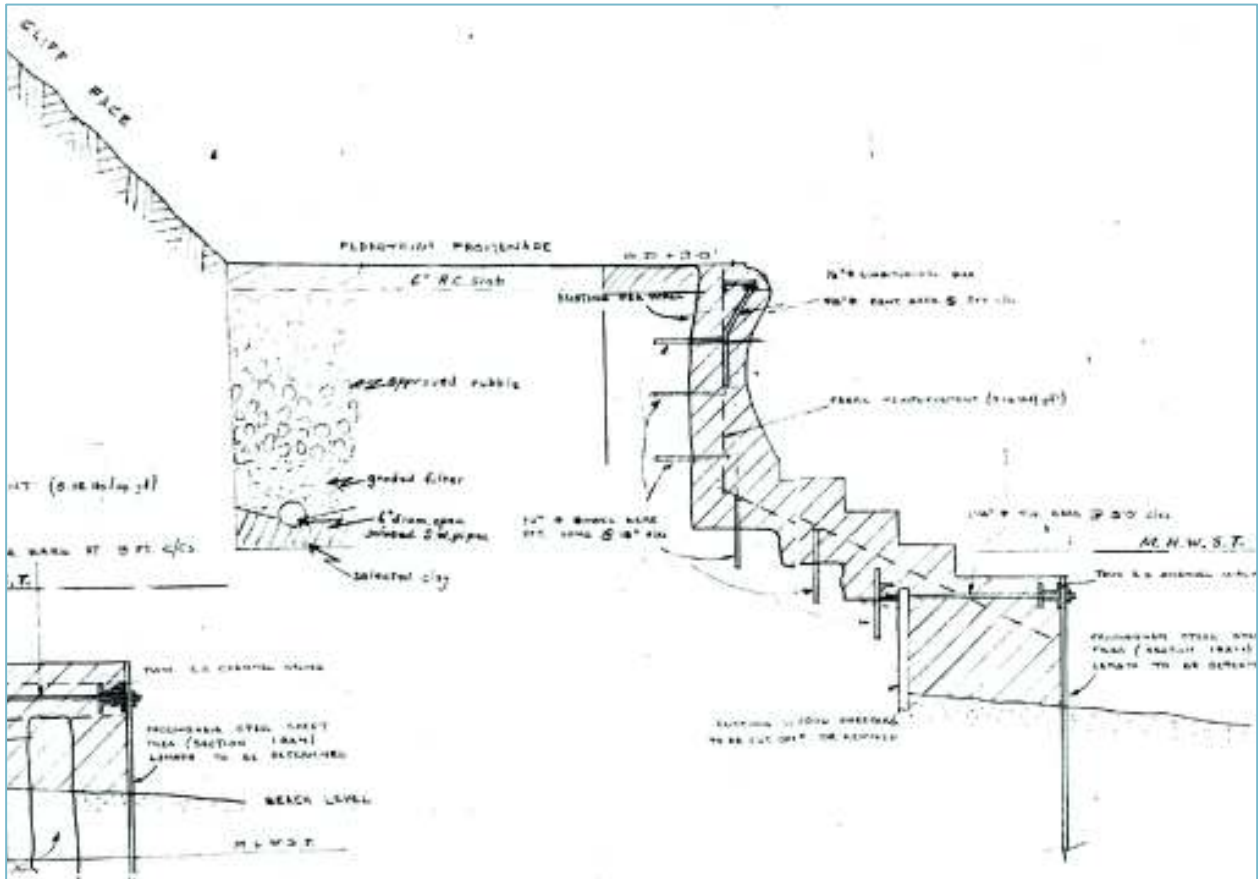
Figure 8.14: Proposed seawall cross section from 1966 remedial works

The cross section of the seawall construction illustrates the described proposal in the Report of the County Surveyor (1966), refer to Figure 8.14. It shows the proposed installation of the sheet piling, stepped concrete apron and concrete encasement tied to the existing wall with dowel bars.

The site visit to the landslip (conducted 20<sup>th</sup> September 2013) was able to view the cross section of the seawall at the failed section (Figure 8.15) and confirms that the general arrangement shown in Figure 8.14 was installed as proposed.

Figure 8.17 was taken by the Isle of Wight Council during low water in February. At this section the CCO analysis (Refer to Appendix A) shows the wall has displaced seawards by 17m. The image shows that the central sections of seawall have remained intact, but failure of the piles and apron connection has occurred. Along the section it can be seen that as the piles have rotated they have caused the stepped apron concrete to be cracked horizontally allowing the tie bars to pull free from the concrete. It is not clear if the walings were fitted, as proposed within the original design (shown in Figure 8.14), or if only the hooked tie bars were installed.

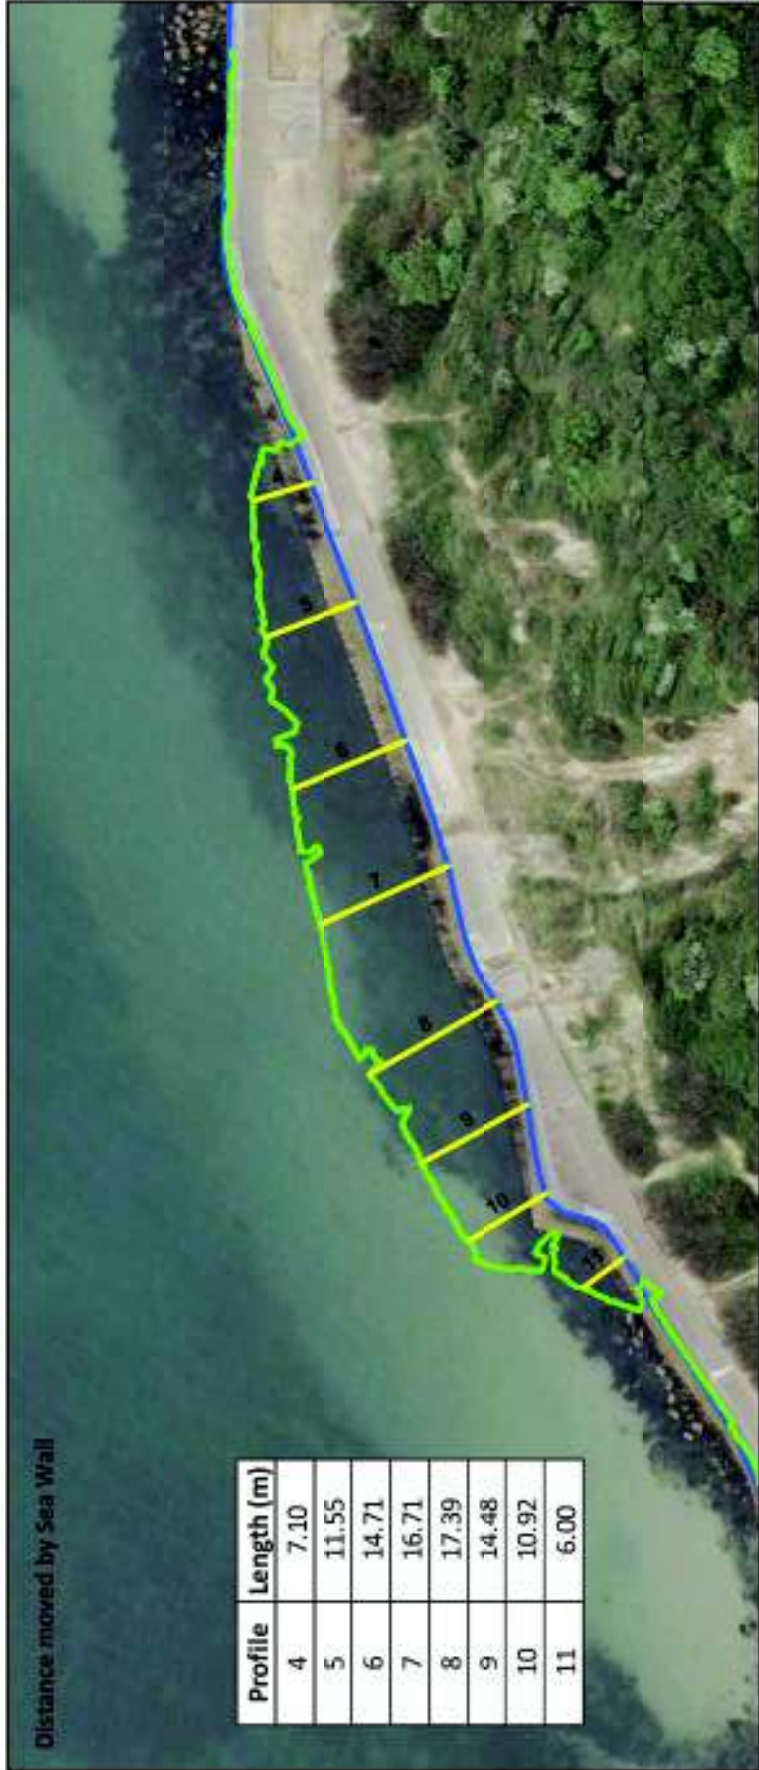
Distance moved by Sea Wall

Profile	Length (m)
4	7.10
5	11.55
6	14.71
7	16.71
8	17.39
9	14.48
10	10.92
11	6.00

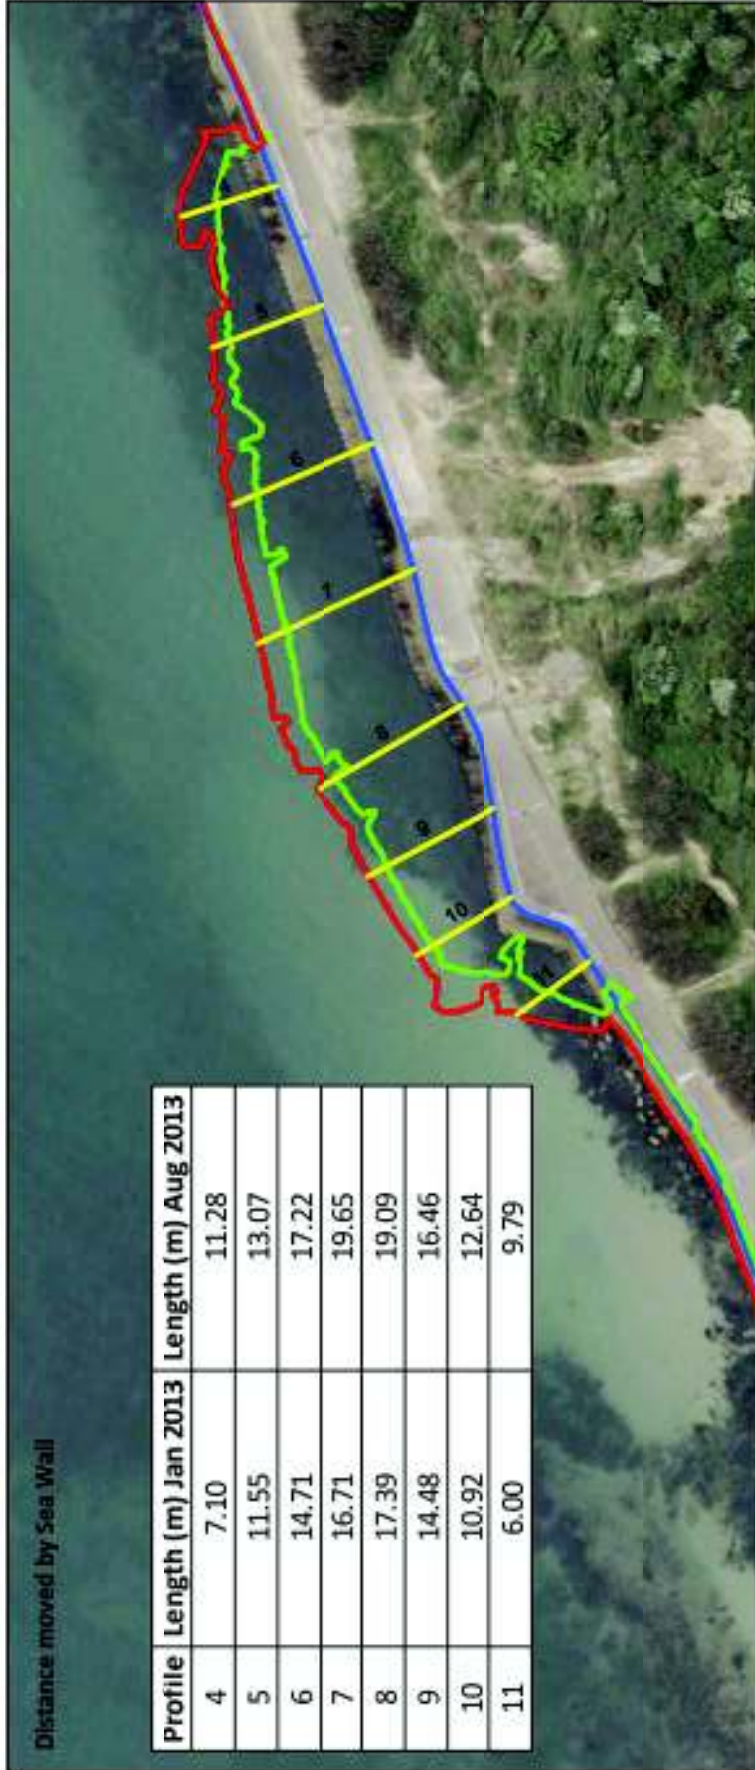
Distance moved by Sea Wall

Profile	Length (m) Jan 2013	Length (m) Aug 2013
4	7.10	11.28
5	11.55	13.07
6	14.71	17.22
7	16.71	19.65
8	17.39	19.09
9	14.48	16.46
10	10.92	12.64
11	6.00	9.79

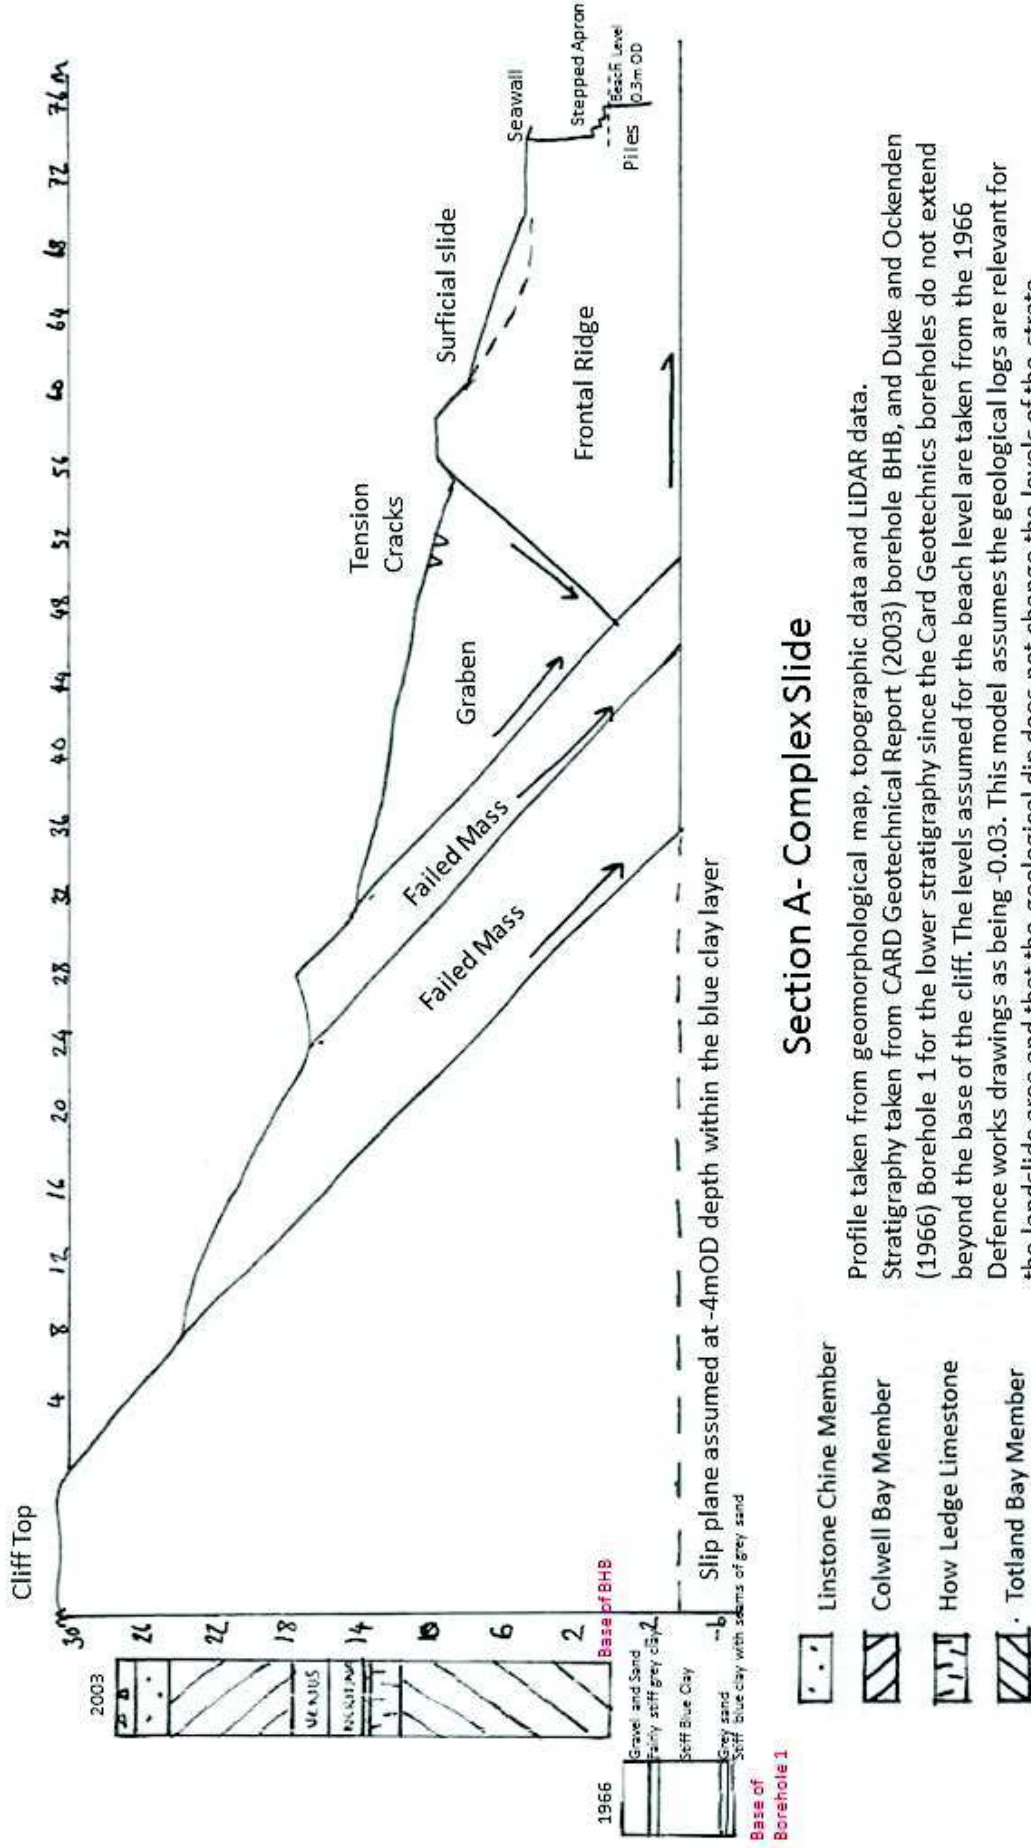
Figure D.2: Ground Model of Section A

### Section A - Complex Slide

Profile taken from geomorphological map, topographic data and LiDAR data. Stratigraphy taken from CARD Geotechnical Report (2003) borehole BHB, and Duke and Ockenden (1966) Borehole 1 for the lower stratigraphy since the Card Geotechnics boreholes do not extend beyond the base of the cliff. The levels assumed for the beach level are taken from the 1966 Defence works drawings as being -0.03. This model assumes the geological logs are relevant for the landslide area and that the geological dip does not change the levels of the strata.
