**GEOLOGICAL  
FAILURE REPORT**  
RED ZONE 10: CARAVAN  
PARK,  
UNDERCLIFF DRIVE  
May 2014

GEOLOGICAL FAILURE REPORT: RED ZONE 10 CARAVAN PARK

# ISLE OF WIGHT HIGHWAYS PFI UNDERCLIFF SITE 10, CARAVAN PARK GEOLOGICAL FAILURE REPORT

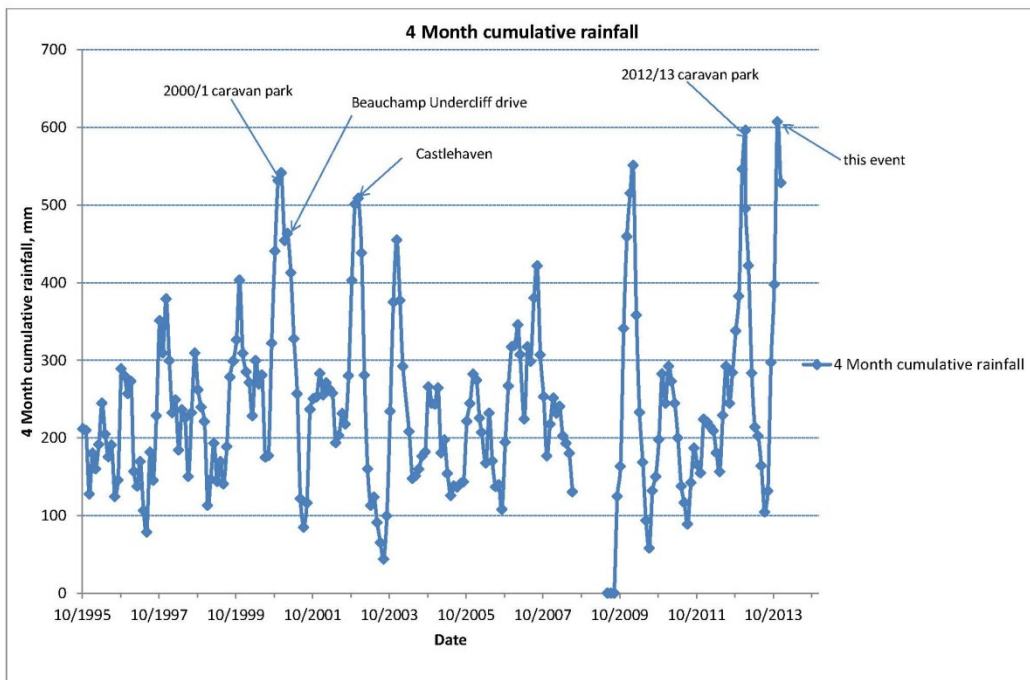
Figure 2 Four Month Moving Average Rainfall and Landslide Events

Subsequent to previous large scale ground movements along the Undercliff, a landslide forecast model was developed for the Undercliff by High-Point Rendel in 1996 based on the work by Lee et al (1991)<sup>1</sup>. In order to try and predict the likelihood of future movements along the Undercliff, data was collected concerning the occurrence and location of previous landslides and the volume of rainfall preceding them. The model gave a threshold value of effective rainfall (the percentage of total rainfall that enters the ground) over a preceding 4 month period which would be likely to cause instability or increased ground movement rates within the Undercliff landslide complex. When comparing the occurrence of previous landslide events with the corresponding 4 month antecedent effective rainfall (4AER) value it appears to correlate with ground movement events with a good degree of accuracy (Figure 2). Once the 4AER drops back to below the threshold value the likelihood of further movements at that point in time is reduced. The Isle of Wight Council has employed this model in order to aid in assessing the likelihood of ground movements in areas throughout the Undercliff. Table 2 summarises the trigger threshold values. This placed the rainfall during February and March 2014 as Class 3, and at risk of major instability.

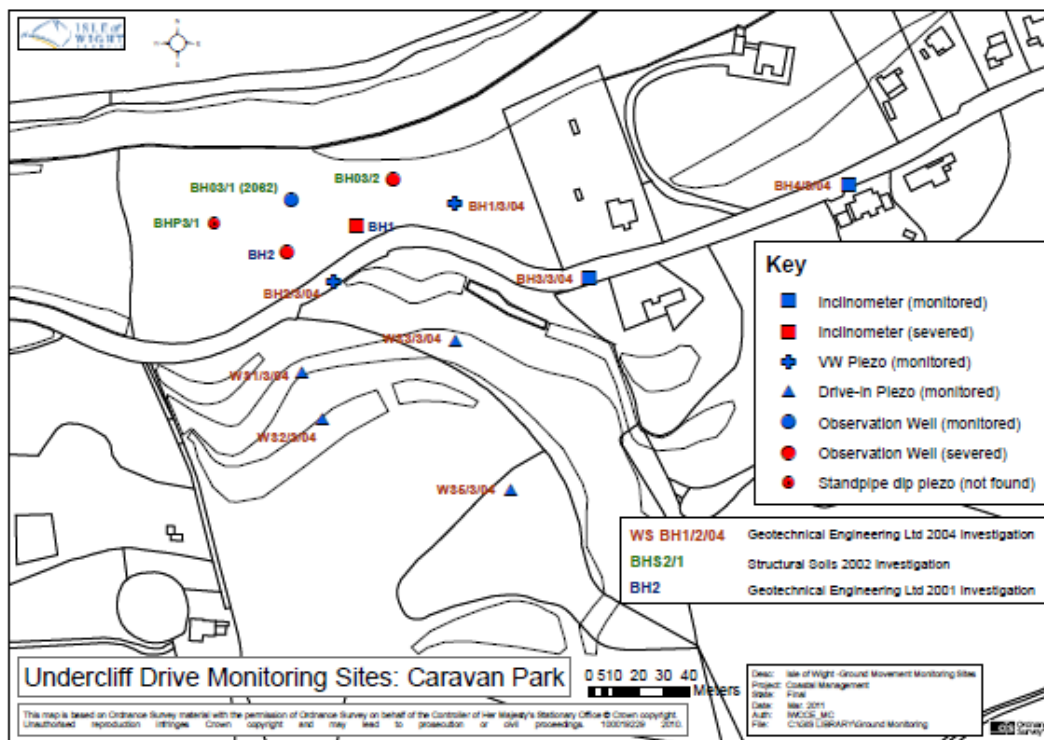
Figure 3 Undercliff Drive Site 10 Monitoring Location Plan

A location of the available monitoring points is shown in Figure 3, which comprise piezometers installed at a range of depths to monitor groundwater, and inclinometers to 50 metres depth to measure ground movement.

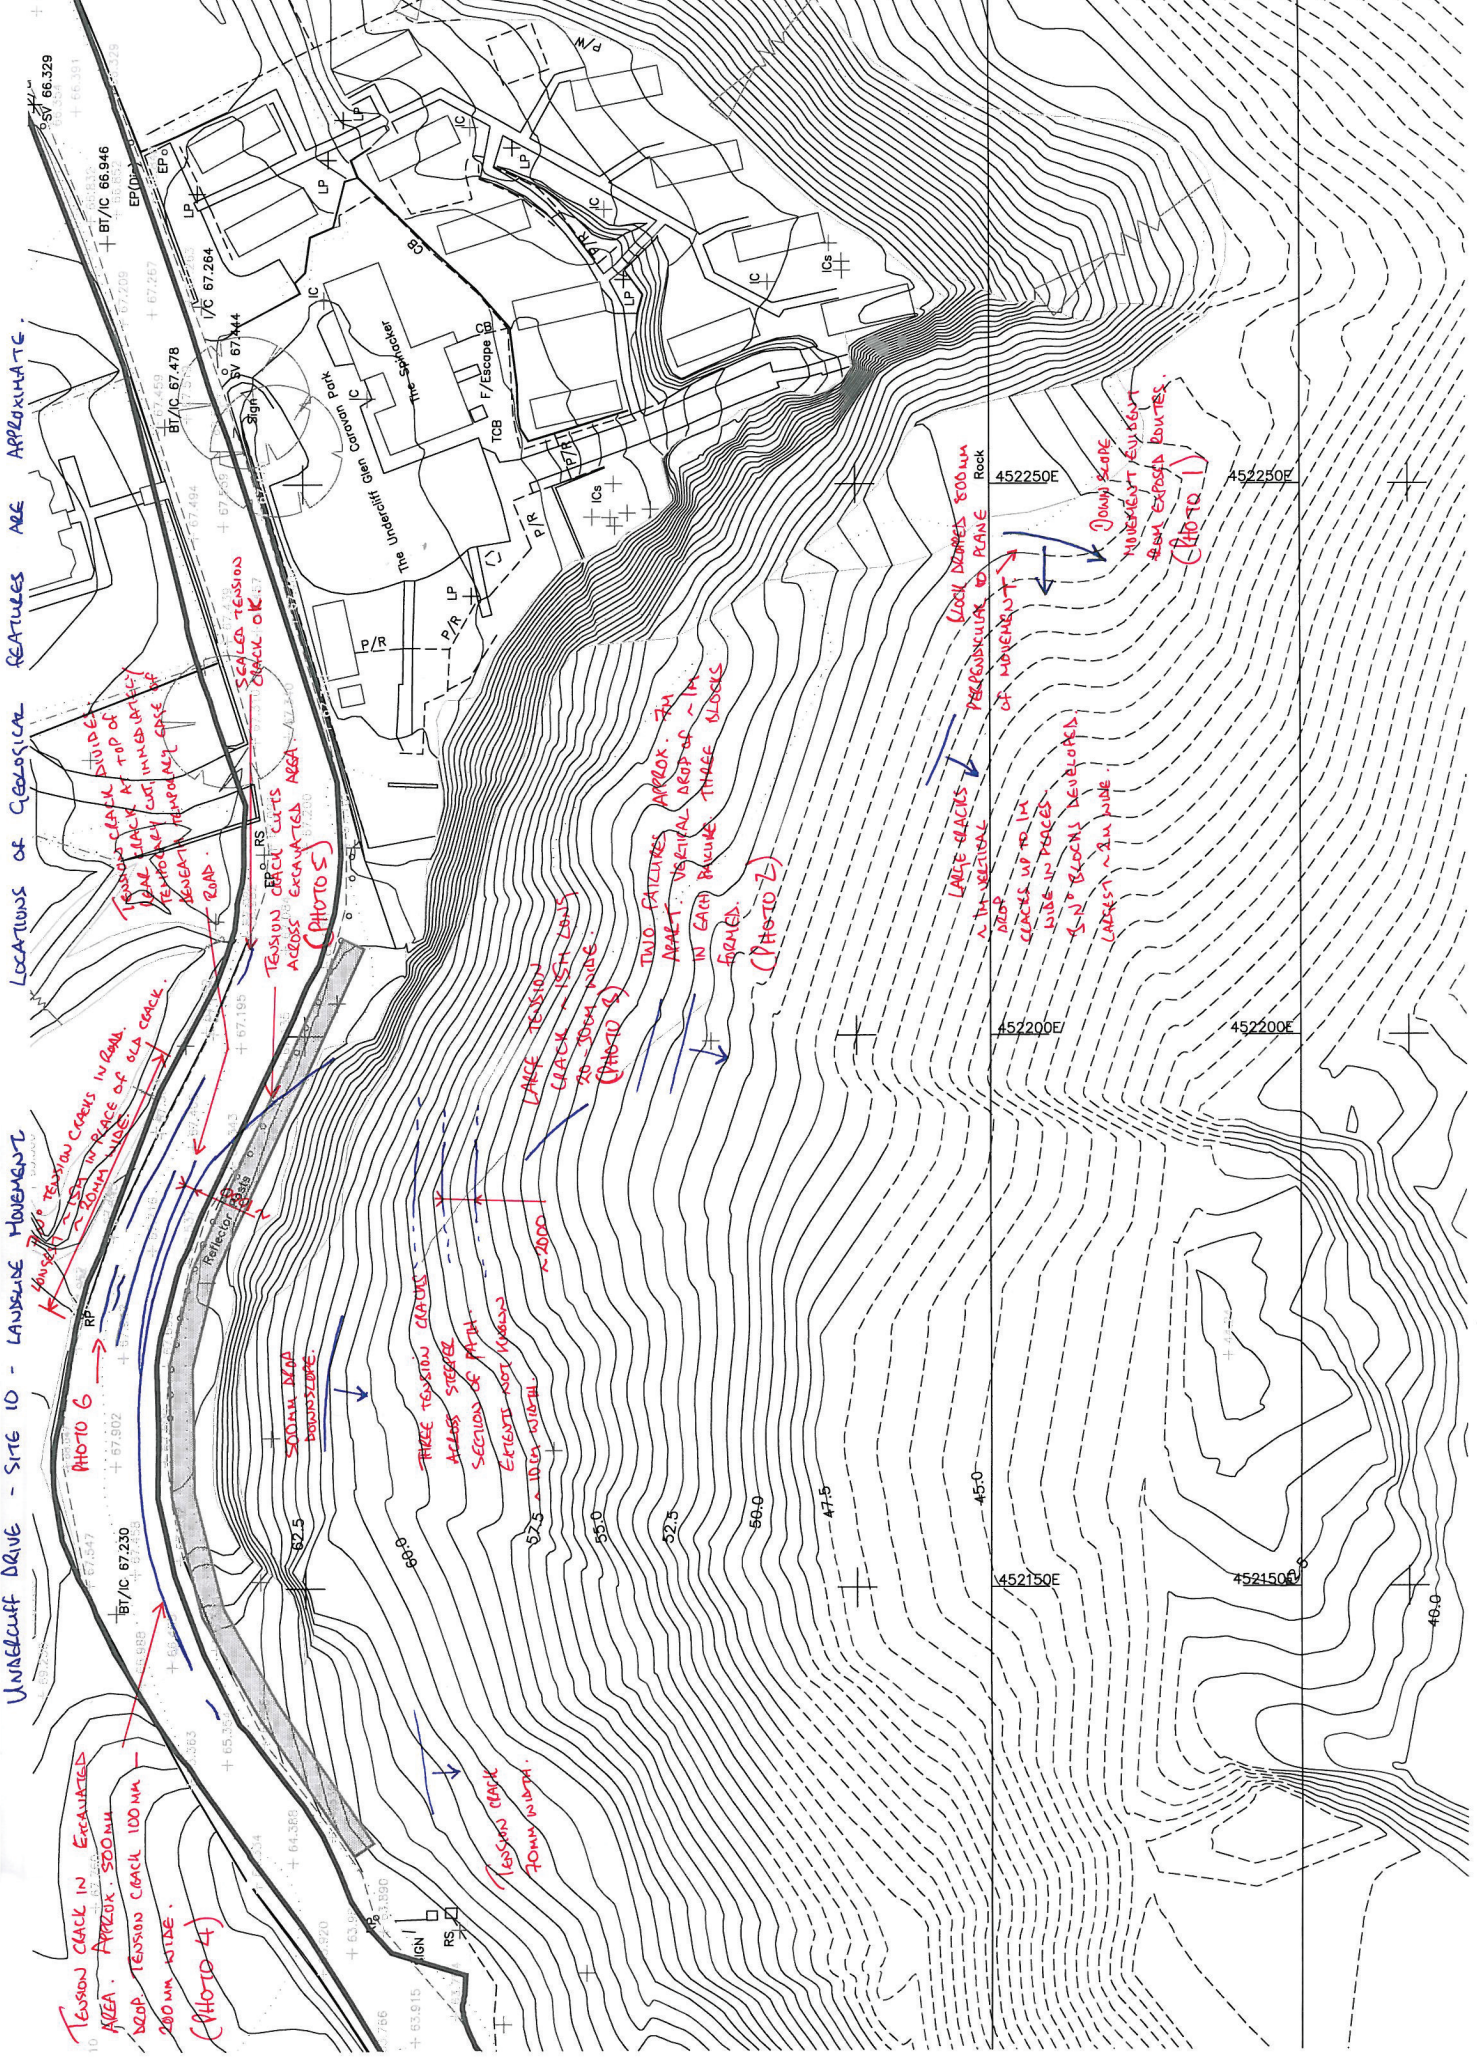
TWO FAILURES APPROX. 7M APART. VERTICAL DEPTH ~ 1M IN EACH BLOCK THREE BLOCKS. (PHOTO 7)

LARGE CRACKS A FEW METERS DEEP CURVES UP TO 1M HIGH IN PLACES. 5-10 BLOCKS DEVELOPED. LARGEST ~ 2M WIDE.  
LARGE CRACKS APPROX 500MM DEEP PERPENDICULAR TO PLANE OF MOVEMENT.  
JUMP SCALE MOVEMENT SURVEY BY EXTERIOR BOUNDS. (PHOTO 1)
