# Ventnor Options Appraisal

Technical Report

Revision 5

Isle of Wight Council

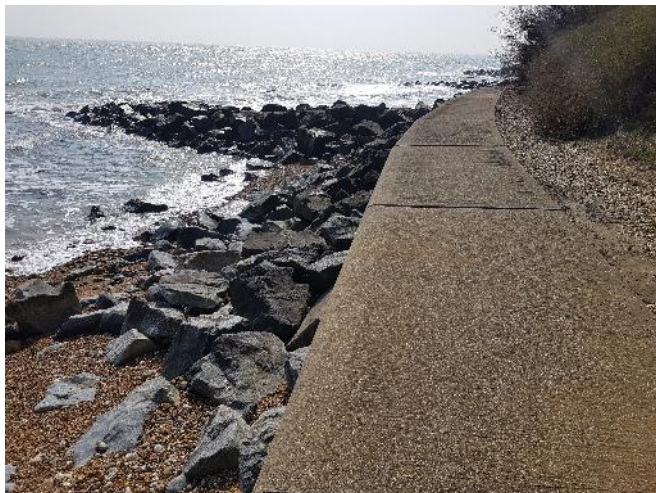
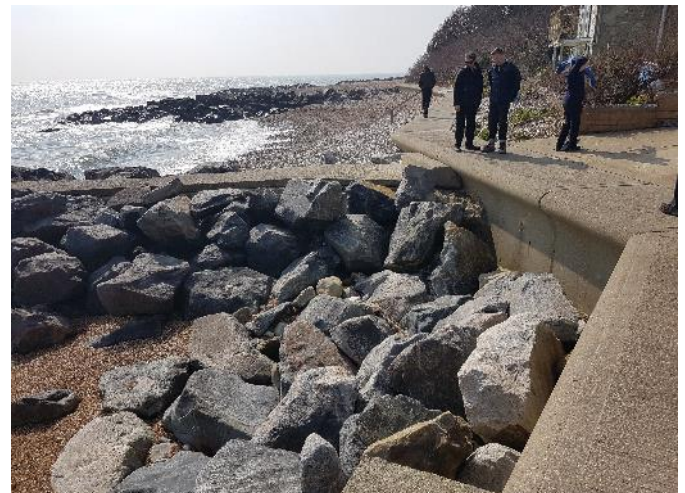
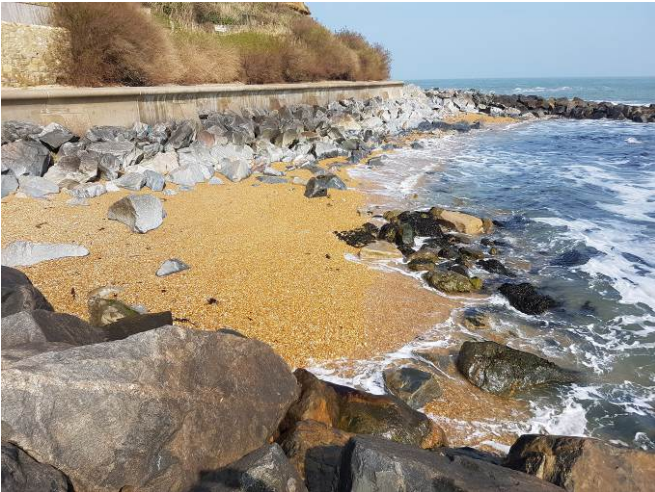
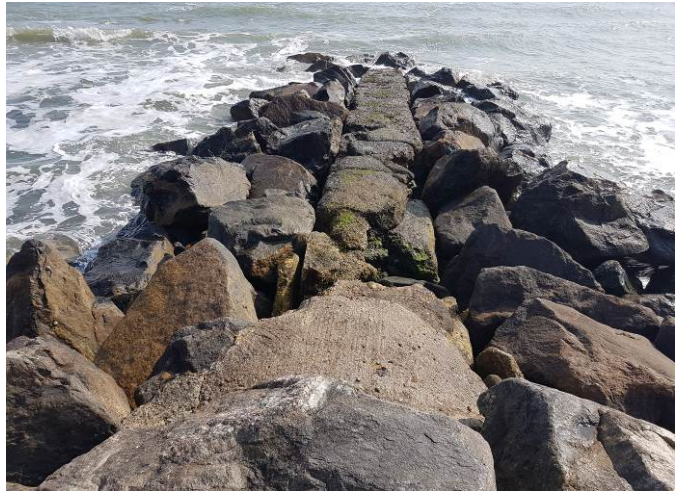
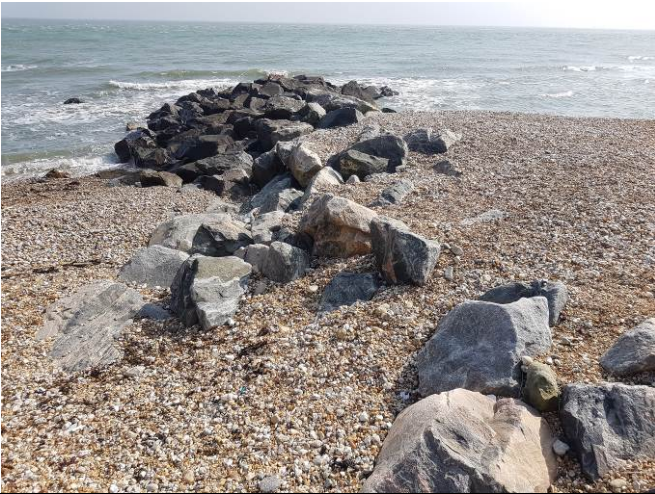
- Japanese Knotweed identified behind wall (refer to IWC IW30-001 -V.2-294 coastal inspection report).

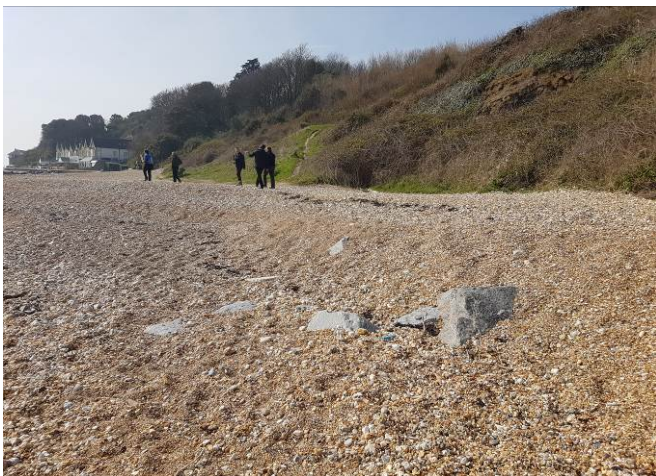
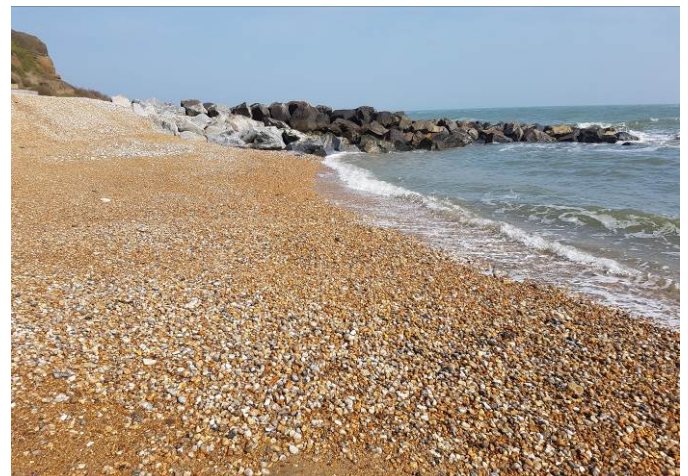
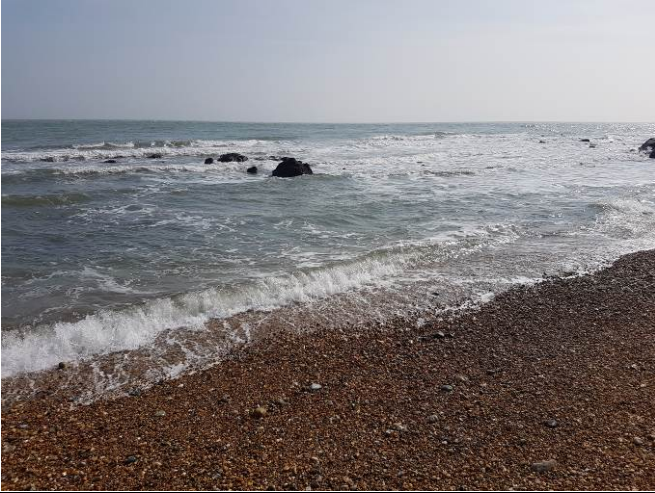
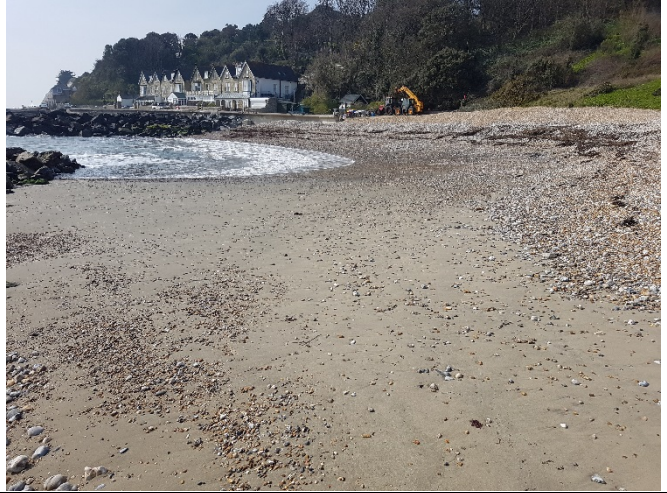
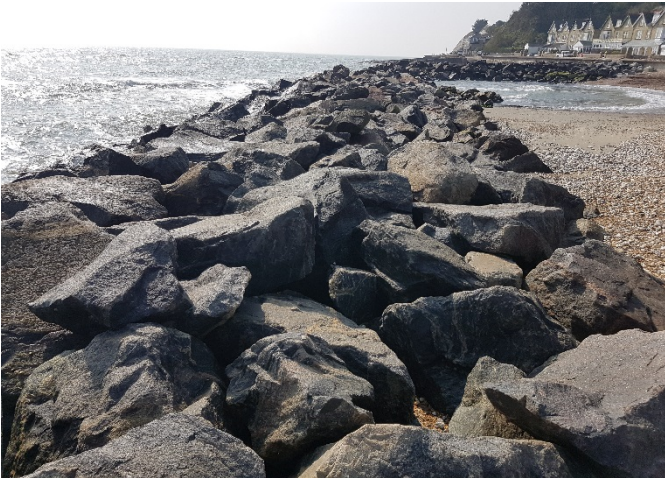
- Rock structures are robust structures and even in the event of localised damage these structures would continue to function adequately. Any deterioration in function of these structures would be slow.
- Protection to hinterland is reliant on regular recycling of beach material from the northeast to the southwest. Without this ongoing beach maintenance the slopes behind the western bay would become more exposed and access to the beach would become compromised (direct impact on local fishermen).
- Tombolo behind breakwater is extensive and stable.
- IWC have advised of settlement of the breakwater and localised damage to rock armour

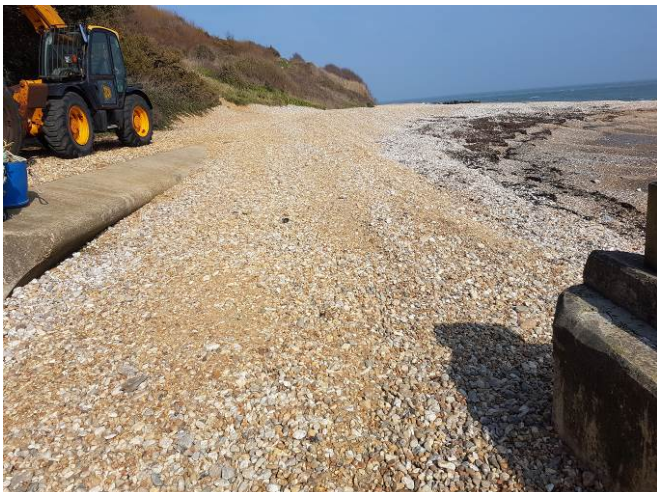
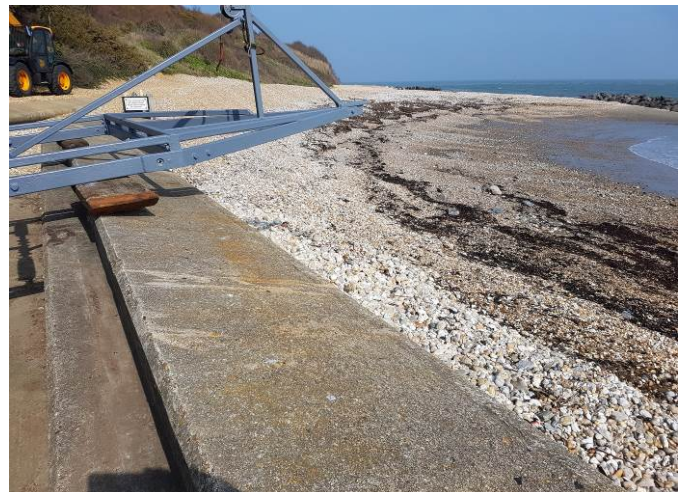
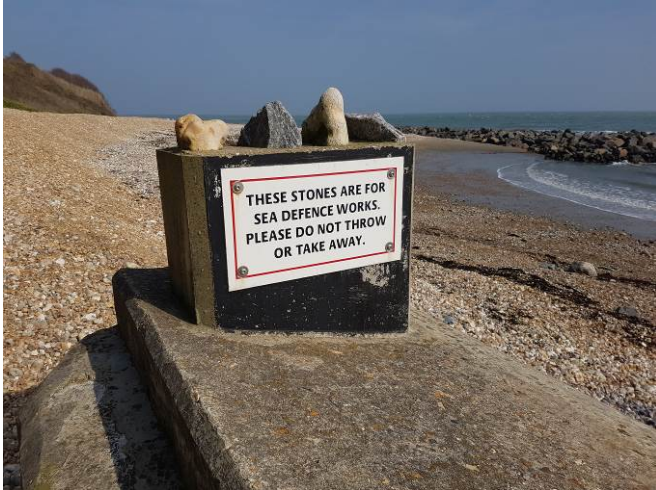
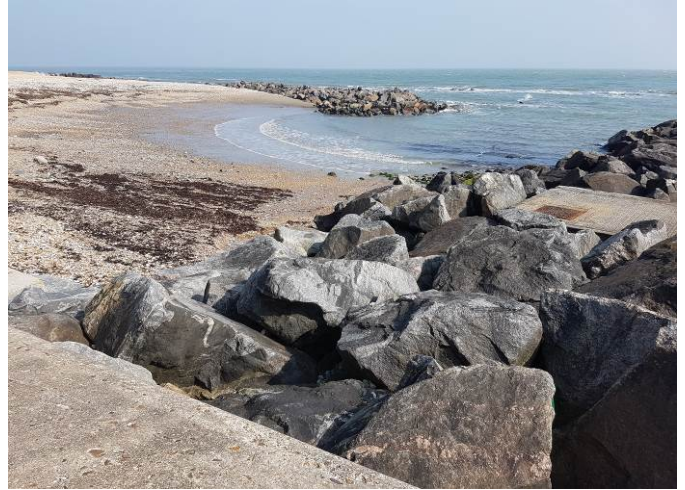
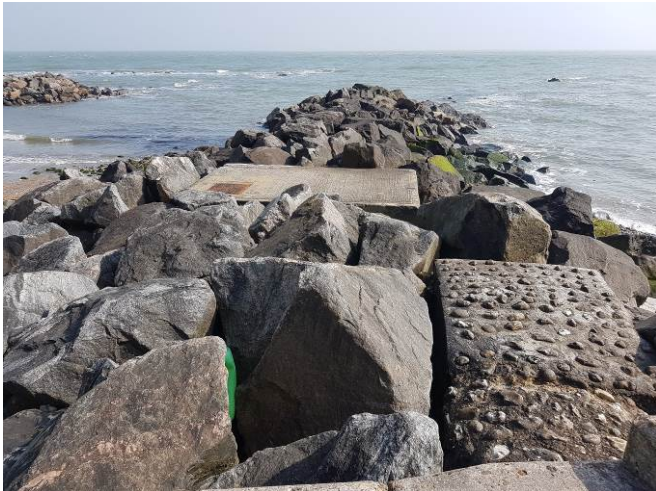
- Defence standard is strongly linked to beach levels, which are controlled by the gap opening between the breakwater of IW 30 / 002 and the rock groyne (extension of groyne may increase protection to Monks Bay).
- Users of the ramp (fishermen) have in the past maintained the beach levels at the ramp to retain access to the beach. This is in addition to formal shingle recycling typically undertaken annually by IoW at a cost of £3k to £4k per year. This typically involves moving shingle from the bay to the north of the breakwater to the ramp/seawall area of IW 30 / 003. Post-storm loss of beach material has been recorded (refer to IWC IW30-002-003 -V.2-580 coastal inspection report).
- If beach maintenance ceased then the susceptibility to wall undermining would likely increase to High as wall foundations are not very deep and are regularly exposed.

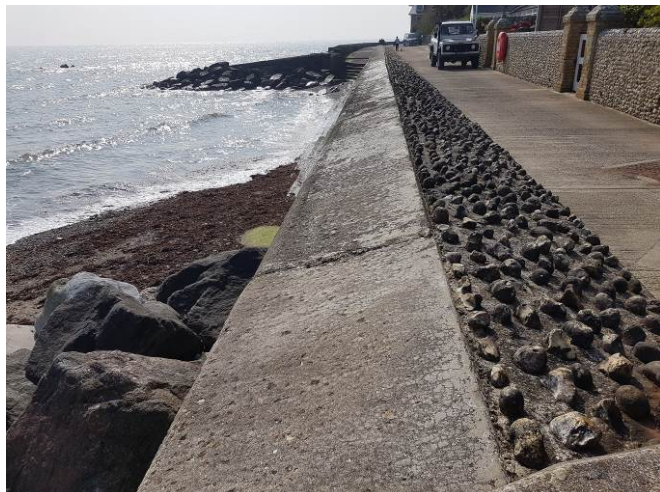
Photo 1:

- Extents of rock toe protection and depth of shingle over toe unknown. From site observations and IWC IW31-001-V.2-554 coastal inspection report, it appears that there is some rock at each end of the bay but an absence of any formal or appropriately sized rock in the main central sections.
- Extent of movement of toe rock unknown but likely to have been displacement as rock appears relatively small.
- Whilst the concrete seawalls are old structures, they appear to be worn rather than critically compromised, hence overall rating of fair. Locally there was some reinforcement exposed in the toe in 2015 (refer to IWC IW31-001-V.2-554 coastal inspection report). Condition will continue to deteriorate but addition of toe rock has extended the life of these structures.

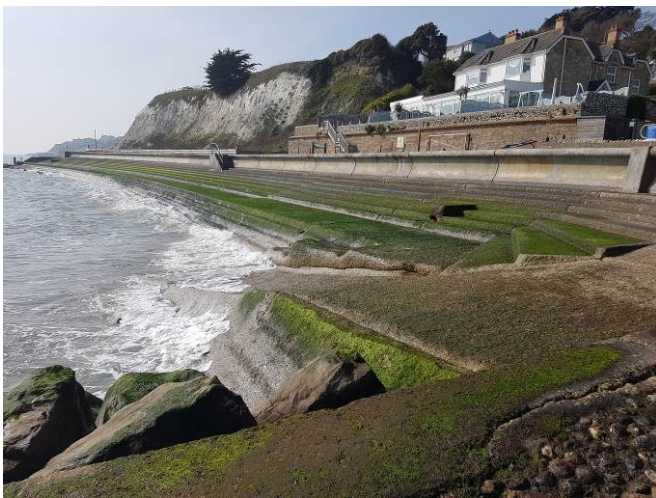
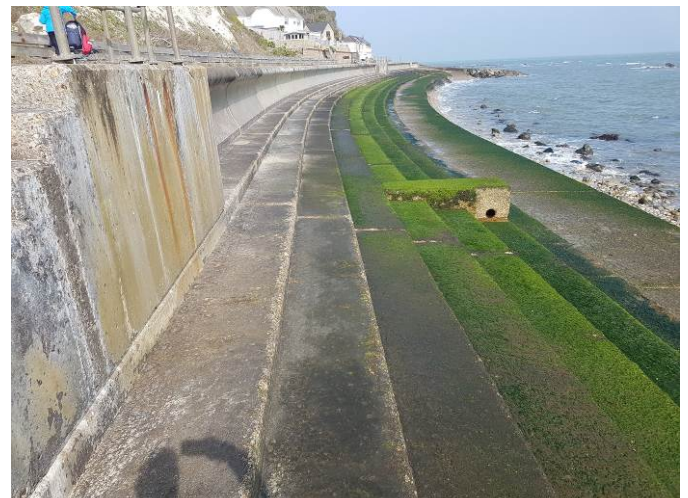
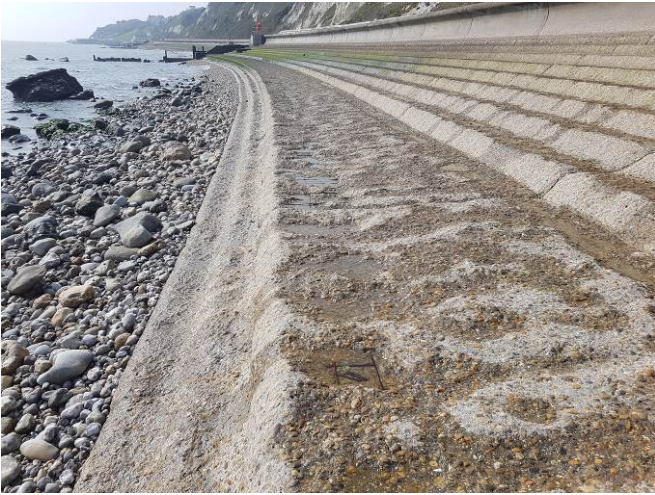
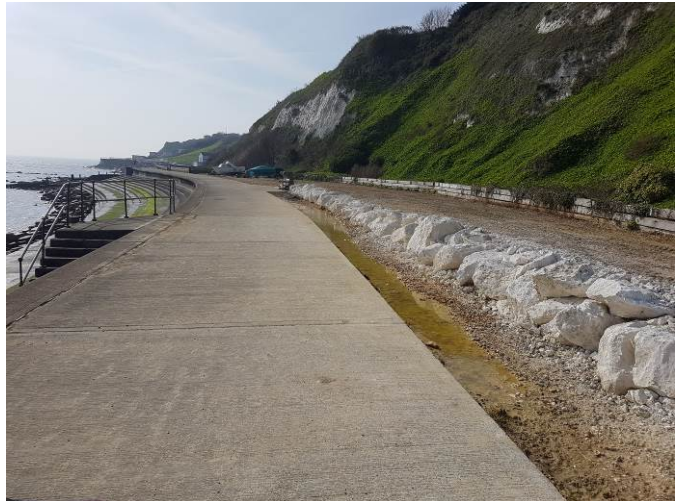
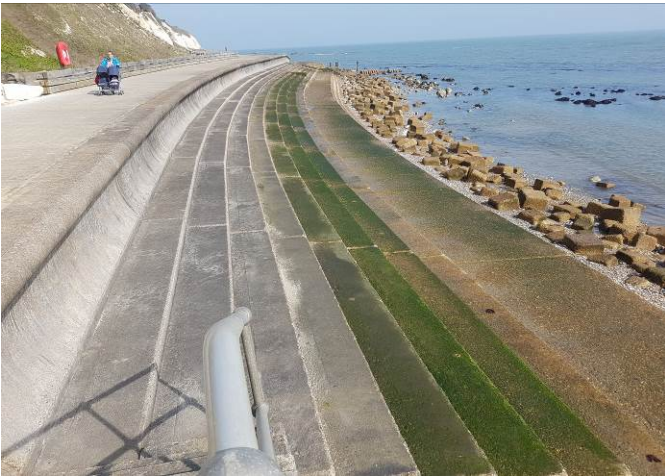
- Localized severe abrasion of lower concrete apron platform of structure with reinforcement exposed. Upper sections of seawall generally in very good condition.
- Groynes are in a poor condition but it is not expected that a beach could be held with existing groyne spacing, so function of groynes is largely redundant. Hence, overall condition of defence system remains good as largely dependent on the concrete seawall.
- Risk of structure undermining being managed by rock over the wall toe.
- Historically, cliff falls have damaged the catch fence at the back of the promenade, but such occurrences do not compromise the coastal defence structure.

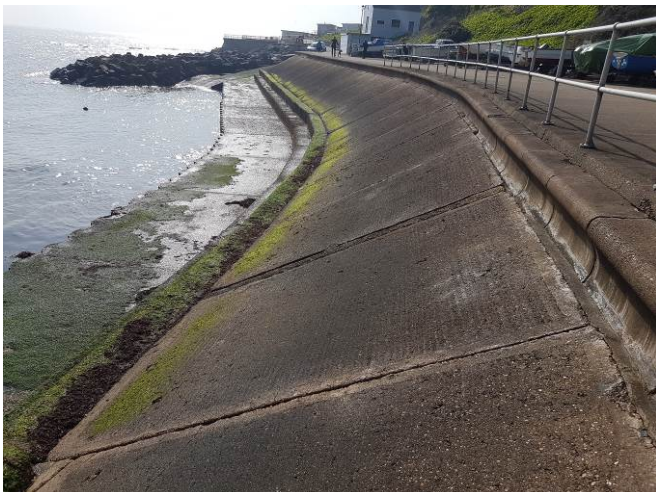
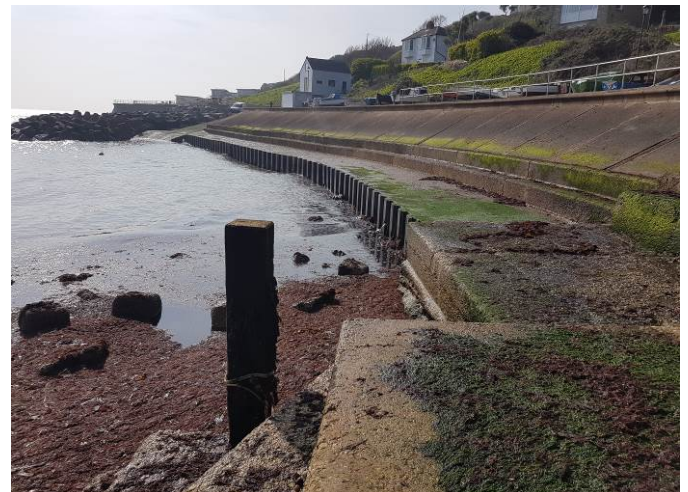
- Sheet piled toe is in a failed state (refer to IWC IW32-001-V.2-290 inspection report from 2010) with extensive eroded holes in the sheet piled toe and loss of fines from beneath the toe. The degree of corrosion should be expected to have worsened since this inspection but tide heights during March 2017 site visit prevented access to re-inspect.
- The extent of washout voids underneath the structure is unknown.
- Despite failure of the sheet piled toe, the revetment and the seawall remains in serviceable condition (no significant movements observed) and the overall structure could have residual life if the toe is reconstructed and voids filled (assuming voids do not extend fully under the structure).
- Beach levels remain low and the sheet piled toe remains exposed.

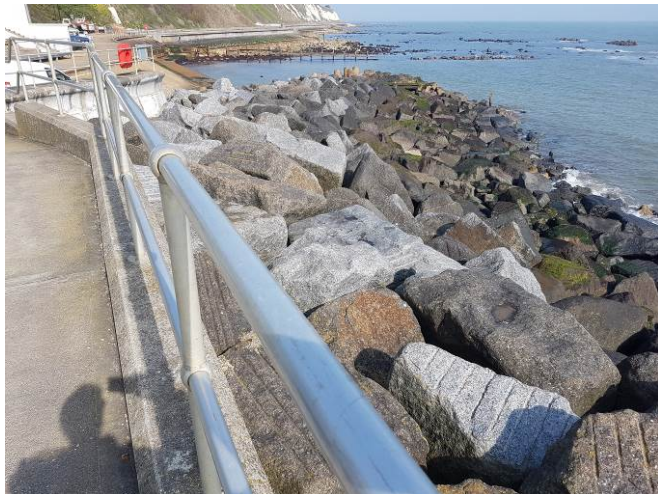
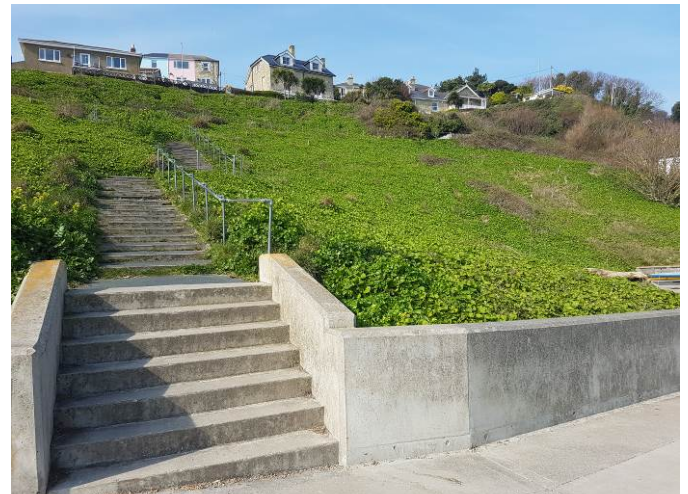
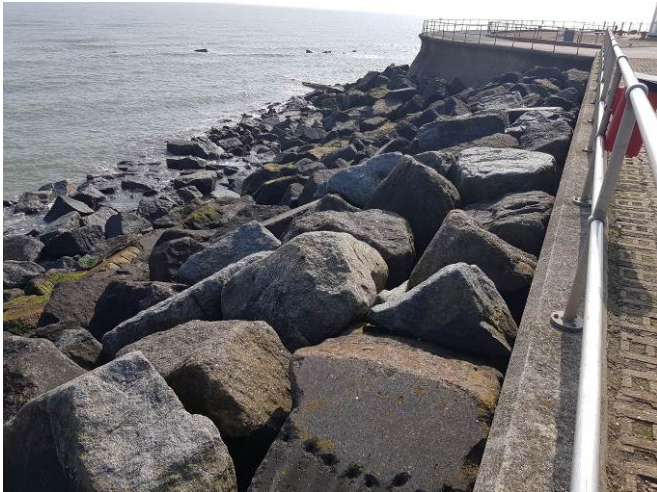
- Structures were built in 1993 and in 2000 as part of the Wheeler's Bay Protection and Slope Stabilisation Scheme. No stresses of the structures was observed.
- Rock appears to be in good condition but unknown if rock has settled since construction.
- Access to the slipway may be compromised by adjacent IW 32 / 001 defence condition.

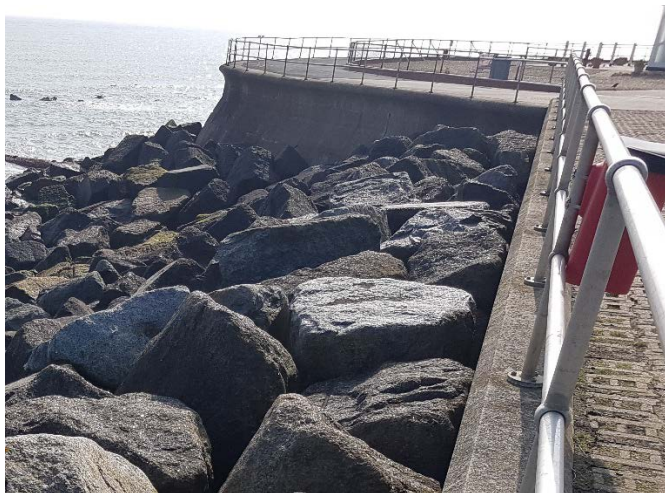
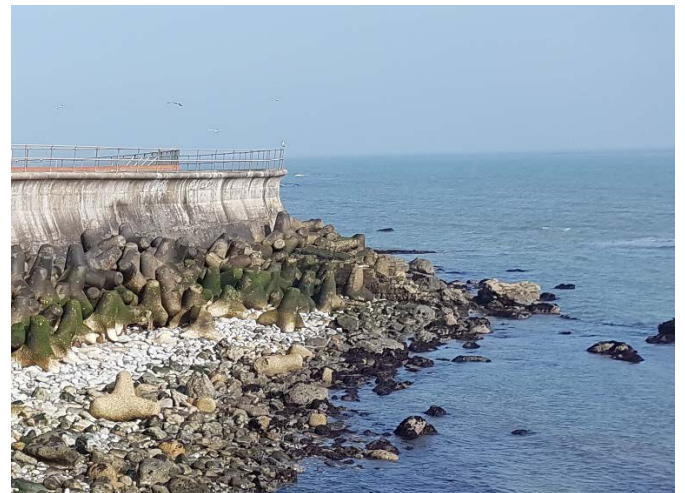
- No evidence of structure failures.
- Rock protection geometry and rock size/quality is not uniform, but does not appear to be adversely compromising the concrete seawall at present, hence, overall condition grade of Good.
- Rock protection and the concrete seawall is lower than adjacent IW 32 / 003, despite being in a more exposed location.

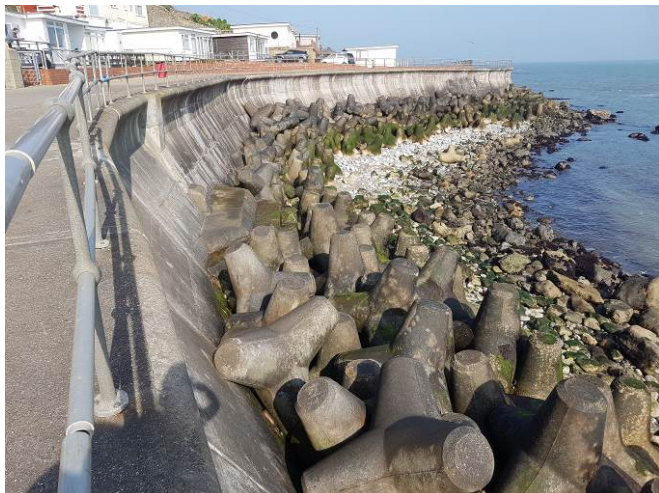
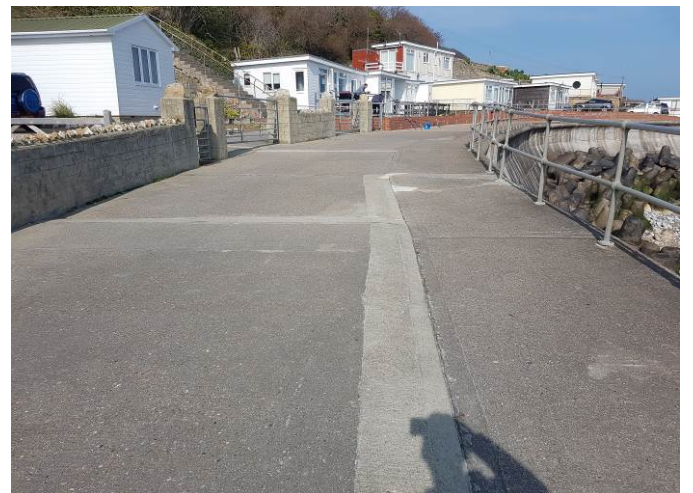
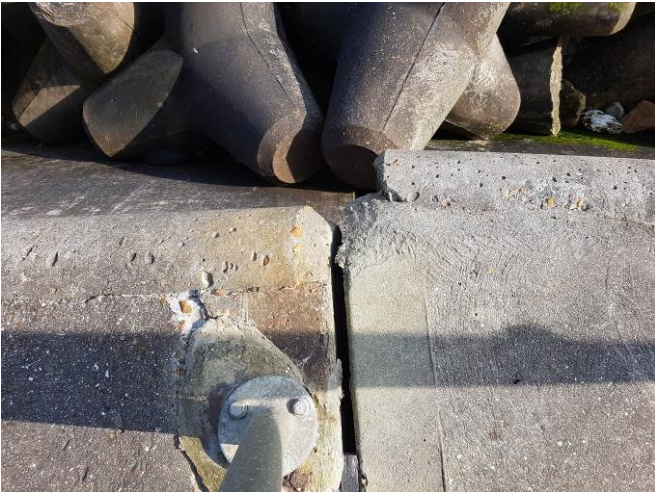
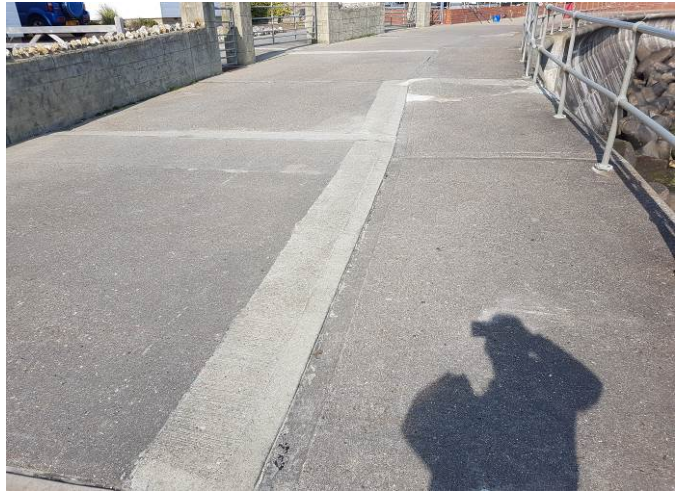
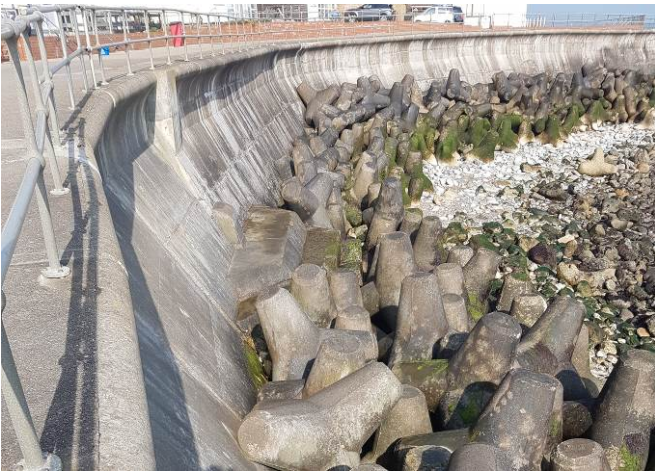
- Significant displacement of central/southwest section of wall and promenade. It is suspected that this movement is due to structure loading from ground movements caused by deep clay landslides. CCO comparison of 2015 and 2017 laser scans has identified movement over that 2-year period of up to 30mm as a southerly displacement and vertical settlement of up to 25mm – this is being investigated further.

- Patch repairs to promenade surface following structure displacement (refer to IWC reports IW33-001 V.2-427, V2-430, V.2-536 and V2-547) but currently no measures implemented to prevent further movement.

- Other than the movement (which is serious), there are no other causes for concern with the seawall.
- Although many of the Tetrapods are still in fair condition (IWC IW33-001-V2-329-V2.16), some have failed and it is not possible to identify which have settled or been displaced by ground movements over the longer term. It is assumed that they have displaced with the historical seawall movement. CCO comparison of 2015 and 2017 laser scans identified movement the Tetrapods. Overall, the Tetrapods remain functional.

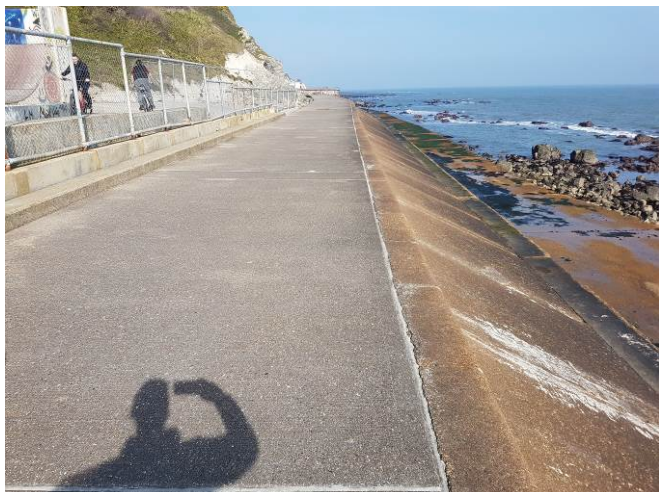
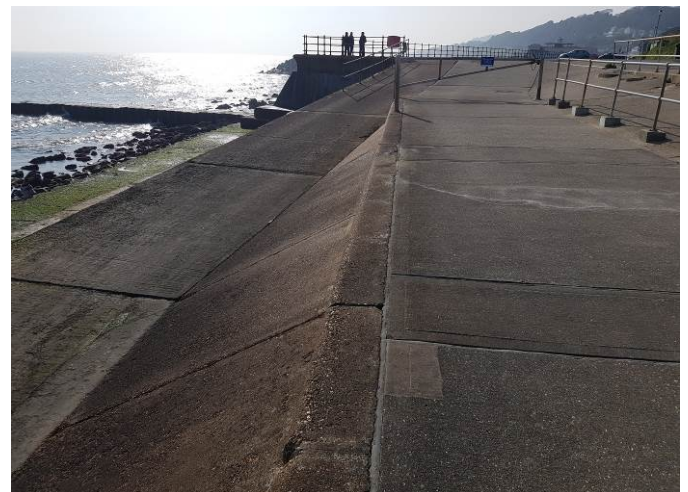
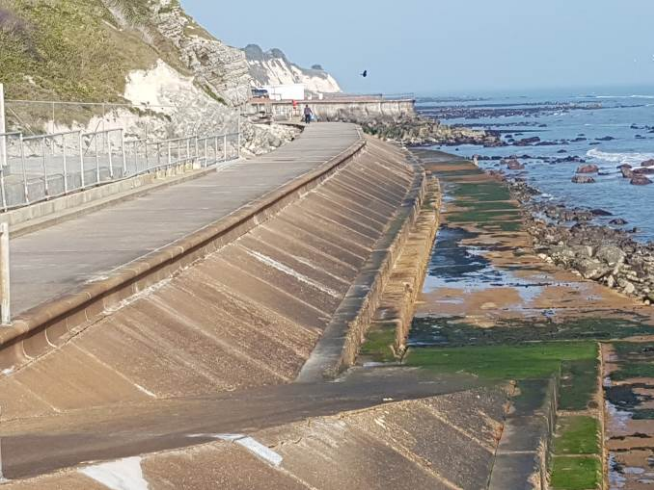
- Steel sheet piled toe in very poor condition with extensive corrosion holes and material wash out (refer to IWC IW33-002-V.2-330 inspection report). The degree of corrosion should be expected to have worsened since this inspection but tide heights during March 2017 site visit prevented access to re-inspect.

- Despite the failed sheet piled toe, the revetment and the seawall remains largely in serviceable condition.
- CCO comparison of 2015 and 2017 laser scans has identified extensive movement over those 2 years of between 25mm and 50mm lateral southerly displacement between 7mm and 25mm of vertical settlement – this is being investigated further. Evidence of landward rotational slip of slope (refer to IW33-002-V.2-616)

- Beach levels remain low and the extent of washout voids underneath the structure is unknown.
- Historical movement of structure resulting in joint failure (refer to IWC IW33-002-V.2-419 for details).

- Evidence of significant wave overtopping causing localised cliff erosion at this structure during storm/spring tide conditions (refer IWC IW33-002-V.2-569)

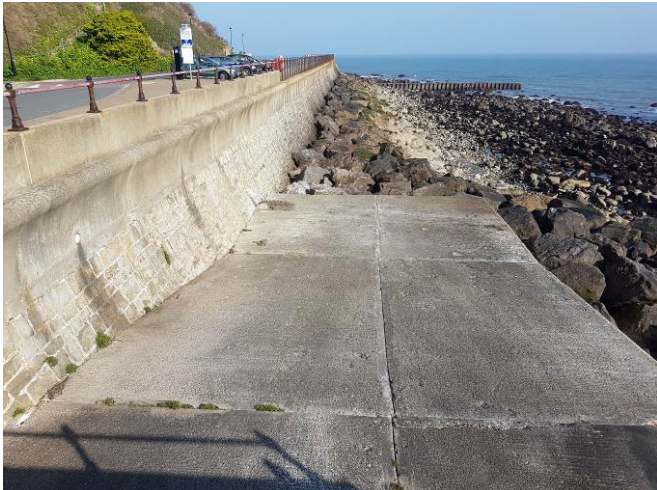
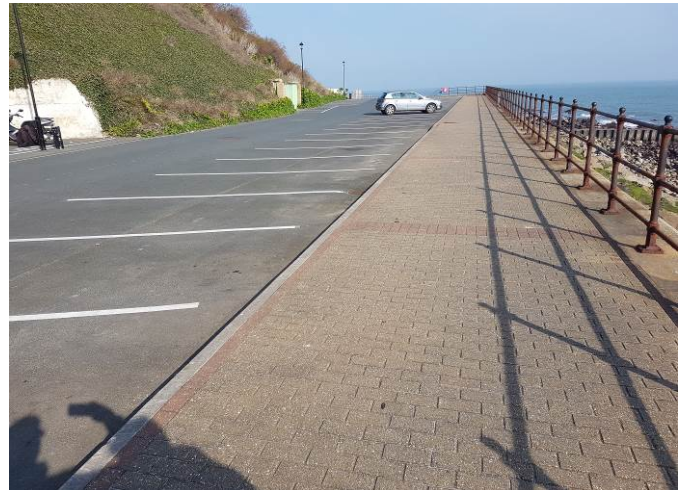
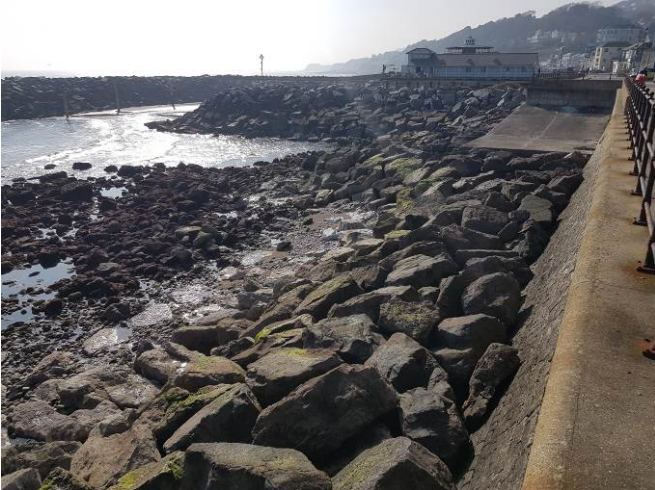
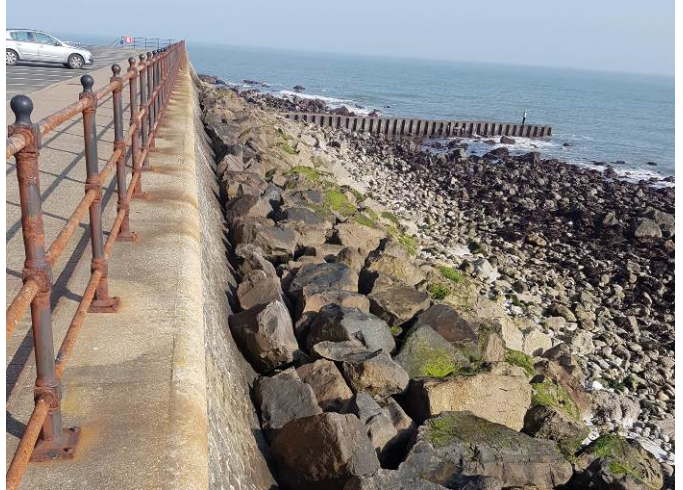
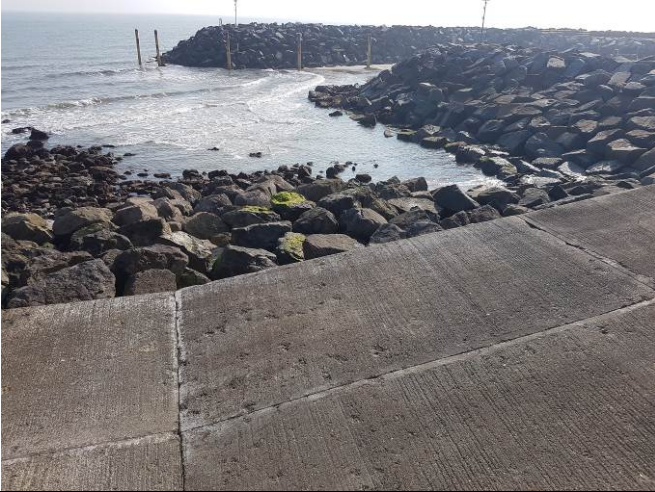
- No evidence of seawall failures or structural stress.
- Rock armour appears to remain in good condition with no obvious signs of displacement or degradation.
- Outfall not included in assessment as not considered part of coastal defence system.

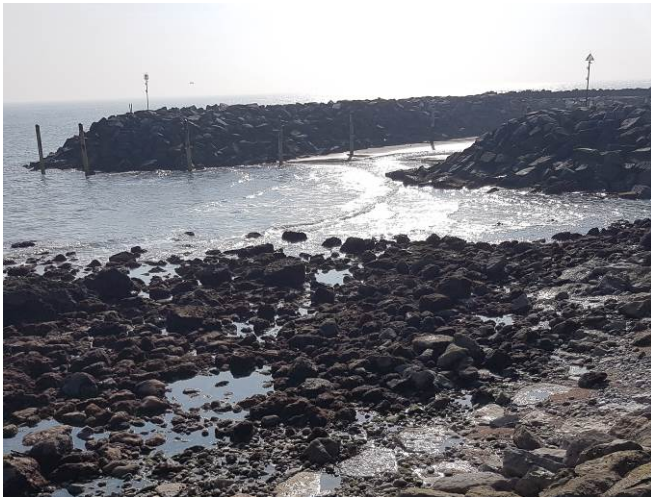
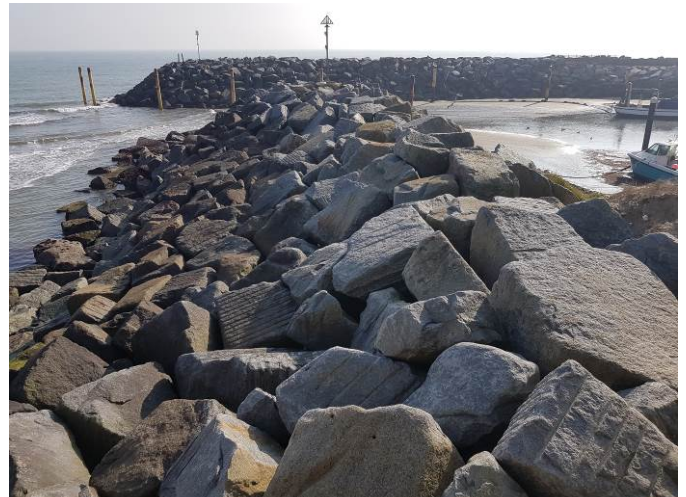
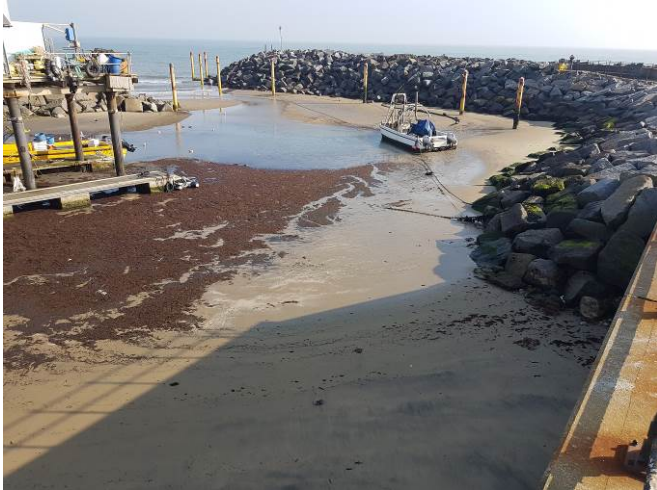
- No signs of displacement of rock from within these structures that were constructed in 2003.

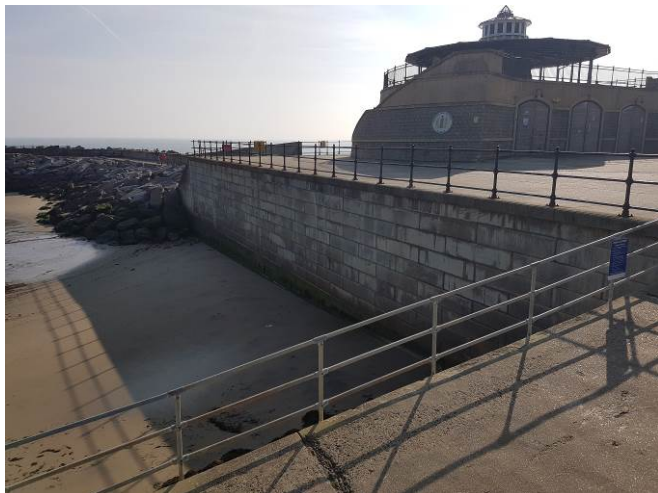
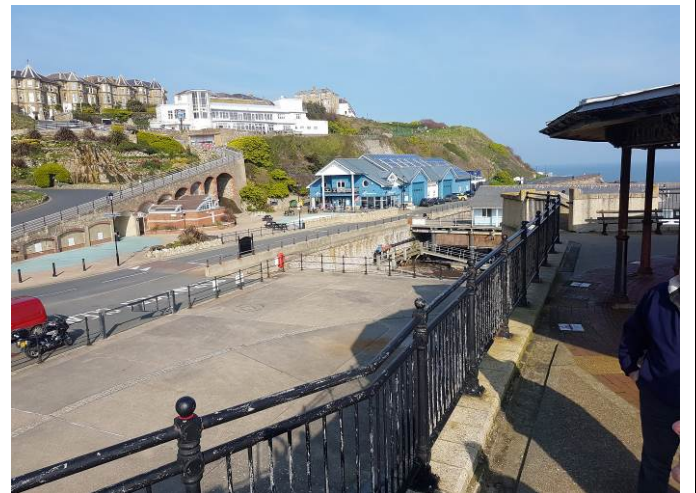
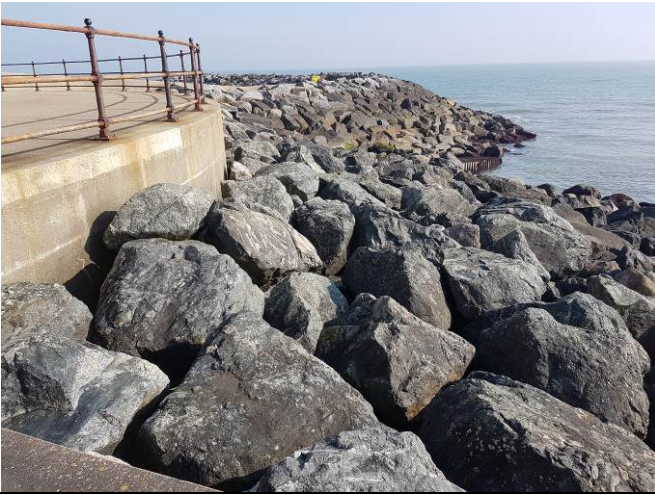
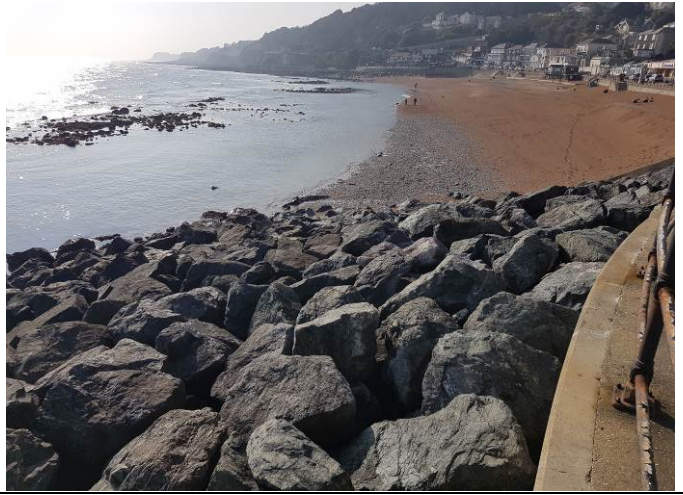
- No evidence of structural failures or stress in the seawall.
- Rock armour appears to remain in good condition with no obvious signs of displacement or degradation.

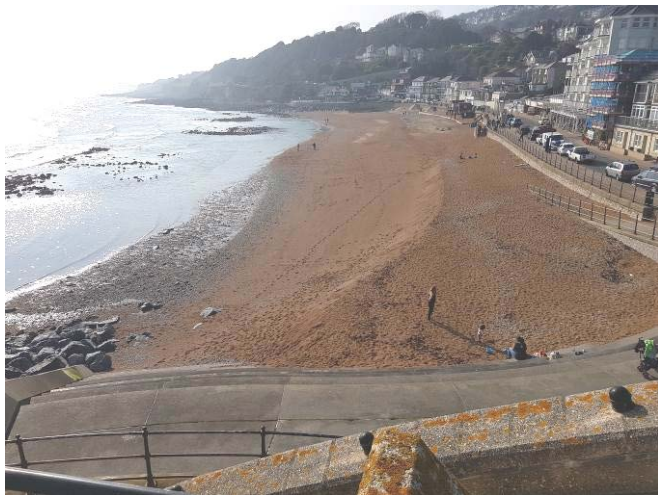
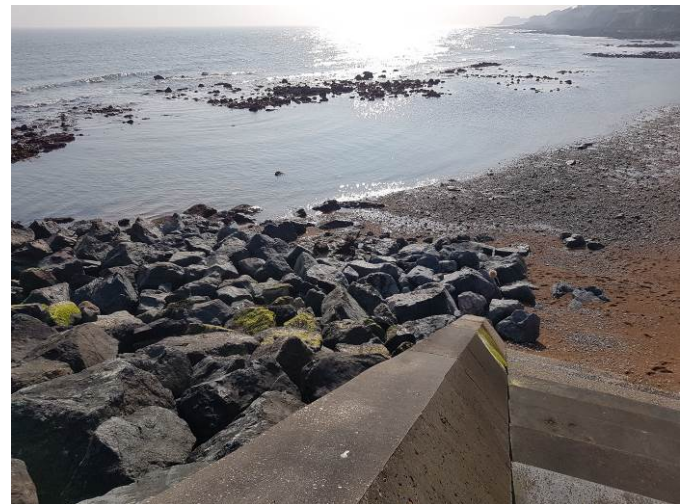
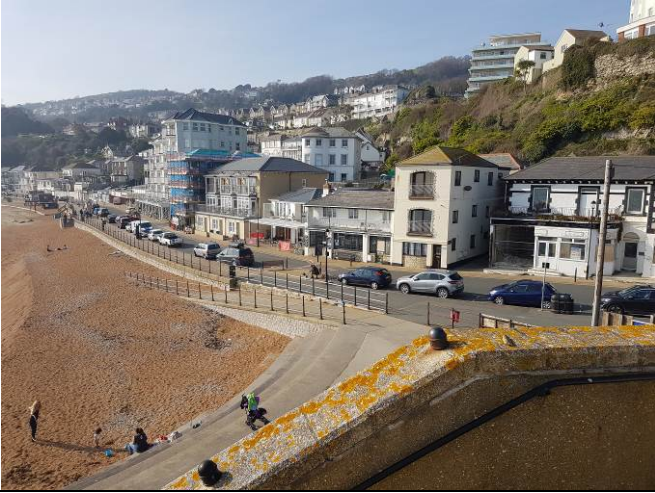
- No evidence of structural failures or stress in the seawall.
- Beach levels appear to be relatively healthy at the structure. Main risk to the wall and safety of pedestrians is from lowered beach levels and resultant increased wave heights at the structure.

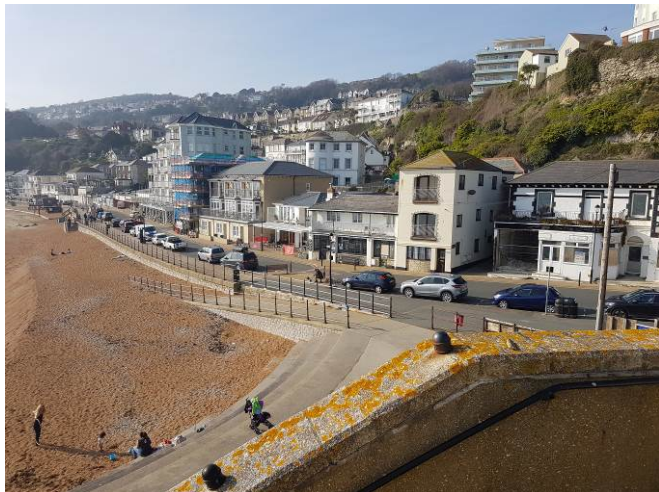
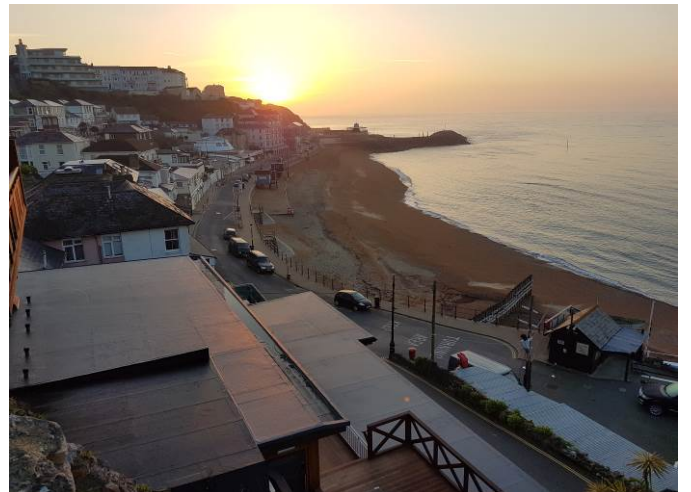
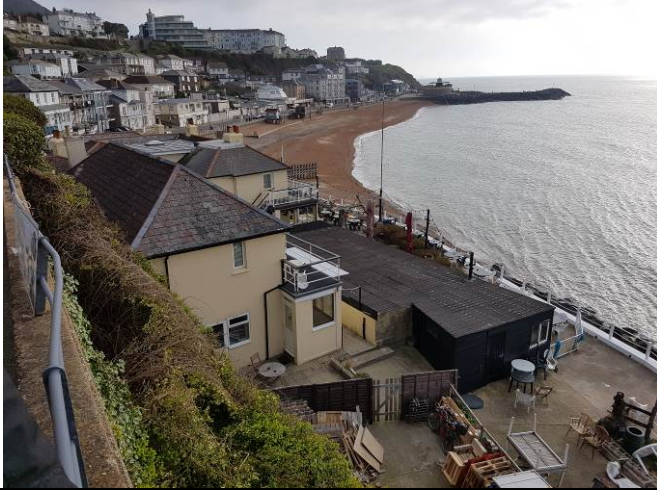
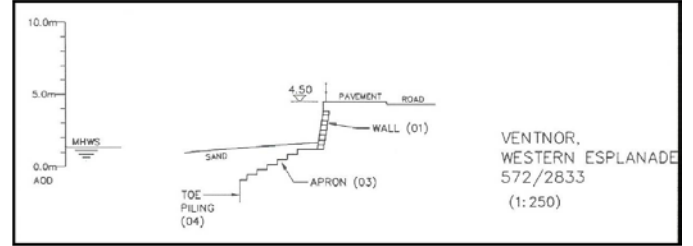
- Wall has been in-situ for over 20 years and despite fluctuating beach levels (refer to IWC IW35-001-V.2-425-V.2.23 inspection report) the overall defence has no signs of structural stress. The exception is in the SW corner where there is a localised bulge and further repairs works may be required in the future. Loss of passive loading when beach sediment lost, which worst-case could reactivate central landslide complex.

- Timber revetment holding small beach area is not critical to the defence system and is not included above.

- Maintenance requirements such as steps repair (IWC IW35-001-V.2-581) and re-pointing will be ongoing.
- Beach volume is relatively stable (particularly since the building of Ventnor Haven), but there are seasonal shifts in material accumulations within the bay. Likely to be occasional beach recycling requirement.

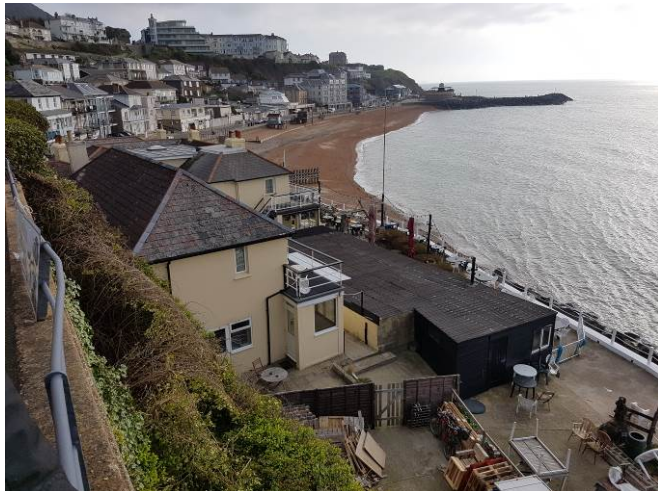
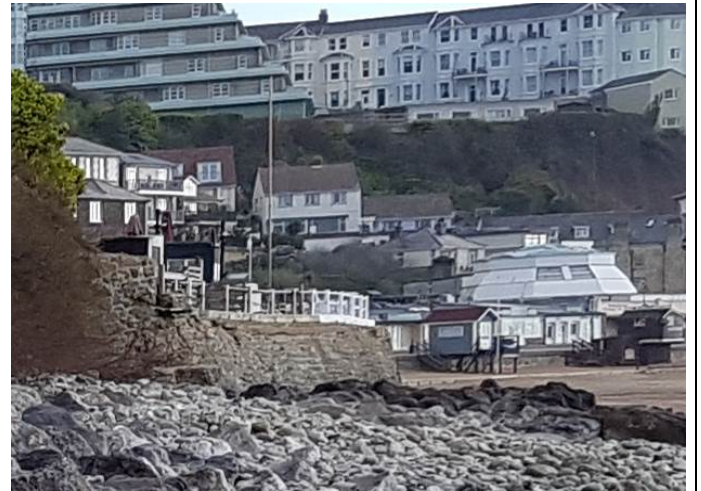
- Low rock revetment and lower concrete encasement in front of the structure protects the structure from undermining, limits wave impact and provides toe weight to the structure and cliffs.
- Strengthened structure as a whole is good condition with no signs of structural stress.

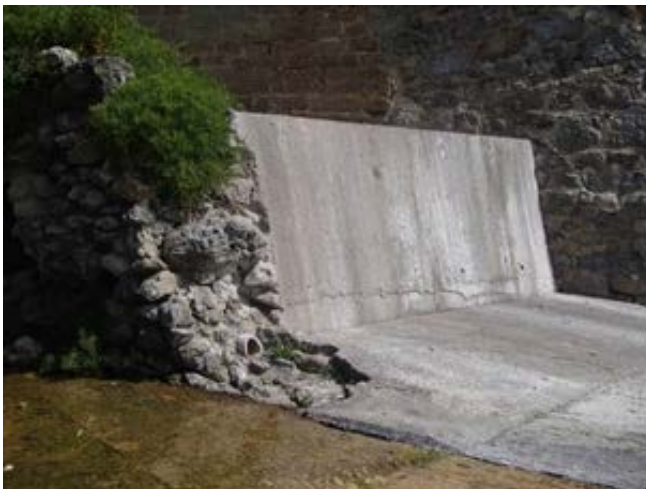
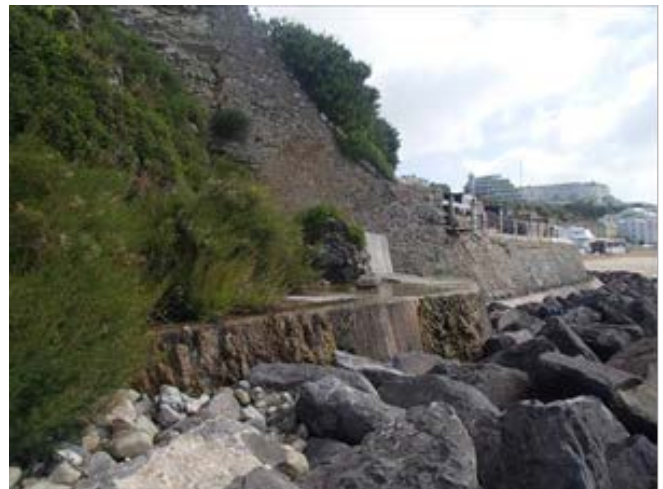
- Low rock revetment and lower concrete encasement in front of the structure protects the structure from undermining, limits wave impact and provides toe weight to the structure and cliffs.
- Concrete element is in poor condition due to pressures from groundwater, with flows exiting through the structure (refer to IWC IW35-003/4-V.2-617 inspection report). This is compromising the structure giving a high risk of failure from global instability (which could be a quick failure) and washout of material (which would be a slower failure). High retained heights and cliffs behind the structure present an elevated risk of failure.
