# Ventnor Options Appraisal

Technical Report

Revision 5

Isle of Wight Council

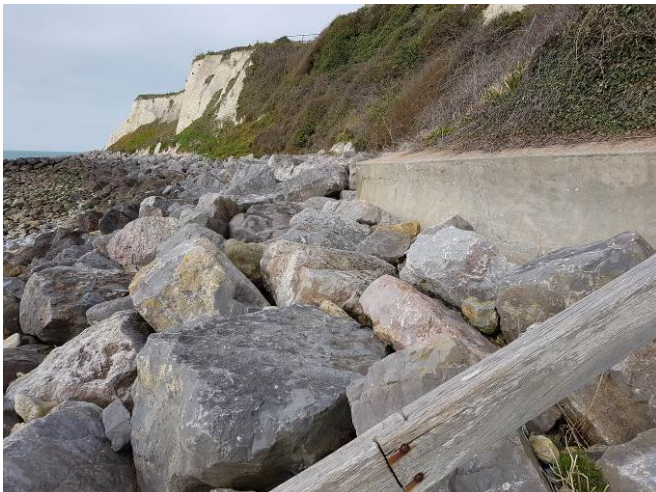
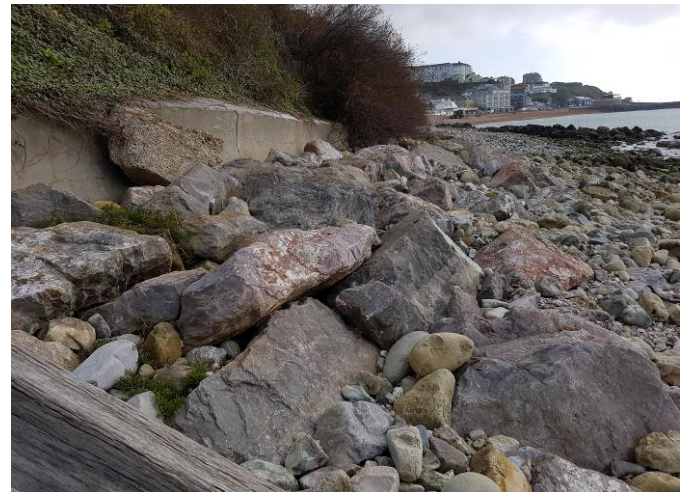
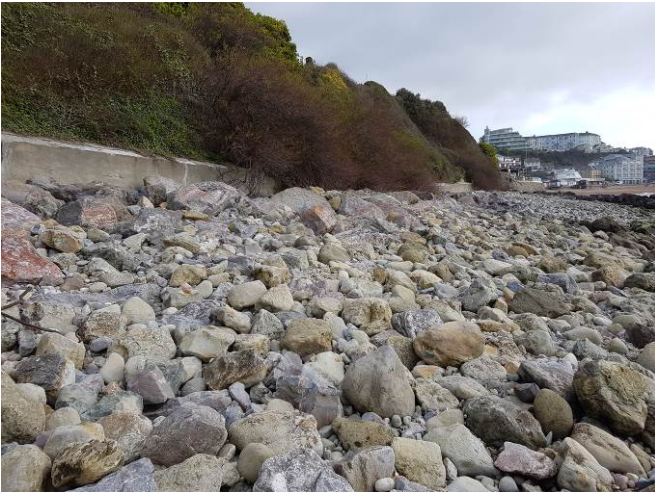
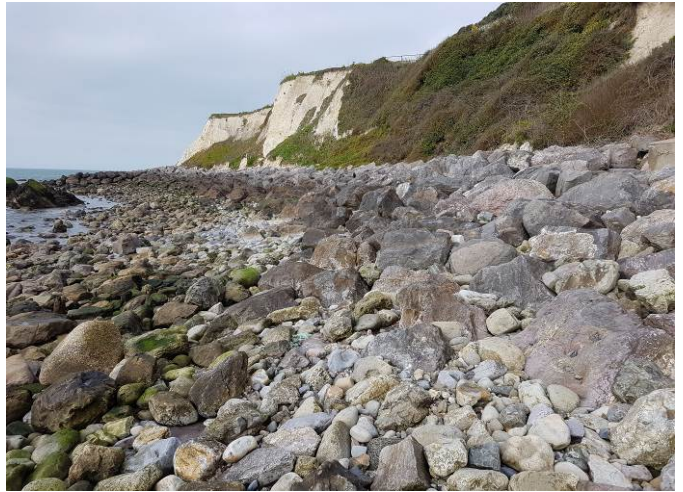
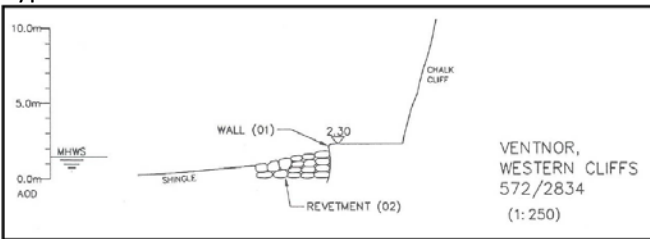
- Rock revetment protecting the old (1950) wall is in good condition.
- Damage to the rendering of the seawall requires maintenance, but in combination with the rock revetment, the overall structure appears to be in good condition (refer to IWC IW35-003/4-V.2-617 inspection report).
- Timber access steps require maintenance but this is not compromising coastal defences.

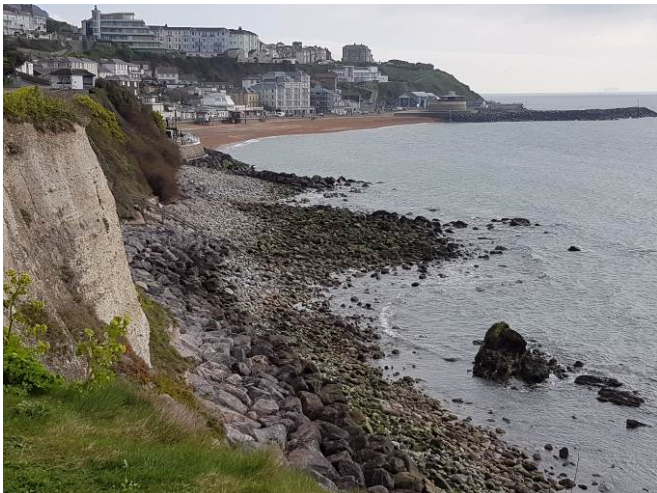
Photo 1:

- Rock revetment continual along base of the cliff affording good protection to the cliff. Although overtopping is much reduced by the revetment, there will be residual overtopping at the base of the cliff which will allow continuation of slow rates of erosion. Following any further recession of the cliffs the rate of erosion will then fall further as long as the rock structure remains in situ without a compromise in its geometry/stability.
- Rock groynes providing sheltering function to the rocky foreshore, particularly in SW storms.
- All rock structures appear to be in good condition.
- Southern water outfall protected by rock is providing some costal defence function as a groyne. This is considered as a “Rock Groyne” above.
- Section of footpath has been diverted due to landslides; this could be required again in the future.

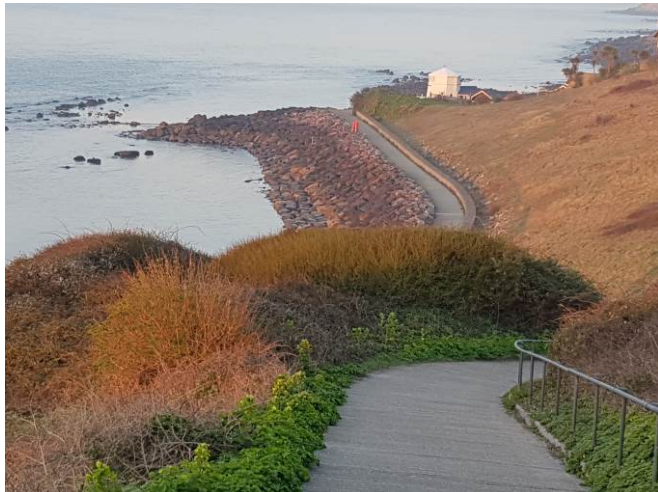
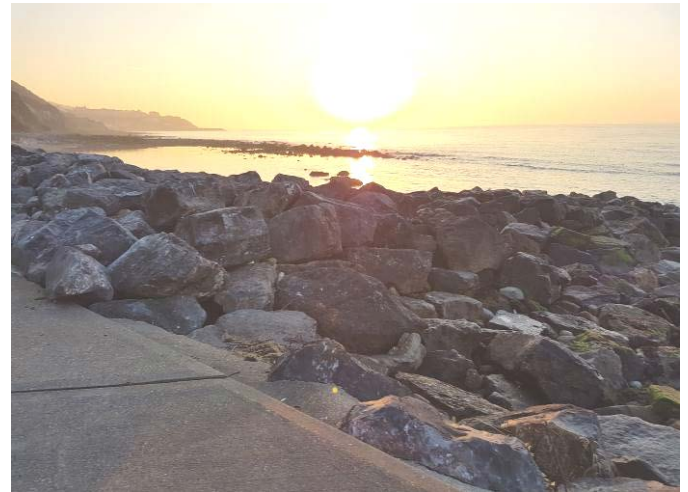
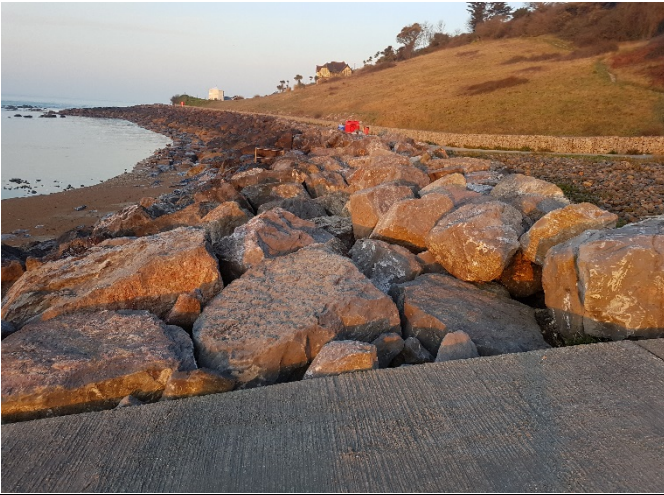
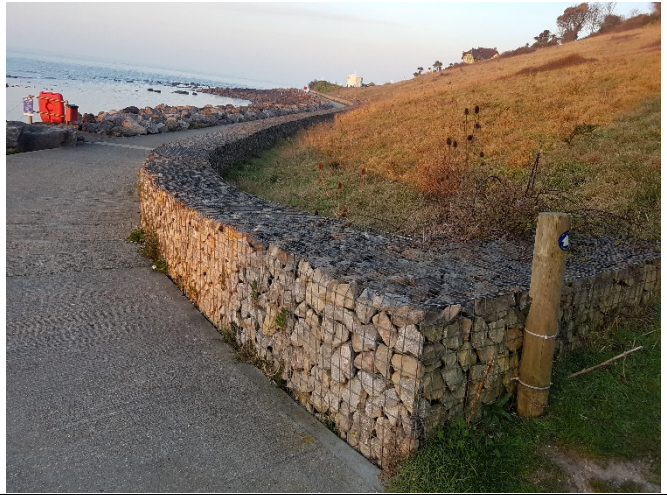
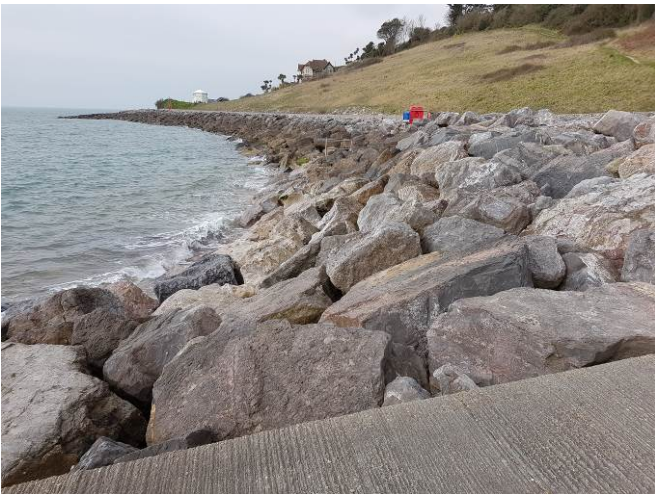
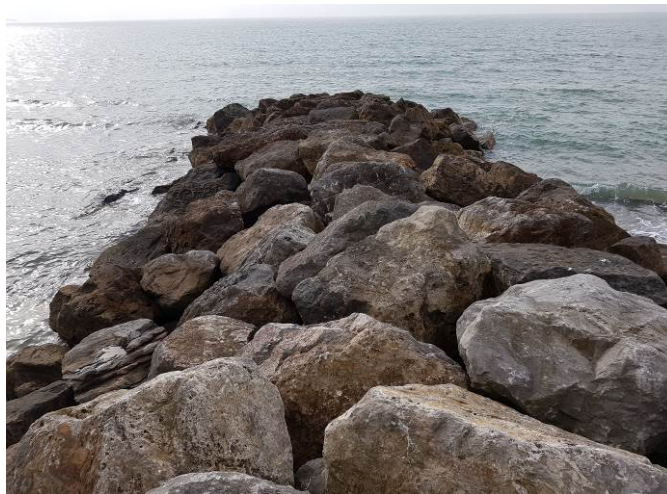
- Most elements of this 1996 coastal defence scheme appear to be in good condition with no signs of structural stresses or failure.
- Rock structures are providing toe protection and toe weight to active slopes behind, with no signs of major lateral displacement. However, in the SW corner there may have been 50mm to 100mm of displacement as evidenced in the surface defects at the interface with the concrete steps. Although minor defects, this could be recent evidence of some more significant larger-scale ground movements. Refer to IWC IW36-001-V.2-472 V.2.28 and IW36-001-V.2-511-V.2.28 inspection reports.
- Slipway and concrete structures are all in good condition. Concrete roadway included as an element of the rock revetment above.

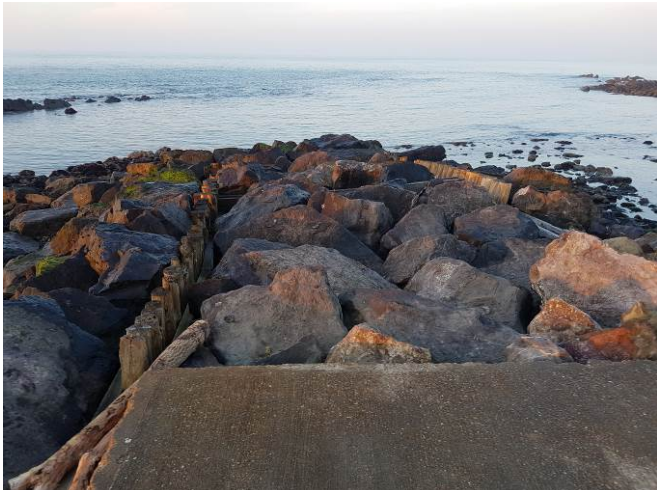
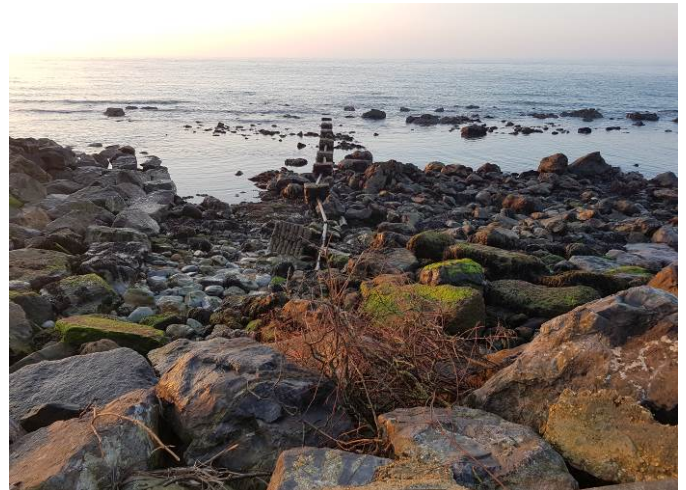
- Timber cribwork groyne is largely sacrificial as entirely surrounded/infilled with rock (hence not included above).
- Groyne has important function as a terminal groyne but low risk of failure since timber groyne was upgraded with rock in 1996.

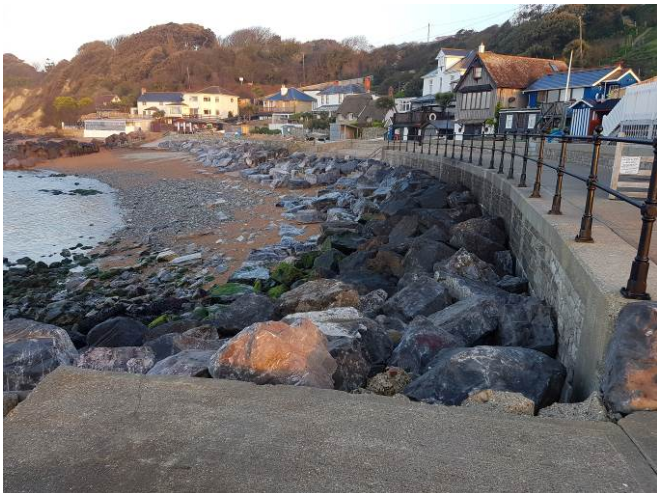
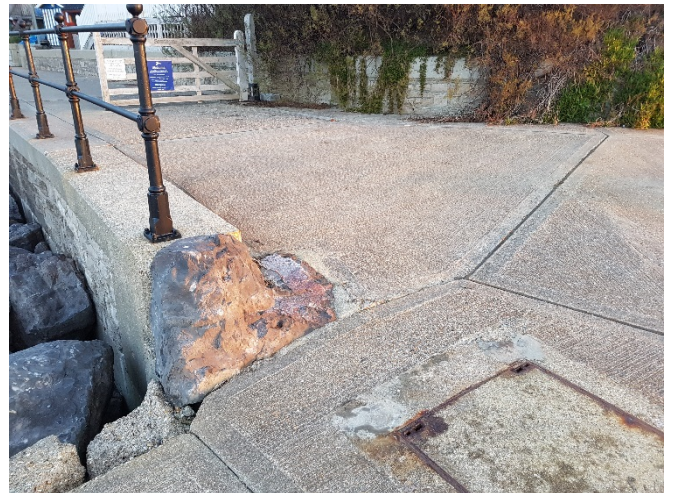
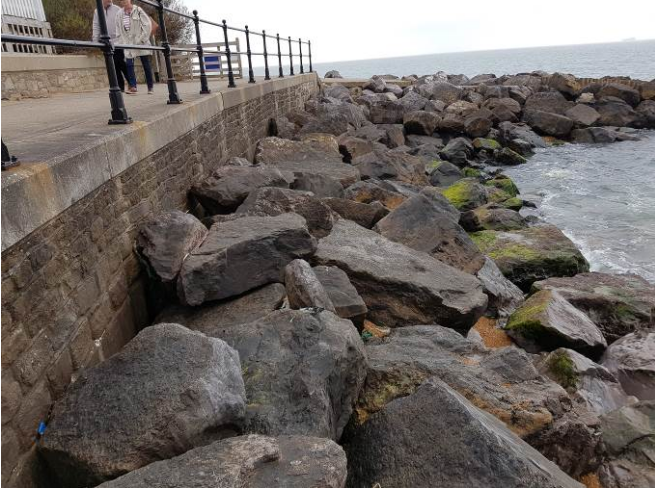
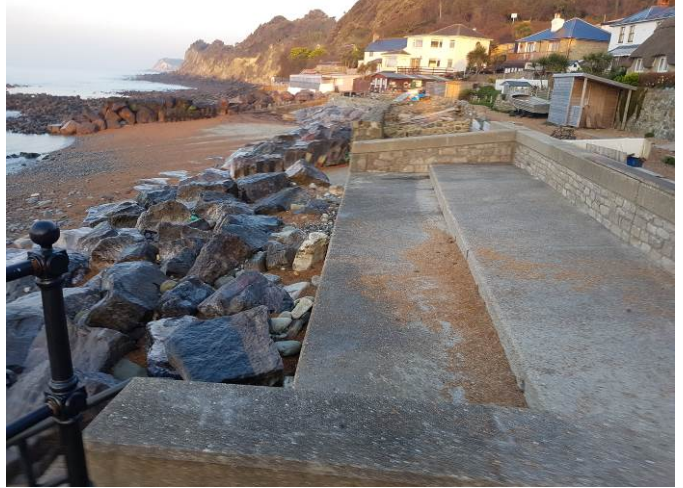
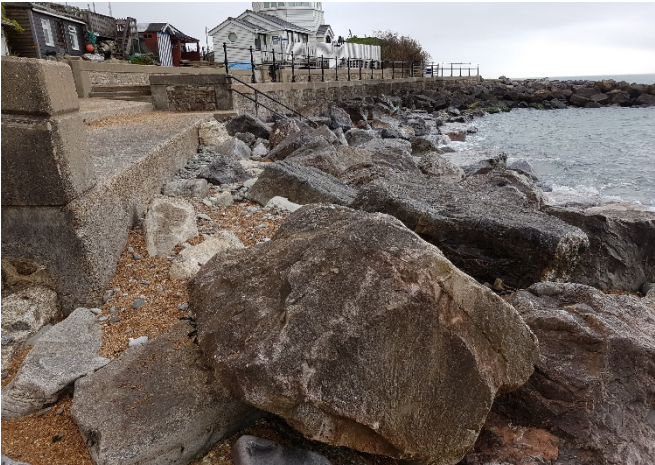
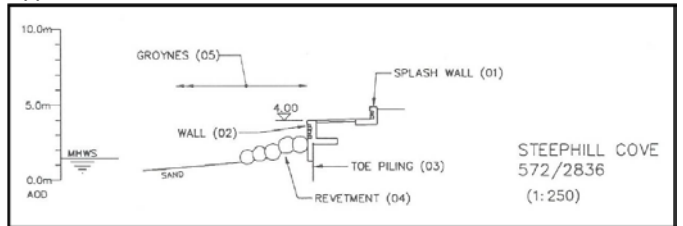
- Beach levels fronting the structure are susceptible to significant lowering during storm events. Following the Valentine’s Day storm in 2014, the loss of beach material exposed and then eroded part of the underlying Gault Clay. Beach material has since returned to re-cover the clay.

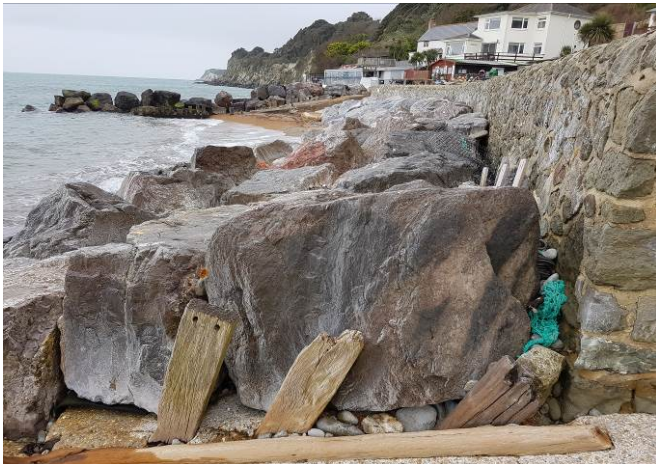
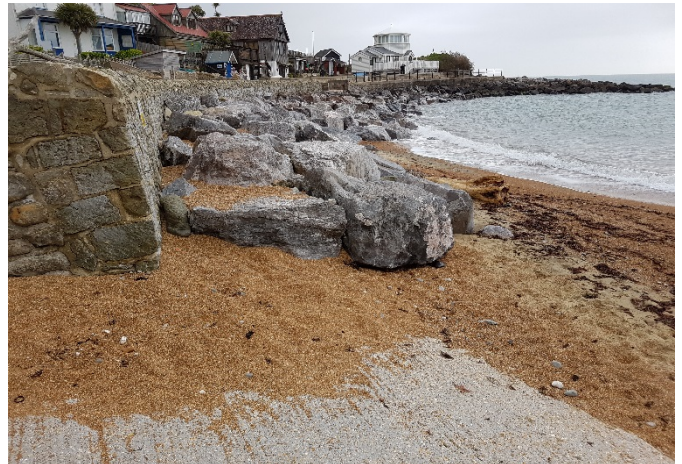
- No evidence of settlement or structural stresses in any of the elements of this 2006 strengthening scheme.
- Poor geotechnical conditions and beach vulnerability to storm lowering present risks to failure and increased exposure to wave overtopping.

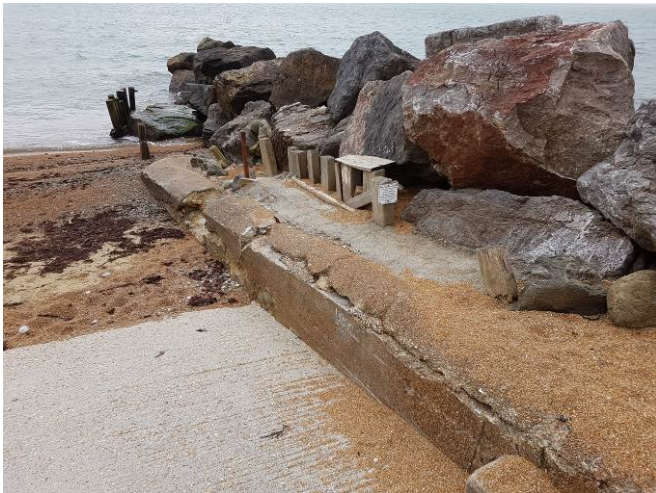
Photo 1:

- Rock groyne is not of robust design as there is not the interlink and geometry required for this sized rock. There may be some localised displacement of rock but overall the rock structure is functioning.
- No signs of failure of the concrete wall/slabs but construction details unknown.

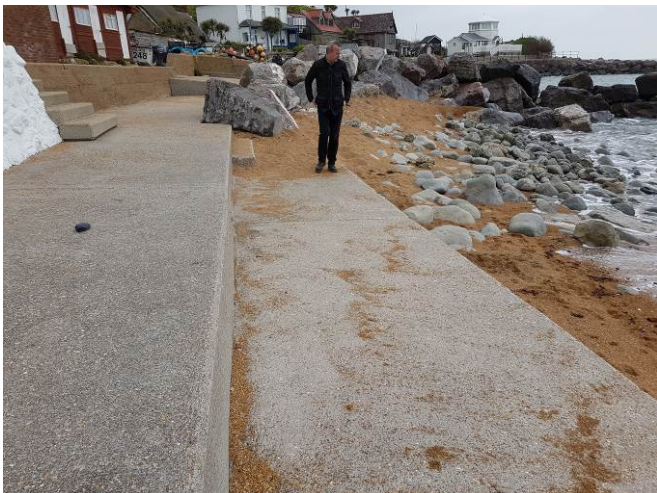
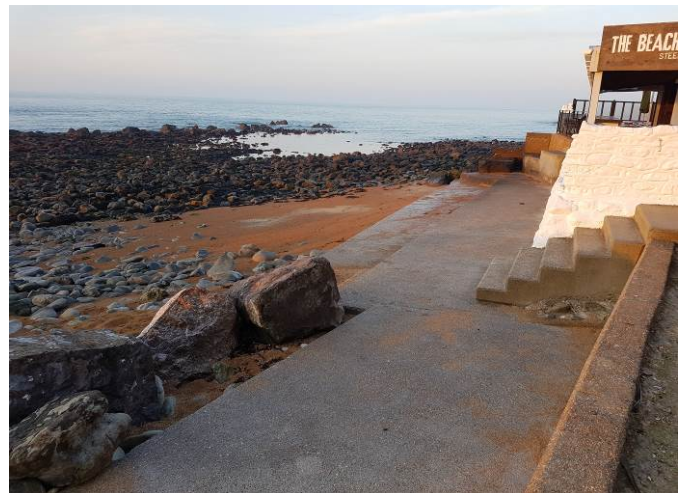
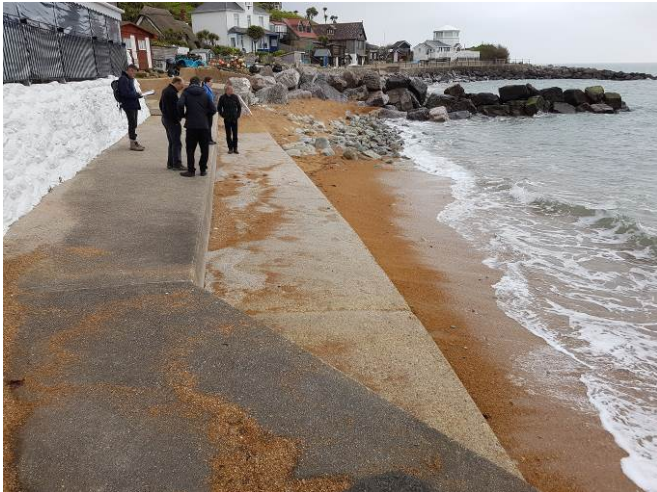
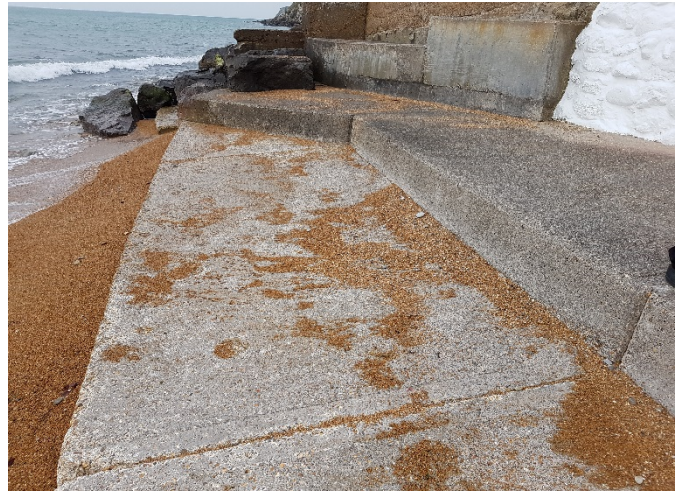
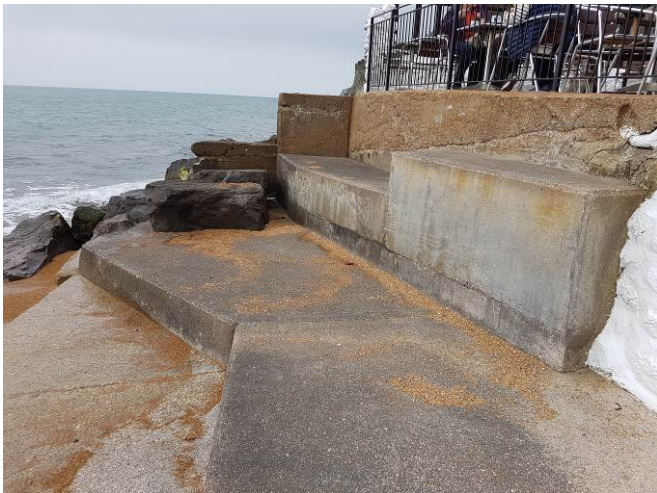
- Foundation/toe construction of concrete steps constructed in 1992 unknown, but extensive lower rock foreshore means undermining risk is limited.
- No signs of structural stresses to the defence elements.

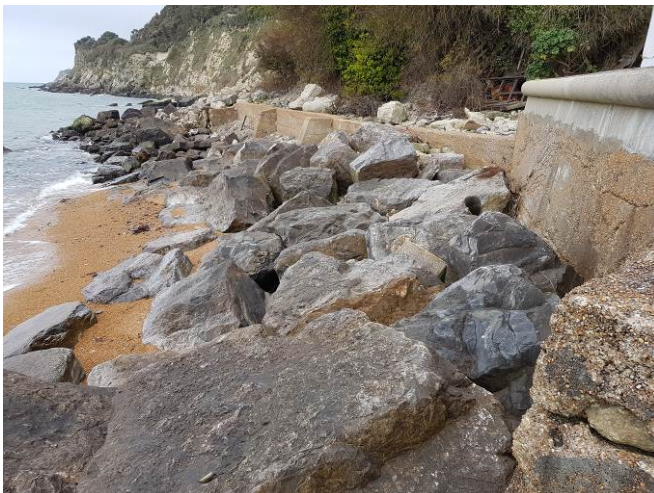
Photo 1:

- Upper wave return wall and toe rock added (in 2006) to the original 1950’s wall.
- Despite the age of the underlying concrete structure, there appears to be no signs of structural stress or defects of any elements of the defence.

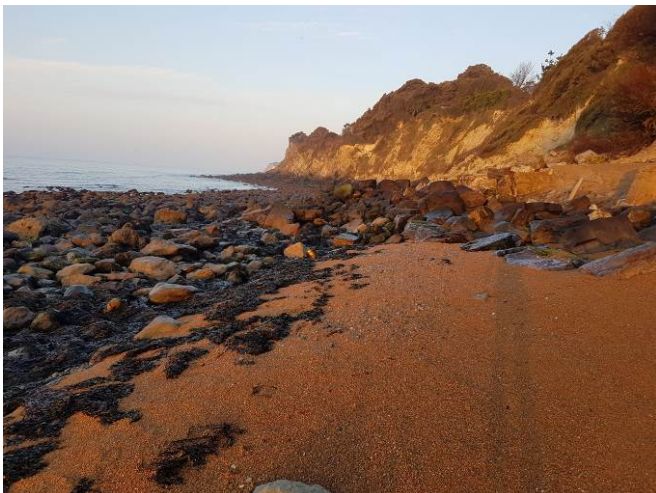
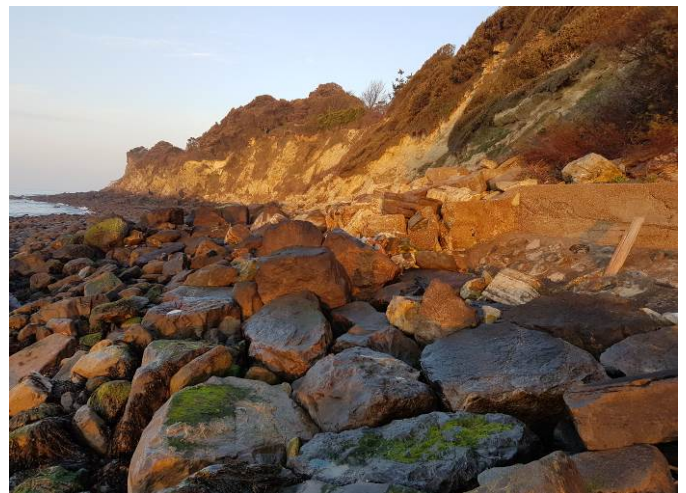
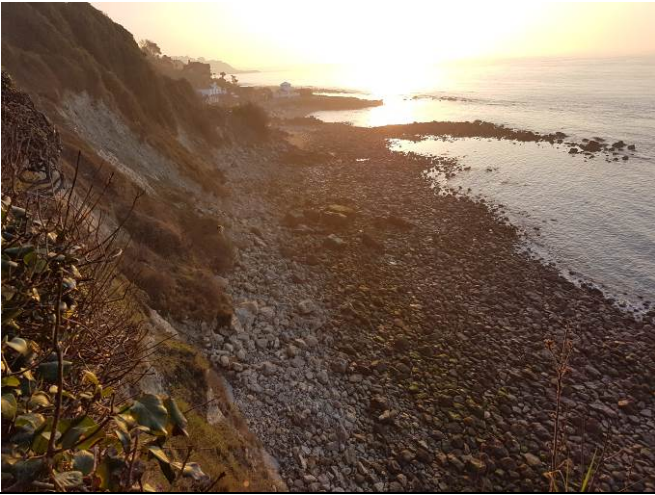
- Original seawall constructed in 1950’s is showing signs of age, but due to the addition of rock in front, the structural and geotechnical stresses on this wall are significantly reduced. Even on failure of this wall, the rock would continue to provide relatively good protection to the base of the cliffs.
- Rock revetment and groyne appear to be in functioning condition with no obvious signs of displacement.

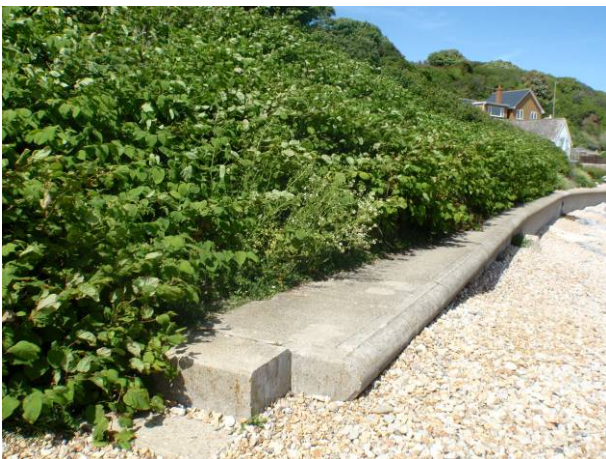
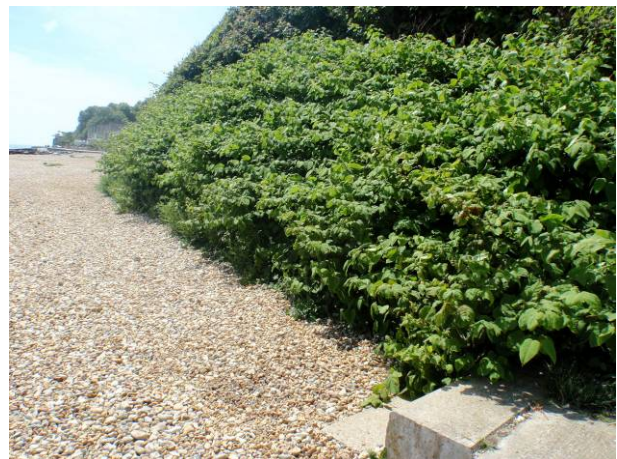
Japanese Knotweed identified at Monks Bay.  
 Historical photographs - See Observation ID. V.2-065.

Monitor

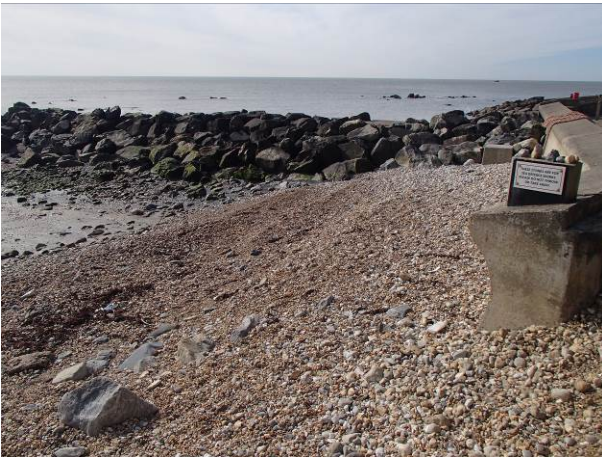
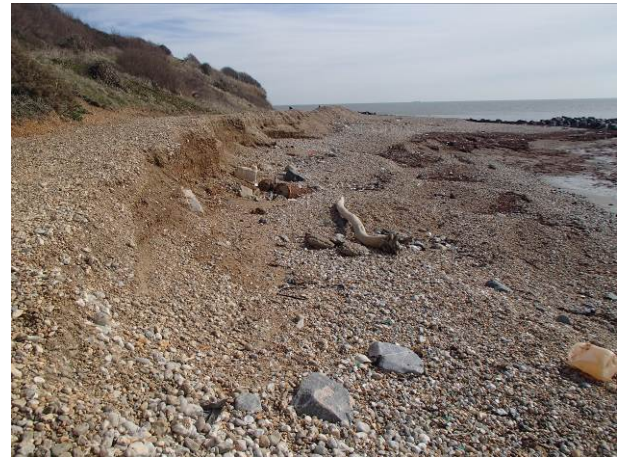
Storm Katie – Monks Bay – Beach removed – Vertical cliff

Carefully remove and dispose of four off exposed concrete filled oil drums, and concrete.

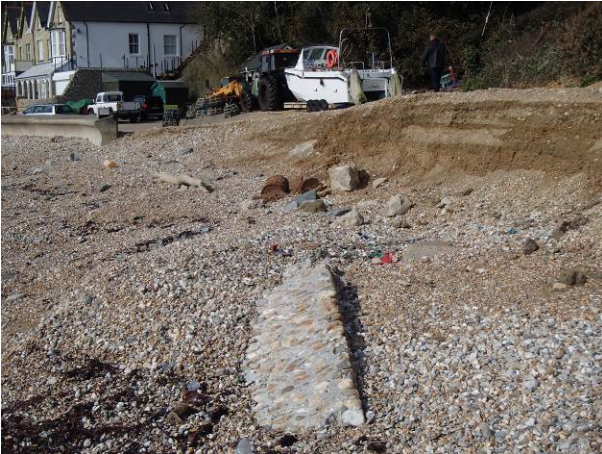
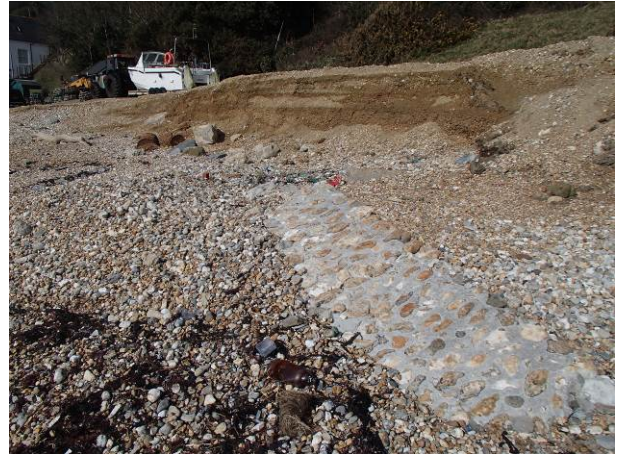
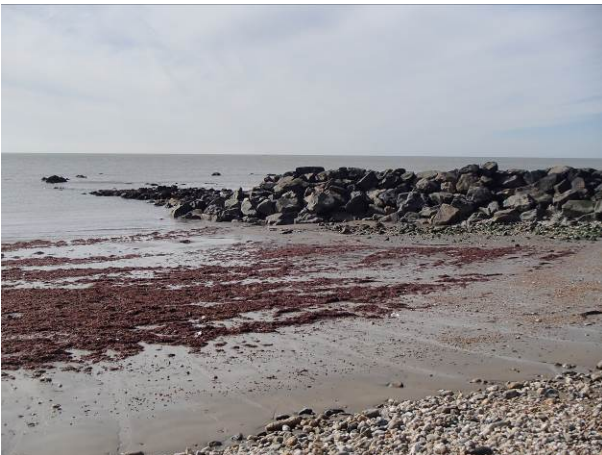
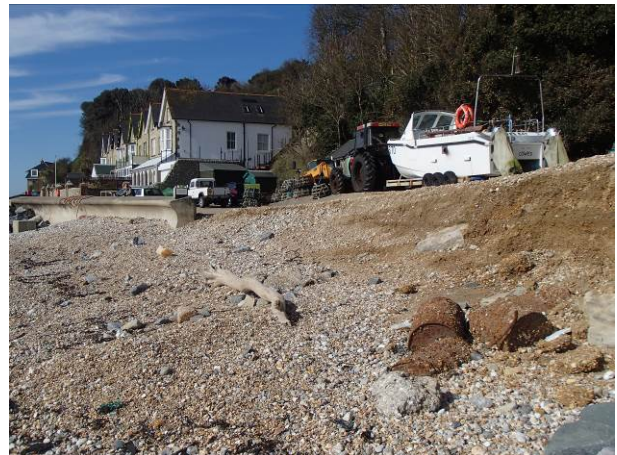
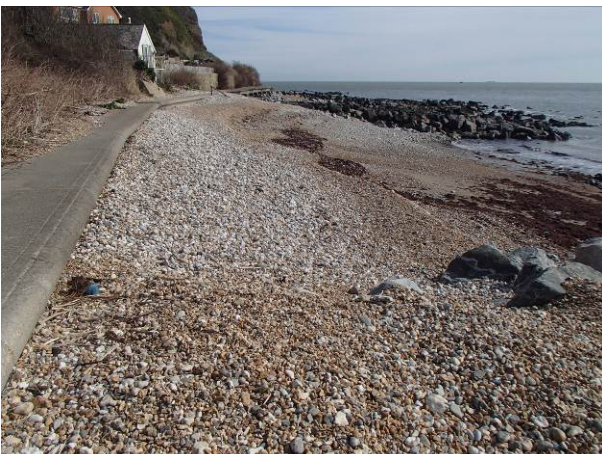
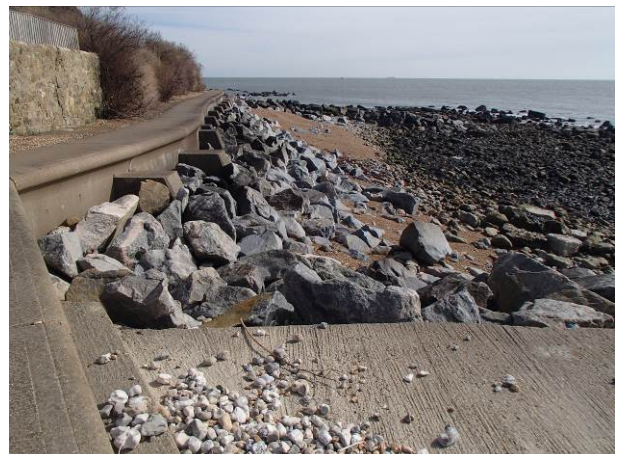
Old stone masonry coastal structure.

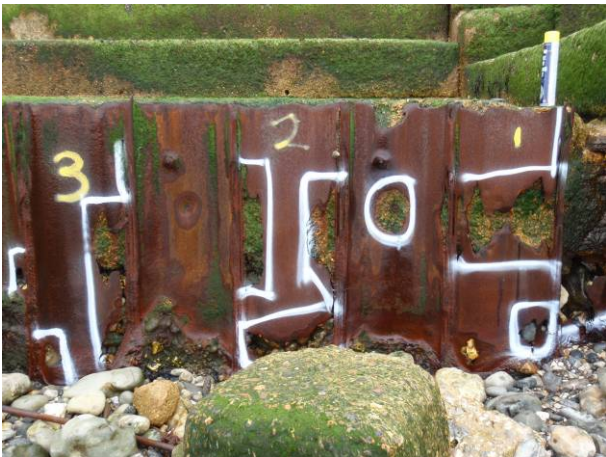
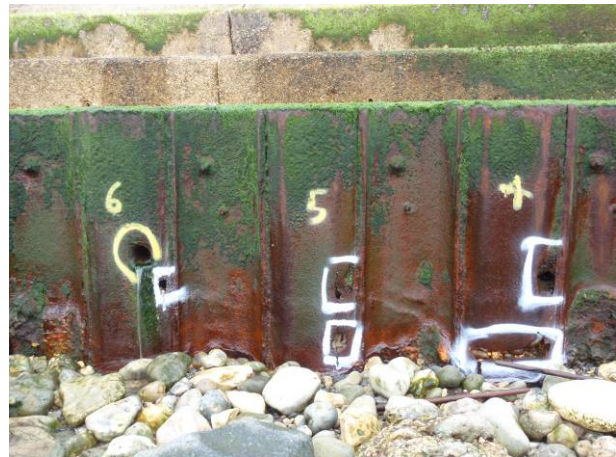
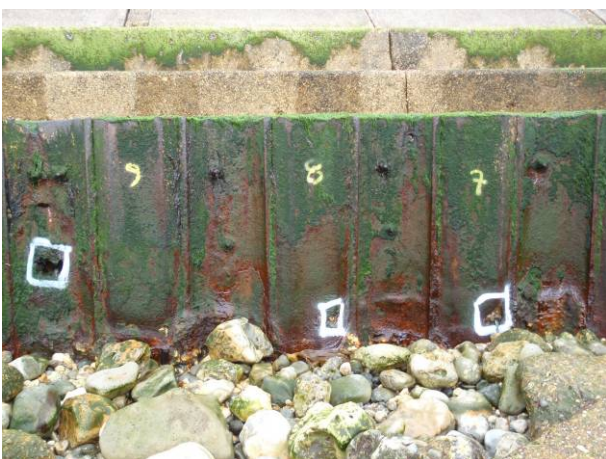
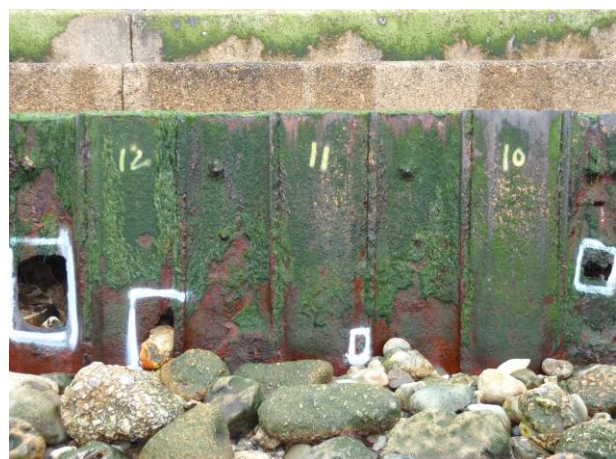
Condition of steel sheet piling – Wheelers Bay.

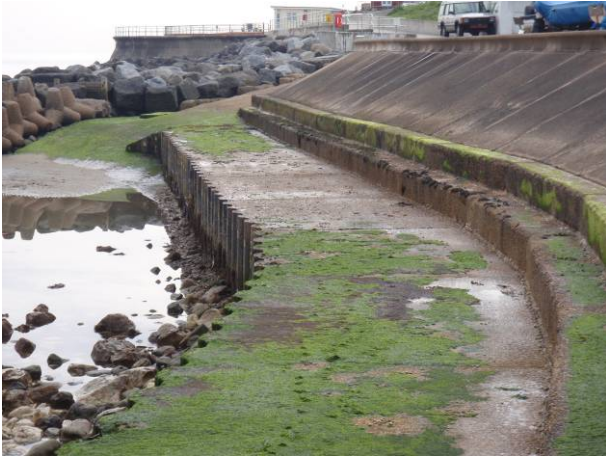
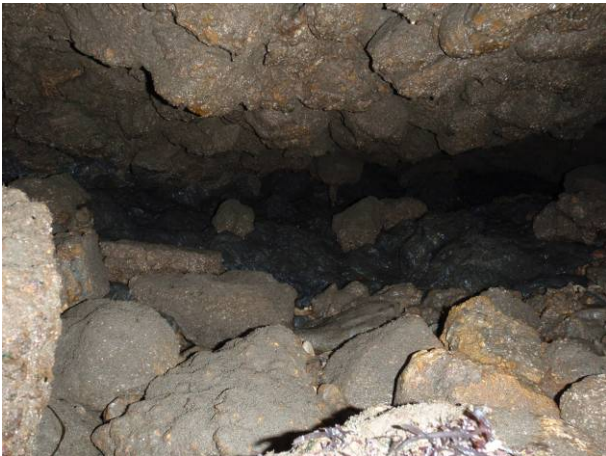
Total length = 64.5m

Height of sheet piling from foreshore = 1.9m

Width of apron = 4m

Typical view inside large void.

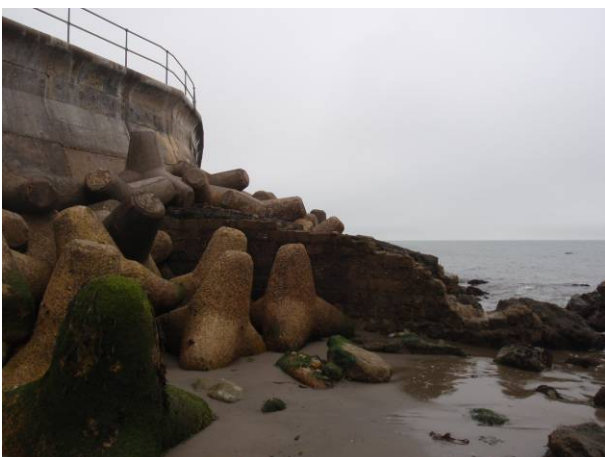
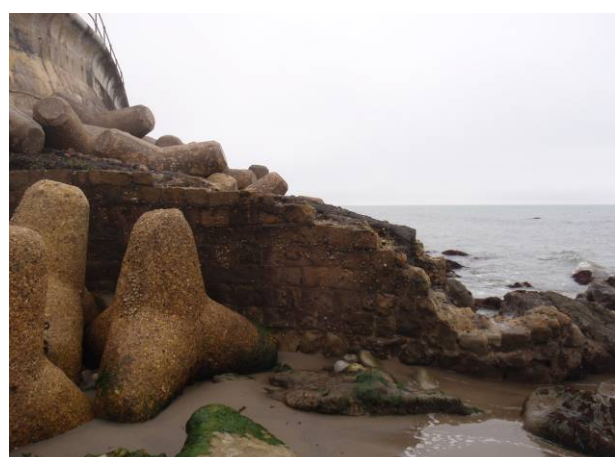
Inspection of Tetrapods – Wheelers Bay

After recent dredging of Ventnor Haven, sediment has built up along the Eastern Frontage and has allowed access to inspect the Tetrapods and associated infrastructure.

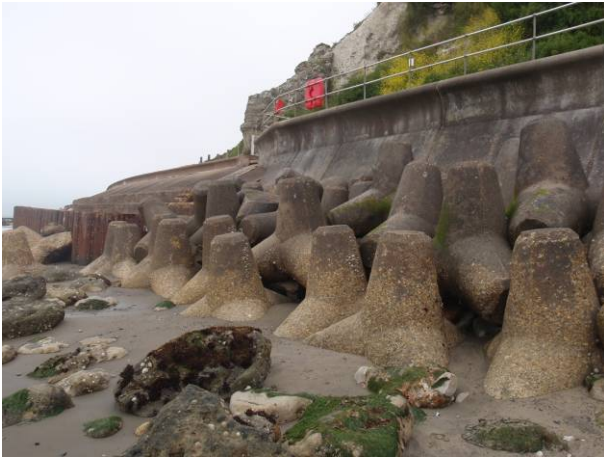
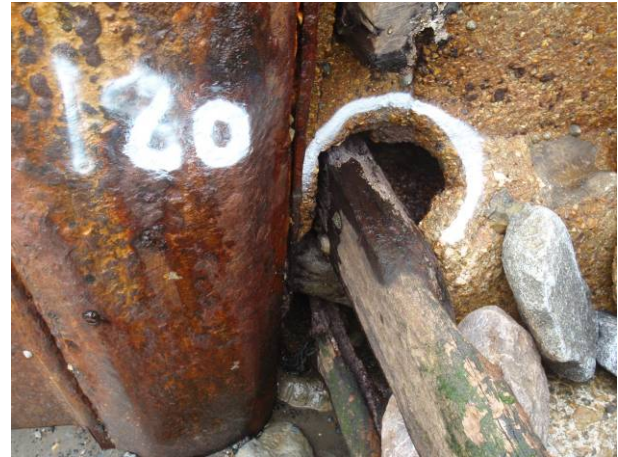
Very limited / no access to foreshore at this location.

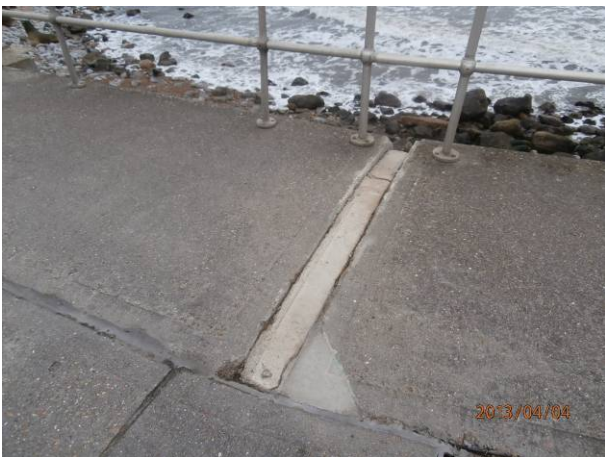
Condition of Promenade Joints – Wheelers Bay

Location was last repaired November 2012

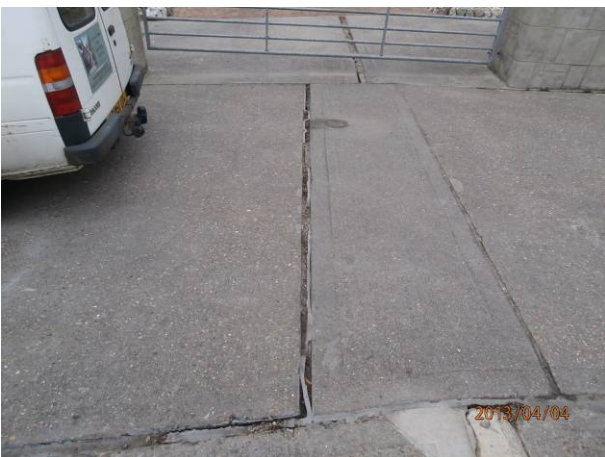
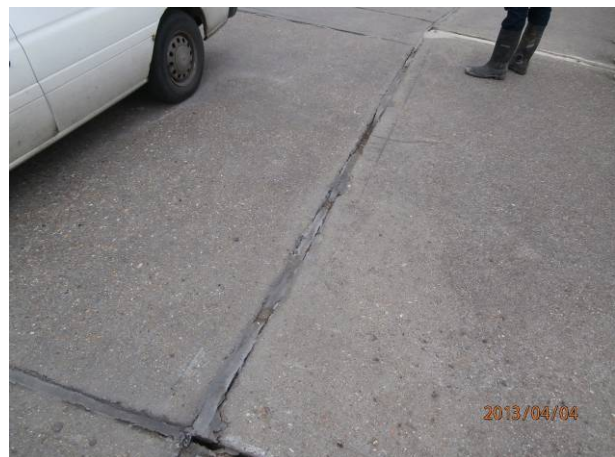
Location not repaired V.2-401

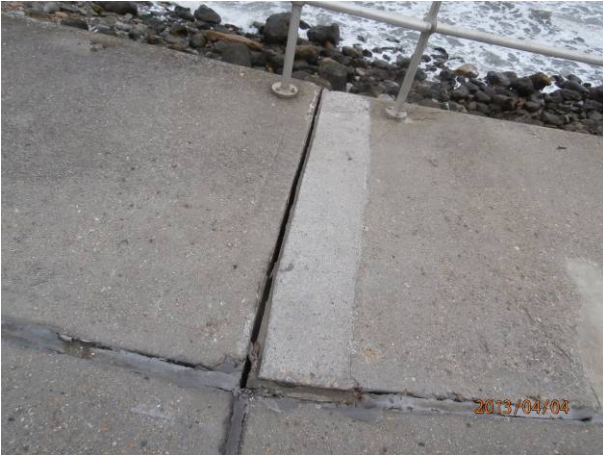
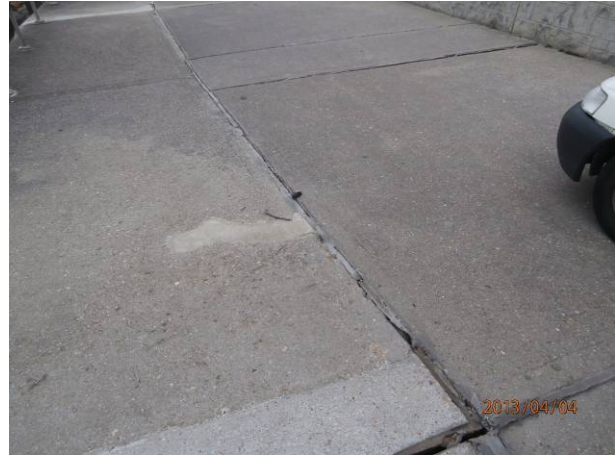
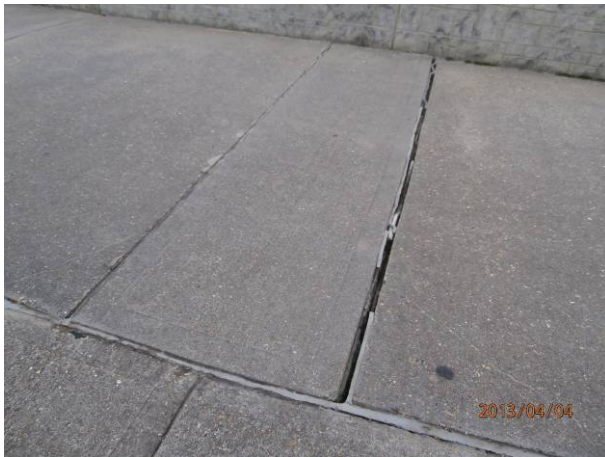
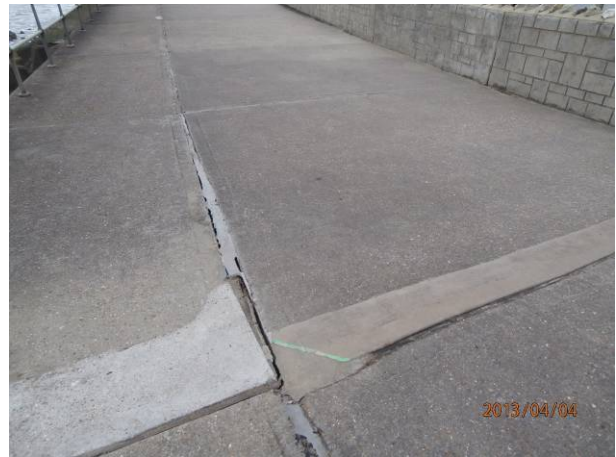
Location was repaired Nov 2011 and has moved approximately 25mm.

Repair dropped concrete repair.  
Polysulphide Sealant promenade joints 20m in total  
(3.5m remaining from purchase order 3500139849).

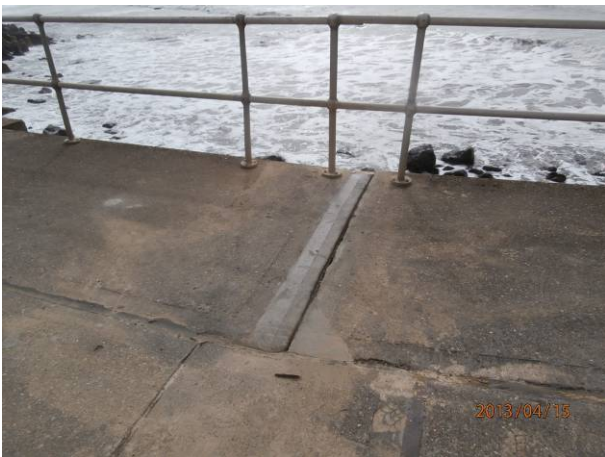
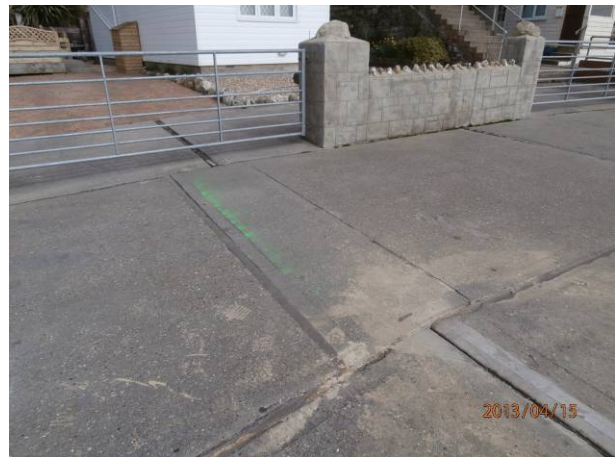
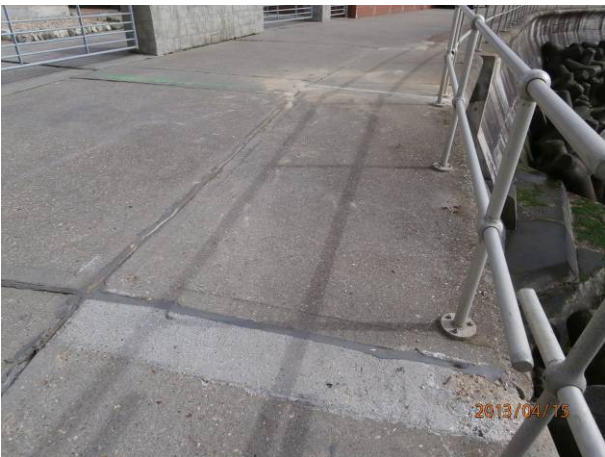
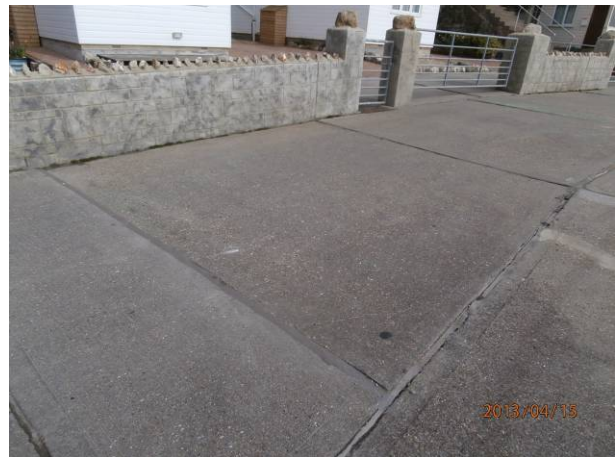
Locations repaired.

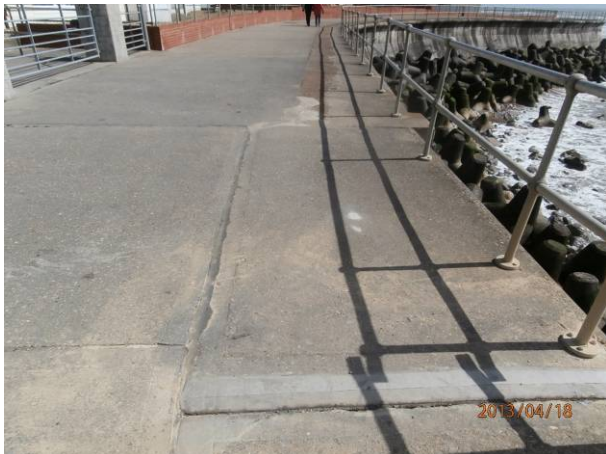
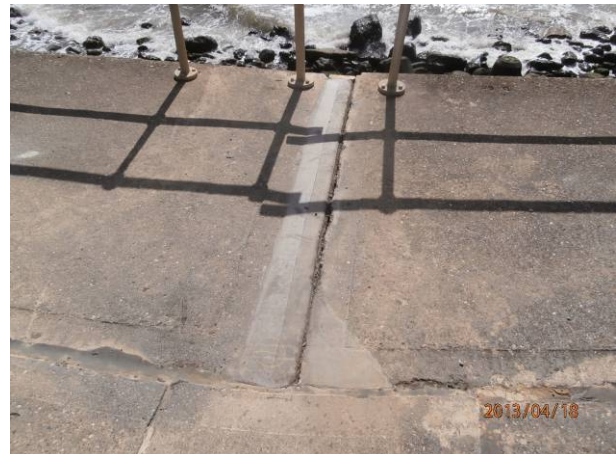
**Location 1**

Current Joint - Length 1.85m – Width 20mm  
Clear / clean joint and seal with polysulphide sealant

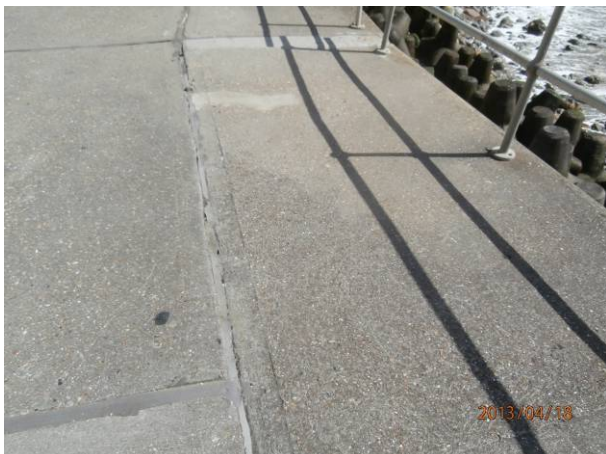
**Location 2**

Current Joint - Length 3.5m – Width 40mm - Slight step between slabs  
Cut landward slab 400mm from joint edge, dowel into landward slab, re-cast slab edge with reinforced concrete to remove step flush with existing surfaces. Polysulphide new joint.  
Ensure existing 'normal' slab joints are retained.

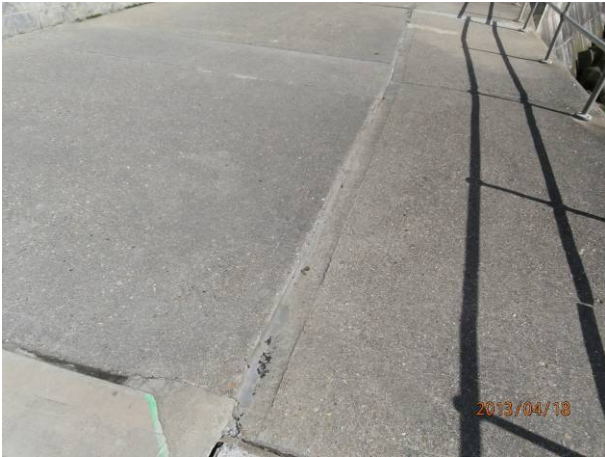
**Location 3**

Current Joint - Length 4.3m – Width 20mm - Slight step between slabs and expanded joint  
Cut landward slab 400mm from joint edge, dowel into landward slab, re-cast slab edge with reinforced concrete to remove step flush with existing surfaces. Polysulphide new joint.  
Ensure existing 'normal' slab joints are retained.

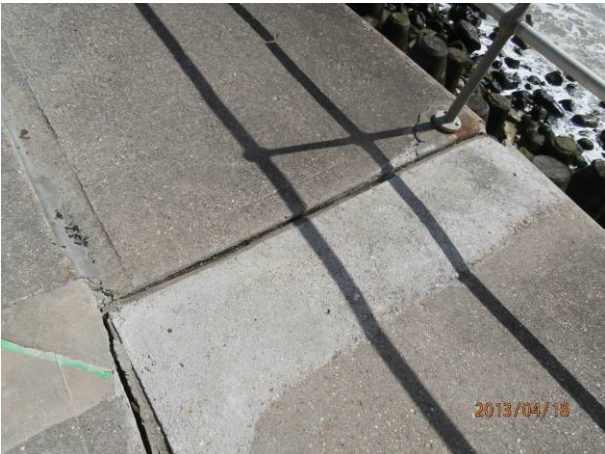
**Location 4**

Current Joint - Length 1.9m – Width 40mm  
Clean / clear joint and seal with polysulphide sealant

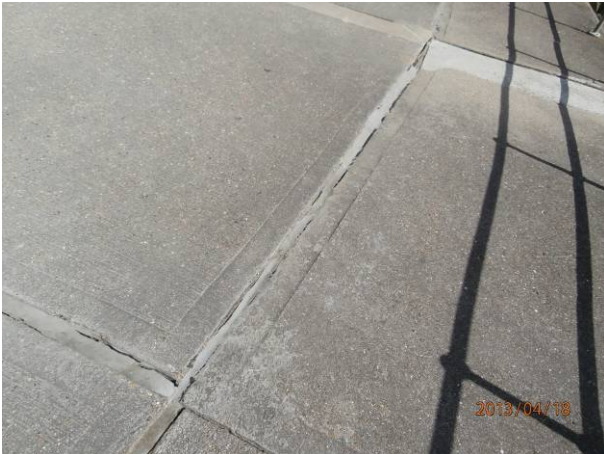
**Location 5**

Current Joint - Length 3.75m – Width 80mm (max) - Slight step between slabs and expanded joint  
Cut landward slab 400mm from joint edge, dowel into landward slab, re-cast slab edge with reinforced concrete to remove step flush with existing surfaces. Polysulphide new joint.  
Ensure existing 'normal' slab joints are retained.

Monitor / Repair

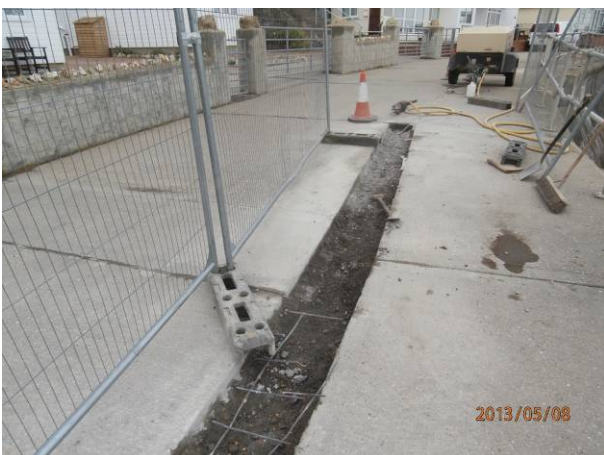
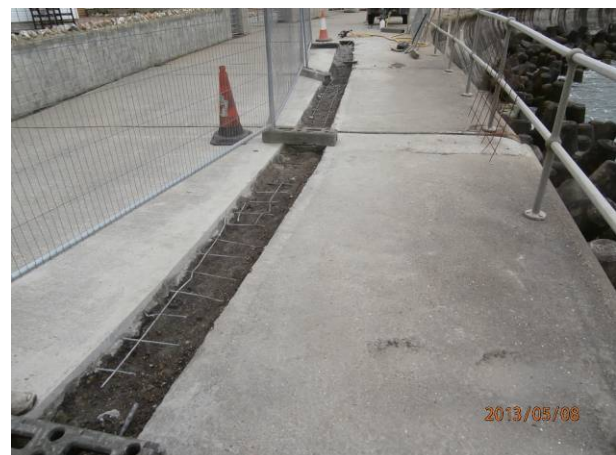
Repairs in work

Slab has raised interface, as a result of continuing movement – Length 3.9m.  
Instructed contractor to extend repair to cover this additional slab 08.05.13
