# Ventnor Options Appraisal

Technical Report

Revision 5

Isle of Wight Council

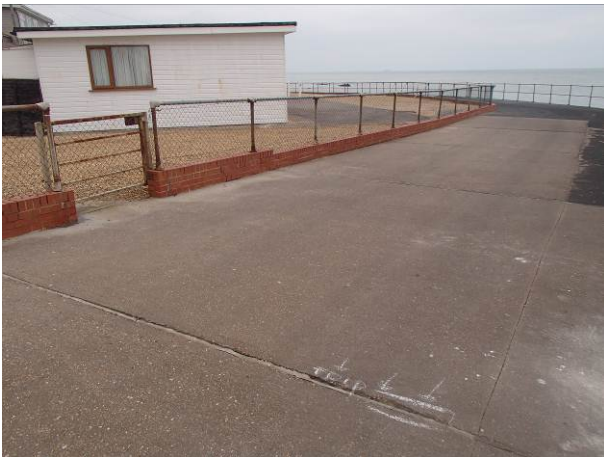
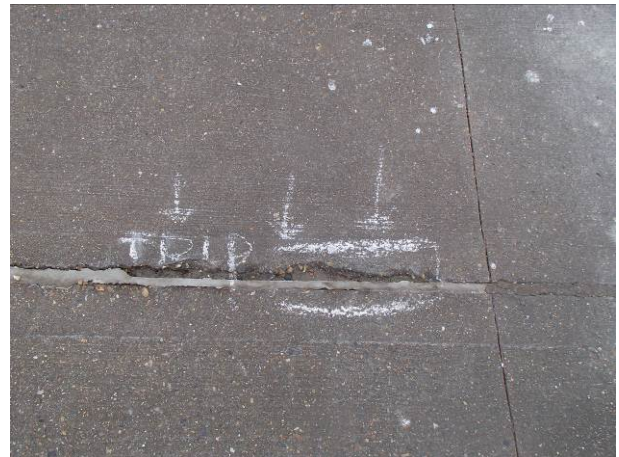
Location 1

Existing polysulphide sealant edge has been removed  
Total Area 700mm \* 50mm (max width)

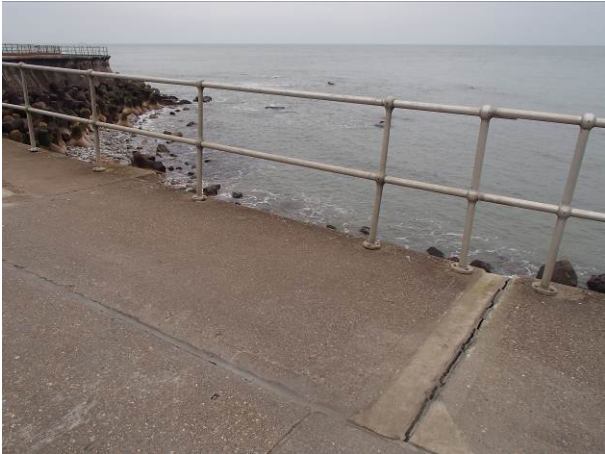
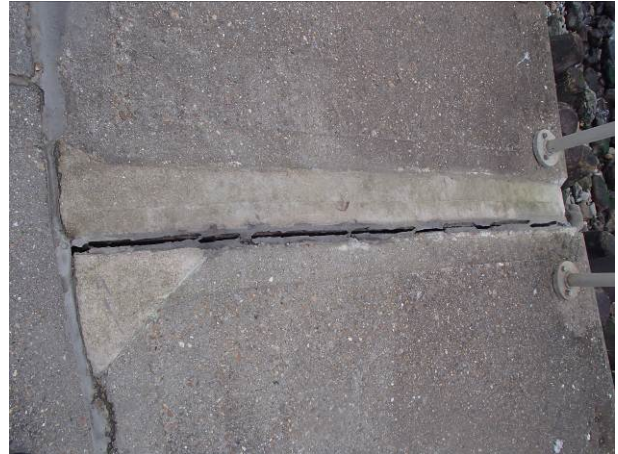
Location 2  
1900mm x 200mm (Including concrete repair)  
Total width of joint including existing sealant 50mm  
Gap 15mm

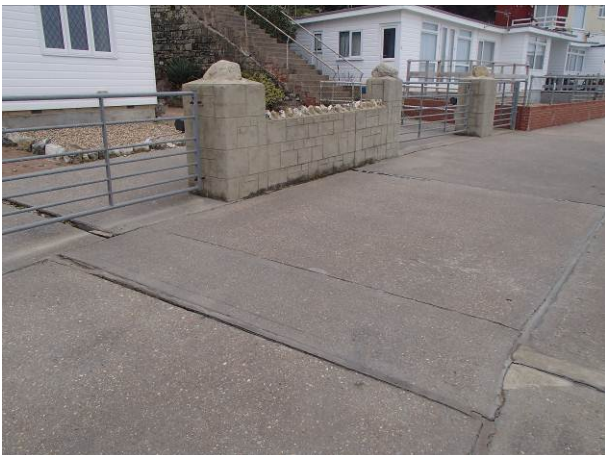
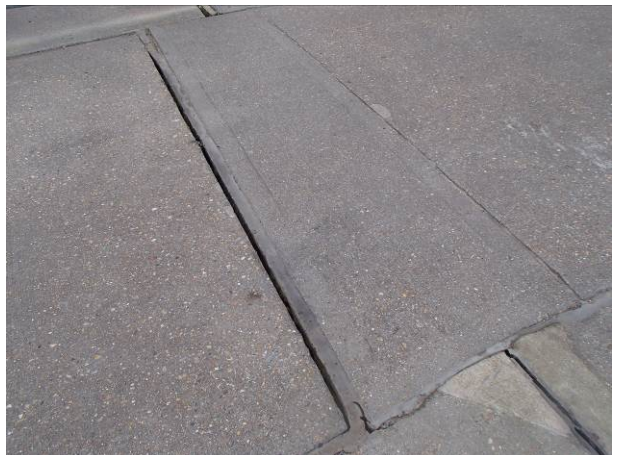
Location 3  
Length 3700mm  
Total width of joint including existing sealant 50mm  
Gap 25mm

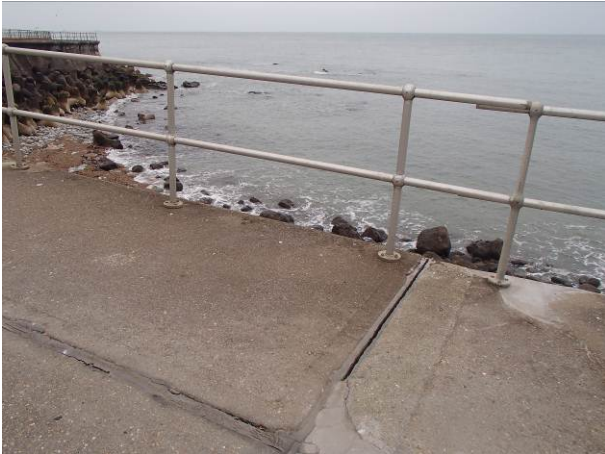
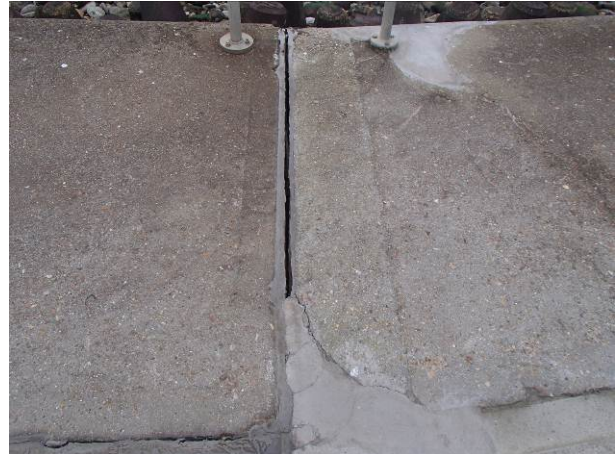
Location 4  
Length 2000mm  
Total width of joint including existing sealant 65mm  
Gap 15mm

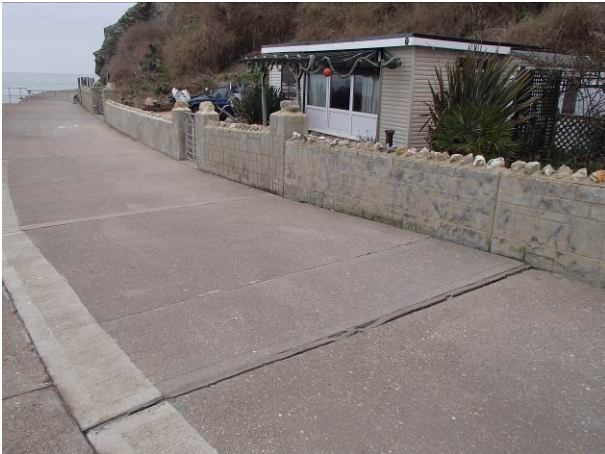
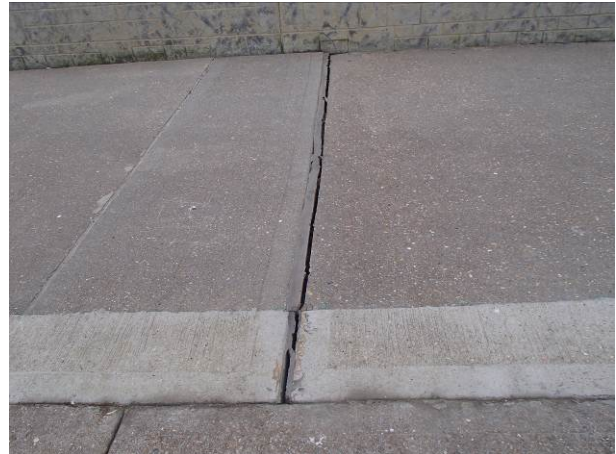
Location 5  
Length 4100mm  
Total width of joint including existing sealant 70mm  
Gap 20mm

**ACTION**  
Monitor / Repair

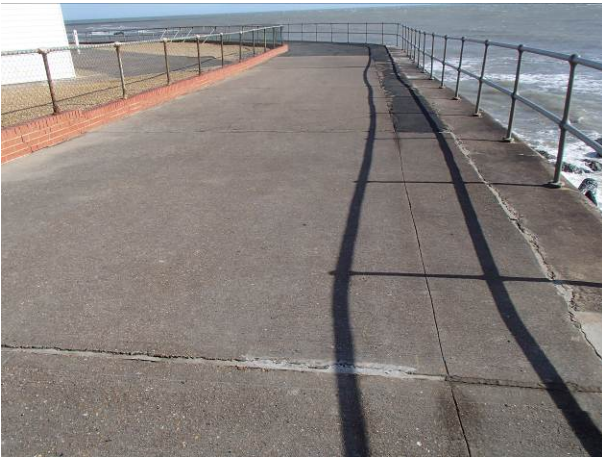
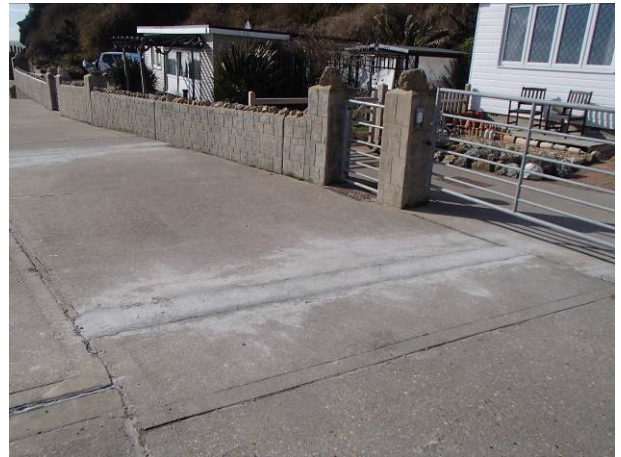
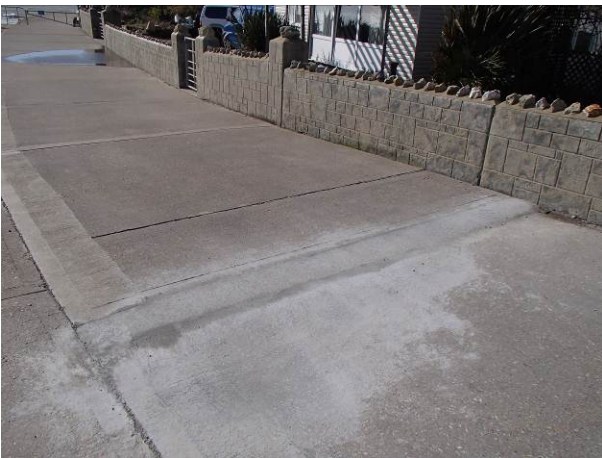
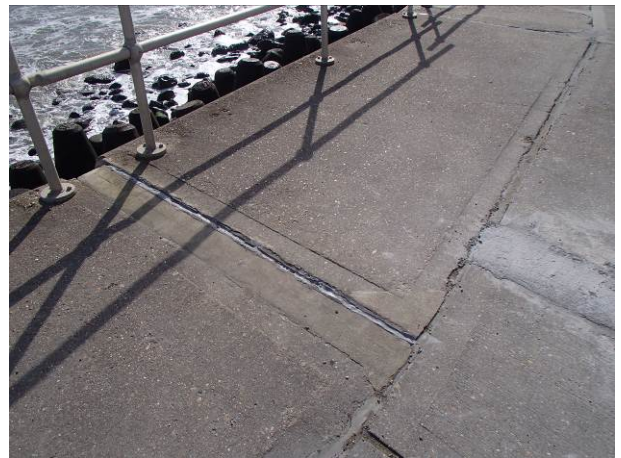
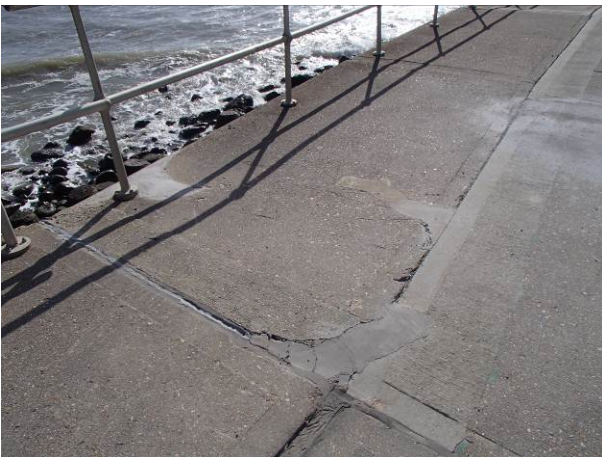
Locations repaired – Observation closed

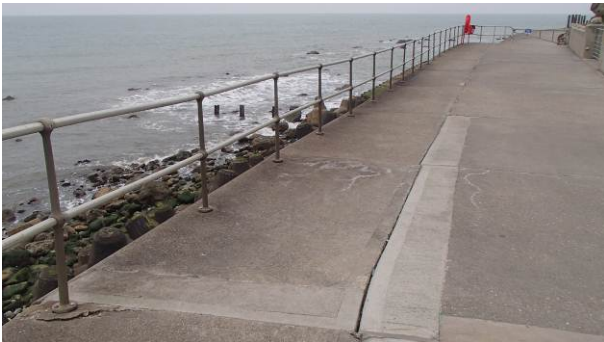
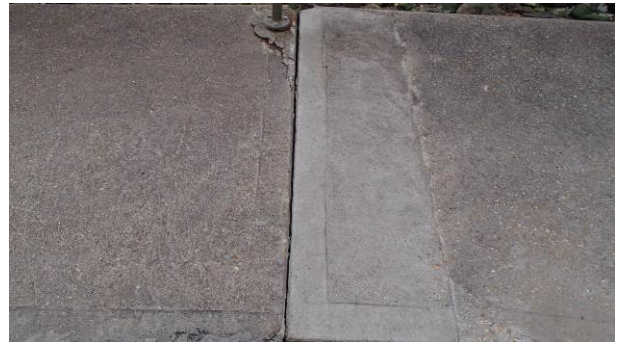
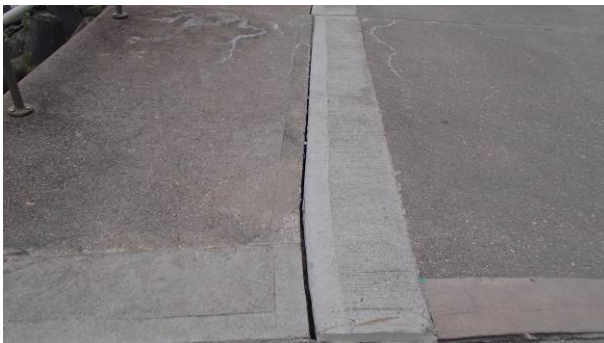
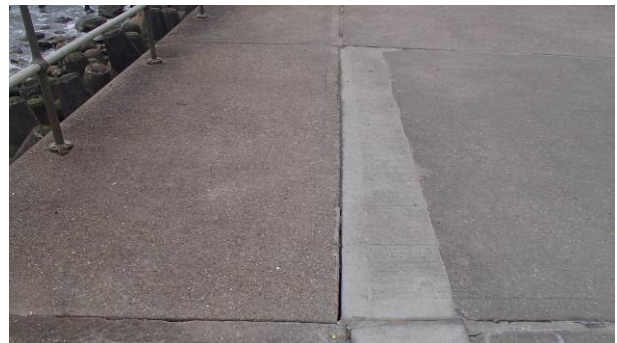
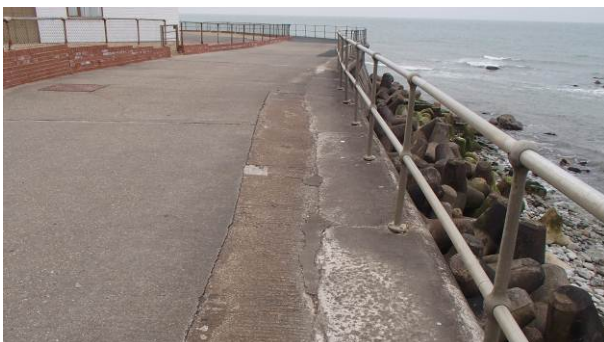
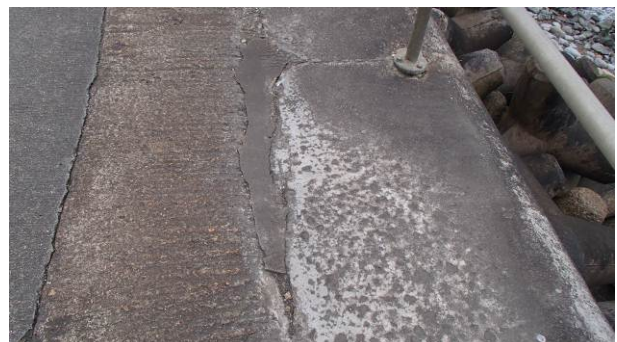
Monitor Joints – Wheelers bay

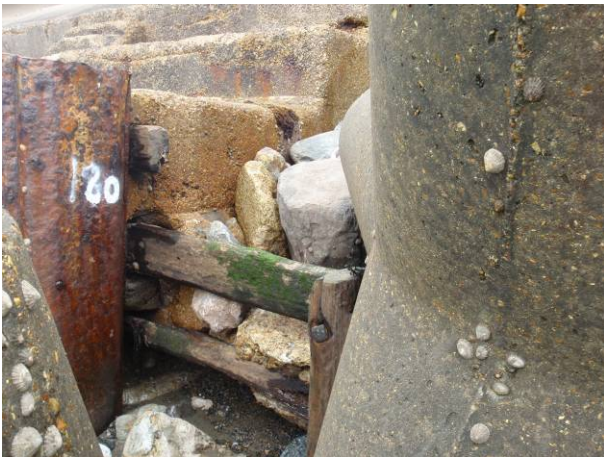
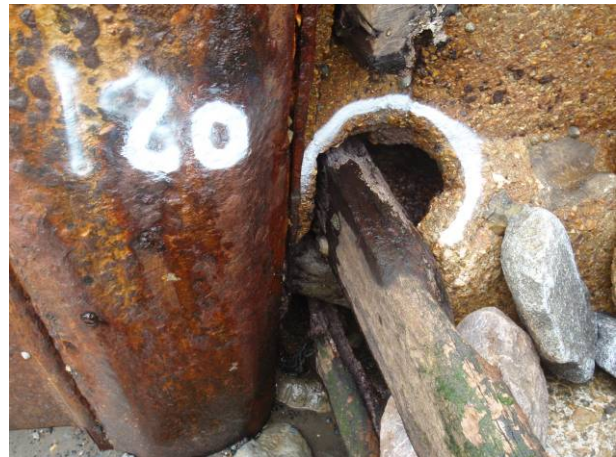
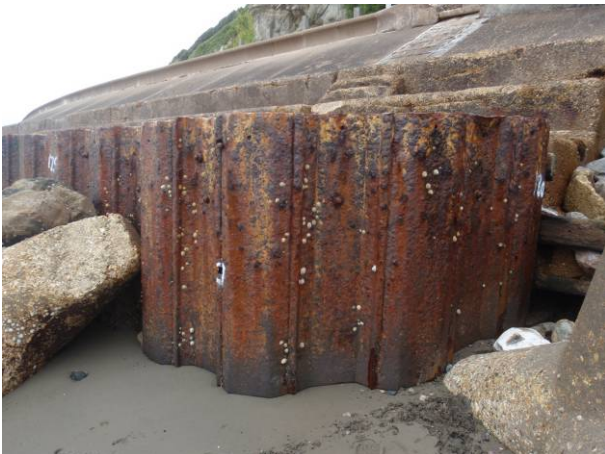
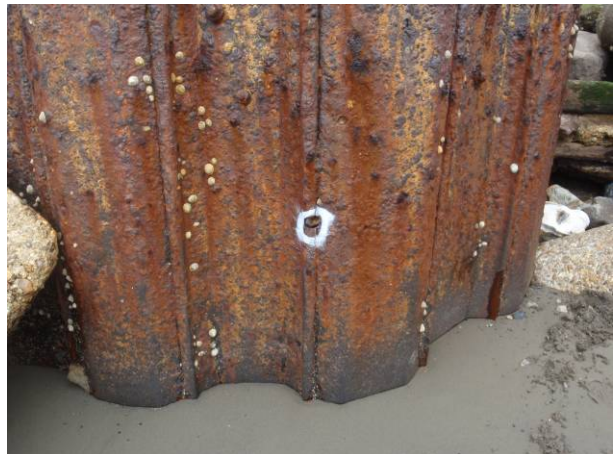
After recent dredging of Ventnor Haven, sediment has built up along the Eastern Frontage and has allowed access to inspect the steel sheet piling and associated infrastructure.

Note: Defects may not also be visible due to the higher sediment levels.

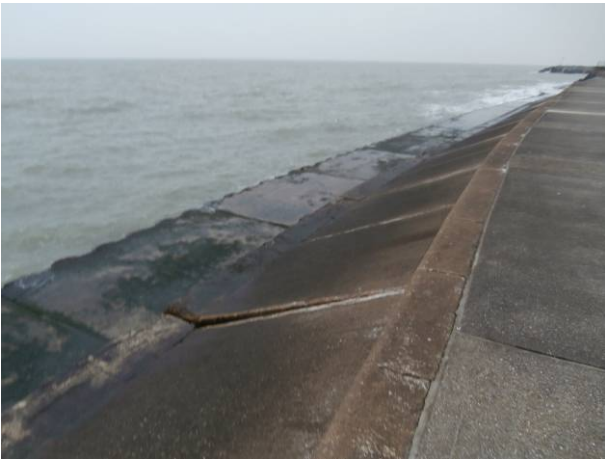
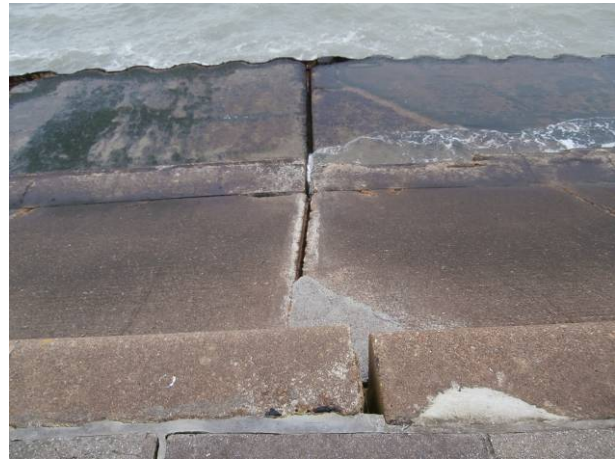
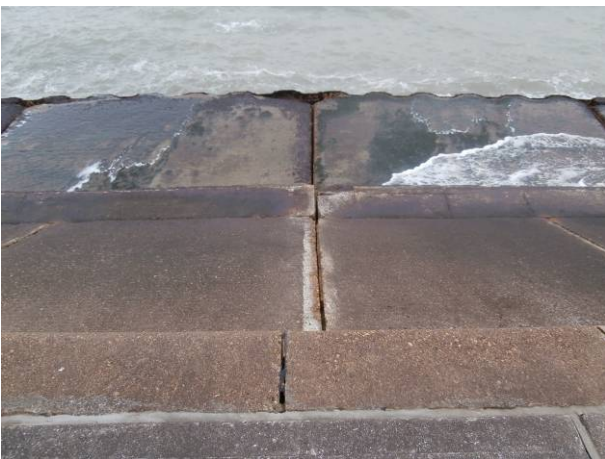
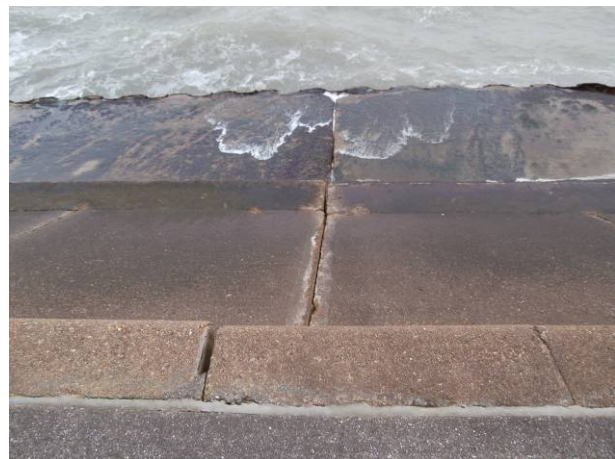
Monitor Apron Movement – Eastern Esplanade

Monitor

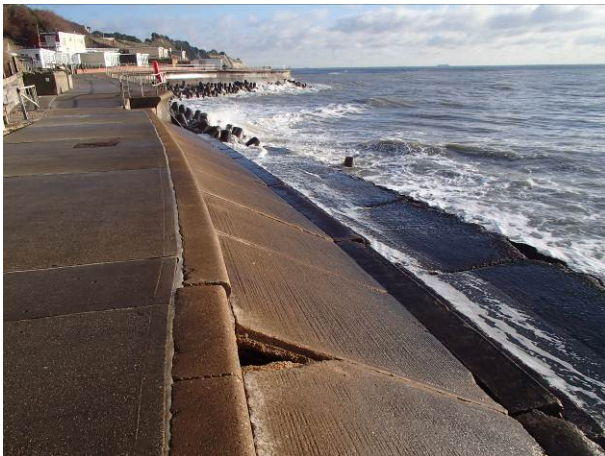
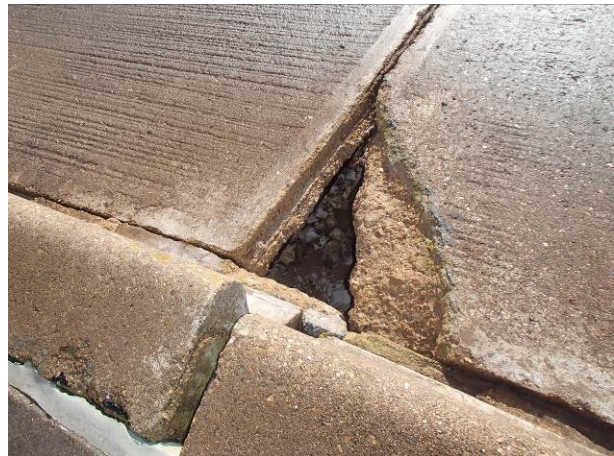
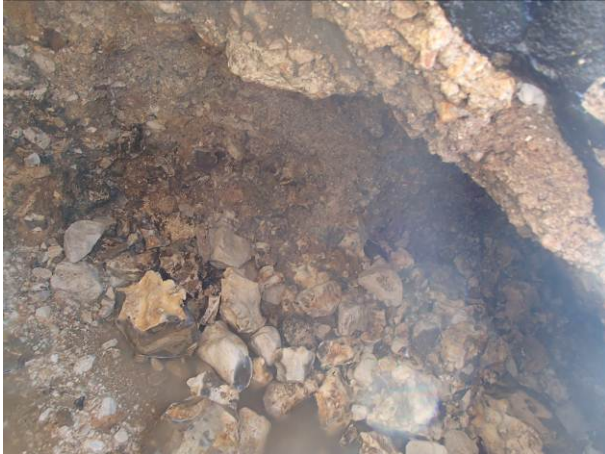
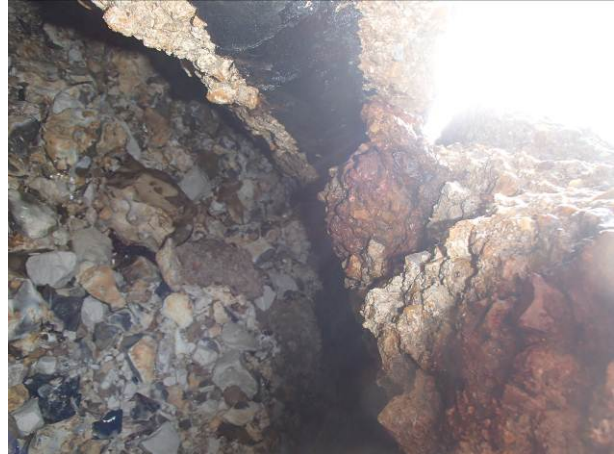
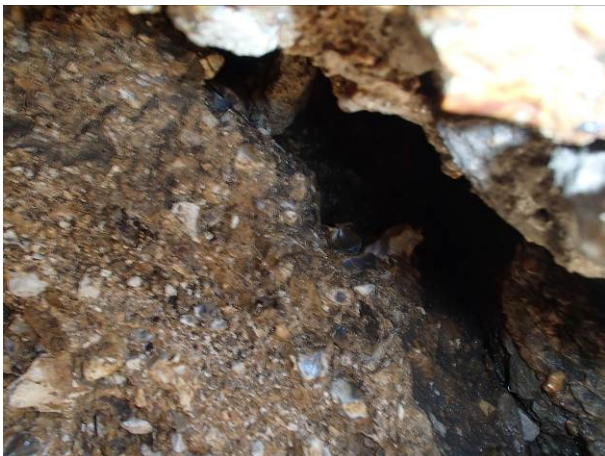
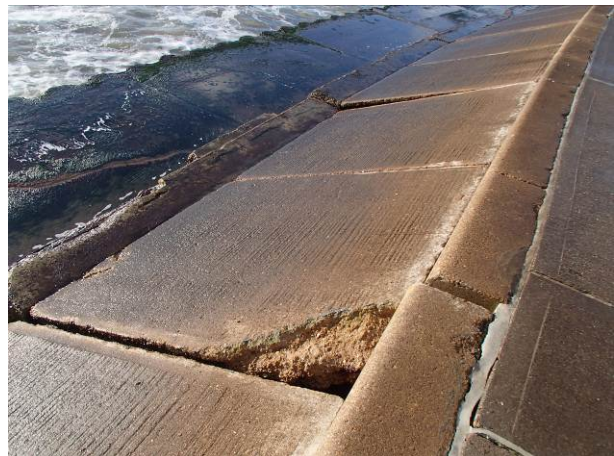
Old repair has popped out exposing void under concrete sloping revetment.

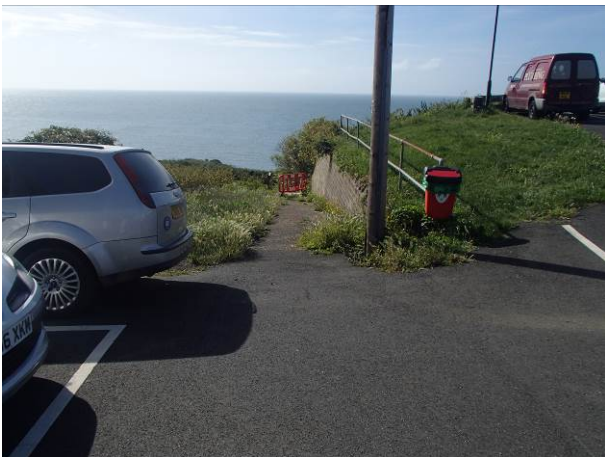
Dudley Road Car Park Footpath Timber Steps – Movement

Steps closed

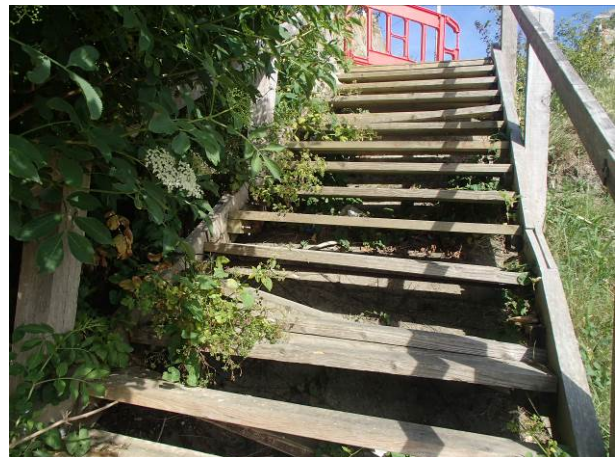
Stressed joint

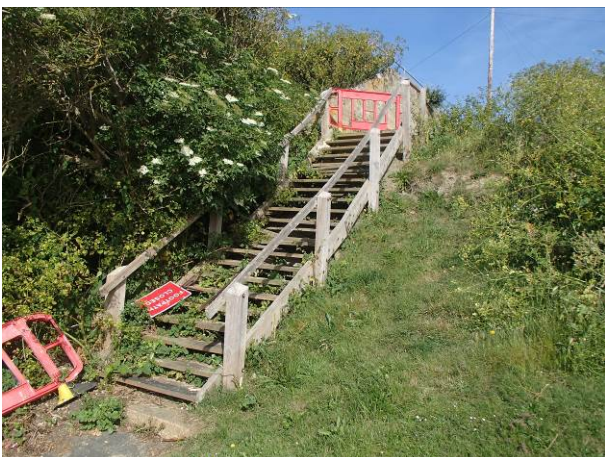
Scarp visible

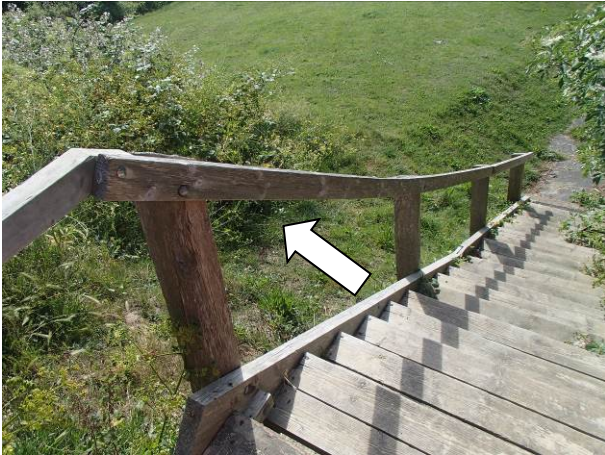
Timber rail bend

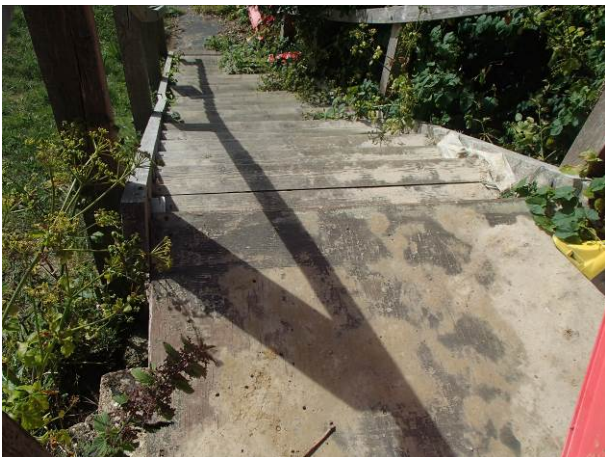
Displacement of timber steps

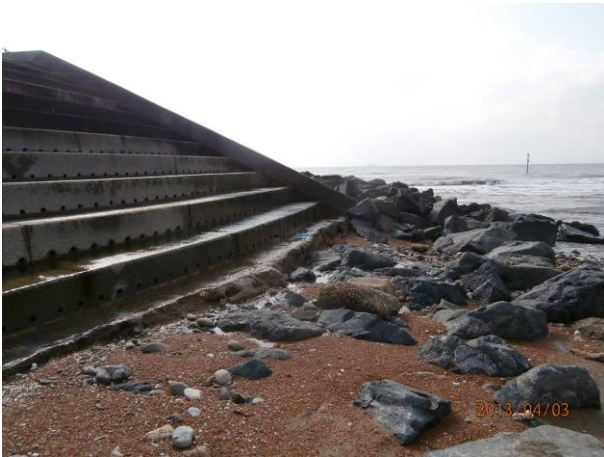
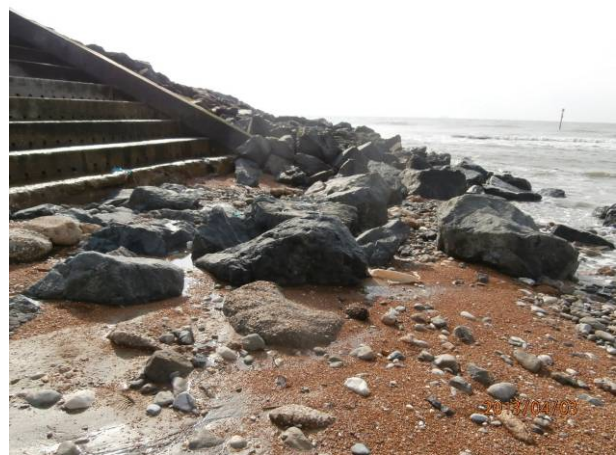
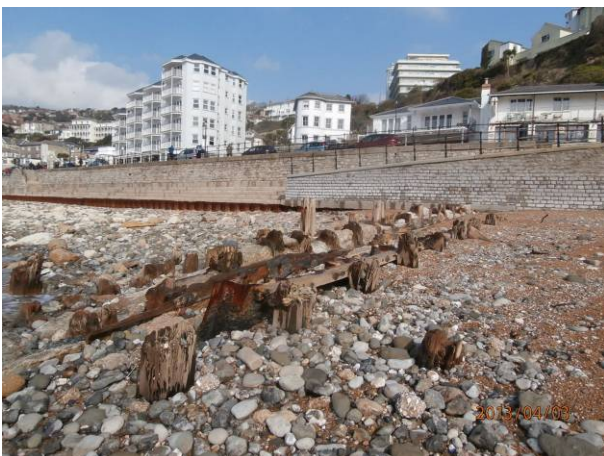
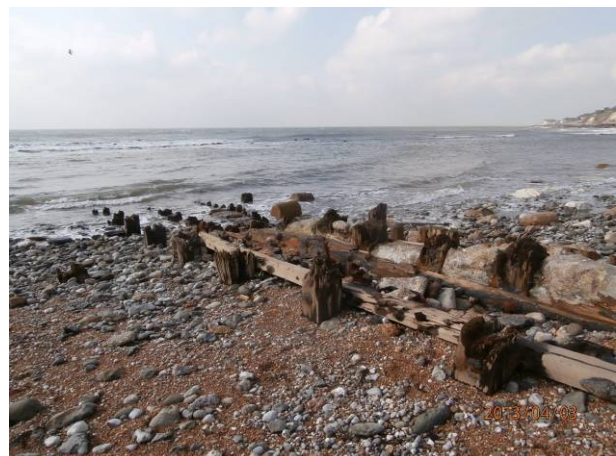
Low beach Levels – Ventnor Esplanade – Exposed Groyne Structures.

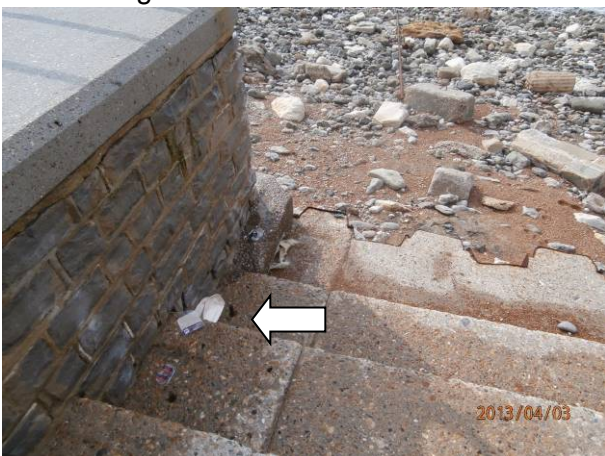
Protruding bar

Carefully remove and dispose of all loose / protruding metal work on the foreshore.  
Carefully trim and dispose of protruding timber groyne spikes.  
Ensuring no sharp edges remain.

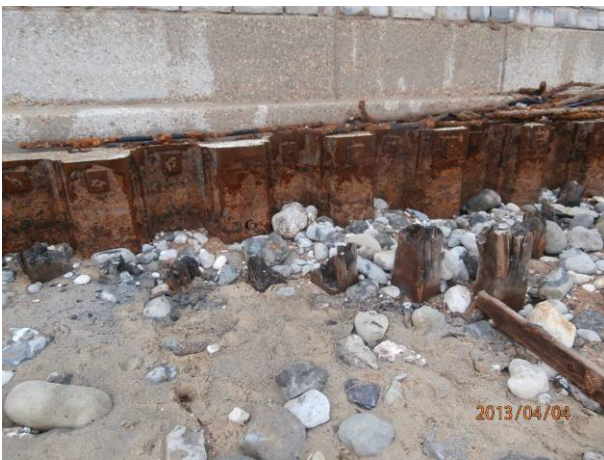
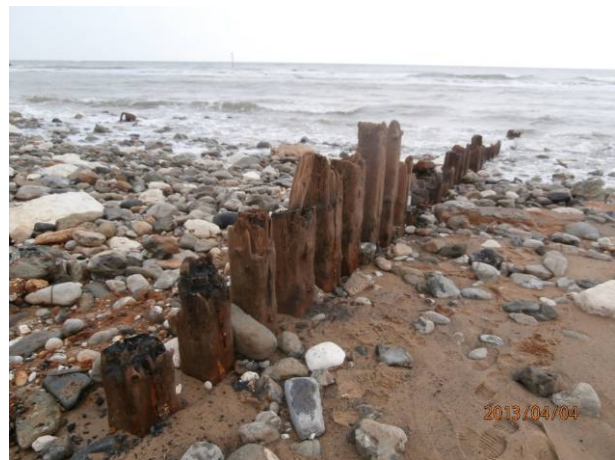
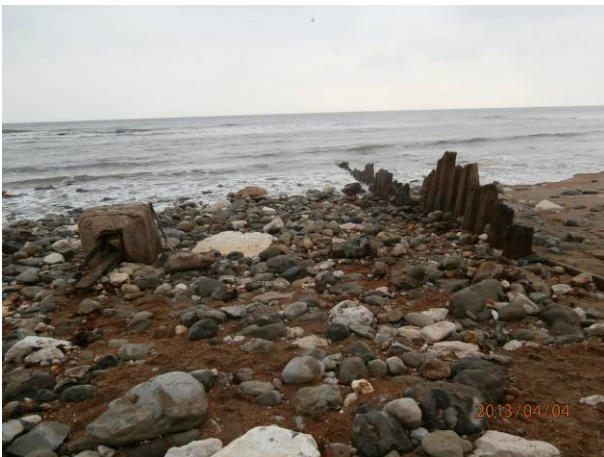
Material and protruding elements removed.

Observation closed

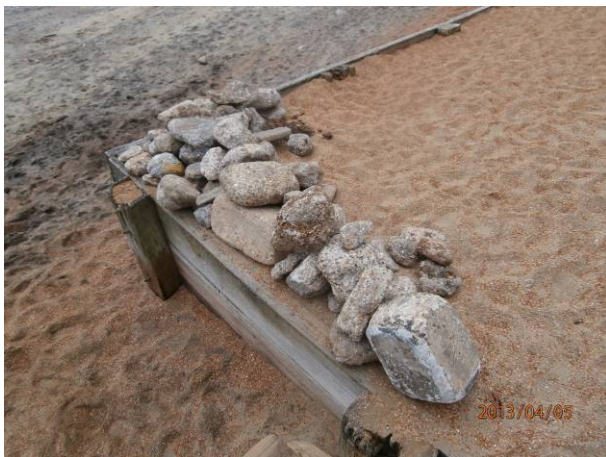
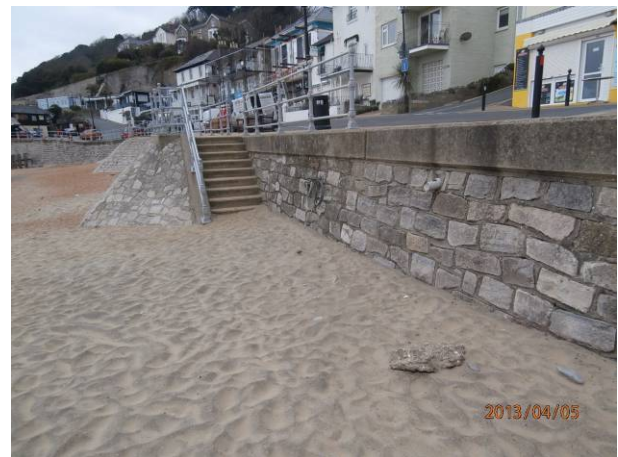
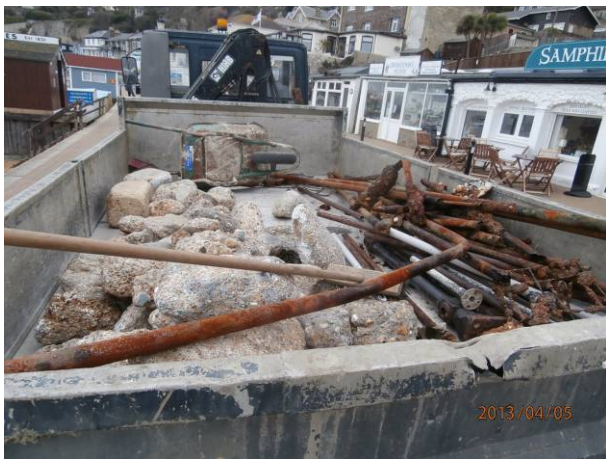
Second load of material removed from the foreshore

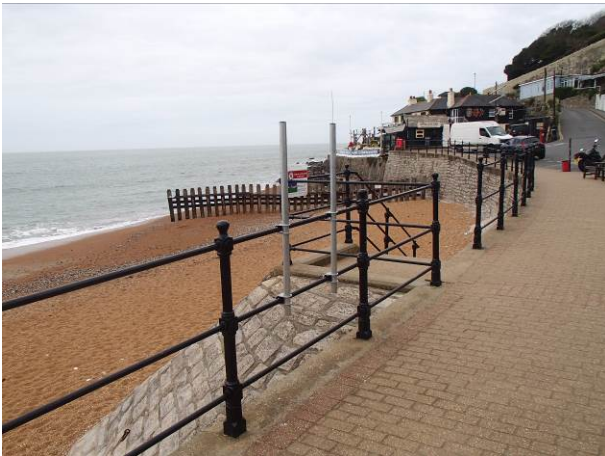
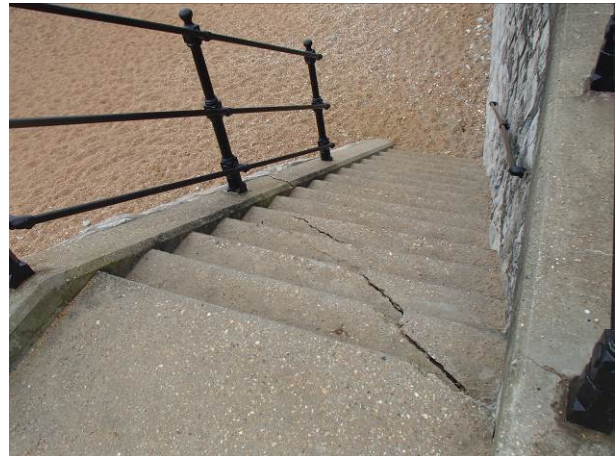
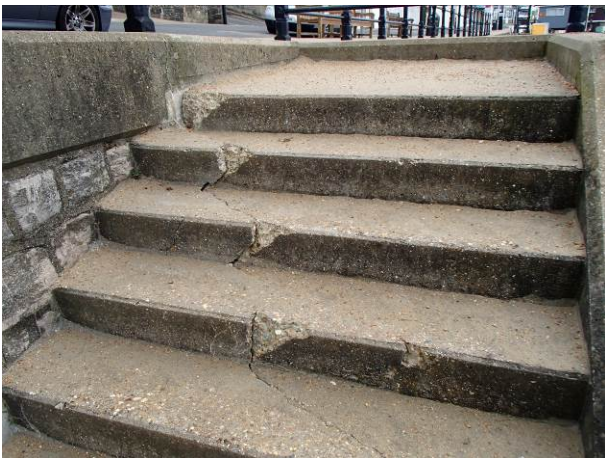
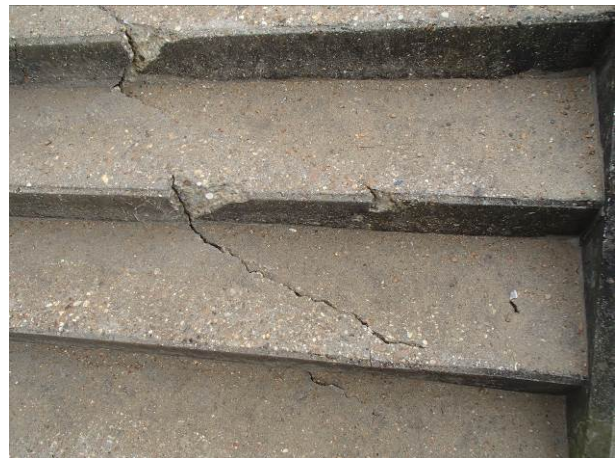
Condition of steps – Ventnor Esplanade

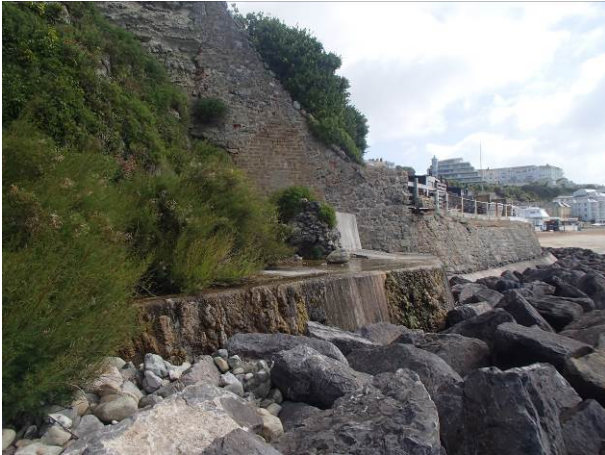
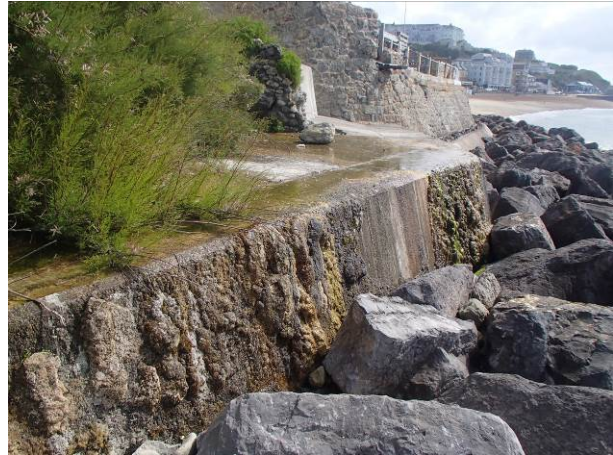
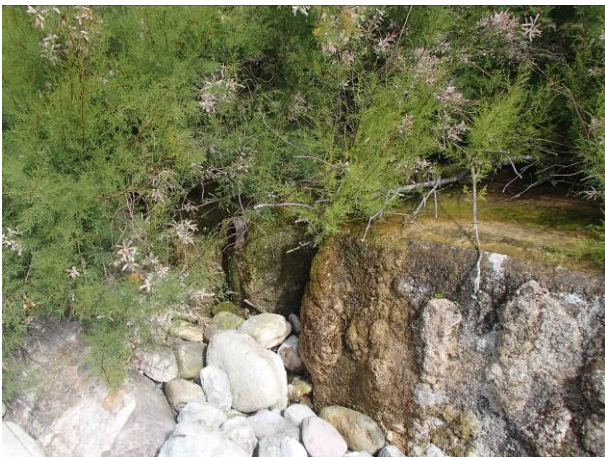
Running water appears to be exiting the cliff at two separate locations

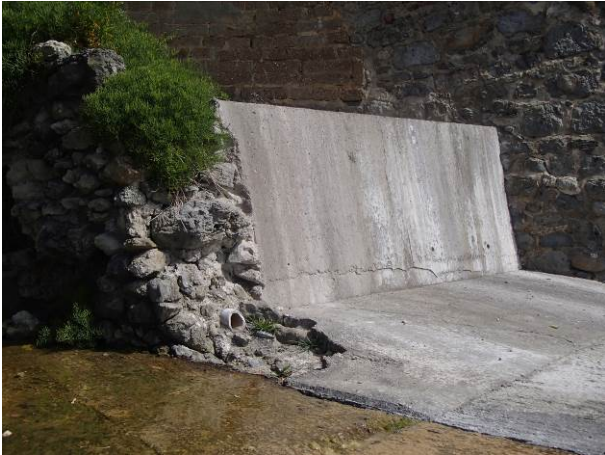
Old outfall pipe – no running water

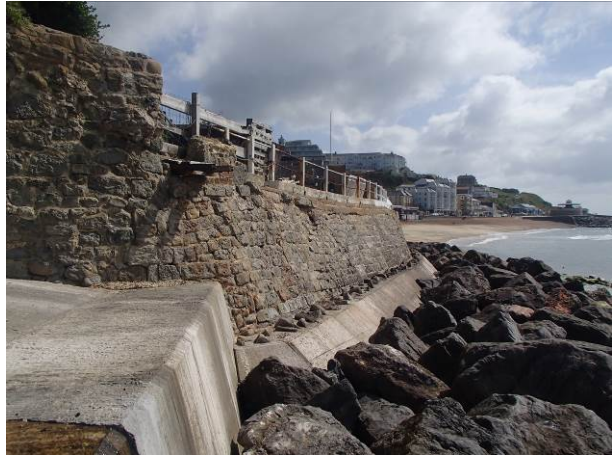
Spyglass - Stone masonry wall

**ACTION**  
Monitor

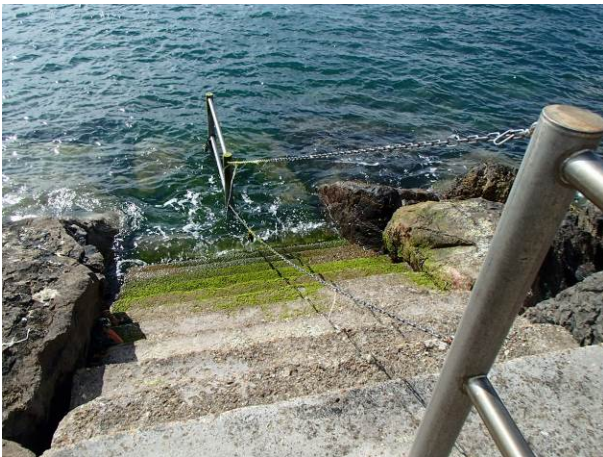
Castle Cove step block movement

Tight upper chain observed

Chain amended – Observation closed

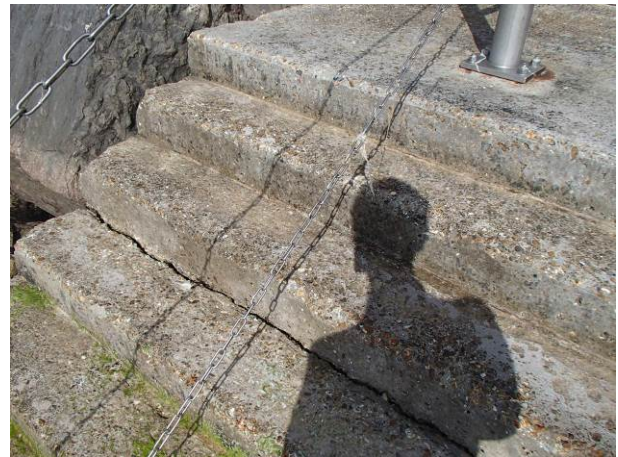
Cracked step block

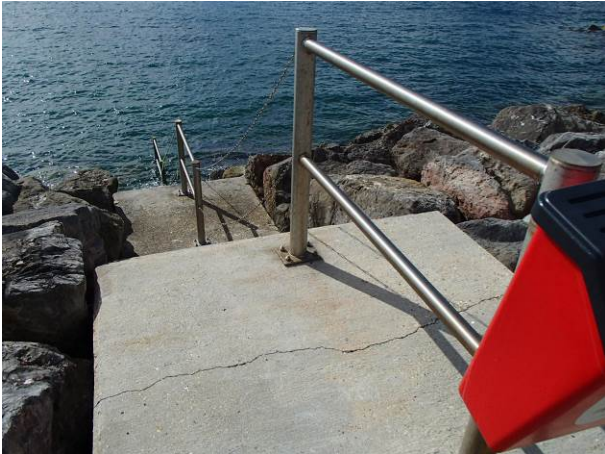
Cracked step block

Monitor
