Isle of Wight Council

Ventnor to Niton Options Study

Undercliff Drive Geotechnical Options Appraisal

December 2009

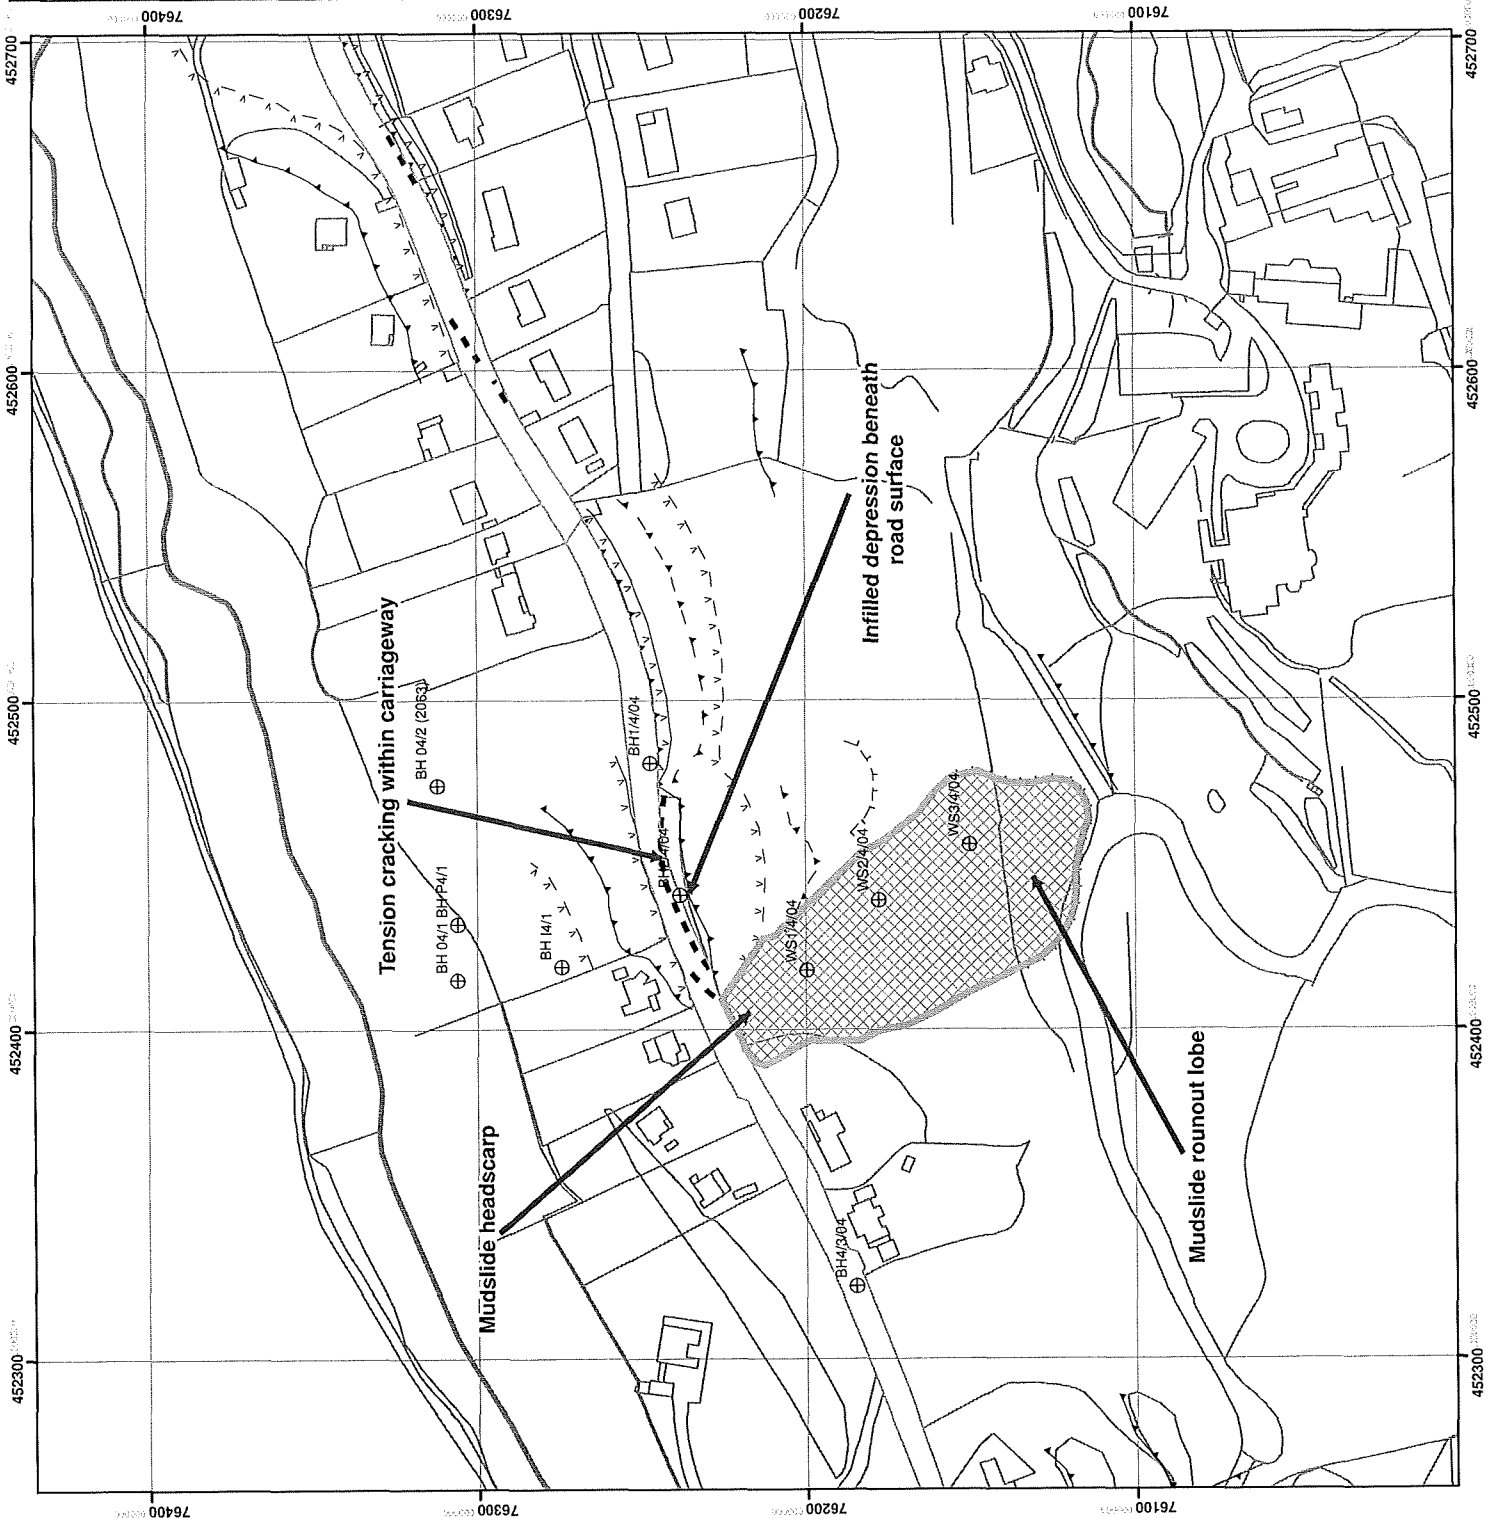
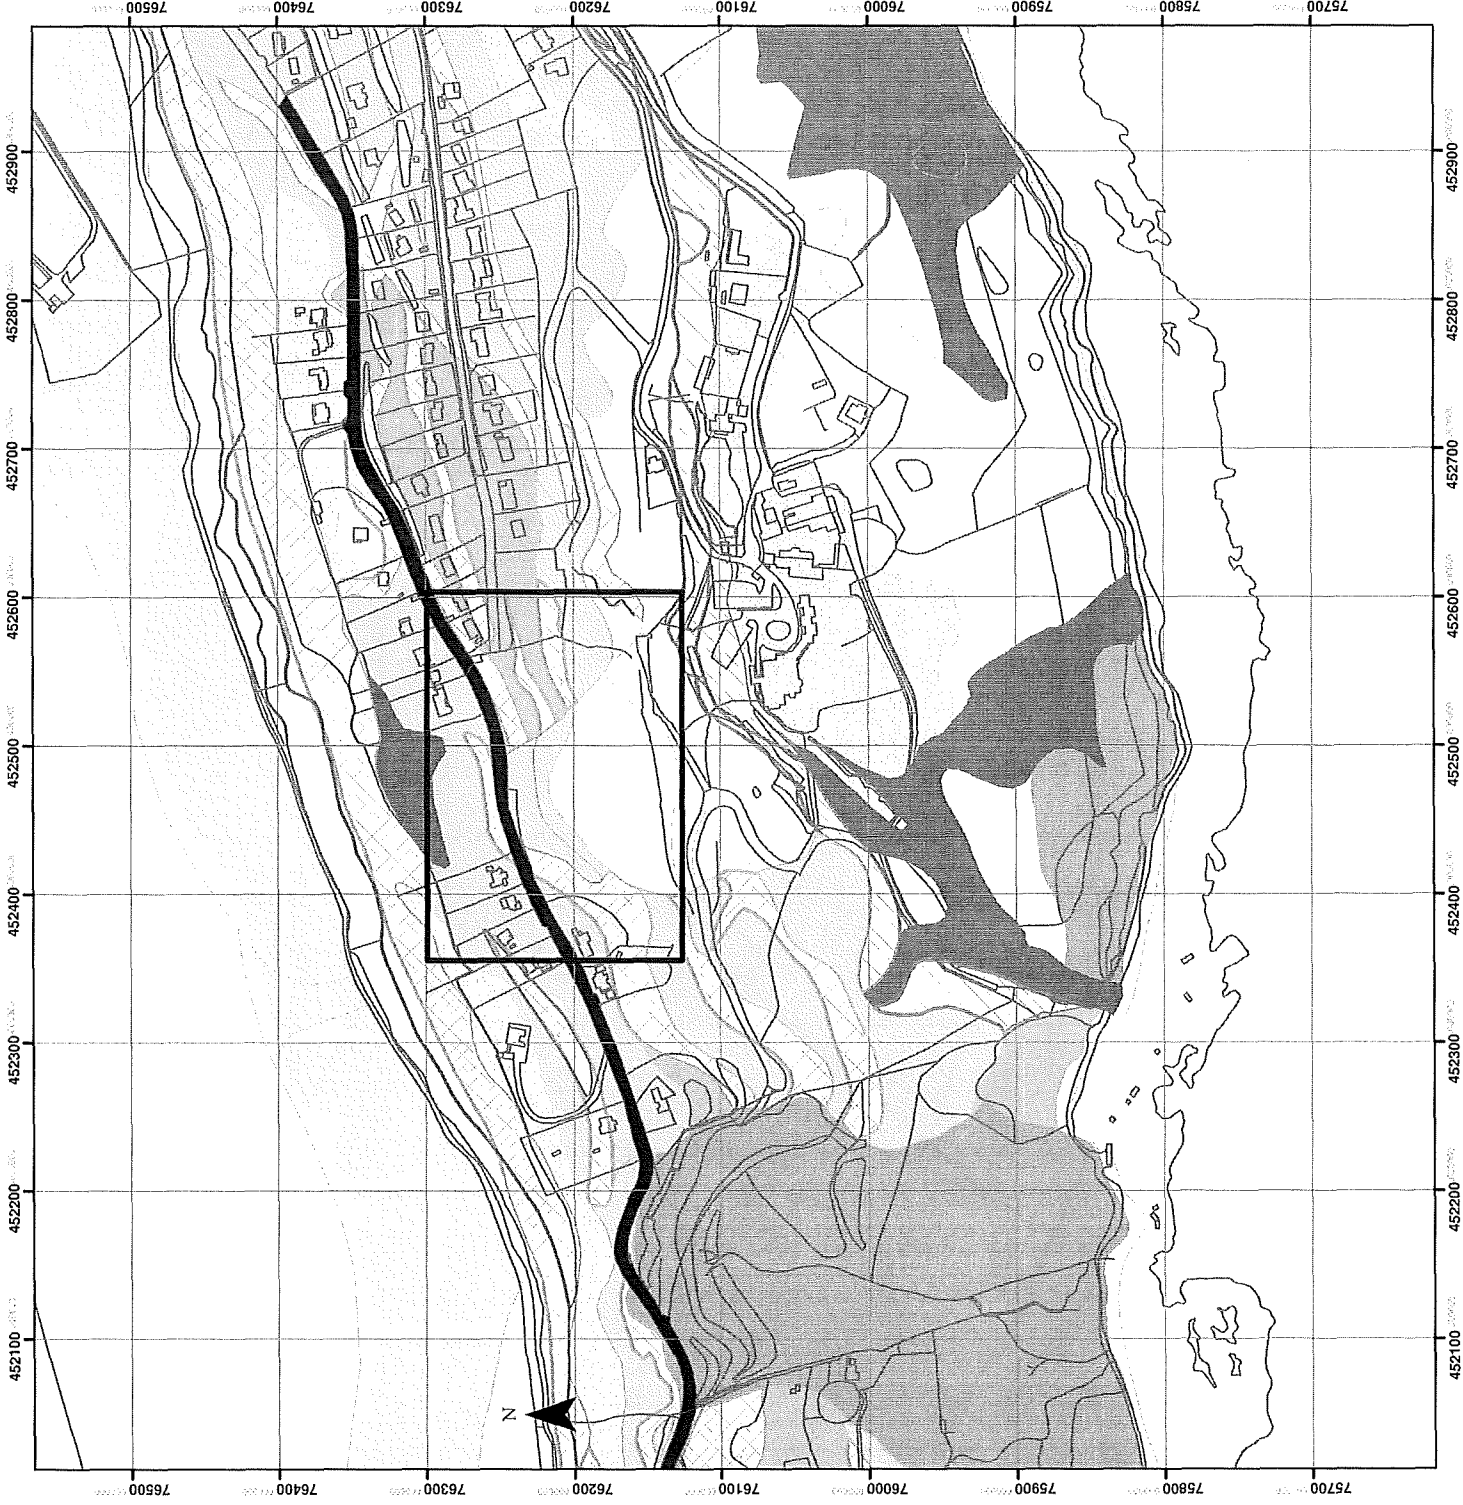
Figure 6.1. Area 4; Woodlands,
Site inspection map

The geomorphology of the Woodlands site is illustrated in Figure 6.1 and summarised in Table 6.1.
