# COASTAL LANDSLIP POTENTIAL ASSESSMENT:

## Isle of Wight Undercliff, Ventnor

## TECHNICAL REPORT

**GEOMORPHOLOGICAL SERVICES LIMITED,**

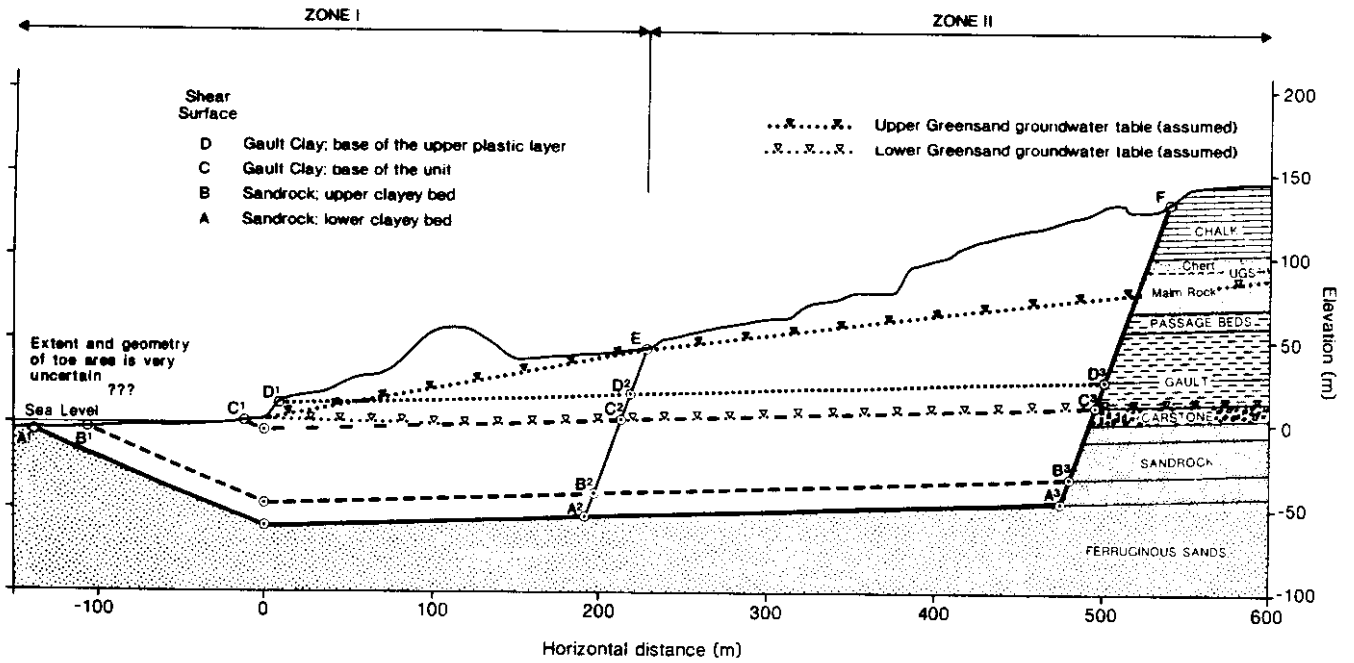
**Figure 5.7:** Preliminary stability analysis: cross-section from the Western Cliffs to Lowtherville showing the relative positions of possible shear surfaces and ground water levels.

A section of the Undercliff through the Western Cliffs and Lowtherville has been chosen for preliminary stability analyses, largely to test the validity of the proposed two-tier model. The section (Figure 5.7) shows the expected geology, four potential levels of basal slip surface, the piezometric surfaces for the assumed perched and confined groundwater tables and the main rear, intermediate and toe shears. Morphologically the section divides into the two main zones identified above. Zone I comprises a compound failure, seated in clay layers in the Sandrock and giving rise to the formation of the large elongate ridge in the Ventnor Park area (subsequent marine erosion has caused a series of rotational slides from the seaward flank of this ridge); Zone II consists of multiple rotational failures seated within the Gault, giving rise to the sequence of narrow terraces in Upper Ventnor, backed by the Lowtherville Graben.

Pore-water pressures are taken as hydrostatic beneath the piezometric line (PL) for the perched groundwater table in the Upper Greensand and landslide masses, and hydrostatic beneath the PL for the confined groundwater table in the Lower Greensand. Within the Gault, the higher value of pore-pressure is taken.

Considering the large numbers of assumptions made in the analyses, it is encouraging that the Factors of Safety fall generally quite near to the expected value of, or a little above, unity. This suggests that the proposed models are reasonably valid. While too much confidence should not be placed on the precise values in the Table, there is some tendency for the deeper slip surfaces to be more critical. A consideration of all available factors points to the likelihood of the main failure surfaces in this part of Ventnor being seated in a clay layer within the Sandrock in the seaward Zone I, and rising to a surface within the Gault in the landward Zone II.

**Table 5.1** Results of preliminary stability analyses for the Western Cliffs-Lowtherville section, Ventnor. For details of shear surface locations see Figure 5.7.

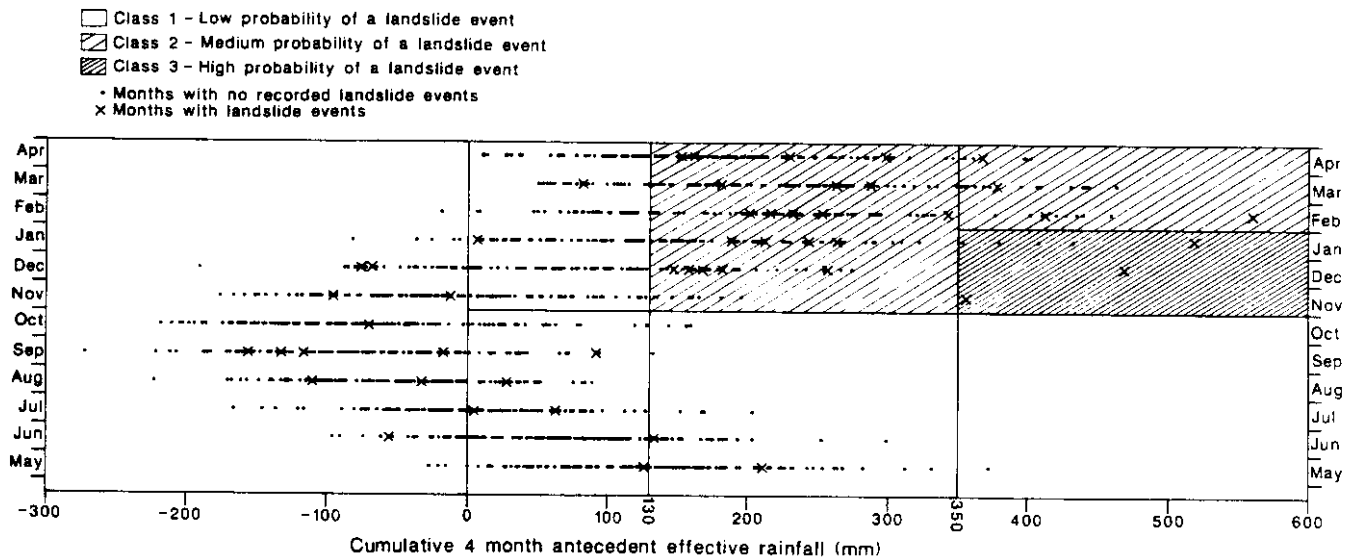
Figure 6.1: The relationship between antecedent effective rainfall and landslide activity.

Very wet conditions in the autumn are clearly a highly significant factor in explaining the frequency of landslide activity over the last 135 years, with over 80% of all recorded landslide events having occurred during periods when the 4-month AER exceeded 130mm. However, this relationship does not account

**Ten main periods of landslide activity have been identified since 1800 (Chapter 2), separated by periods of apparent stability.** It is widely appreciated that they correspond to periods of heavy winter rainfall and coastal erosion. As much of the coastline is now protected it is unlikely that present coastal retreat has a significant influence on promoting future ground movement in Ventnor (although erosion of the shore platform may remain an important factor). There does appear to be a close relationship between landslide activity and periods of high antecedent rainfall conditions. A comparison of the 4-month antecedent effective rainfall (AER) for months when landslide events were either reported or absent suggests that, since 1855 (the date when newspaper records began), the occurrence of ground movement can be defined by three broad classes (Figure 6.1):

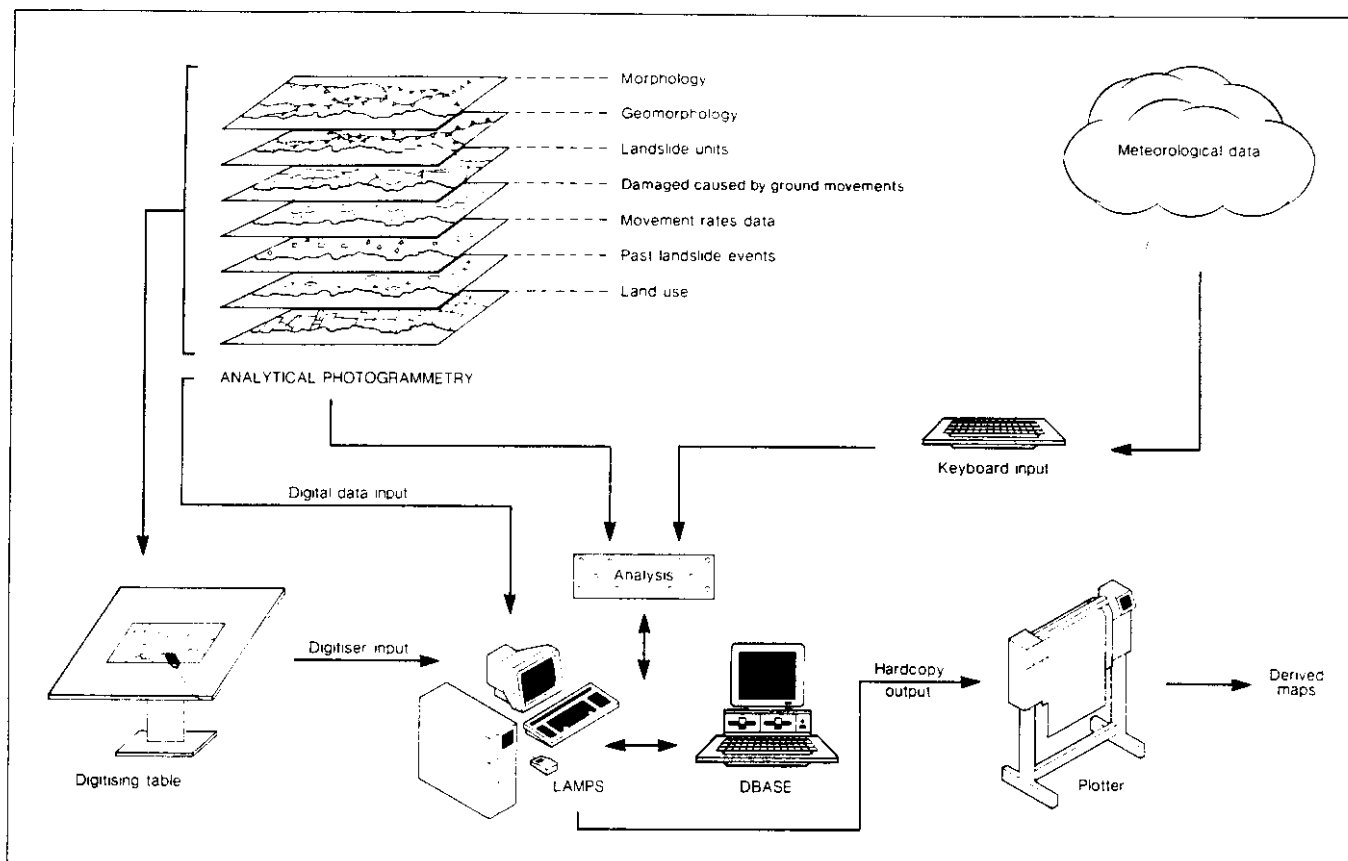
Figure 6.4: Schematic representation of the Geographical Information System

This can lead to misunderstandings and unnecessary alarm amongst those the maps are intended to help, namely the general public. For these reasons this study has attempted to avoid subjective scales and has concentrated on analysing and presenting the wealth of available objective information on movements within the town. A computerised Geographical Information System (GIS) (Figure 6.4) has been used to provide a means for the analysis of the following data sets:

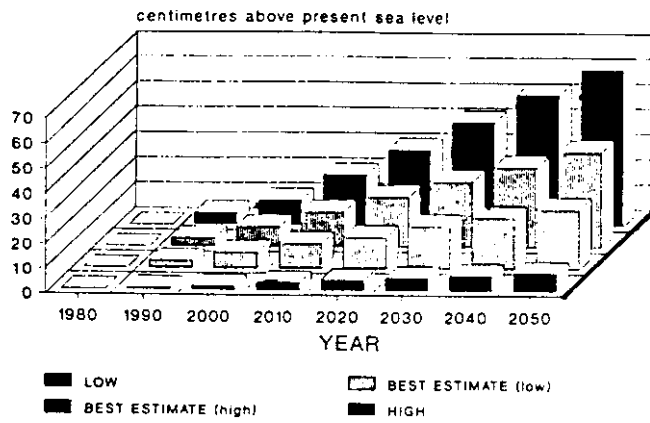
**Figure 7.3:** Estimates of global sea-level rise (after Warrick et al, 1989)

- (ii) evaluating the possible effects of environmental change; although there remains great uncertainty about the effects of global warming, it is clear that significant changes could occur around Britain's coastline. A rise in sea-level is widely believed to be the inevitable result of the greenhouse effect (Doornkamp, 1990; Figure 7.3).
